Preliminary Contamination Assessment

216-234 Pacific Highway,
Charmhaven NSW.

NEW22P-0025-AA
18 February 2022

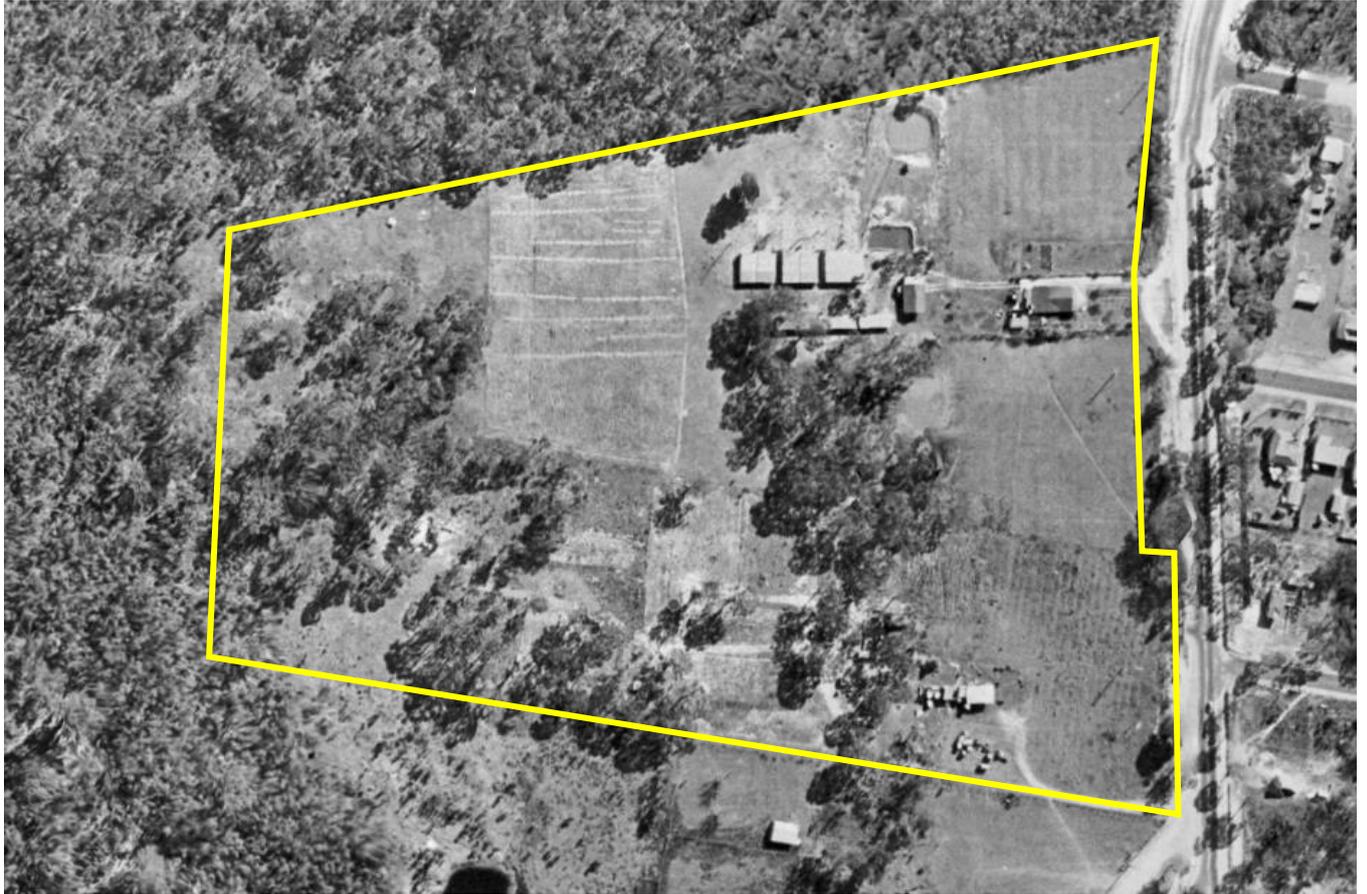
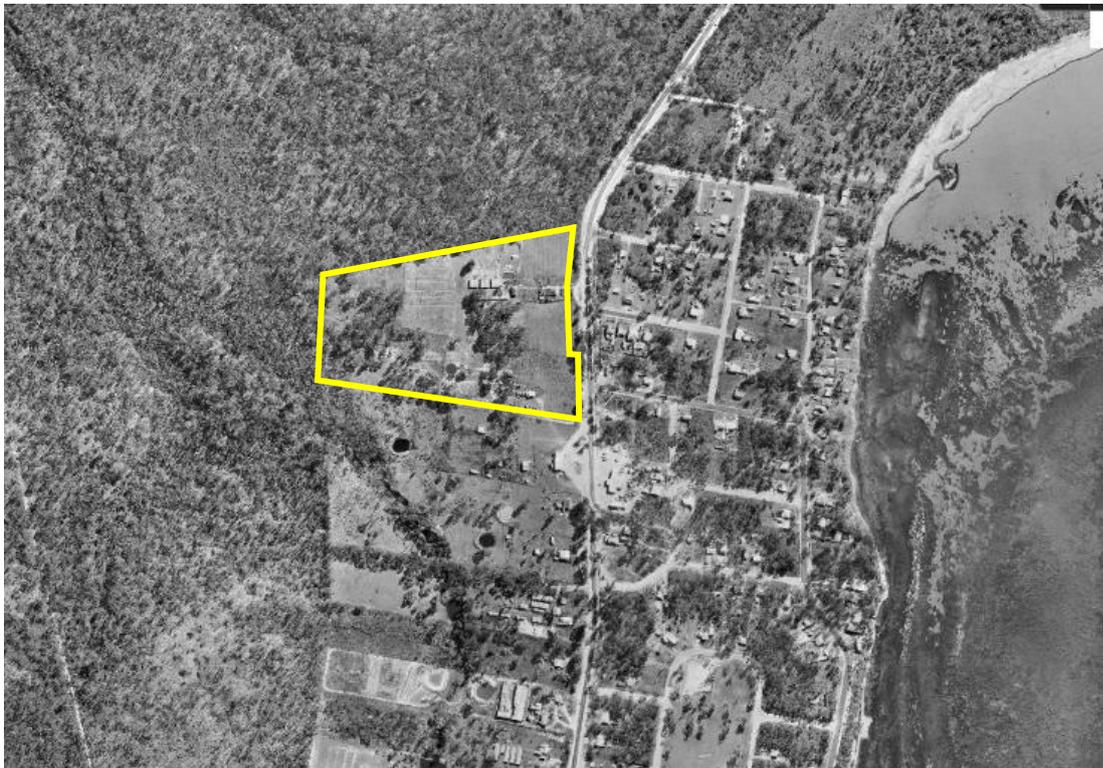
| Year | Site | Surrounding Land |
|---|--|--|
| 1965 | <p>The site appears to be rural residential land.</p> <p>Two rows of buildings/shed structures can be observed in the north-eastern area. Some land disturbance can be observed around the buildings/sheds. A dwelling with a driveway is observed in the north-eastern portion of the site. Two potential dams can be observed in the northern portion, with possible filling in the dam embankments.</p> <p>An additional building/structure can be observed in the south-eastern portion. There appears to be some stored materials, possibly hay bales, near the building to the west and south. Some access roads and land disturbance can be observed in the southern portion. A dam is present in the central western area of the southern portion.</p> <p>There may have been crops grown in the north-central portion of the site and southern portion of the site.</p> <p>The remainder of the site is either uncleared vegetation (trees) in the central and western portions, or grassed for farming purposes.</p> | <p>Dense bushland can be observed to the north and west.</p> <p>Rural residential properties can be observed to the south and rural residential/residential dwellings appear to have been constructed to the east.</p> <p>A possible service station can be observed about 30m south of the south-eastern site boundary.</p> |

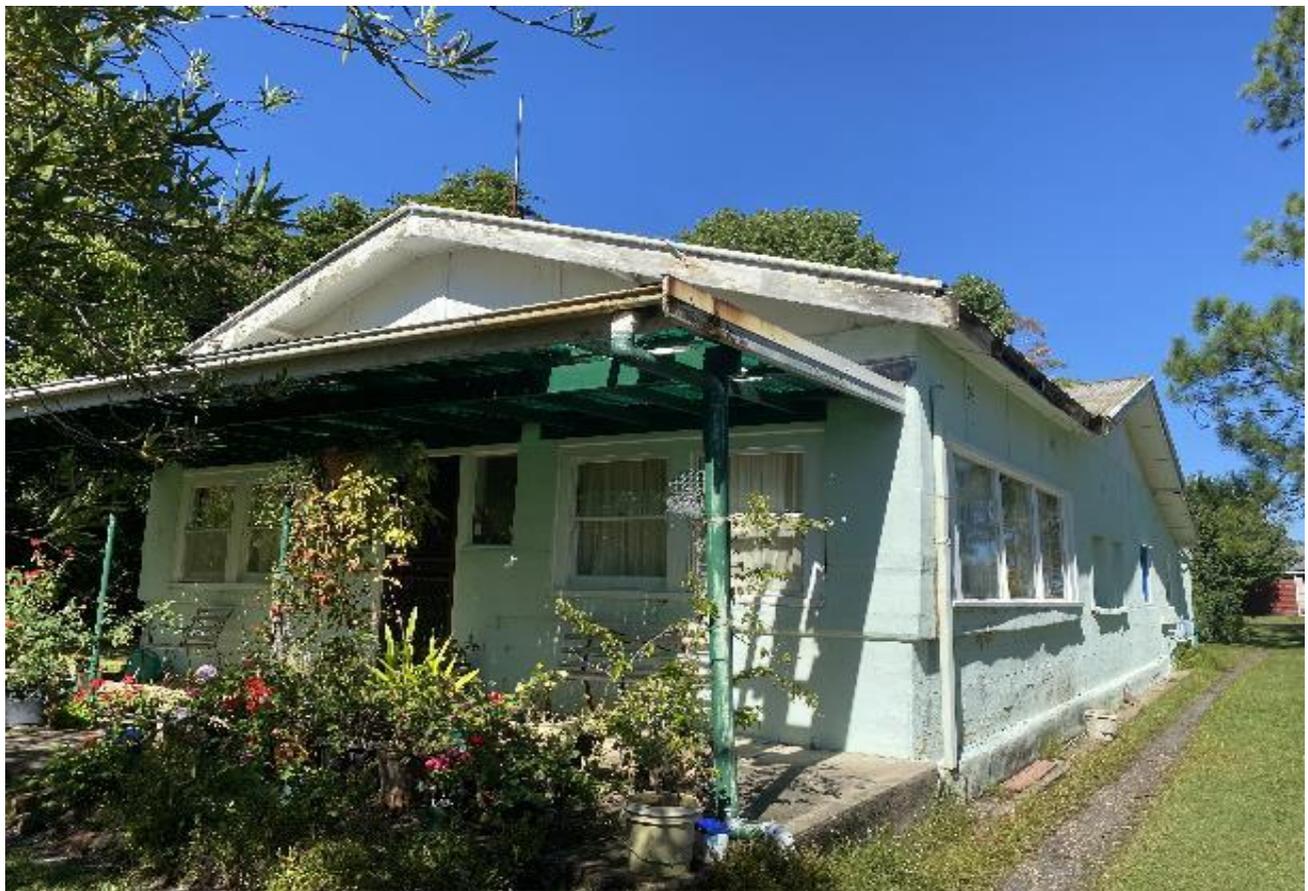
- A residential dwelling was observed in the eastern portion of the site. The dwelling was observed to have been constructed of concrete in the walls and the slab and a corrugated iron roof. A part gravel and grass driveway was observed running along the northern side of the house (see Photograph 1);

Photograph 1 - Showing rural residential dwelling.

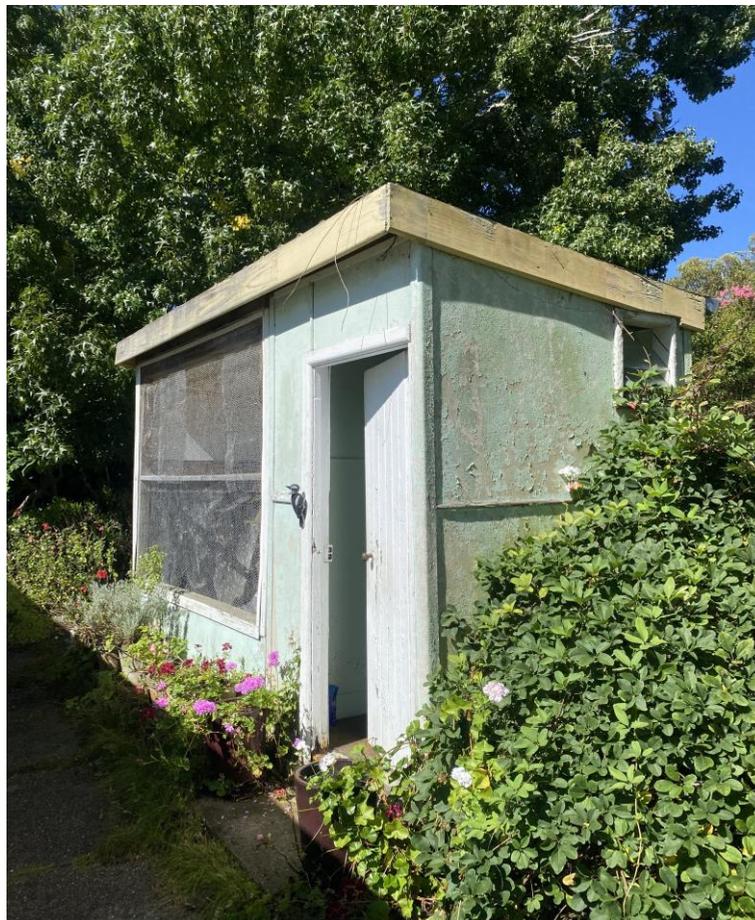
- Five sheds and animal enclosures were observed in the north-eastern portion of the site:
 - Shed 1 was observed to the west of the residential dwelling. The shed was observed to have been constructed with probable ACM and timber with some chicken wire in the window and a concrete slab floor. The shed appeared to be used as a bird aviary (see Photograph 2);

Photograph 2 - Shed 1.

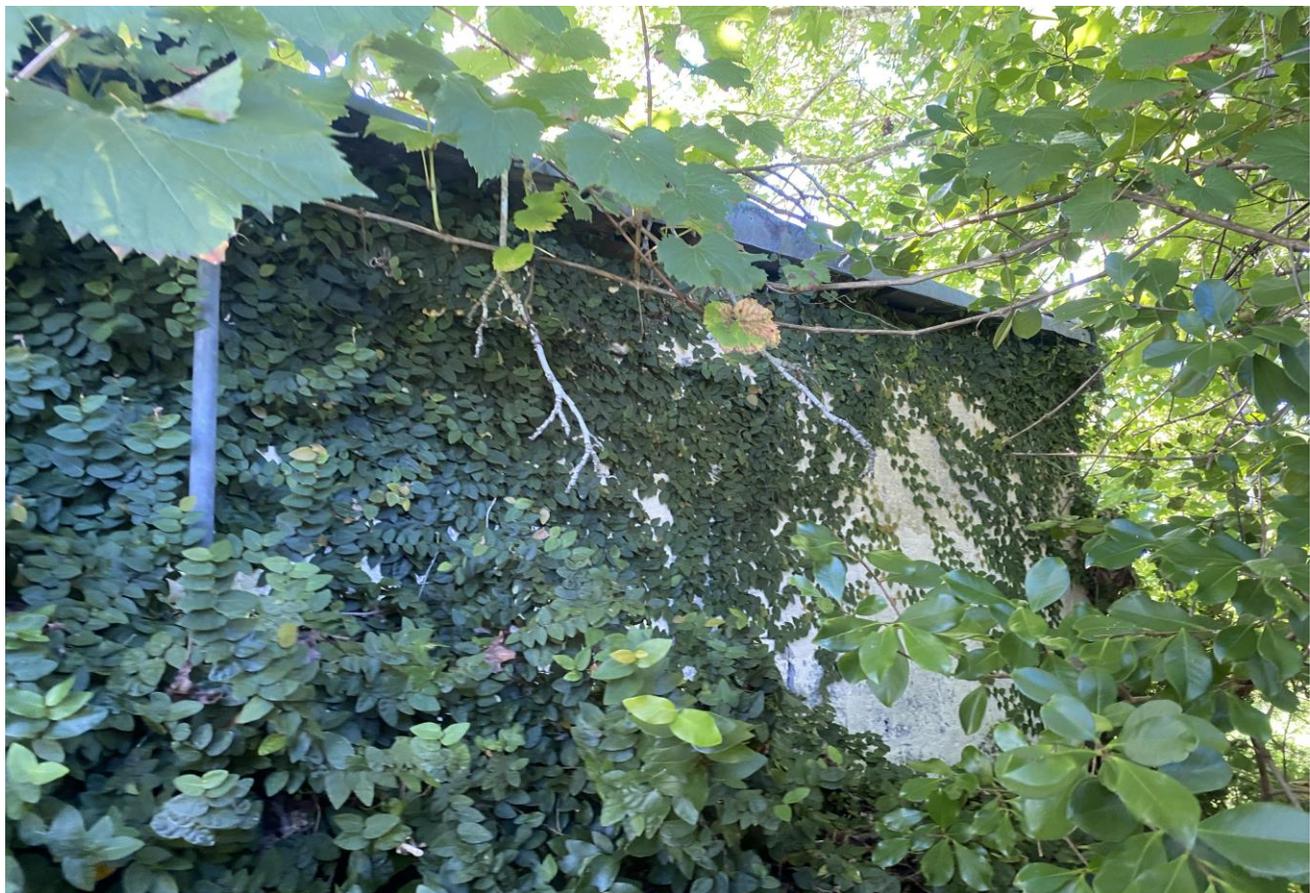
- Shed 2 was observed to the south of Shed 1. The shed was observed to have been constructed with a corrugated metal roof and concrete walls. Shed 2 was heavily overgrown with vegetation, restricting access and visual observations (see Photograph 3);

Photograph 3 - Shed 2.

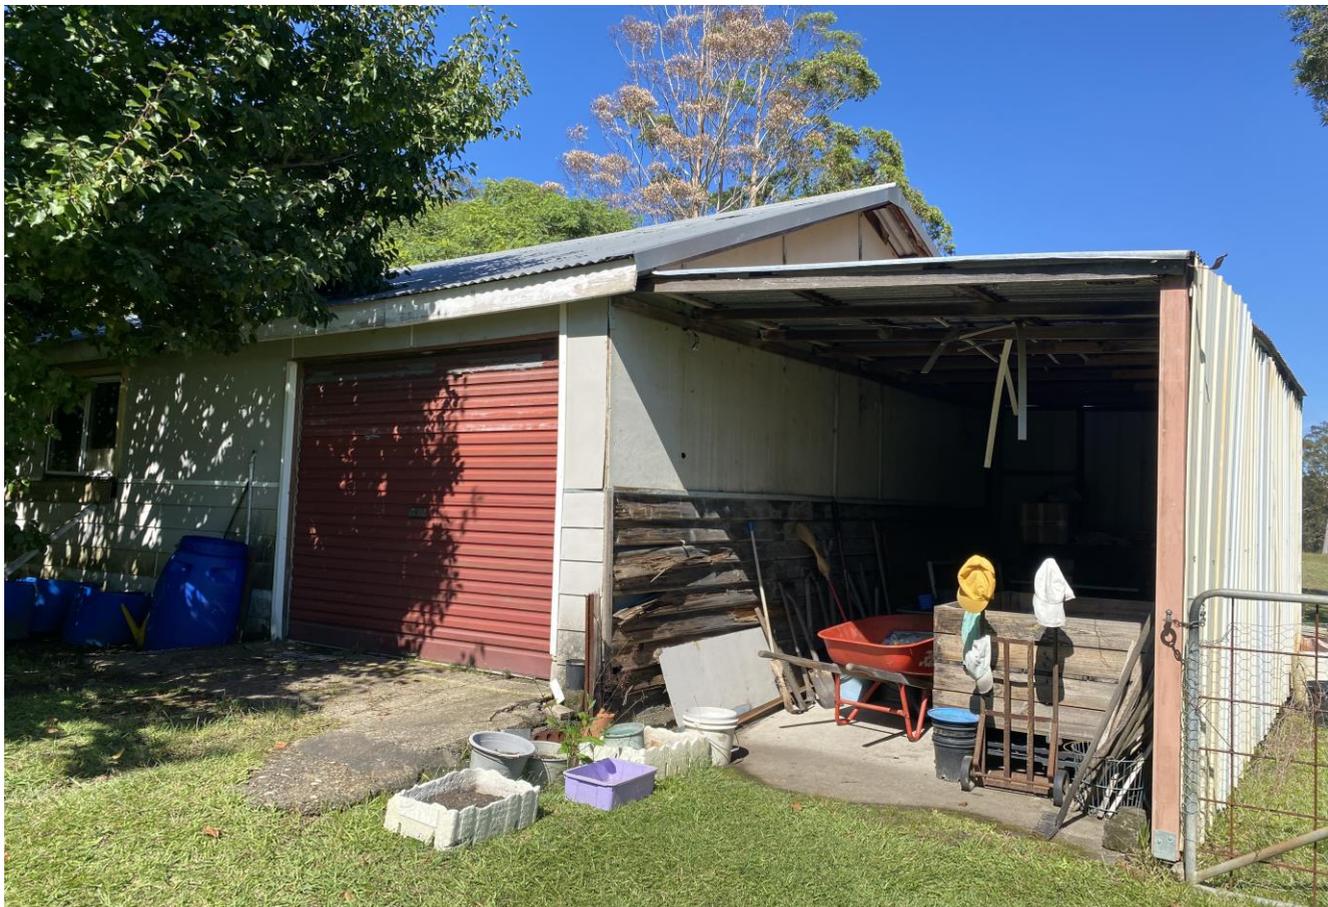
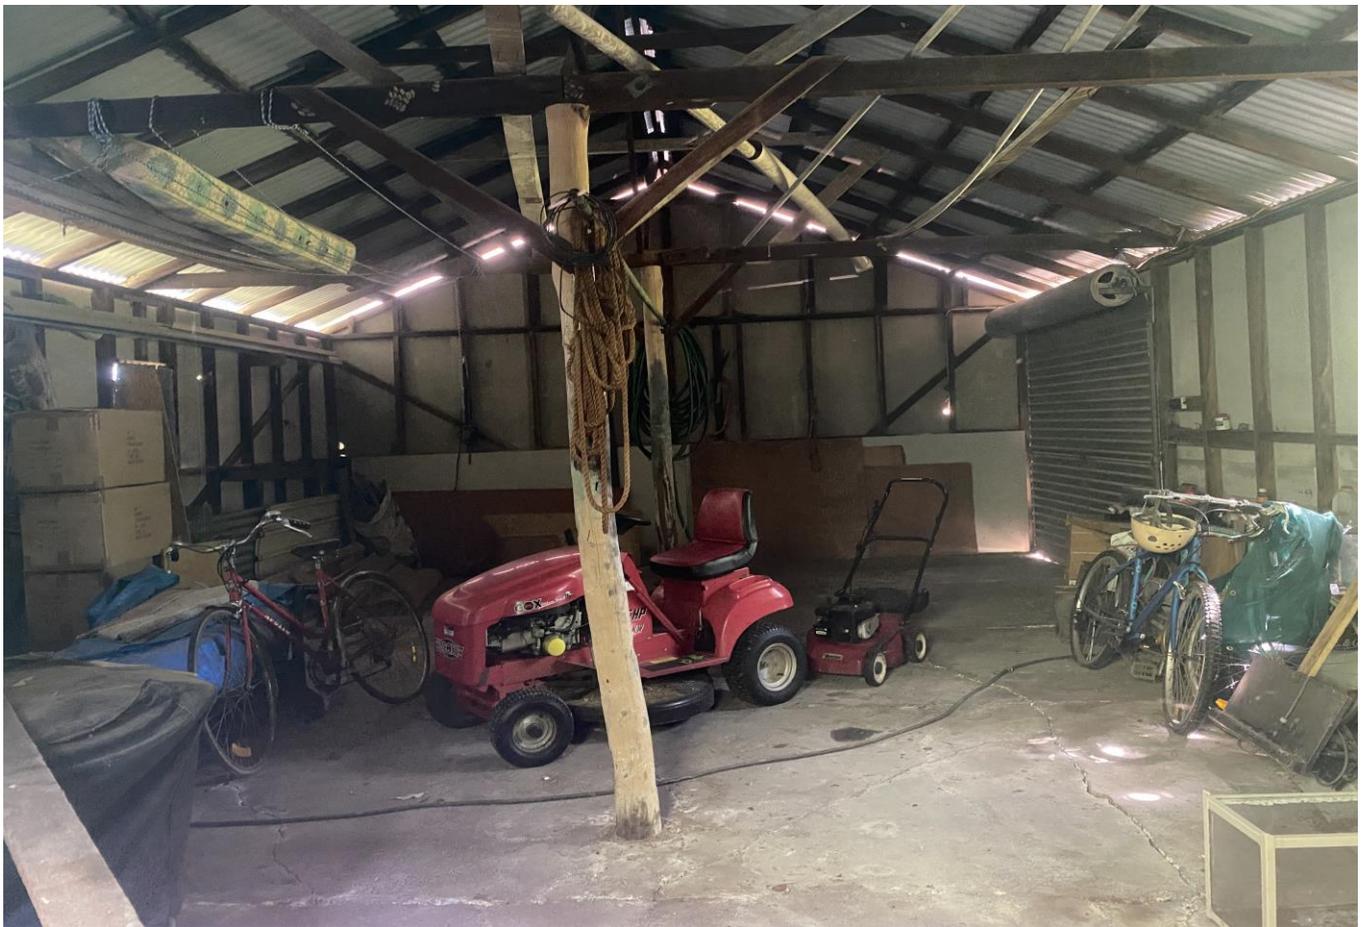
- Shed 3 was observed to the west of Shed 1. The shed was observed to have been constructed with probable ACM, weatherboards, timber, glass windows, corrugated steel roof and a concrete slab floor in relatively good condition. Shed 3 was observed to be primarily used to store gardening equipment such as lawn mowers, pots, picks, shovels, wheel barrows, as well as some timber furniture, push bikes, and cardboard boxes. A sheet of probable ACM was observed leaning against the southern outside wall of the shed (see Photographs 4 and 5);

Photograph 4 - Shed 3.

Photograph 5 - Inside of shed 3.

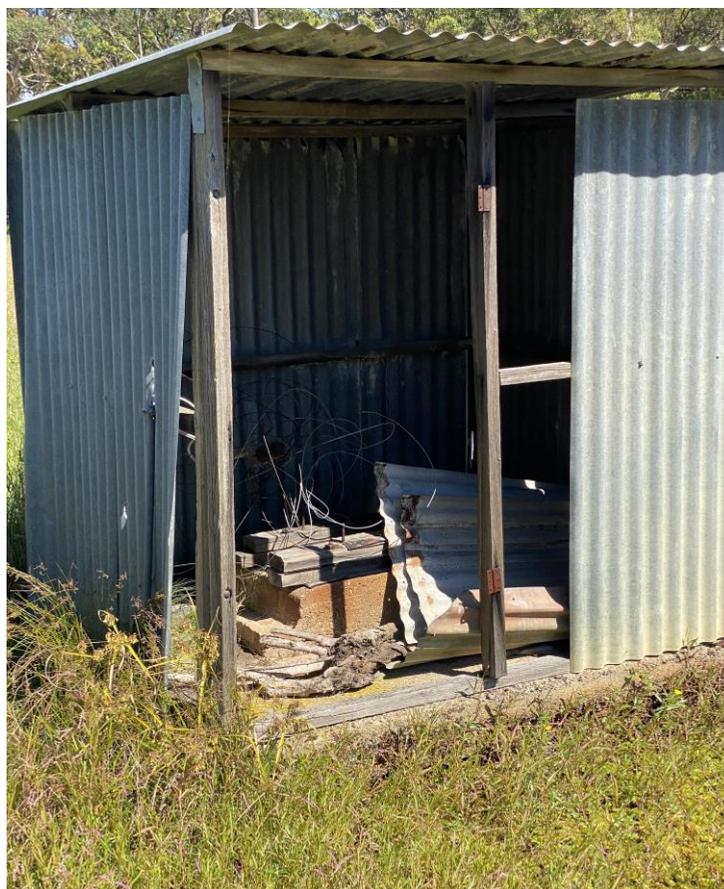
- Shed 4 was observed on the southern bank of Dam 1. The shed was observed to be constructed of corrugated iron and timber. The shed was observed to comprise of concrete, steel, timber, wire and corrugated iron, possibly used to store pumps associated with the dam (see Photograph 6);

Photograph 6 - Shed 4.

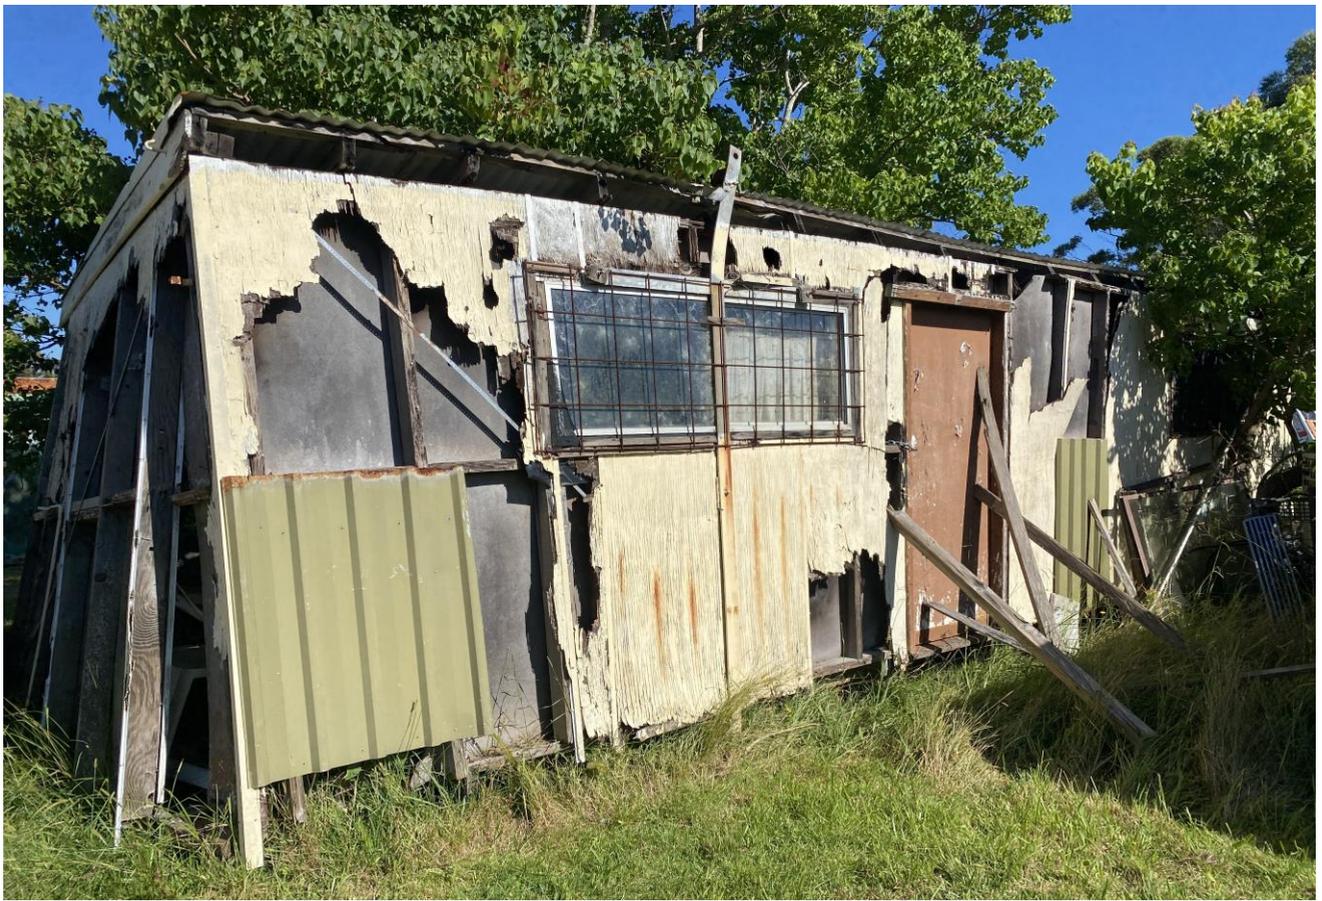
- Shed 5 was observed in the south-eastern portion of the site. The shed was observed to be derelict and appeared to be constructed of probable ACM sheeting walls inside and timber on the outside, corrugated steel roofing and glass windows. The shed appeared to be used to store materials which are unknown as the shed was very dilapidated, and entry was deemed unsafe (see Photograph 7);

Photograph 7 - Shed 5.

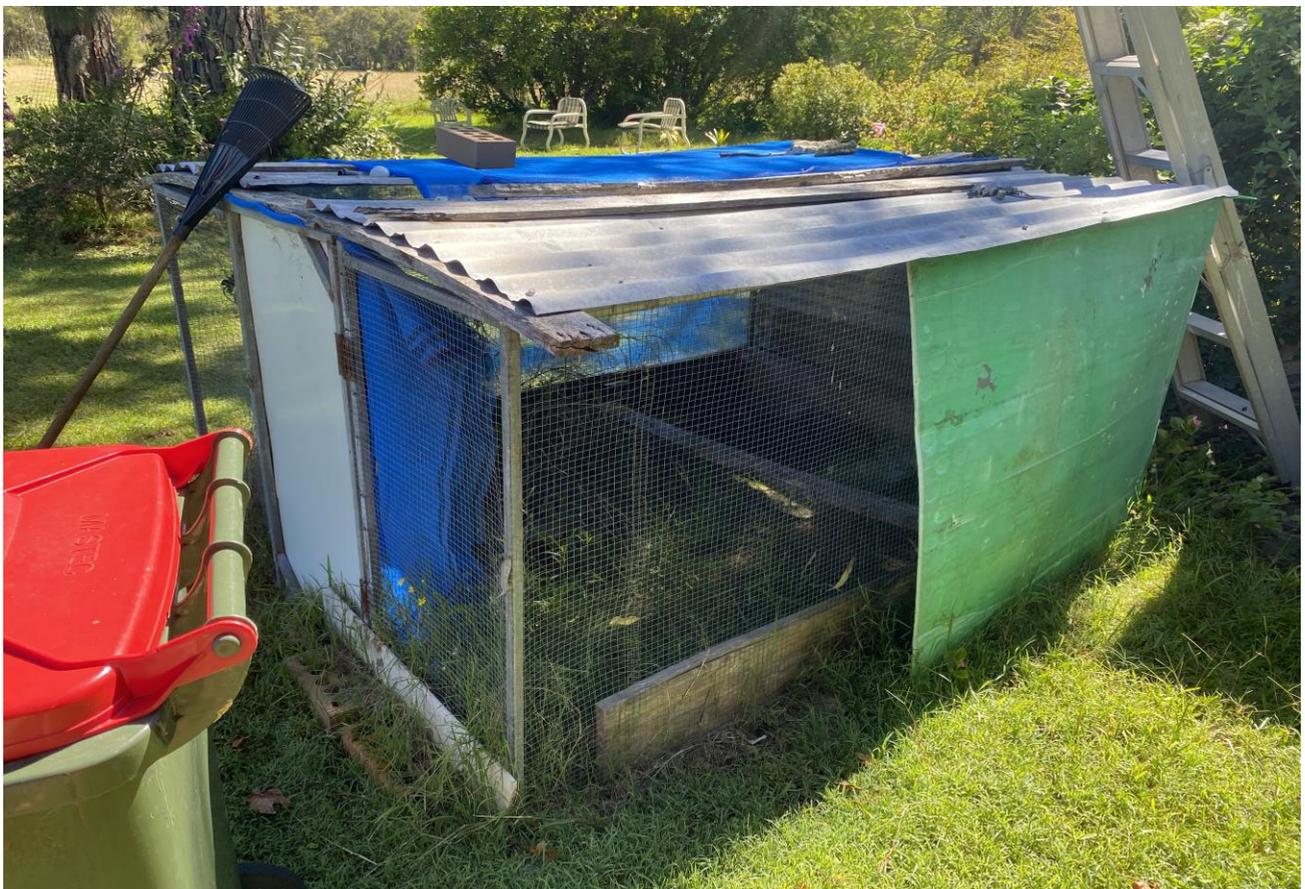
- An additional small structure/animal enclosure was observed west of Shed 1 and was observed to be constructed of mesh wire, corrugated steel roof, plastic tarp, timber and steel with some possible ACM. The structure appeared to have been formerly used as an enclosure for rabbits or other small animals (see Photograph 8);

Photograph 8 - Animal enclosure.

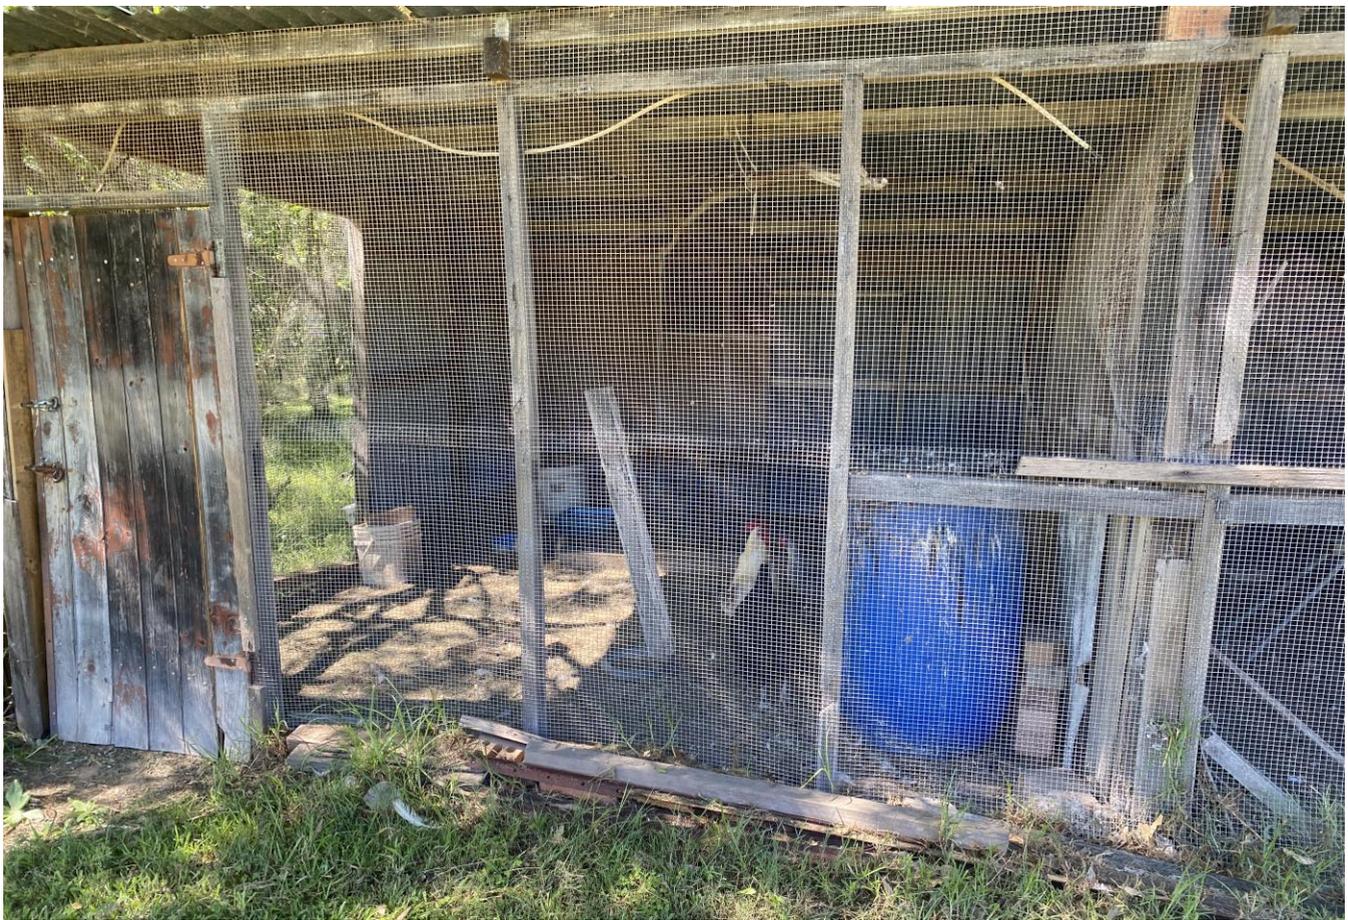
- A chicken coop was observed approximately 40m west of Shed 1. The chicken coop appeared to be constructed of a timber frame, steel mesh walls, corrugated iron roof and an earthen floor. The chicken coop was used to house chickens, buckets, loose timber and some 44-gallon drums (potentially containing chicken feed) (see Photograph 9);

Photograph 9 - Chicken coup.

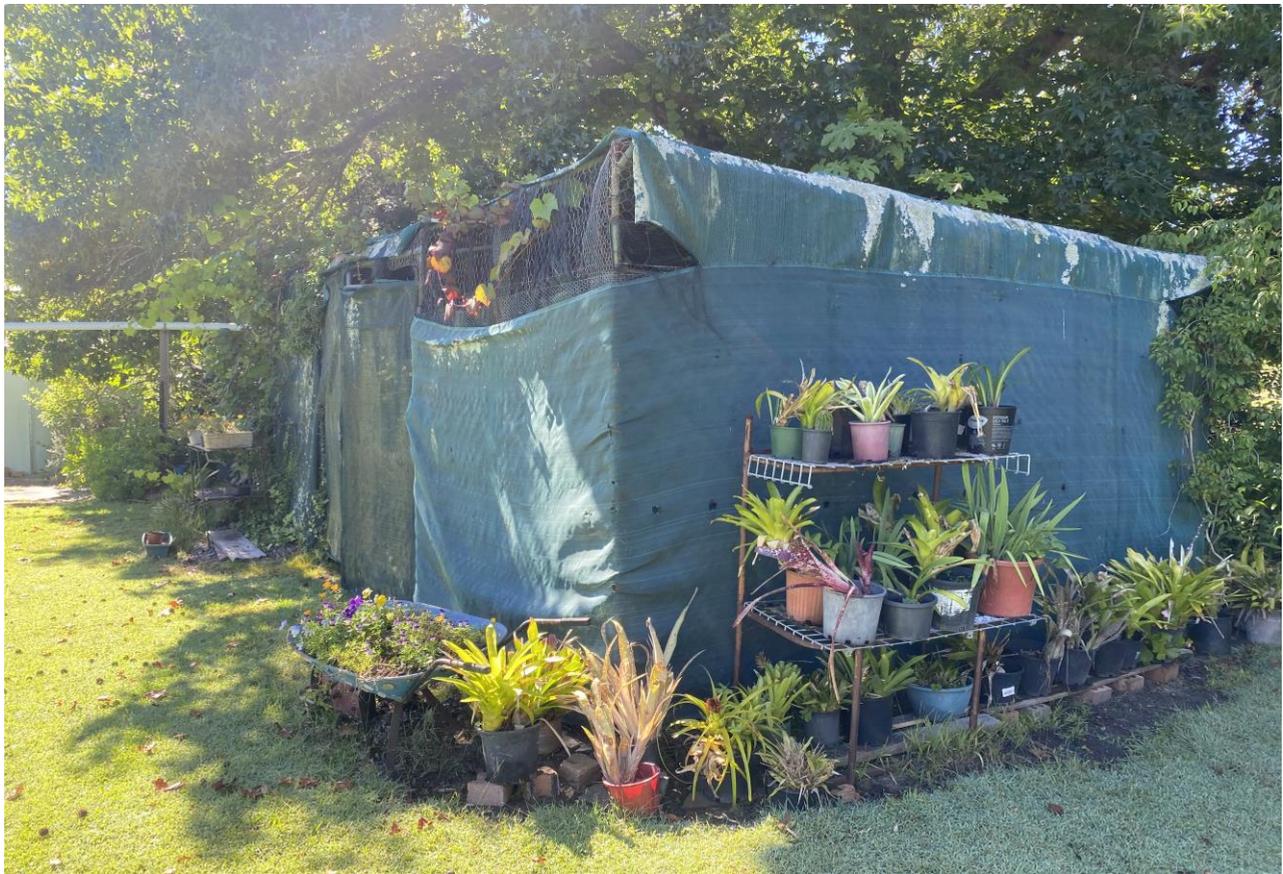
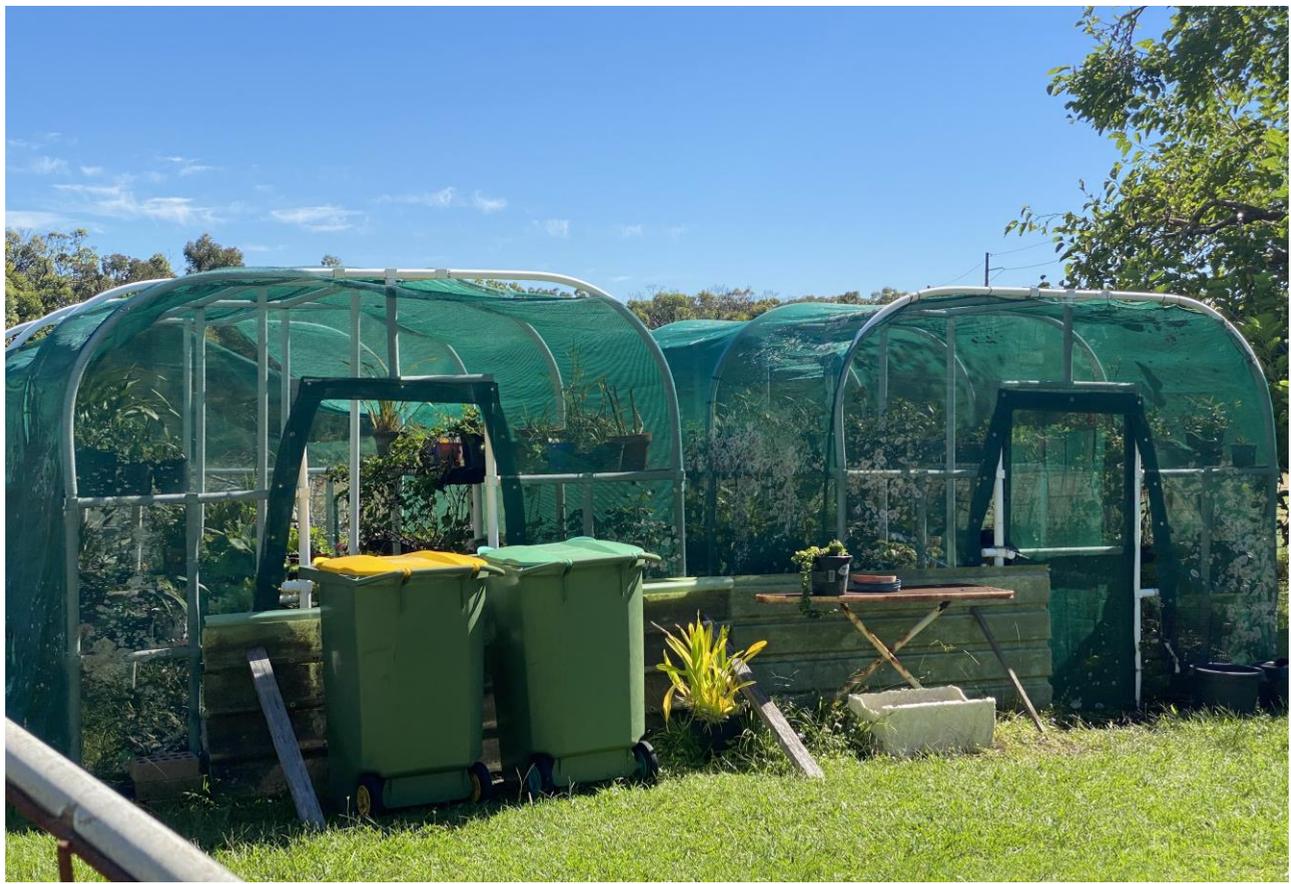
- Three greenhouses were observed in the north-eastern portion of the site. Greenhouse 1 was observed in the eastern portion of the site, approximately 20m south-west of the residential house. Greenhouses 2 and 3 were observed approximately 40m north-west of the residential house. The greenhouses appeared to be constructed of mesh wire, a steel frame, covered with a green shade cloth. The greenhouses comprised of an earthen floor and numerous plants (see Photographs 10 and 11);

Photograph 10 - Greenhouse 1.

Photograph 11 - Greenhouses 2 and 3

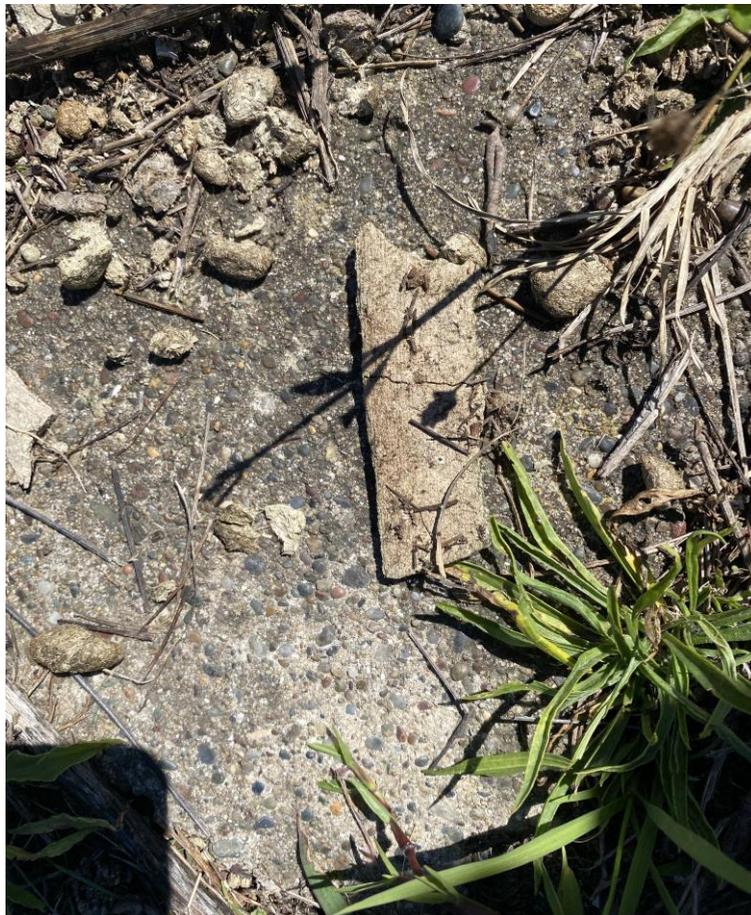
- An old concrete slab was observed approximately 90m west of the house, in the central northern portion of the site. Some loose probable ACM pieces were observed on top of the slab (see Photograph 12);

Photograph 12 - Loose ACM piece on old concrete slab.

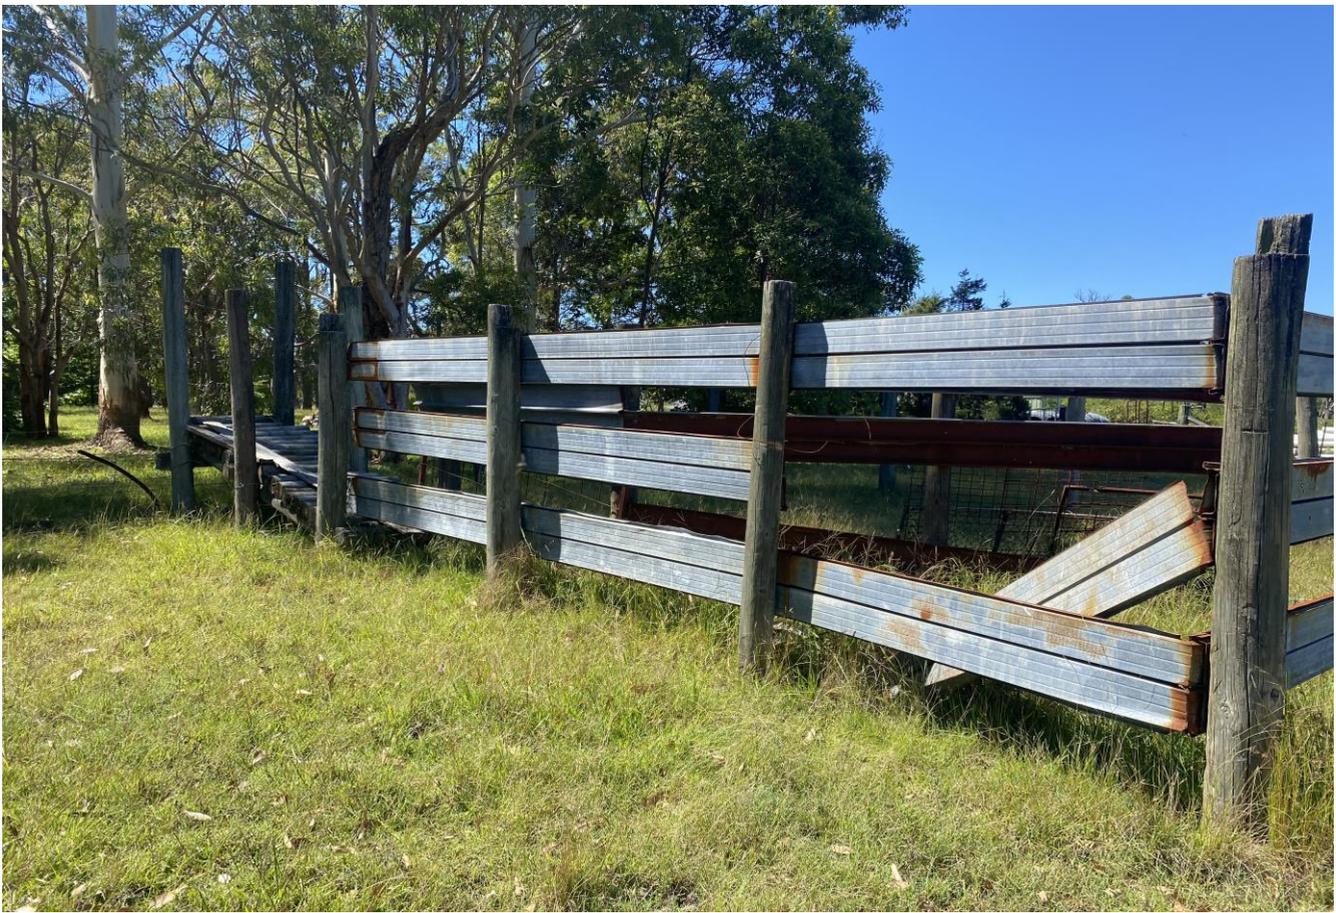
- A stock loading yard was observed in the central portion of the site and was observed to comprise of steel and timber (see Photograph 13);
- Two dams were observed on the site. Dam 1 was located in the north-eastern portion of the site and Dam 2 was located in the south-western portion of the site. The embankments of both dams appeared to comprise material sourced from the dam excavation. Both dams were overgrown with vegetation (see Photograph 14 and 15);

Photograph 13 - Stock loading yard.

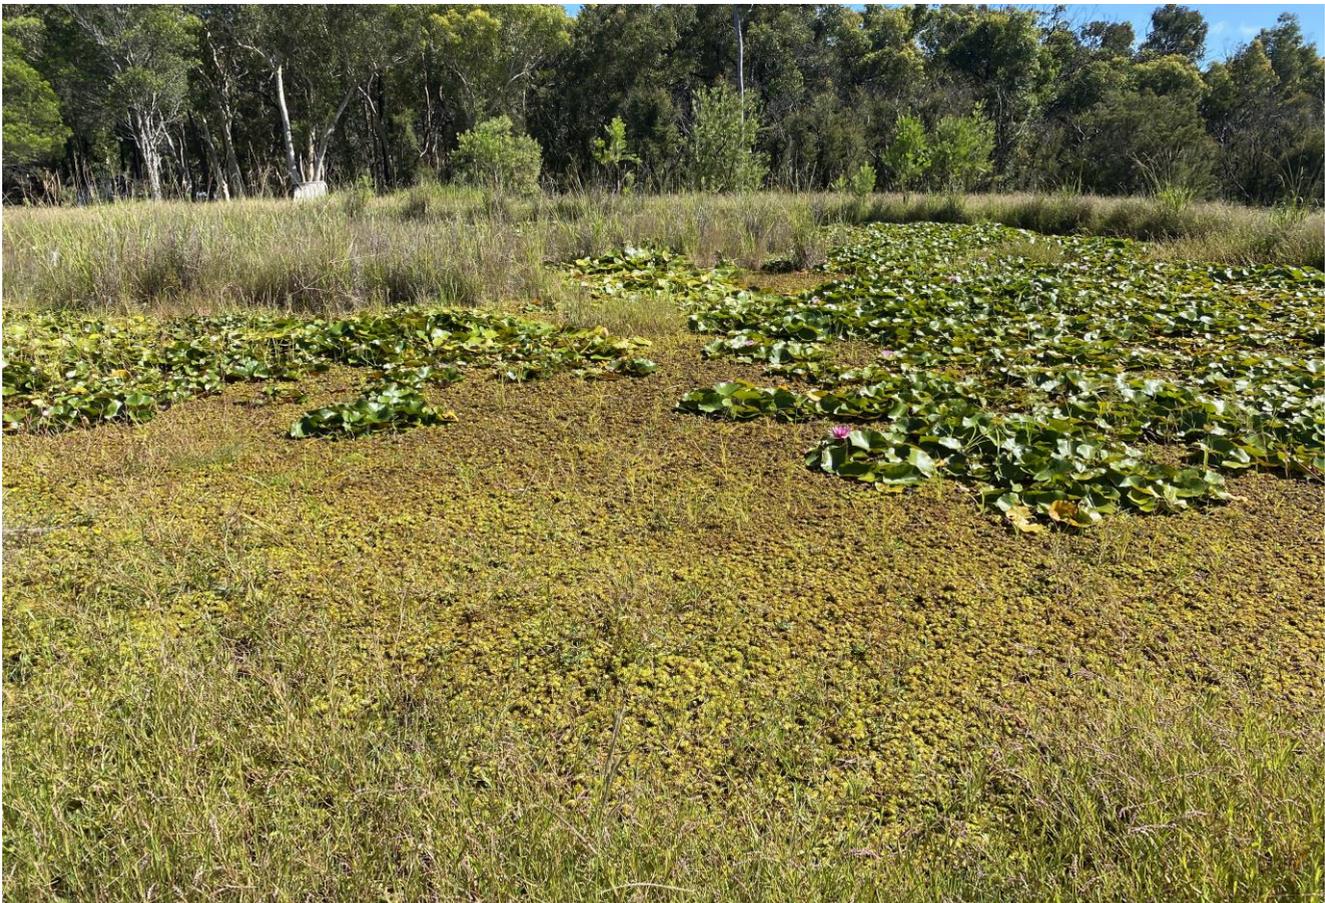
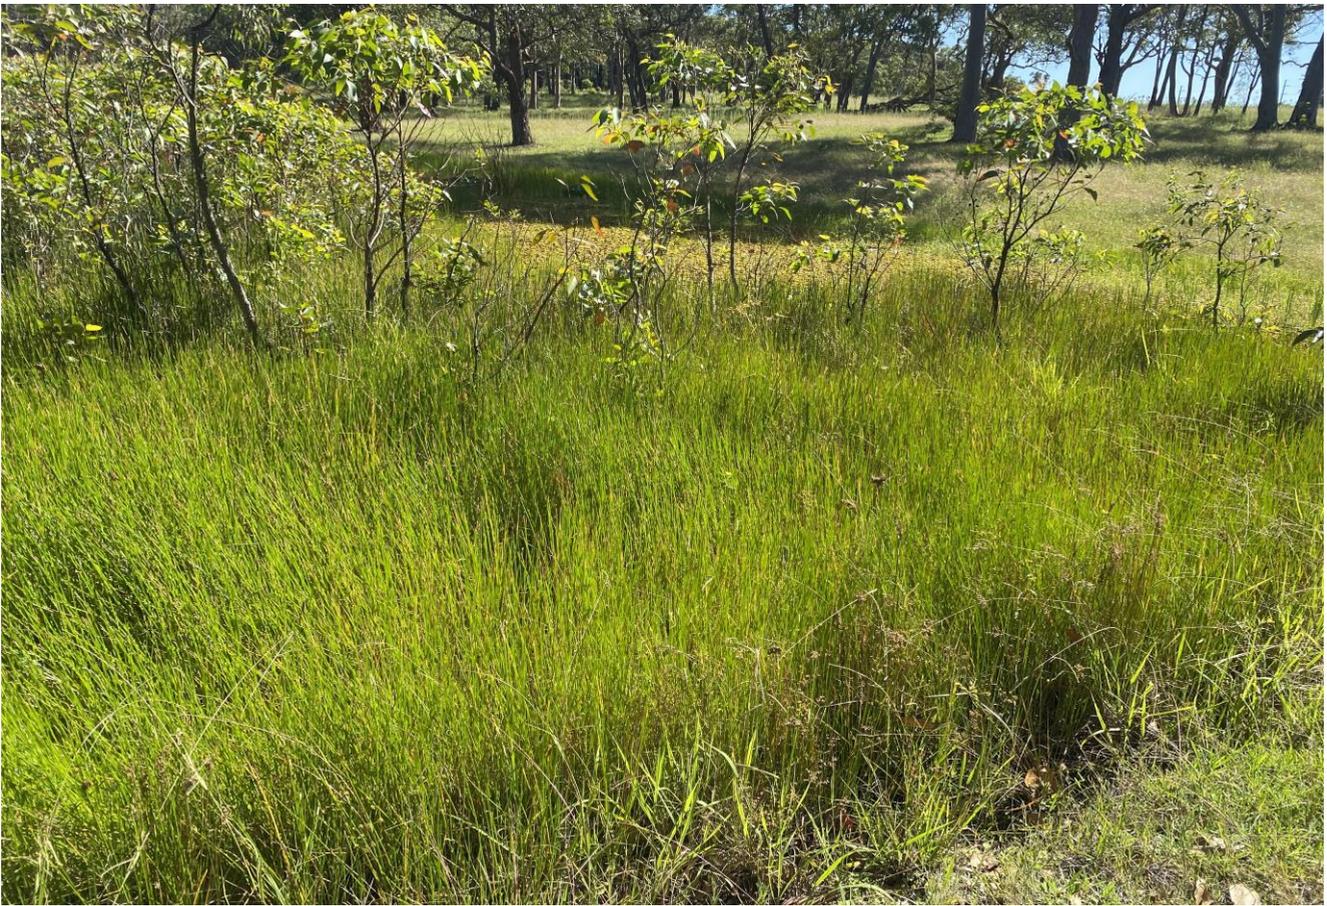
Photograph 14 - Dam 1.

Photograph 15 - Dam 2.

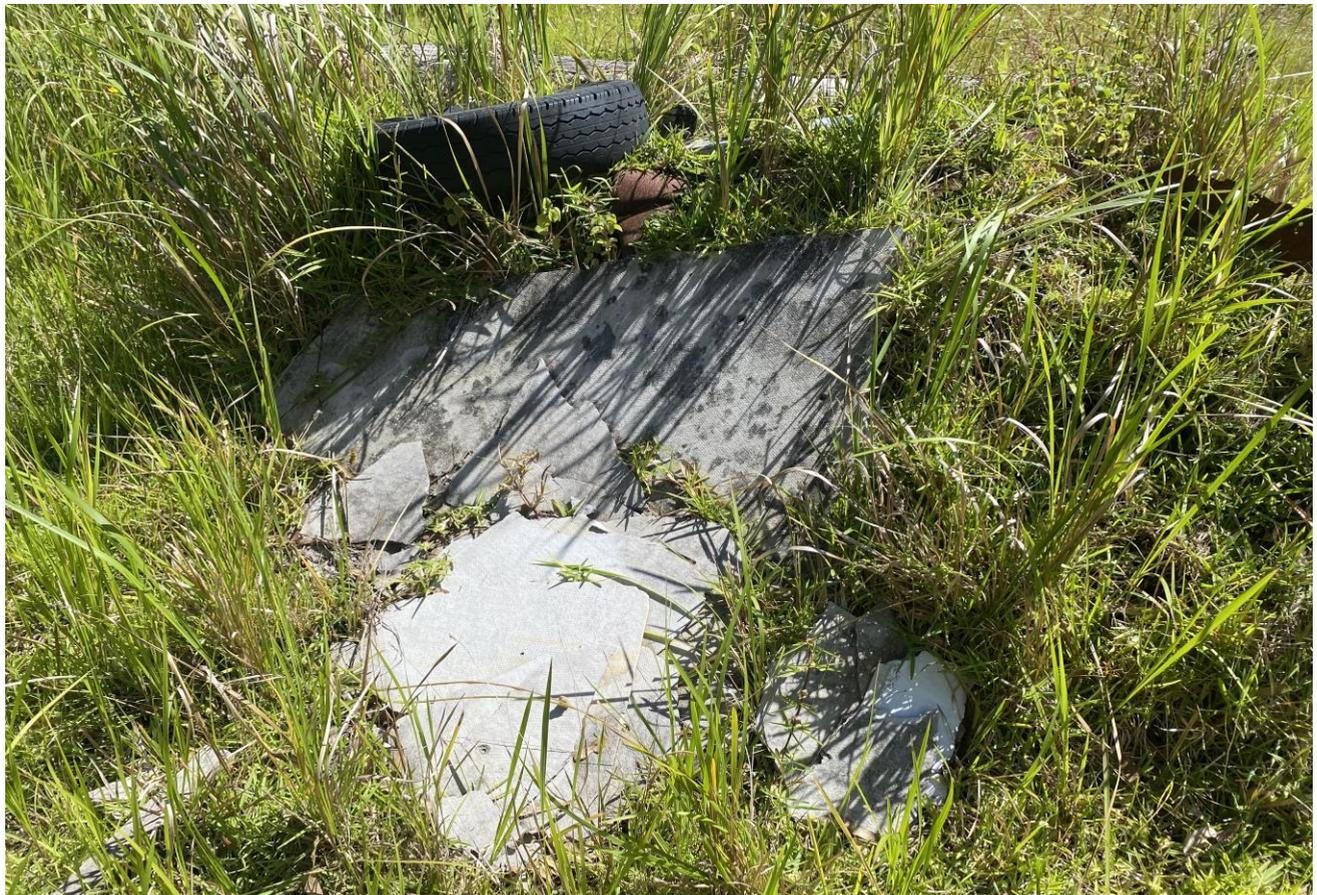
- Six stockpiles of stored waste/materials were observed in numerous locations around the site:
 - Waste/materials 1 was observed in the western portion of the site and appeared to comprise of probable ACM sheeting and small scattered fragments, steel, timber, corrugated iron and tyres (see Photograph 16);

Photograph 16 - Waste/materials stockpile 1.

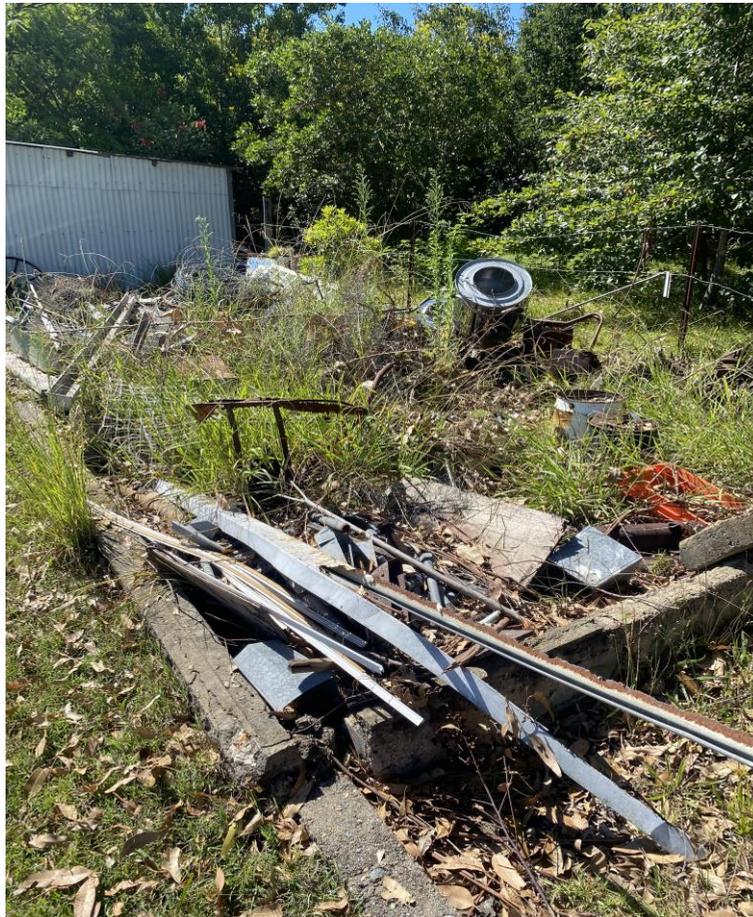
- Waste/materials 2 was observed in the central portion of the site and appeared to comprise of steel, wire, rainwater tank, sink, timber, concrete, drums and cables (see Photograph 17);

Photograph 17 - Waste/materials stockpile 2.
