Preliminary Contamination Assessment

216-234 Pacific Highway,
Charmhaven NSW.

NEW22P-0025-AA
18 February 2022

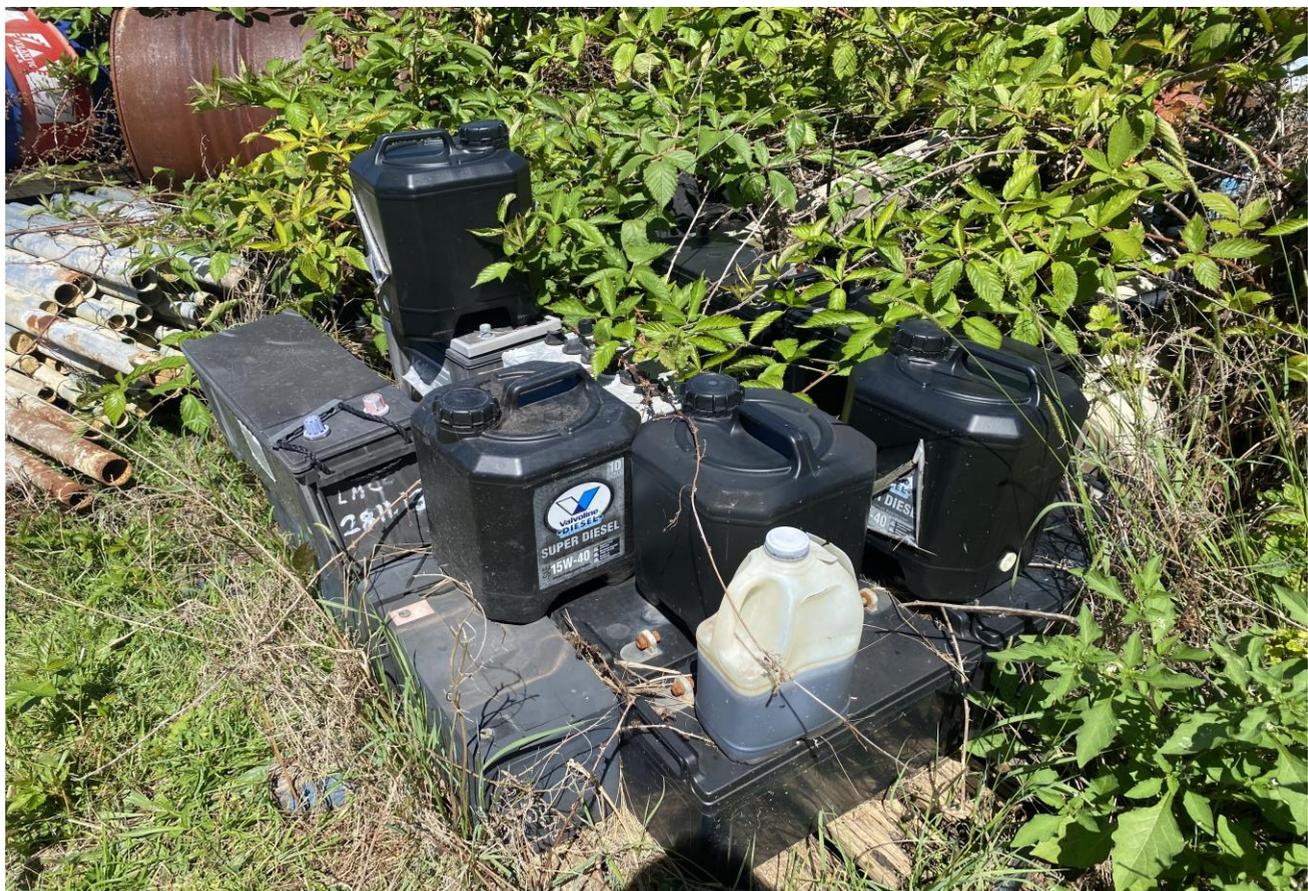
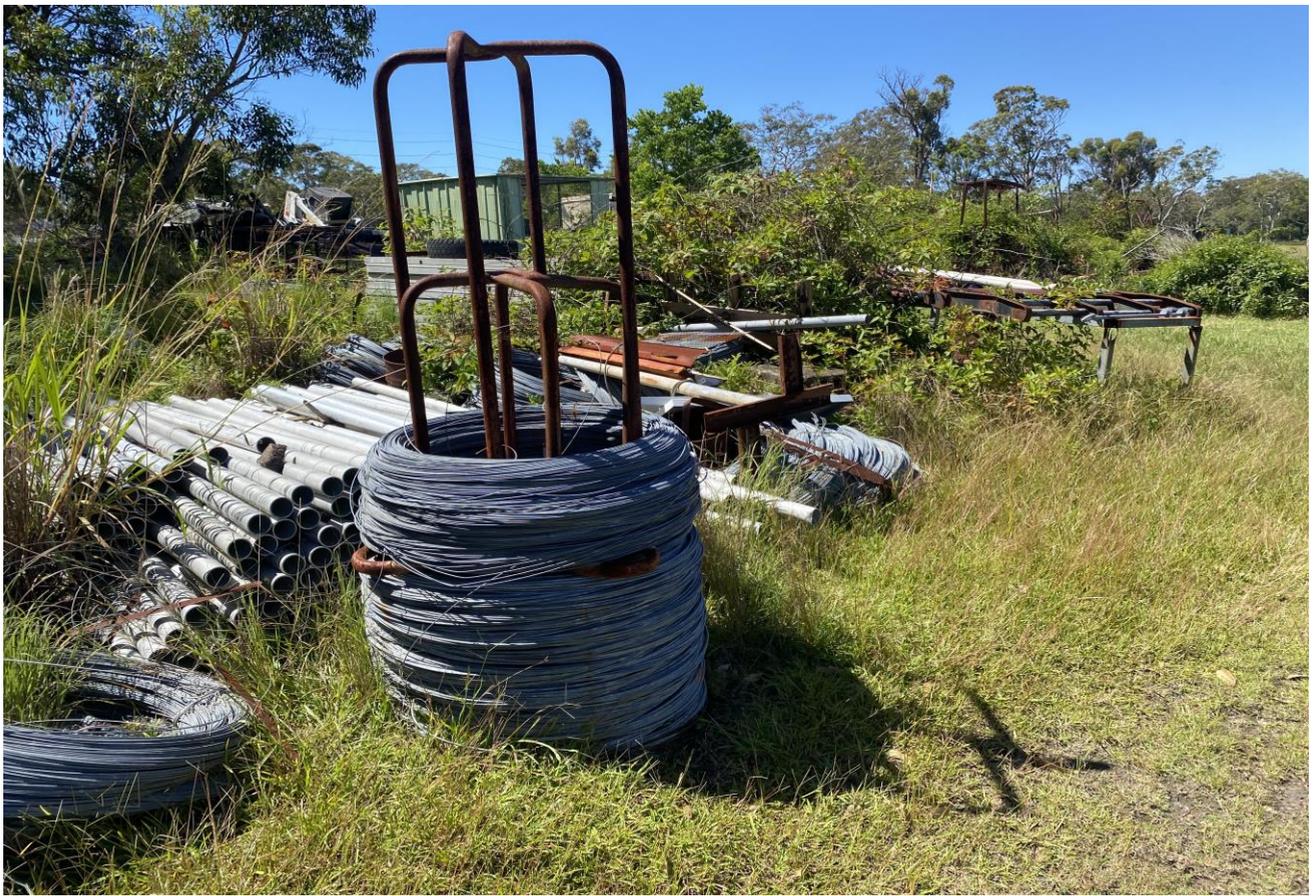
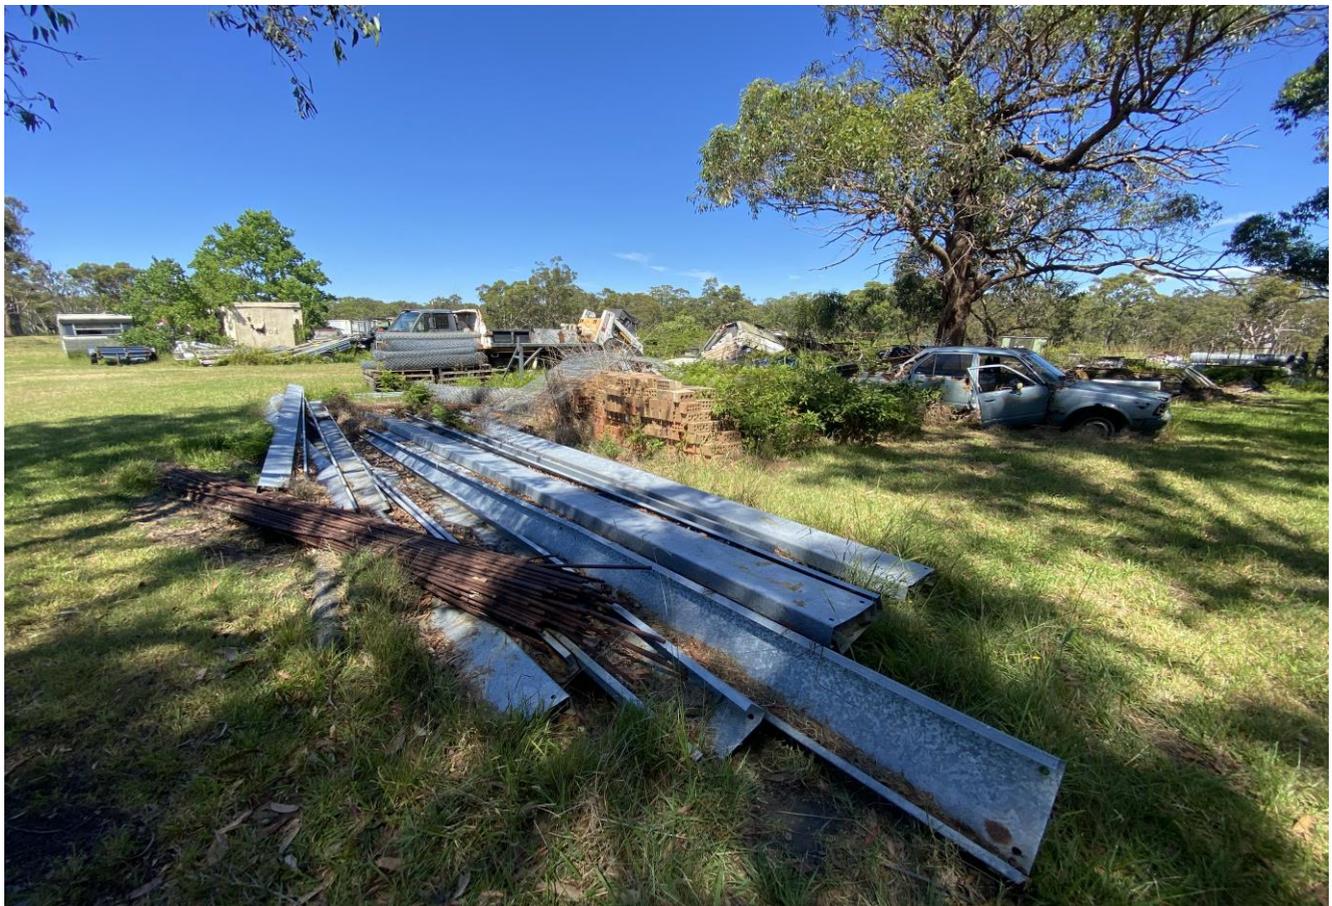
- Waste/materials 3 was observed in the central to southern portion of the site and comprised of aluminium cans, bolts & screws, corrugated iron sheeting, wire rolls, steel cages, fencing, scaffolding and other steel structures. Some 44-gallon drums, PVC piping, bricks, chip board, timber crates, old trailers, cars, trucks, a bobcat, concrete piping (possibly ACM), batteries, oil & diesel drums, transmission fluid drums, and intermittent bulk containers (IBC) with unknown contents (likely rain water) (see Photographs 18 to 20);

Photograph 18 - Waste/materials stockpile 3.

Photograph 19 - Waste/materials stockpile 3..

Photograph 20 - Waste/materials stockpile 3..

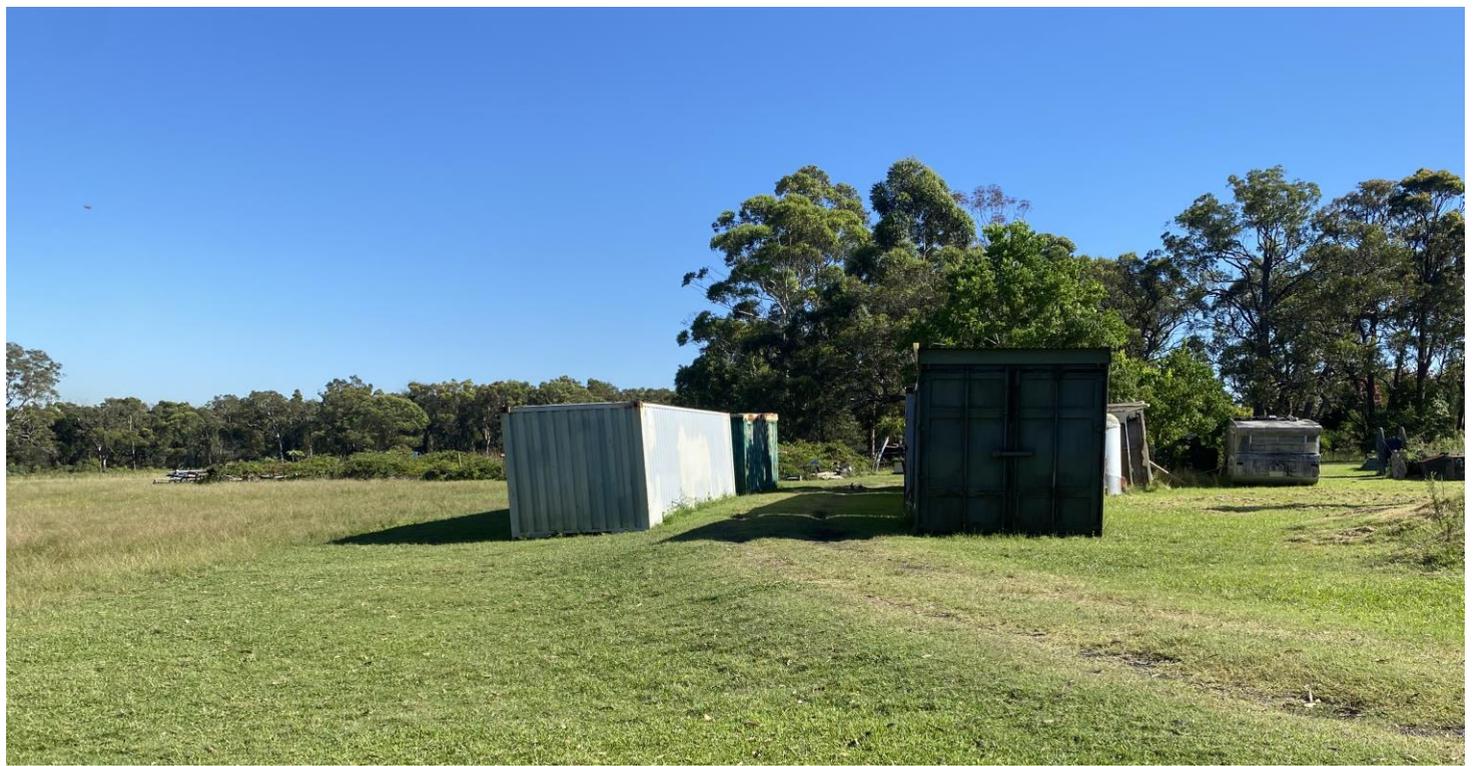
- Some small amounts of concrete waste were observed in the western portion of the site;
- Three shipping containers were observed in the southern portion of the site and were observed to be constructed of steel. The shipping containers were locked during the site walkover, restricting access (see Photograph 21);

Photograph 21 - Shipping containers.

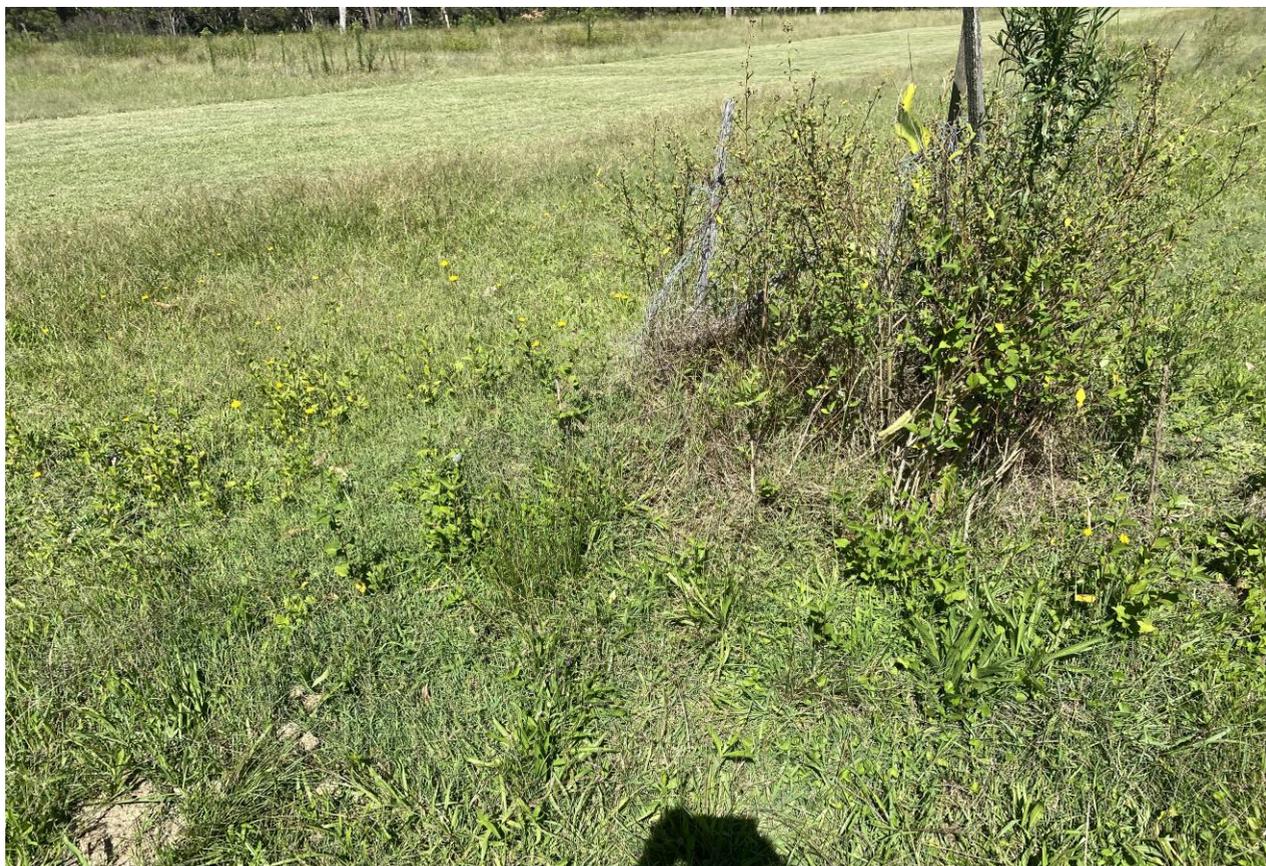
- Ten stockpiles were observed on the site:
 - SP1 was <math><0.5\text{m}^3</math> in volume, and located adjacent to an old concrete slab in the north-east portion of the site. It was overgrown with vegetation but appeared to comprise soil with steel pieces (see Photograph 22);

Photograph 22 - SP1

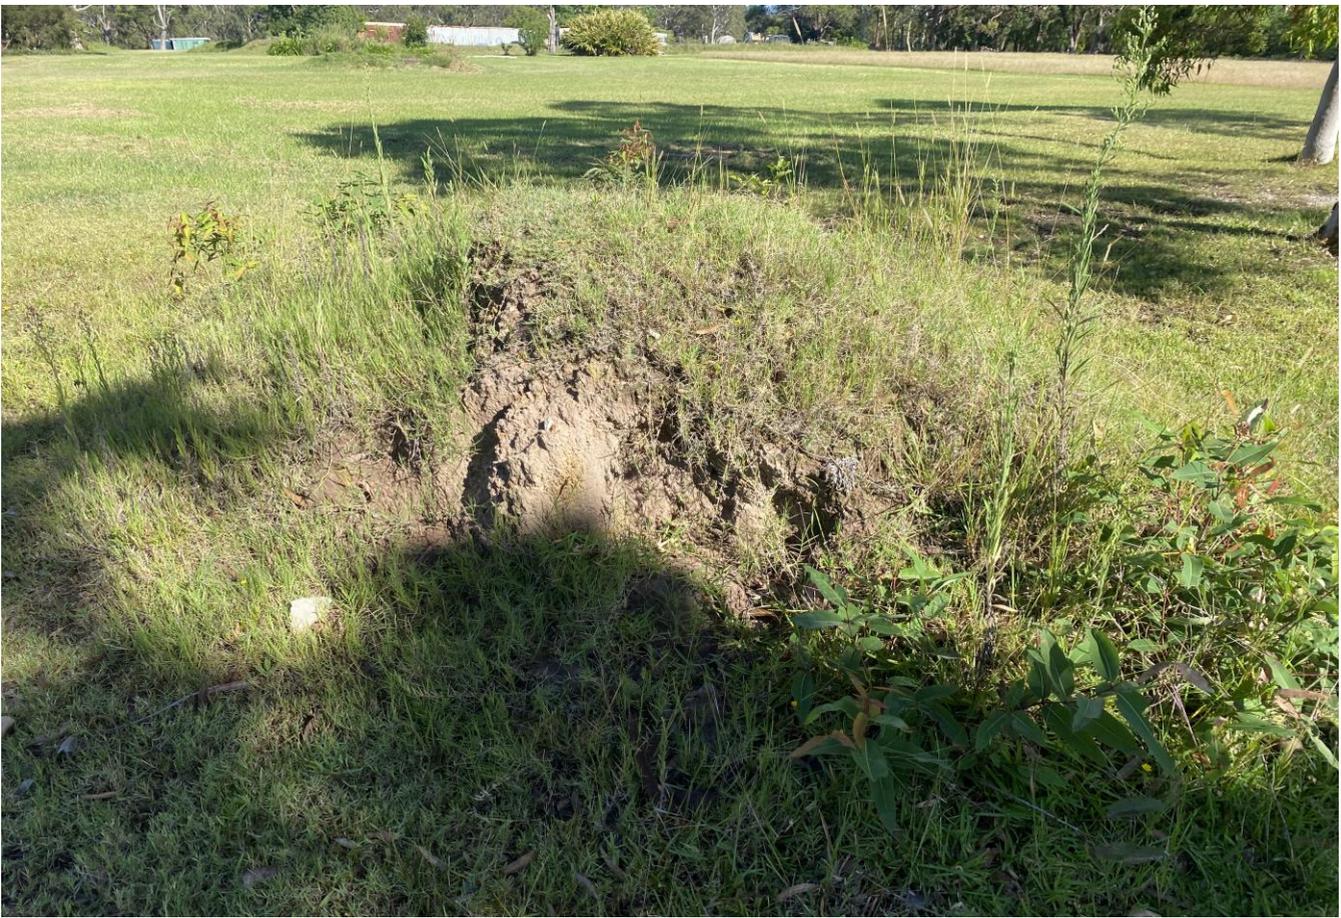
Photograph 23 - SP2

- SP2 was about 4m^3 in volume, and located in the south-east corner of the site. It comprised Gravelly Clay, with some topsoil, overgrown with vegetation (see Photograph 23);

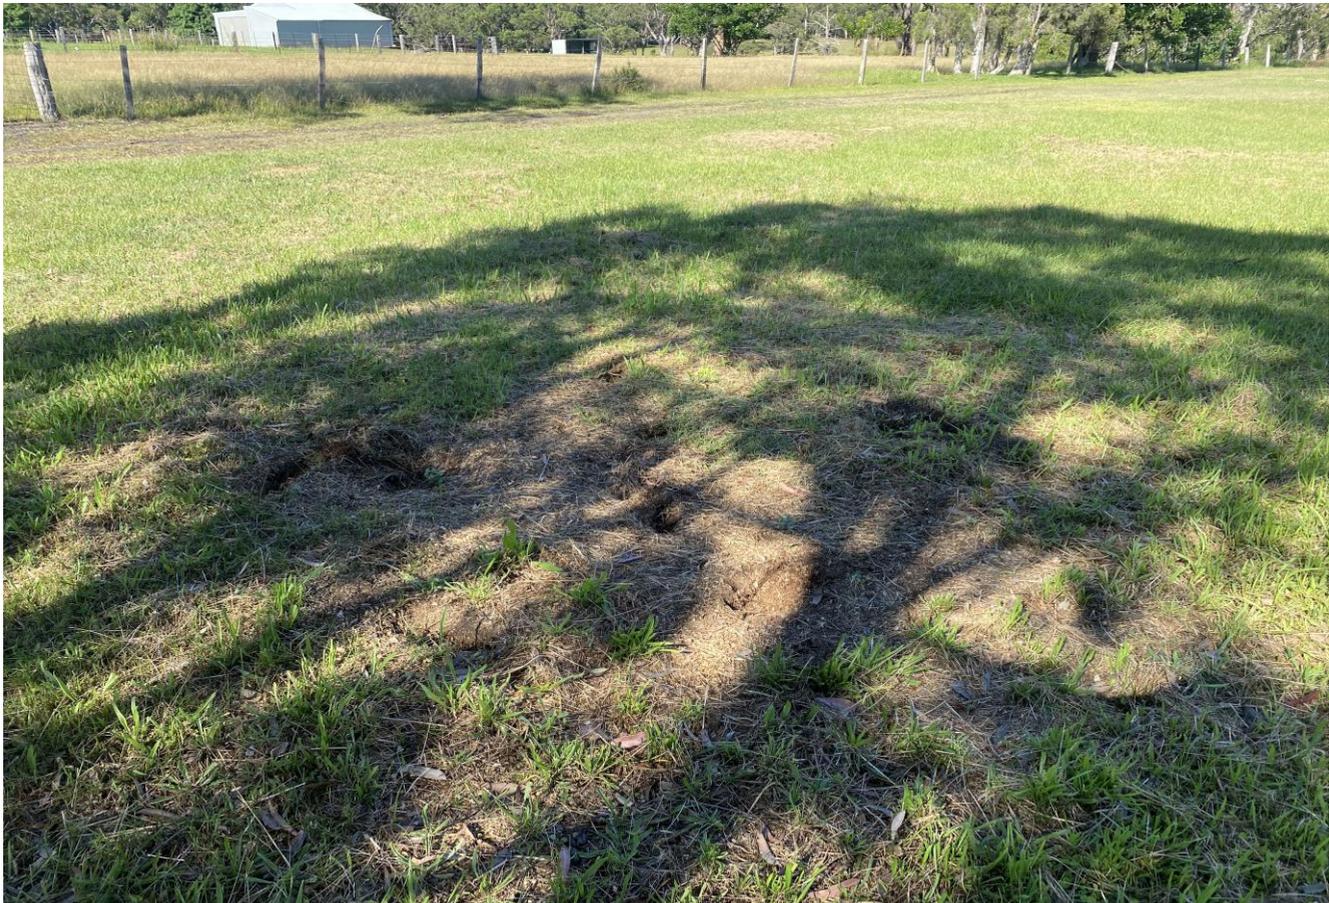
Photograph 24 - SP3

- SP3 was <math><0.5\text{m}^3</math> in volumes, and located in the south-east corner of the site. It comprised topsoil and mulch (see Photograph 24);

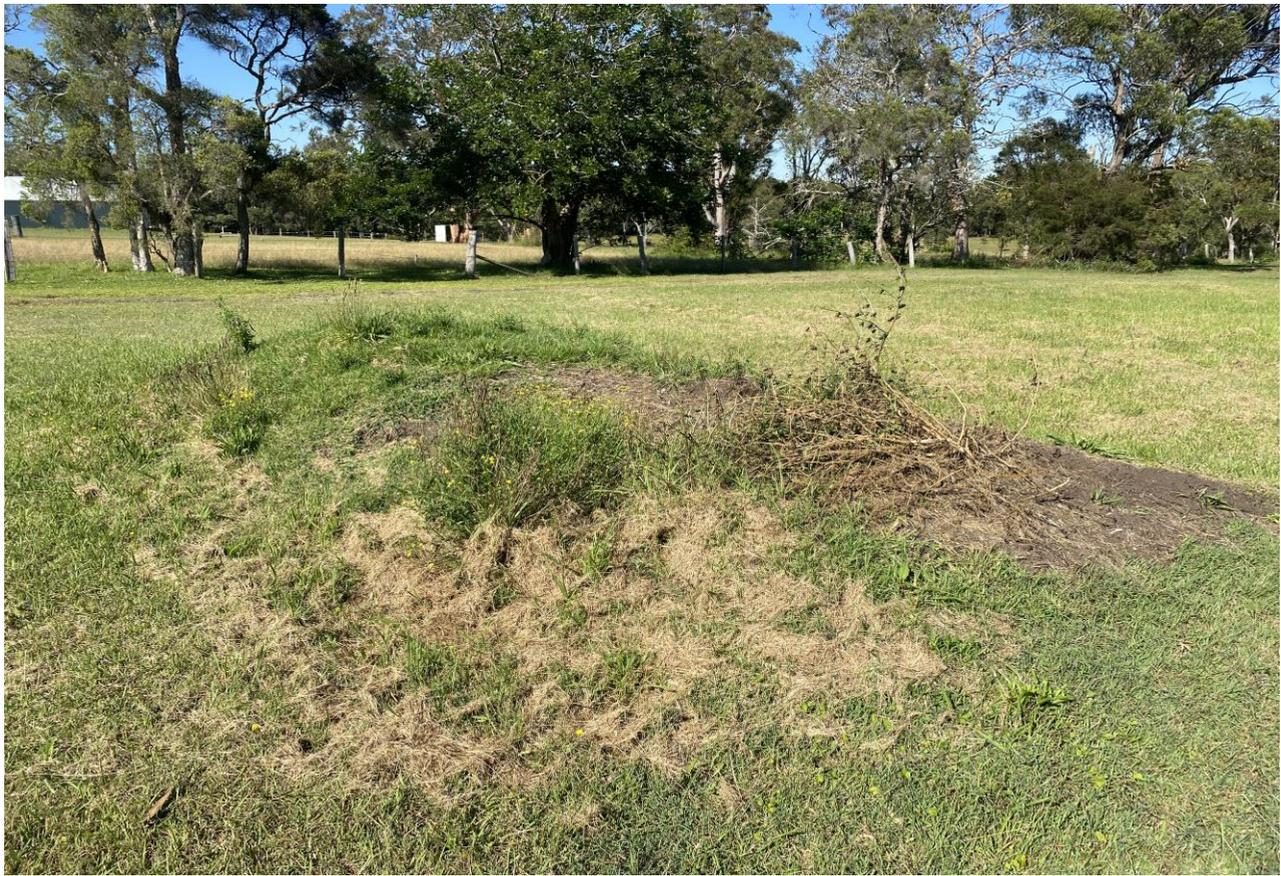
Photograph 25 - SP4

- SP4 was about 8m^3 in volume, and located in the south-east portion of the site. It comprised topsoil overgrown with vegetation (see Photograph 25);

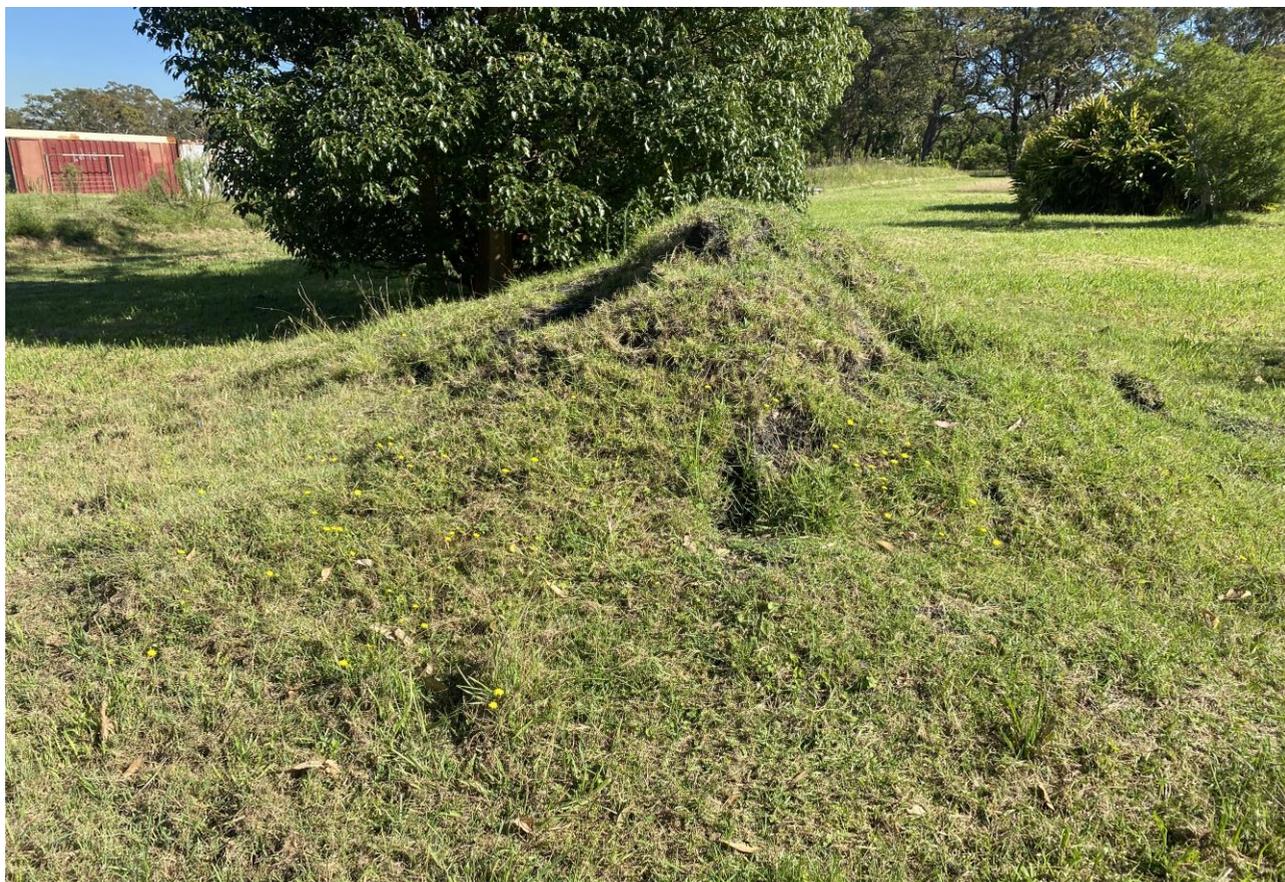
Photograph 26 - SP5

- SP5 and SP6 were about 15m^3 and 6m^3 respectively, located in the south-east portion of the site. They comprised Gravelly Sandy Clay, dark grey, with some possible coal chitter, overgrown with vegetation (see Photographs 26 and 27);

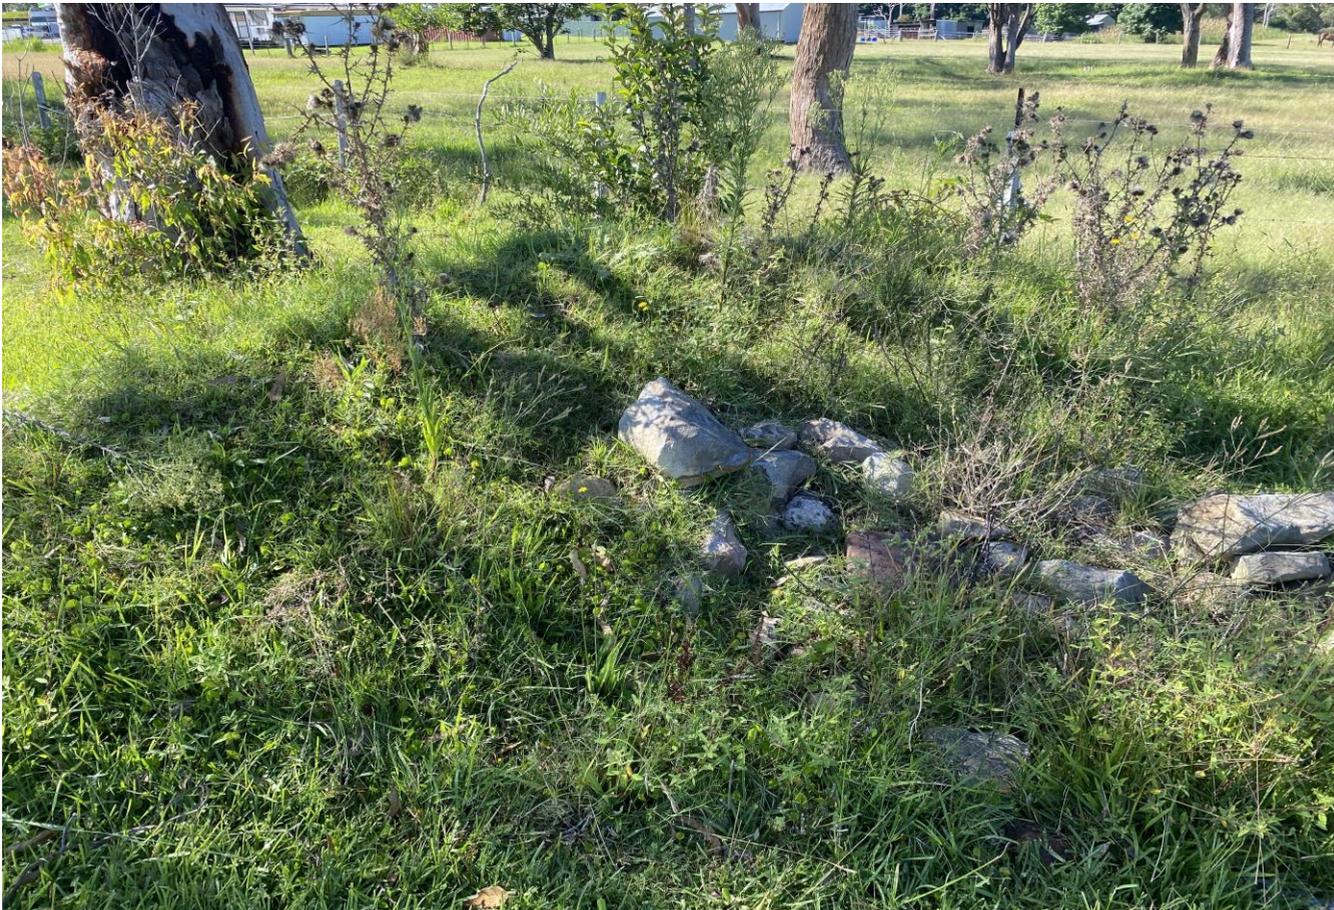
Photograph 28 - SP7

- SP7 was about 3m^3 in volume, located in the south-east portion of the site. It was overgrown with vegetation, with some sandstone and concrete on surface (see Photograph 28);

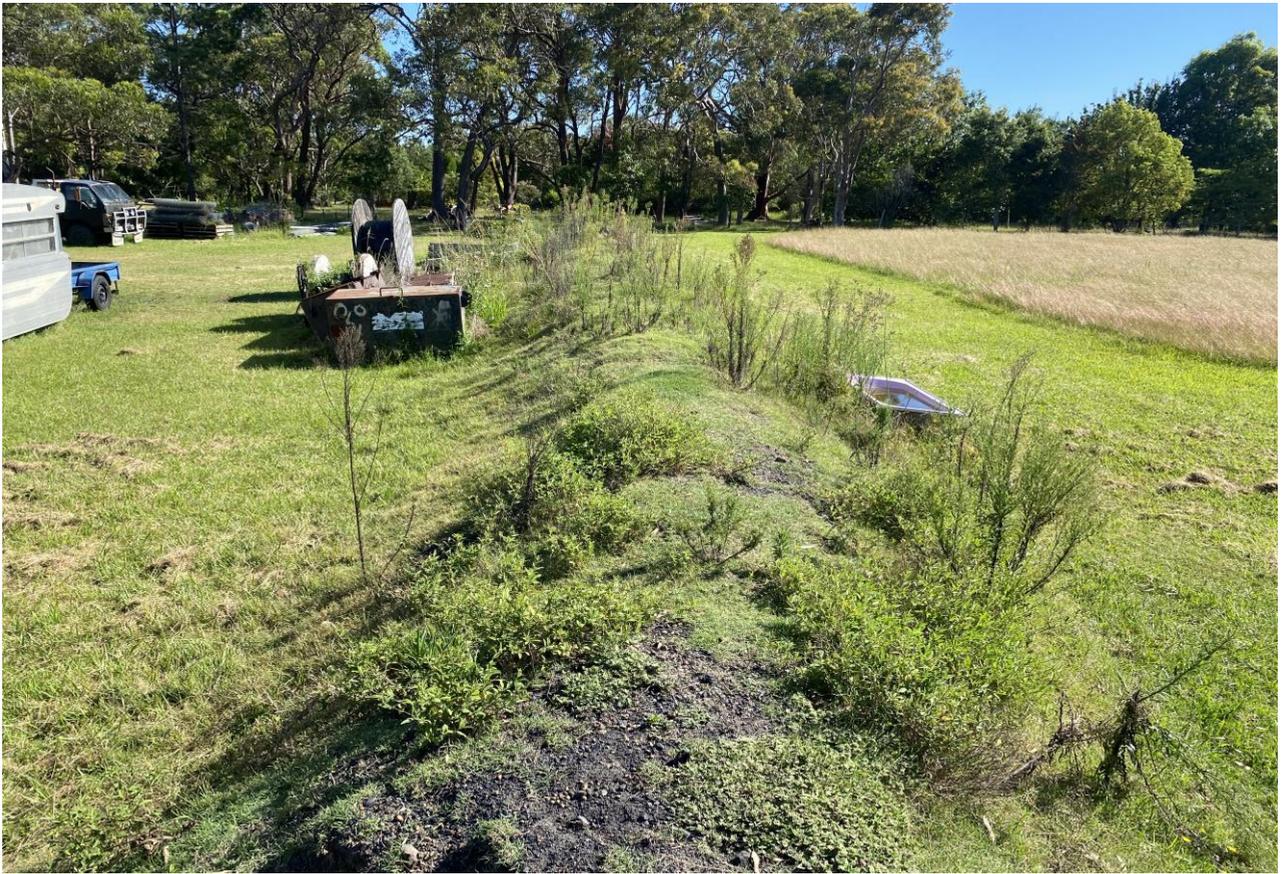
Photograph 29 - SP8

- SP8 was about 50m^3 in volume, located in the south-east portion of the site. It comprised Gravelly Clay and Coal Chitter, mostly overgrown with vegetation (see Photograph 29);

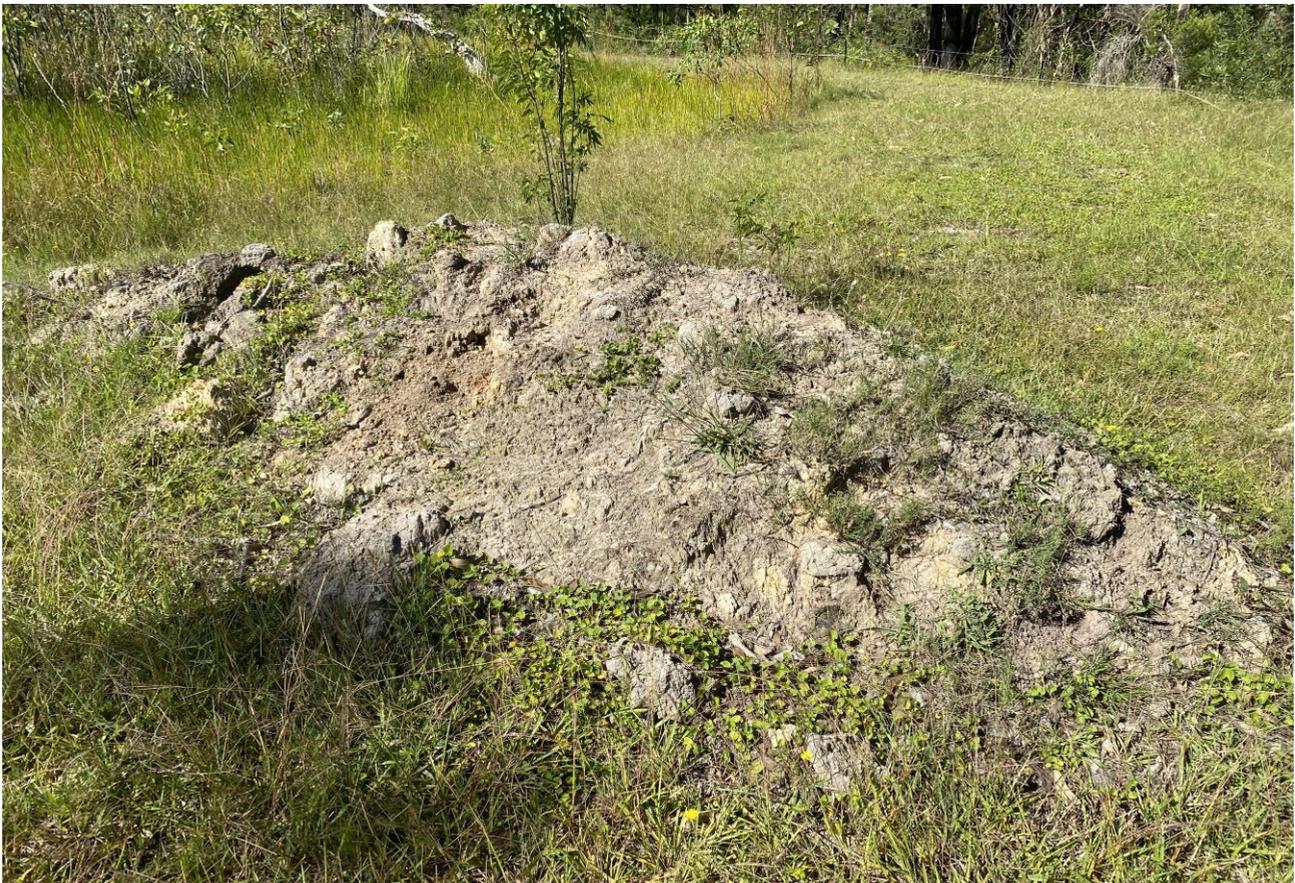
Photograph 30 - SP9

- SP9 was about 3m^3 in volume, located in the south-west portion of the site. It was overgrown with vegetation (see Photograph 30);
 - SP10 was about 50m^3 in volume, located in the south-west portion of the site. It was overgrown with vegetation (see Photograph 31).

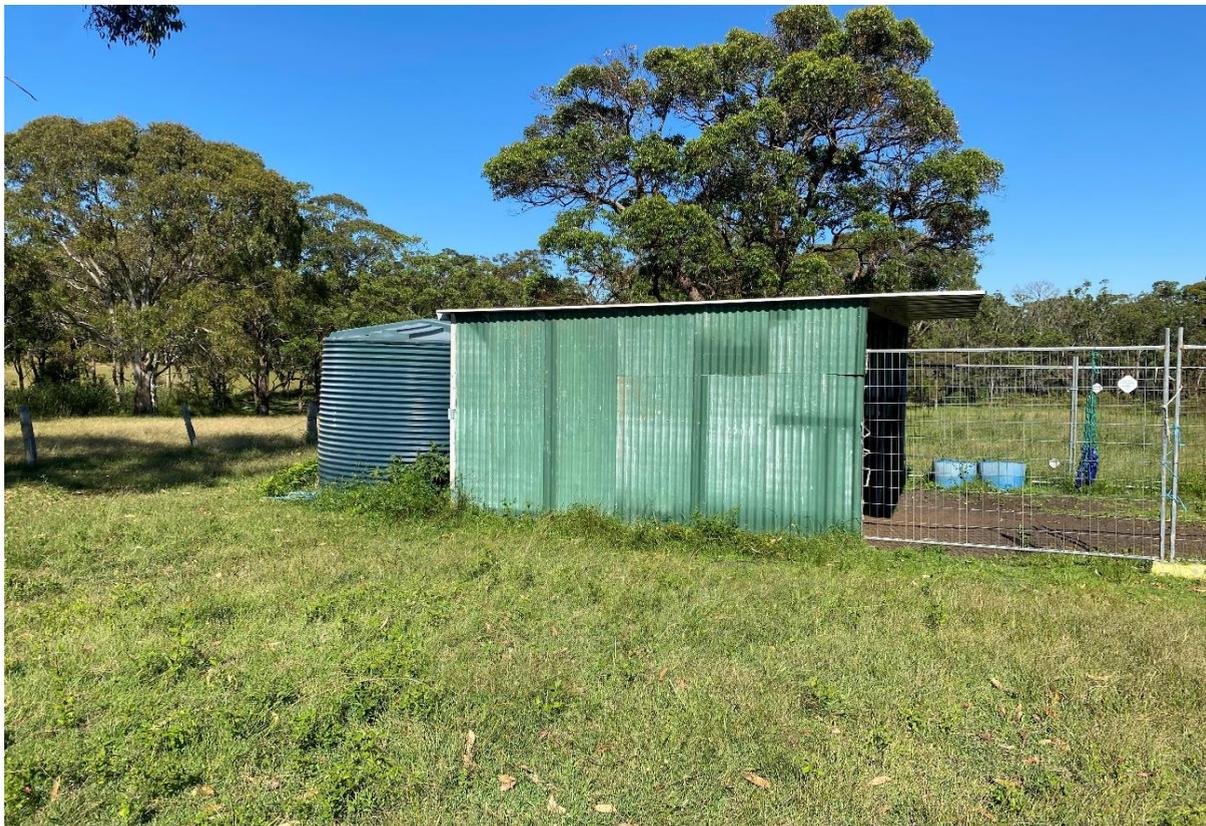
Photograph 32 - Horse Enclosure

- A horse enclosure was located near the southern central boundary of the site. It was constructed with corrugated iron, steel, temporary fencing panels, and had a half earthen / half concrete floor. Some timber was stored inside. Two water tanks were located on the southern side of the enclosure (see Photograph 32).
