ARBORICULTURAL IMPACT ASSESSMENT
&
TREE PROTECTION SPECIFICATION

REF: L&Co22022 | 28 October 2021 | v1.2
SITE ADDRESS | 94 Bettington Road, Oatlands NSW
PREPARED FOR | Oatlands Golf Club
PREPARED BY | Dr Matthew Laurence

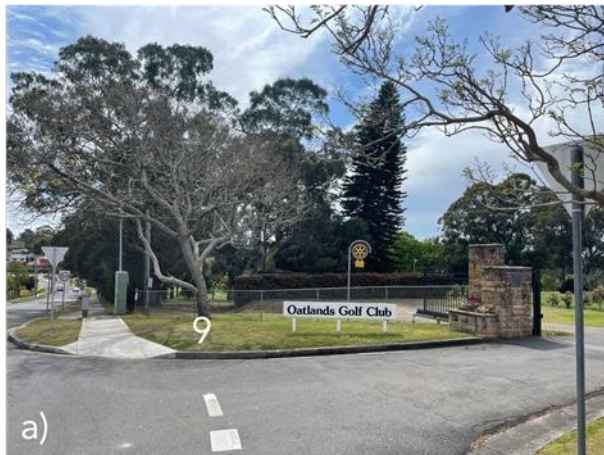
a) Showing site from Bettington Road. b) Showing Tree 8. c) Showing Tree 7. d) Showing the tree group along Bettington Road. e-f) Showing Tree 26. f) Showing recent works within the SRZ of Tree 26.

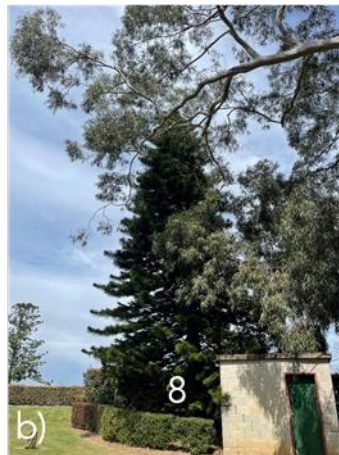
- 4.5.2 Trees 7 & 31 were in fair physiological condition as indicated by reduced crown density, estimated to be 50-75% of an idealised example of these species. Tree 31 had localised crown death. Both Tree 7 and 8 had structures within the SRZ.

- 4.5.3 The supplied plans show that Trees 7, 8, 17 & 31 are within the footprint of the proposed development and will need to be removed.
- 4.5.4 See Appendix 5 for further details.

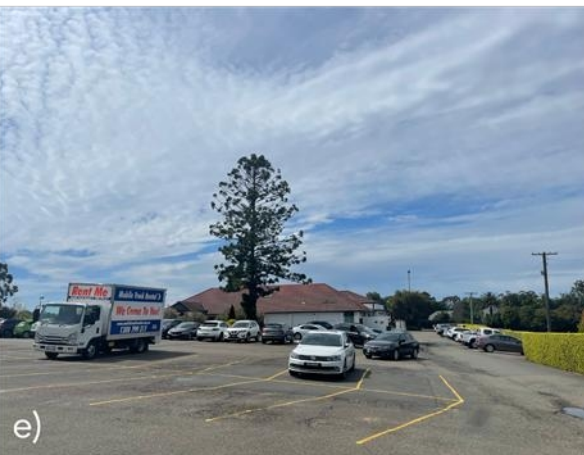
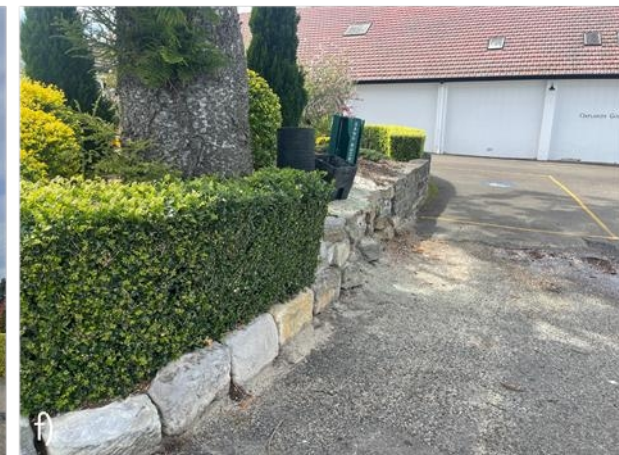
- 4.15.1 Tree 26 was in fair physiological condition as indicated by reduced crown density and chlorotic foliage. The crown density was estimated to be 25-50% of an idealised example of this species. The localised crown death included small diameter branches (<25mm Ø) which were present in moderate volumes. There were structures in the SRZ.

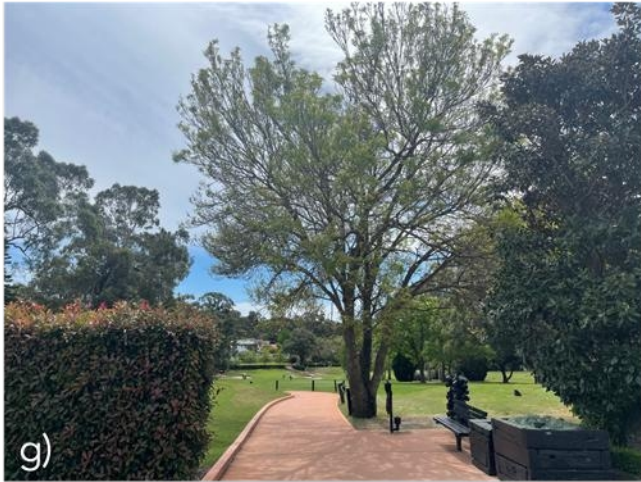
g) Showing Tree 27. h) Showing Tree group 29. i) Showing Trees 27, 28 & 8. j) Showing Trees 32-34. k) Showing Trees 36-45. l) Showing Tree 45 and the branch extending 7m into the site.

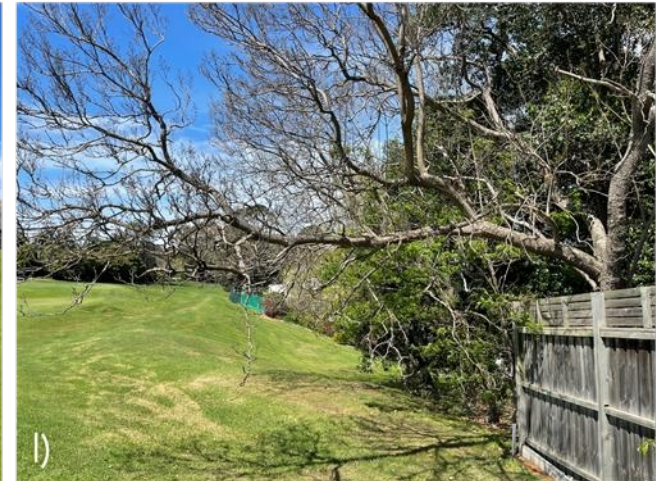
Tree No.	Species	Height (m)	Radial Crown Spread (m)	DBH comb. (mm)	Radial TPZ (m)	TPZ Area (m²)	Radial SRZ (m)	Health Rating	Structural Rating	Age Class	ULE (years)	L/Sign	Retention Value	Comments	TPZ Encroachment (%)
45	<i>Jacaranda mimosifolia</i> (Jacaranda)	12	7	375	5	64	2.3							First order branch extends 7m into the site.	No Encroachment
