HERITAGE IMPACT STATEMENT

186-206 Canterbury Road,
Canterbury

Prepared for
J GROUP
20 May 2022

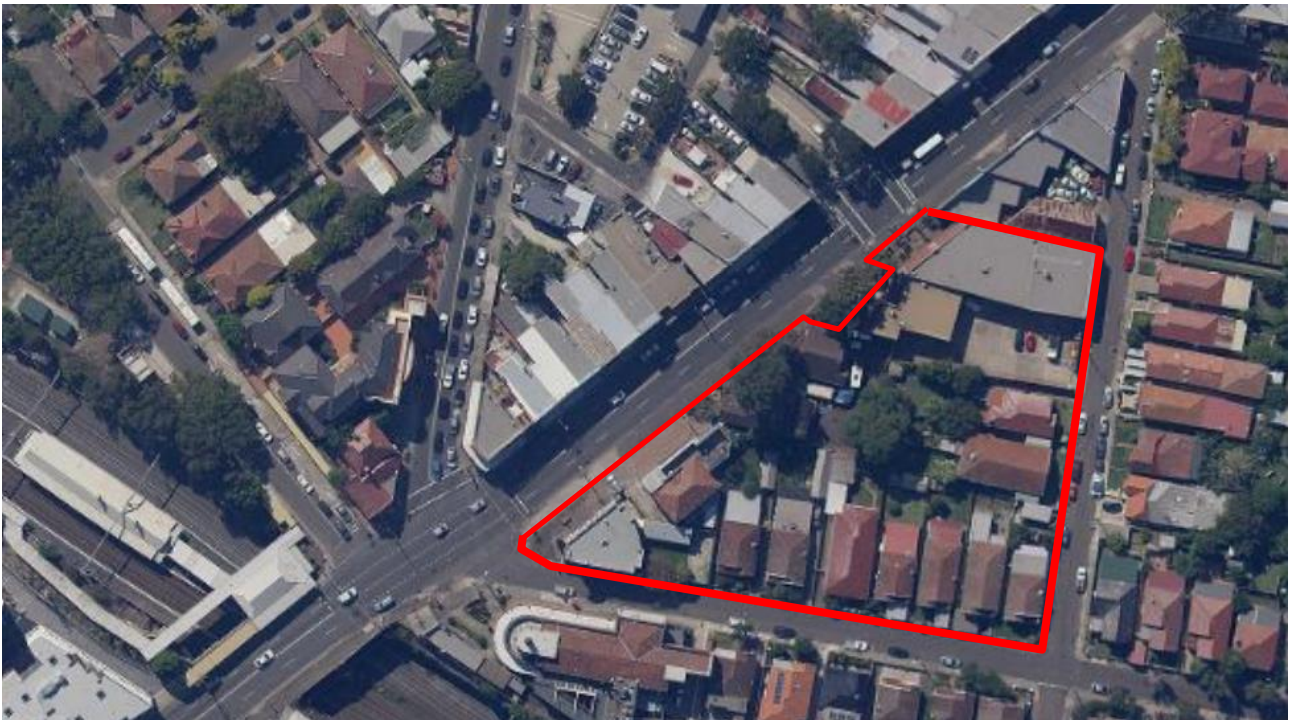
Figure 1 – Aerial view with the subject site boundary indicated in red.

The subject site is located on 186-206 Canterbury Road, Canterbury, within the Canterbury-Bankstown Local Government Area (LGA). The subject site is comprised of a triangular area, bound by Minter Street to the east, Canterbury Road to the west, Tincombe Street to the south and commercial lots to the north.

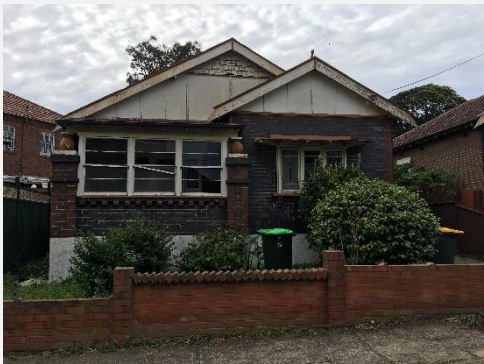
| Photo | Address | Description |
|---|---|---|
| | 29 Tincombe Street, Canterbury. | Typical single storey inter-war style bungalow of liver brick construction with asymmetric and projecting gables and wide set eaves. The front verandah has been infilled. Original casement leadlight windows. |

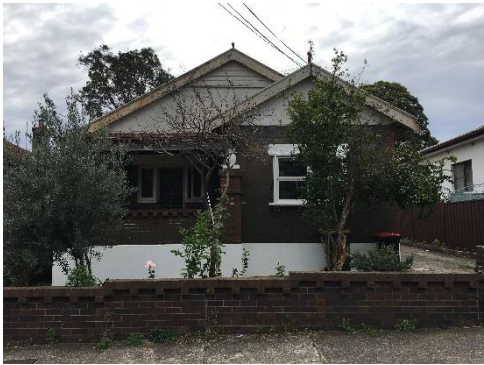
| Photo | Address | Description |
|---|---|---|
| | 27 Tincombe Street, Canterbury. | Typical single storey inter-war style bungalow of liver brick construction with asymmetric and projecting gables and wide set eaves. Modified window to the projecting gable. Original street front fencing. |

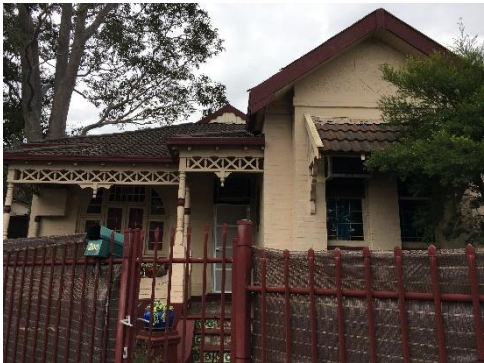
| Photo | Address | Description |
|---|---|---|
| | 198-200 Canterbury Road, Canterbury. | Edwardian bungalow. With hipped and gabled roof and projecting gable to the street. Originally tuckpointed facebrick, now painted. Timber frieze to the verandah and entrance portico. Arched timber window set. Later 20 th century street fencing. |

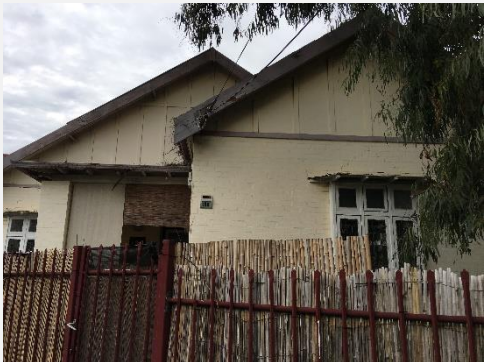
| Photo | Address | Description |
|---|---|---|
| | 194-196 Canterbury Road, Canterbury. | Large early 20 th century bungalow dwelling. Face brick construction since painted. Original triple casement window sets, with leadlights. Later 20 th century street fencing. |

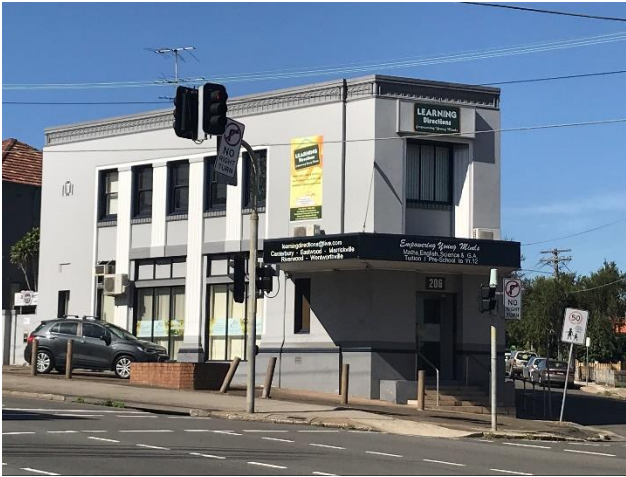
Figure 10 View east from Canterbury Road towards 206 Canterbury Road. The ground floor windows have been modified and there is a later 20th century awning over the entry

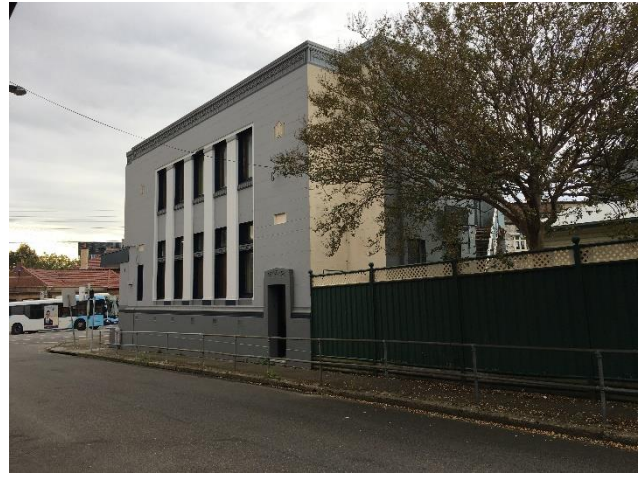
Figure 11 – View west along Tincombe Street towards Canterbury Road. Access to the upper floor residence is via the rear door.

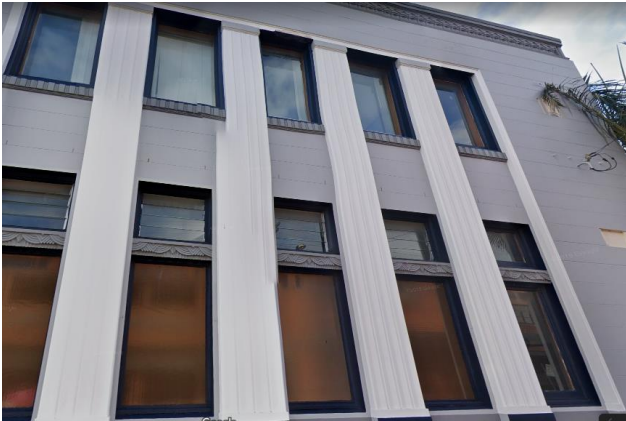
Figure 12 – Detail of the more intact windows on the Tincombe Street frontage.

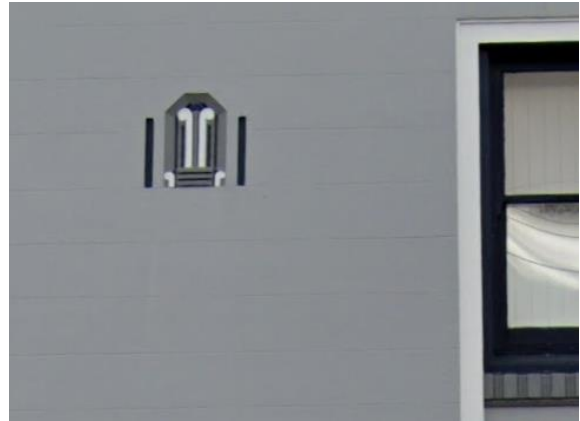
The former Commonwealth Savings Bank building is an interwar Stripped Classical style building situated on the corner of Tincombe Street and Canterbury Road, with art deco detailing on the west (Canterbury Road) and South (Tincombe Street) exteriors (see Figure 10 and Figure 11). The exterior is constructed of rendered and painted masonry with an art deco stucco frieze running across the parapet. The frontage onto Canterbury Road includes the primary entrance, which includes steps leading to a glass entrance door and a suspended contemporary metal awning above it. The windows of the building are a main architectural feature. The ground floor windows are doubled with top lights separated from the bottom panes by decorative band on the Tincombe Street frontage, however these appear to be modified and replaced on the Canterbury Road frontage with the decorative band removed and window levels lowered. The windows themselves are separated by columns, which are squared and fluted. The top floor windows have decorative sills on both the Canterbury Road and Tincombe Street frontages (see Figure 12). On both the Canterbury Road and Tincombe Street frontages, there are Art Deco vents which are retained (see Figure 13)

Figure 13 – Detail of decorative vent on the Canterbury Road frontage.

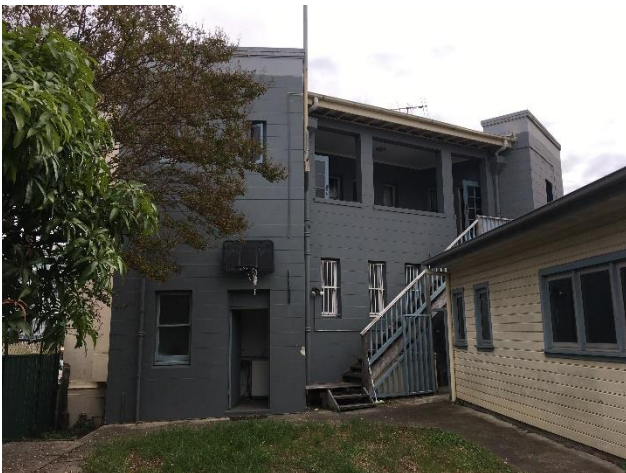
Figure 14 – The rear of 206 Canterbury Road

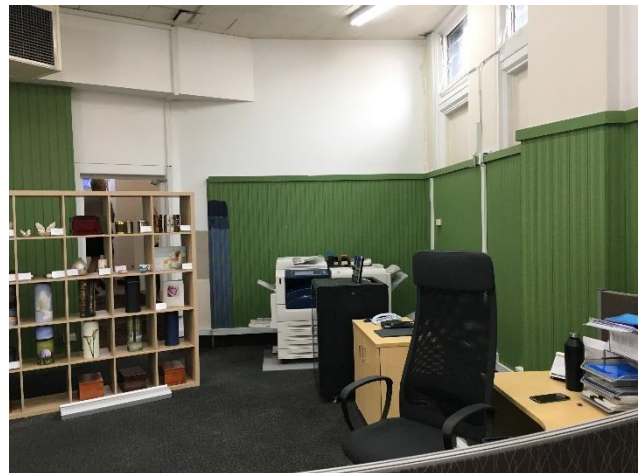
The bank occupied the ground floor of the premises, with a residential flat above. The interior of the former bank has been substantially modified; however some aspects of the former bank remain, notably evidence of the former bank vault, art deco cornices, original doors and some remnant art deco door hardware.

Figure 15 – Interior of 206 Canterbury Road, former banking area.

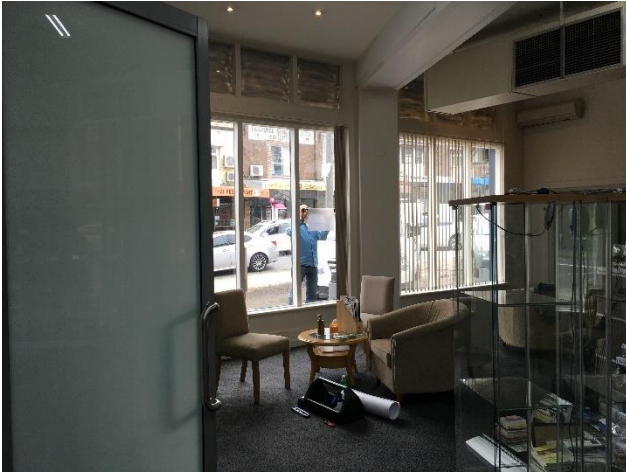
Figure 16 – Interior of 206 Canterbury Road, former banking area and outlook to Canterbury Road

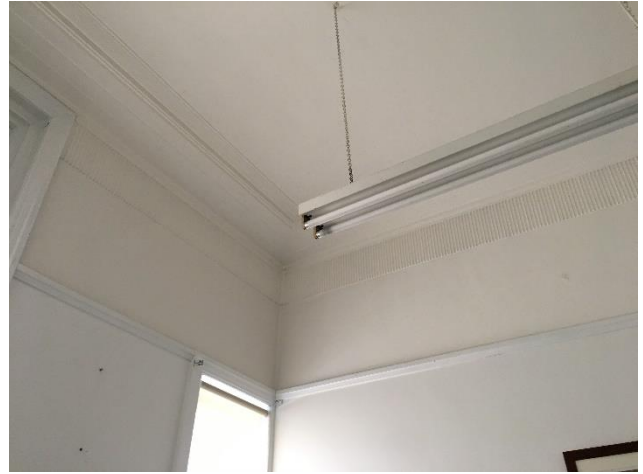
Figure 17 – Interior of 206 Canterbury Road, former office area – detail of the fluted Deco cornice

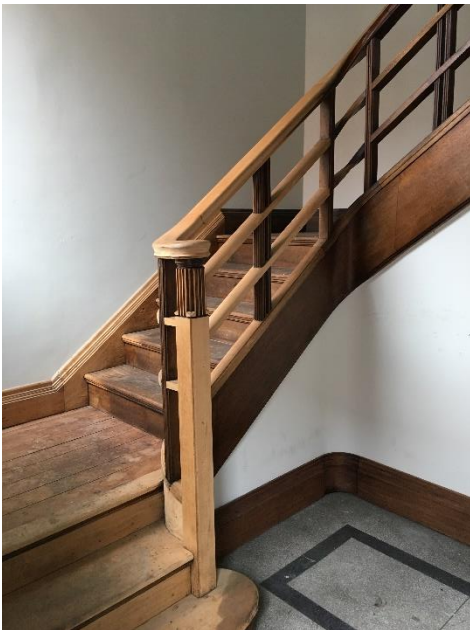
Figure 18 – The rear stair hall (off Tincombe Street) accessing the first floor dwelling

The first floor residence is now used as a boarding house with 4 rooms. It has a common kitchen, living and dining and bathroom areas. Original features include the timber floor and fireplace and some joinery, but it is an otherwise plain interior.

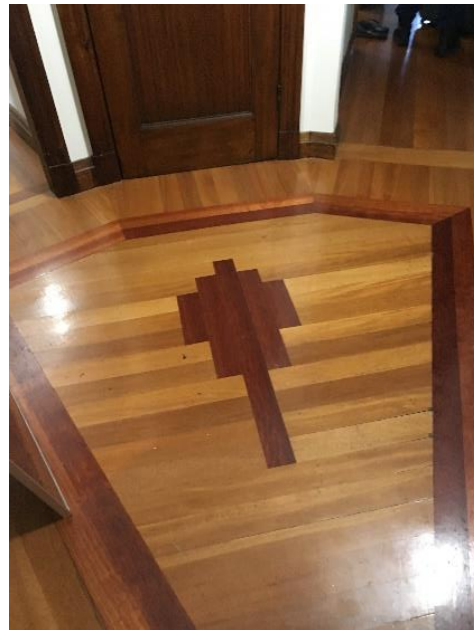
Figure 19 – Detail of the timber floor in the central hall of the first floor residence.

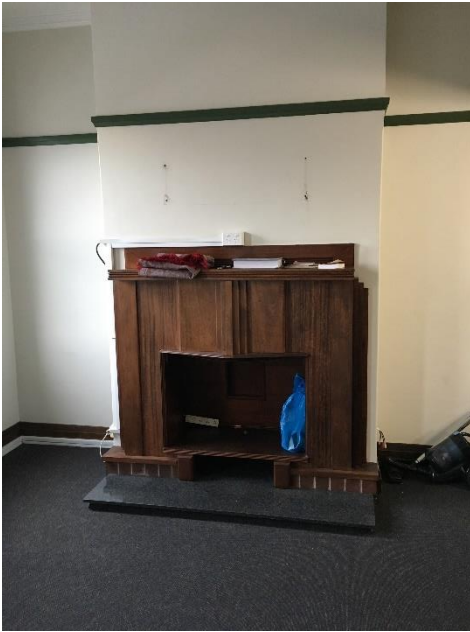
Figure 20 – Detail of the fireplace in the former living area

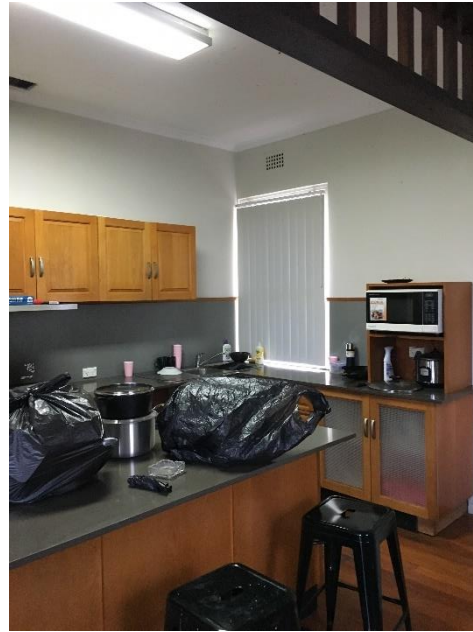
Figure 21 – General view of the common area kitchen

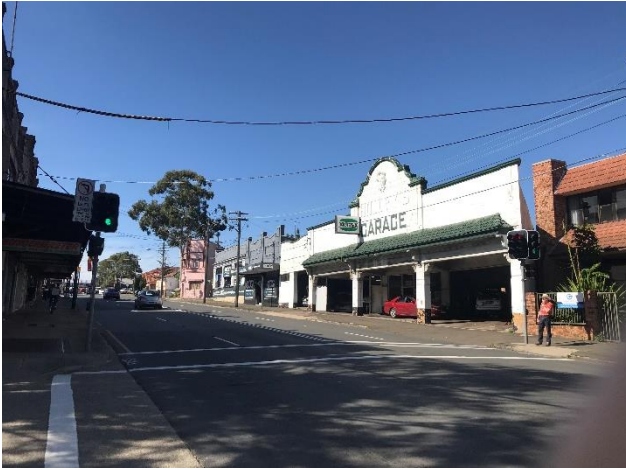
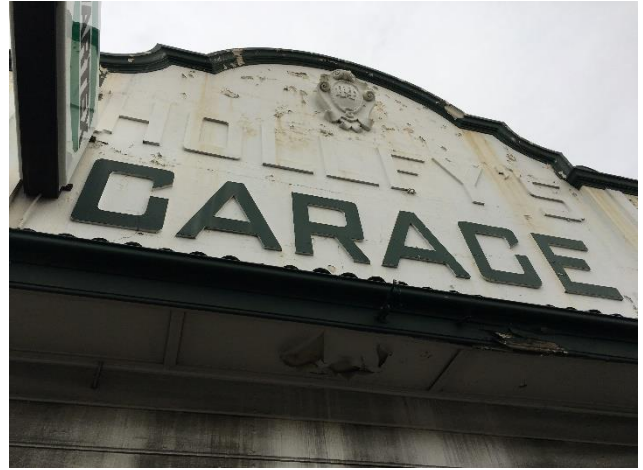
Motor garage built directly on street frontage with bays for cars to pull in off the road. Massive parapet in Spanish Mission style with Dutch gable, Cordova tiles on awnings. Piers bracketed in Spanish Mission style.³

Figure 22 – Holly's Garage entrance on Canterbury Road, view north-east.

Figure 23 – Holly's Garage signage on parapet.

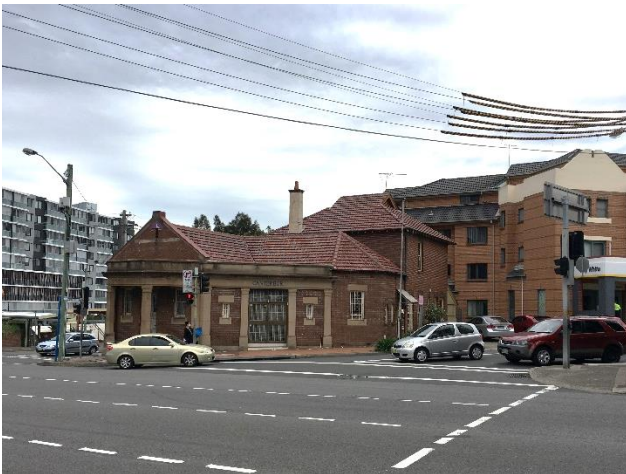
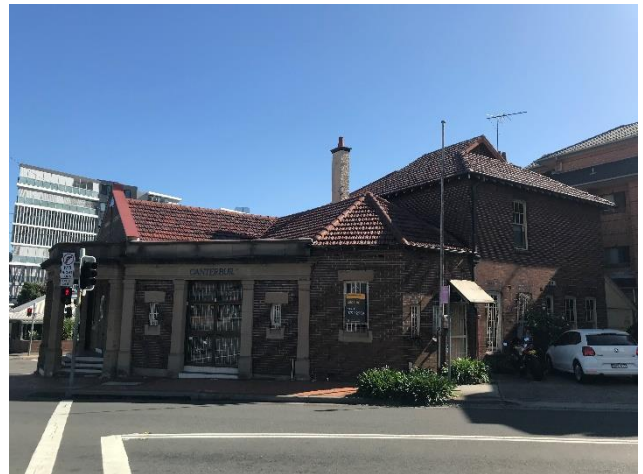
Figure 24 – Former Canterbury post office building, Item No. I66

A single-storey brick post office designed for its corner location. Sandstone porch on pillars, sandstone pilasters extend across facade, sandstone cornice and capping are its features. A Two-storey residence is located at the rear.⁴

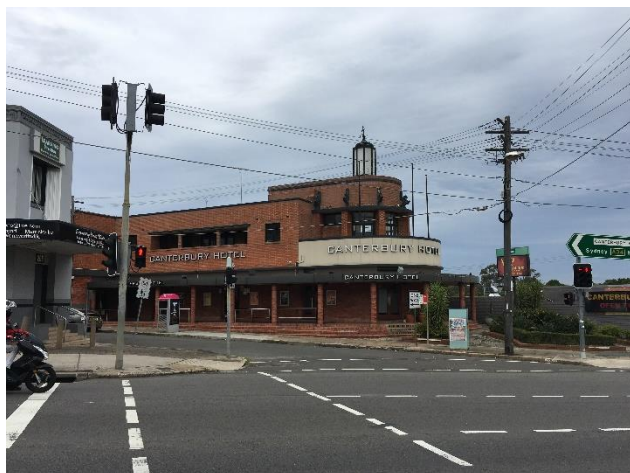
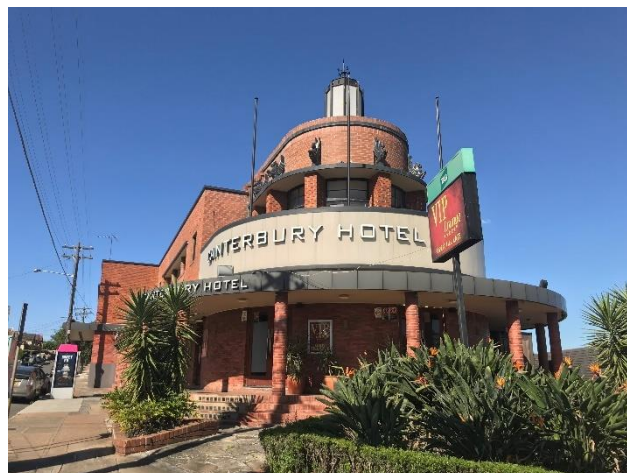
Figure 26- Former Hotel Canterbury, Item No. I68

Massive two-storey brick hotel with colonnade at street level. Balcony stepped back. Parapet with winged horses as ornamentation. Topped by lantern. Decorative treatment reflects proximity of racecourse.⁵

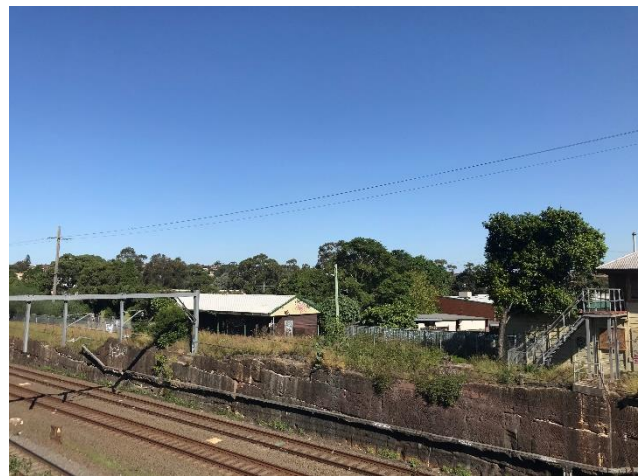
Figure 29- View east over railway line and showing associated rail infrastructure

The overbridge consists of steel girders supporting a jack arched brick and concrete deck. The girders span the Up and Down lines supported on concrete and brick abutment walls. The parapet walls are brick.⁶

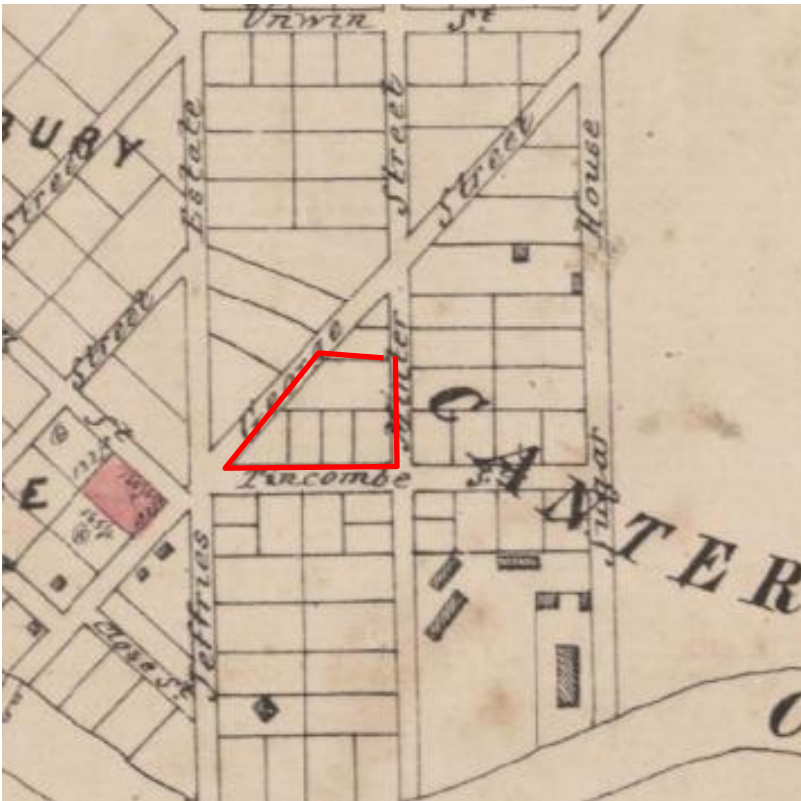
Figure 33 – Canterbury Village, 1850-1859, approximate subject site indicated in red.
Source: National Library of Australia Archives.

As mentioned above, the subject site initially formed part of Reverend Johnson's Canterbury Vale grant, before being purchased with the rest of the estate by Richard Campbell in 1803. Campbell, like Johnson, likely used the subject site for the purpose of farming. The subject site was part of the 60 acres exchanged for shares in the Sugarworks in the 1840s, and subsequently subdivided by the owners to finance the enterprise. By 1841, the subject area was subdivided into at least 4 separate lots (see Figure 32). Tincombe (originally Tingcombe) and Minter Streets were named after two of the largest investors of the Sugarworks, and this section of Canterbury Road was at the time named George Street, likely after Mr. George Minter. By 1859, 'Tingcombe' Street had been renamed Tincombe Street (see Figure 33).

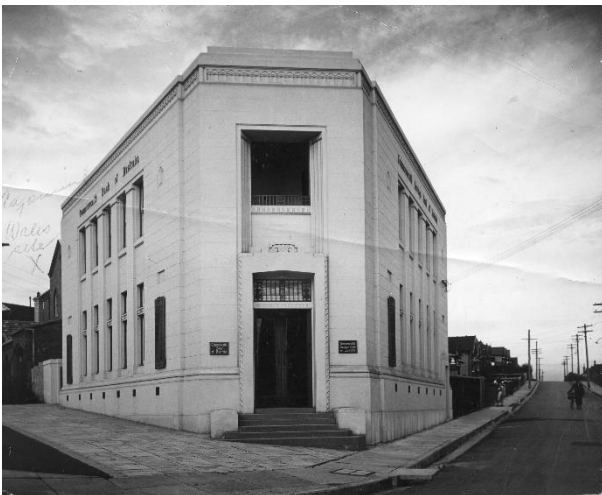
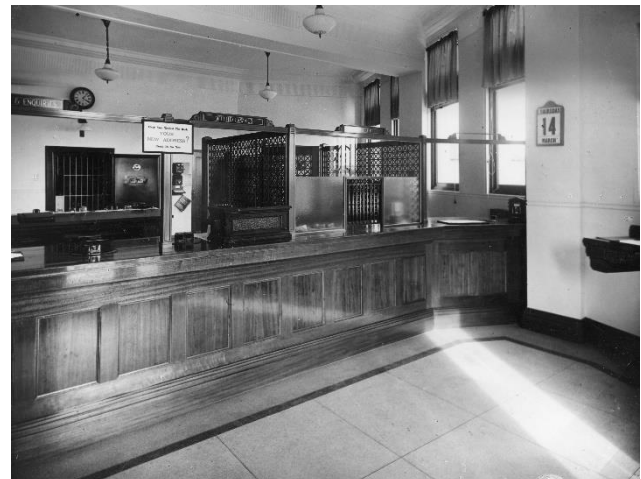
The Canterbury Branch of the Commonwealth Savings Bank of Australia had a decorative façade with details surrounding the door and parapet. The interior included ornate timber teller desks and tiled flooring (see Figure 37 and Figure 38).

Figure 37 – Commonwealth Bank of Australia, Canterbury Branch, exterior. c. 1934

Figure 38- Commonwealth Bank of Australia, Canterbury Branch, interior. C. 1934.

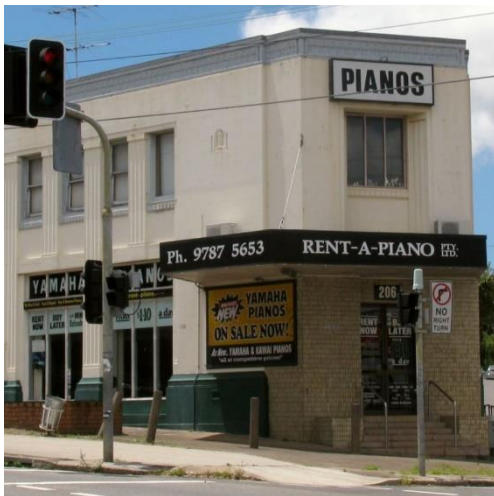
Figure 39 - 206 Canterbury Road in 2012, with signage and tiling.

The Canterbury branch of the Commonwealth Bank of Australia has been modified considerably since its initial construction. The building was sold by public auction on a lease-back basis in 1989, before being officially closed in 1996. While no Development Applications relating to the site between 2006-present were identified on the Canterbury-Bankstown DA tracker, it is evident that works have been undertaken. The façade of the building has been modified, having been tiled by 2012. At the time the site was operating as a piano store, with signage covering the façade (see Figure 39). Since this time, further modifications have been made, including removal of tiling and painting (see Figure 40). An awning has also been added to the corner entry (prior to 2012).

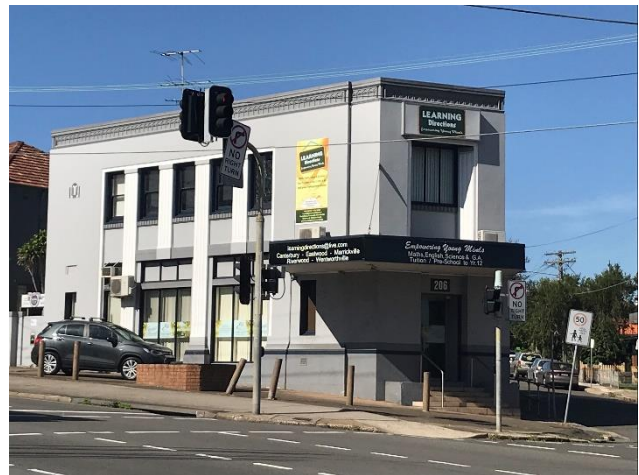
Figure 40 – 206 Canterbury Road in 2020.
