Geotechnical Assessment:
Proposed Seniors Living -
83 Booralie Road, Terrey Hills, NSW

P1404413JR02V01
May 2015

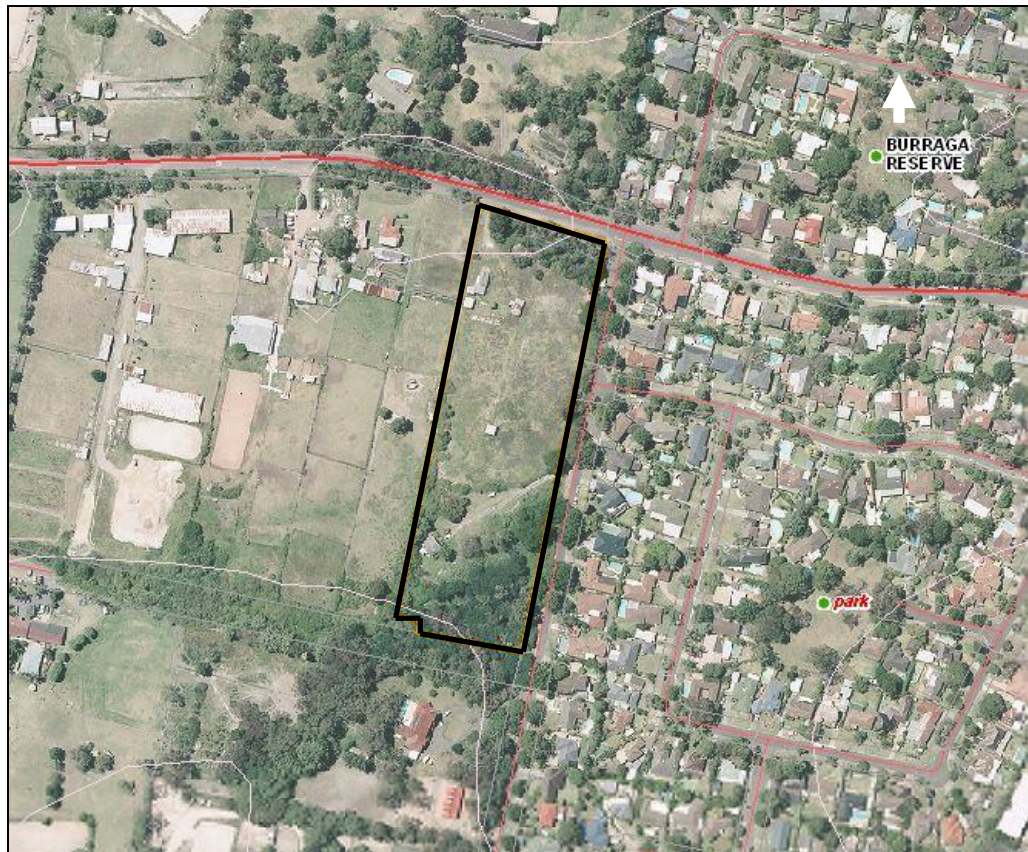
Figure 1: Site location (outlined in black)

The site is located at 83 Booralie Road within the Waringah Council Local Government Area (LGA). The approximate 1.95 ha site is surrounded by residential and rural residential developments (Figure 1).
