WATERWAYS IMPACT STATEMENT

DEE WHY BOWLING CLUB

**221 FISHER ROAD
NORTH CROMER**

OCTOBER 2017

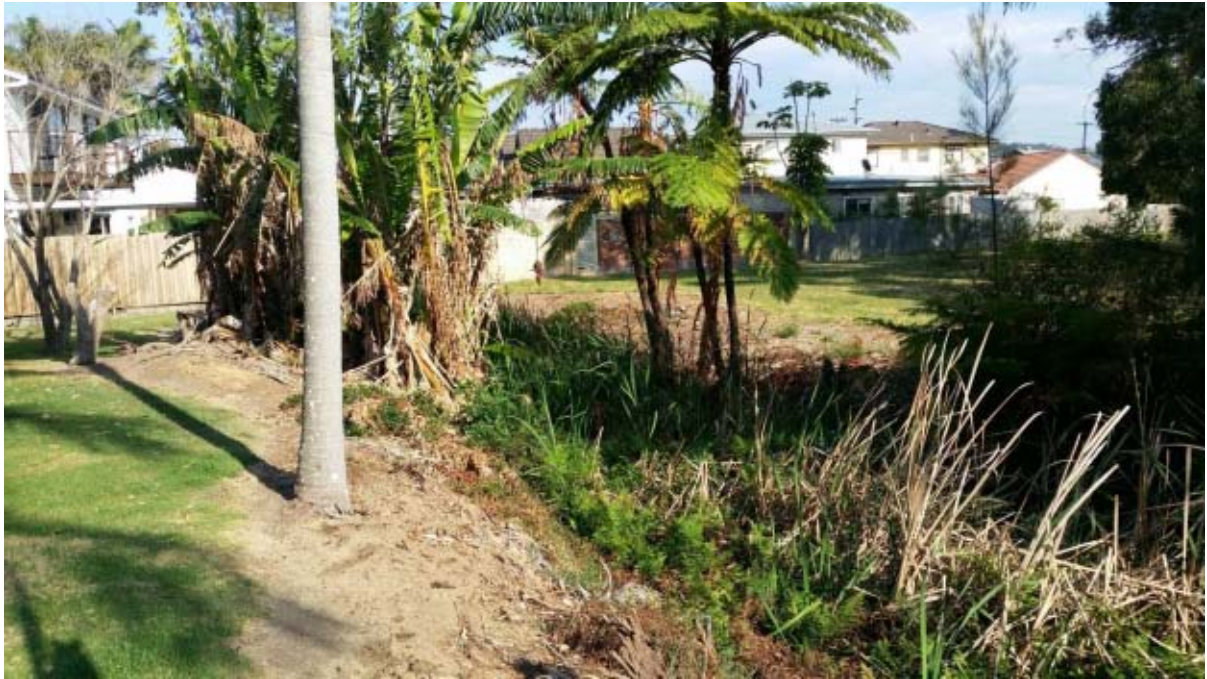
Photo Point 1. Open drainage channel adjacent to northern site boundary.

An area known as the Dee Why Valley Wetlands occurs to the north of the site and drains via an open channel drain to the site where it is piped through the site to the south into Dee Why Creek.

No riparian buffers are proposed or required within the site as drainage through the site is piped. There is a drainage channel present to the north of the site which is not mapped on the current topographic map. No on-site buffers are proposed to this channel.

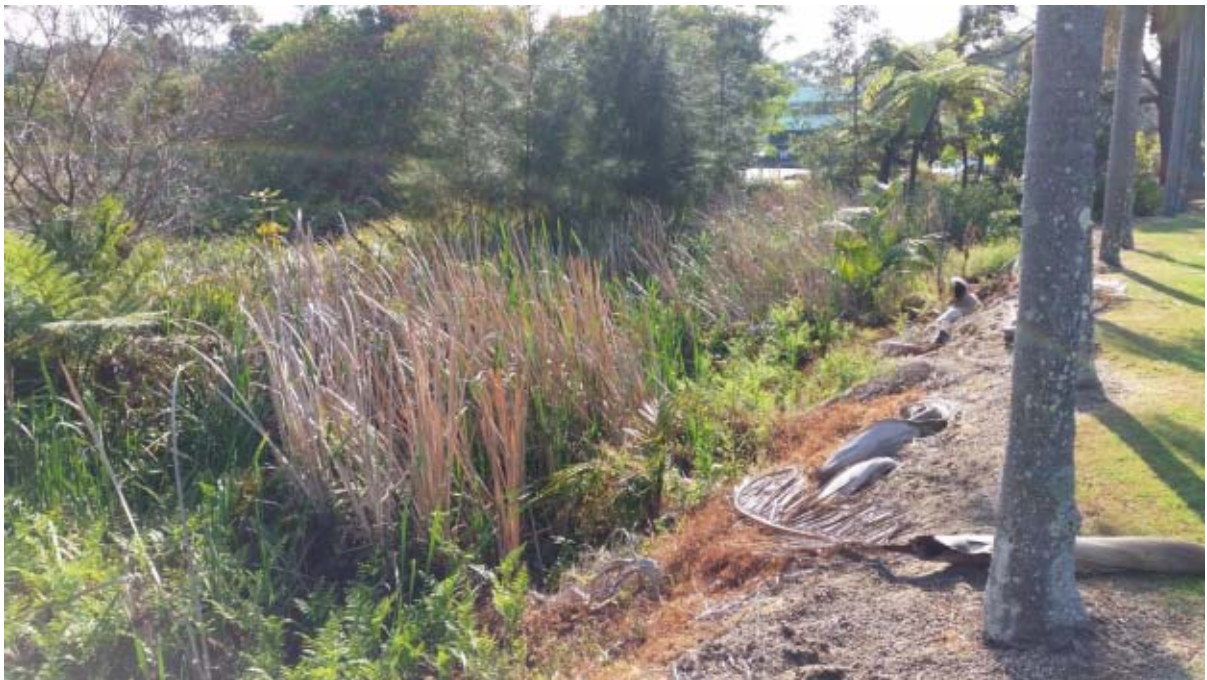
Photo Point 2. Open drainage channel adjacent to northern site boundary.

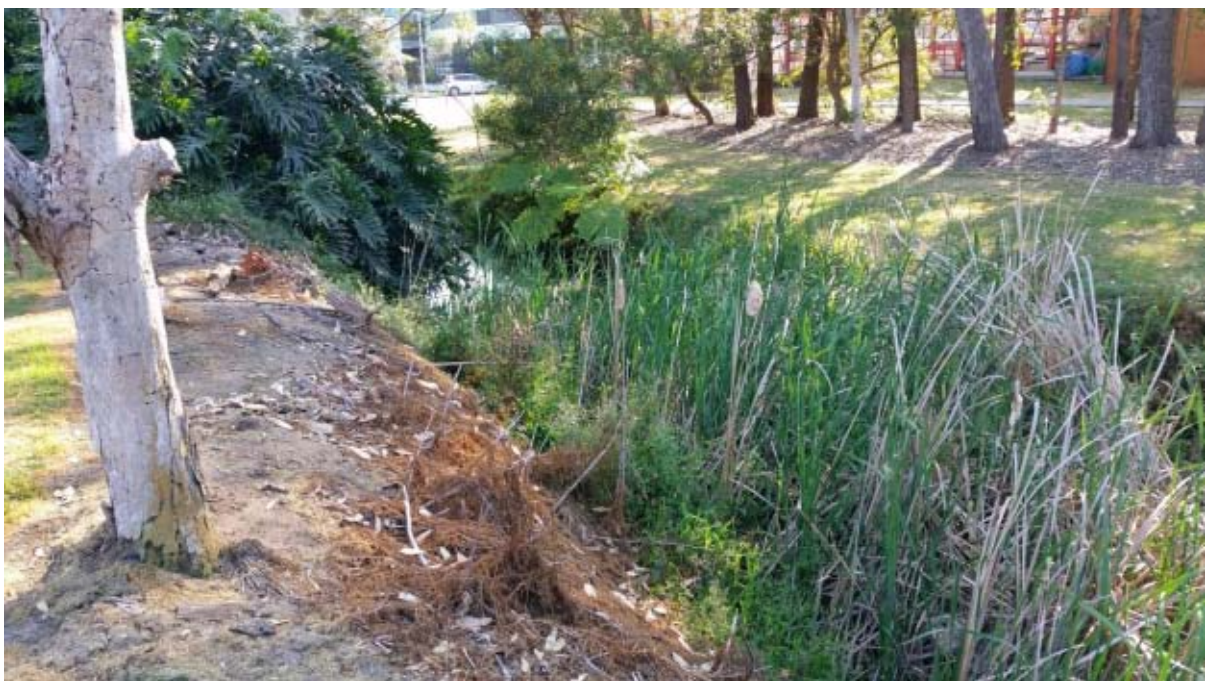
Photo Point 4. Open drainage channel adjacent to northern site boundary.

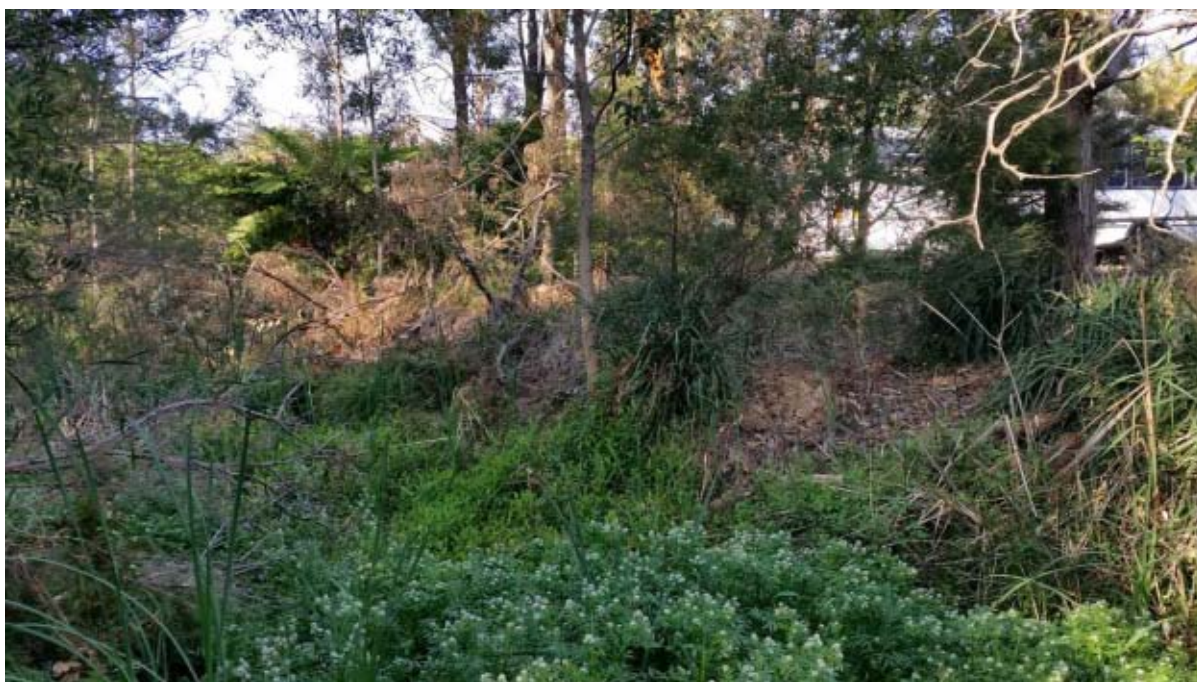
Photo Point 5. Open drainage channel adjacent to southern site boundary

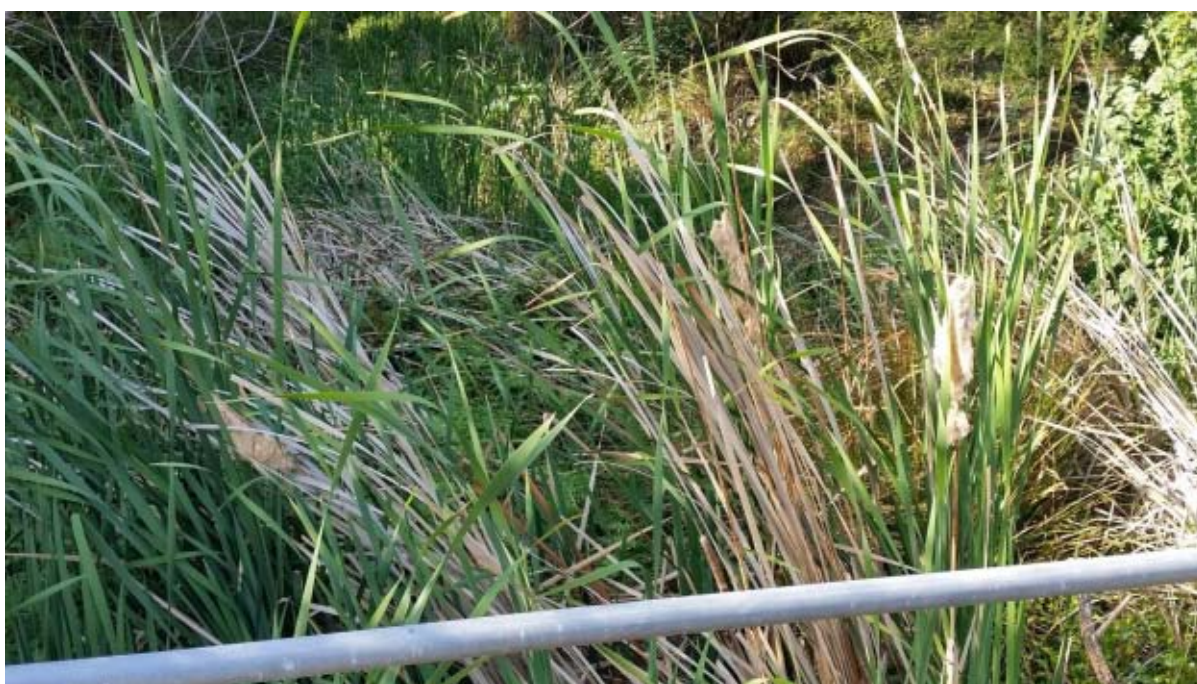
Photo Point 6. Open drainage channel adjacent to southern site boundary

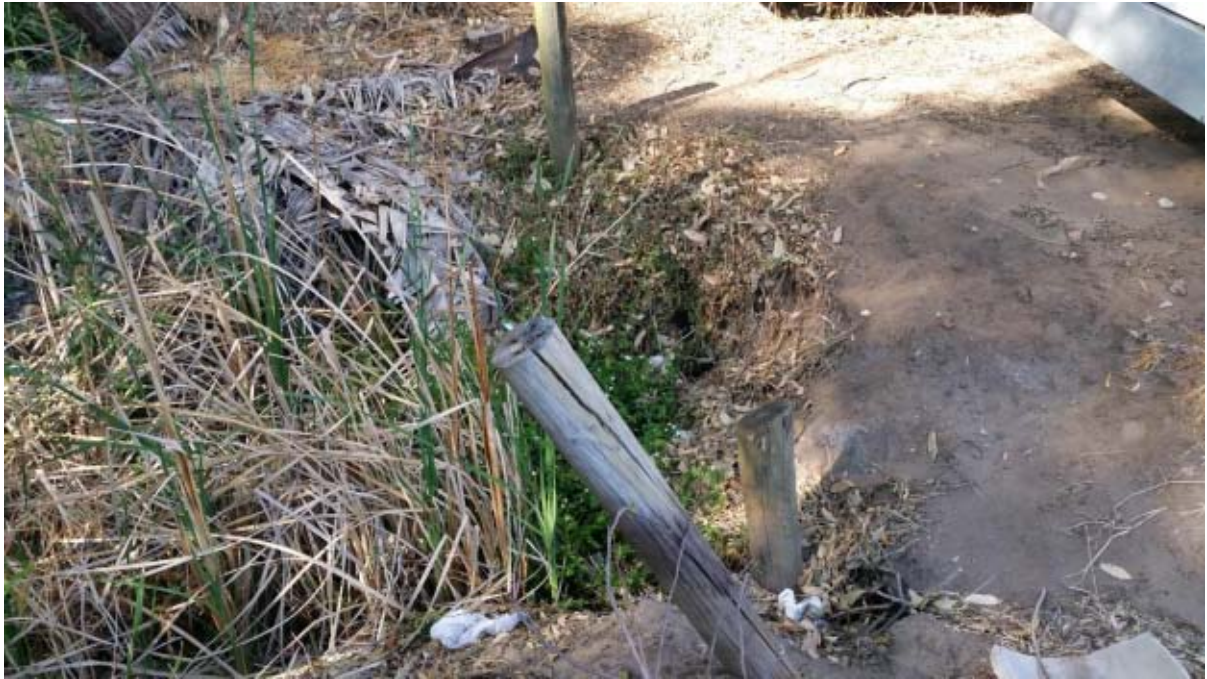
Photo Point 7. Channel outlet in southern section of site.
