**RESPONSE TO ADDITIONAL INFORMATION FOR REQUEST FOR SITE COMPATABILITY CERTIFICATE SELF CARE SENIORS HOUSING AT NO 120 WALKER STREET HELENSBURGH**

## **Attachment 1 – Comments in relation to additional information forwarded to Council on 5 February 2020**

**Attachment Two – Council response dated 11 December 2018 to application for Site Compatibility Certificate**

### Impact of hydrology and hydrochemistry on the ecological continuum of the Maddens Plains Upland Wetlands

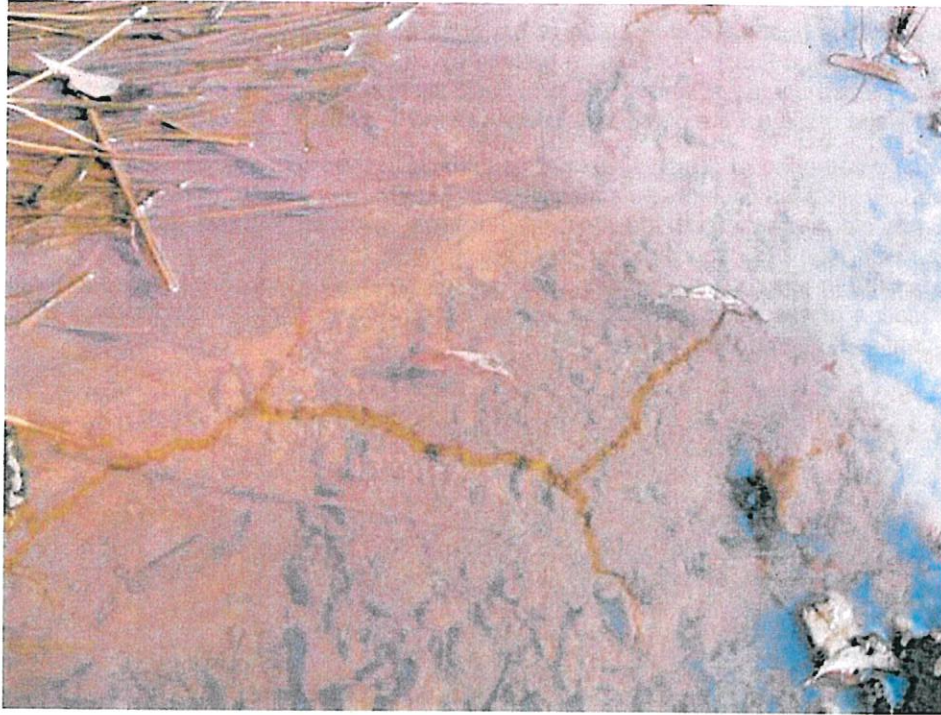
**Figure 1-** Iron oxidising bacteria forming a thin film on the surface of water at the Outlet of the sedge land drain, near the proposed Lot 1A. Bacteria oxidise the soluble iron ( $\text{Fe}^{2+}$ ) into insoluble  $\text{Fe}^{3+}$  and precipitate of Iron hydroxide

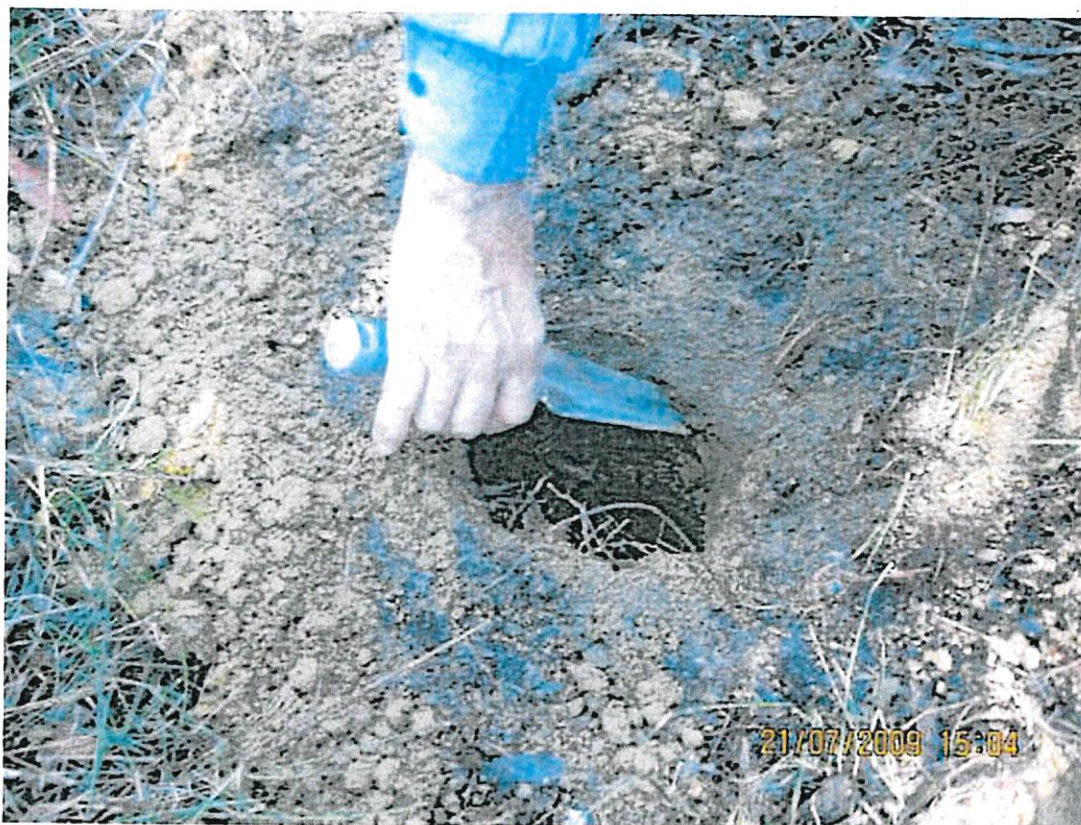
**Figure 9-** Auger hole at the proposed Lot 1A, showing organic crust on the top of weathered unconsolidated sand horizon

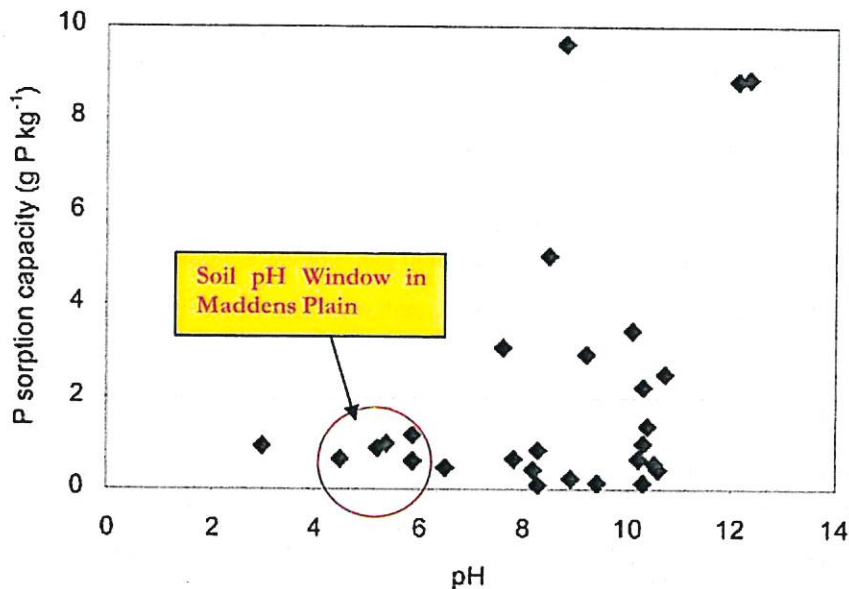
**Figure 11-** Relationship between the P sorption capacity and pH

There is a clear relation between soil pH and soil P sorption capability. The lowest P sorption occurs in acidic soil and highest sorption in alkaline environment. As table 5 shows in Maddens Plain soil acidic pH which generally fluctuate between 4.5 and 5.5 is sever limitation for Phosphorus retention.

Based on soil phosphorus retention capability five classes of soil are identified: very low < 10%, low 10-30%, medium 30-60%, high 60-90% and very high >90%. Soil in Maddens Plain fall within the <10 % category in relation to phosphorous retention.

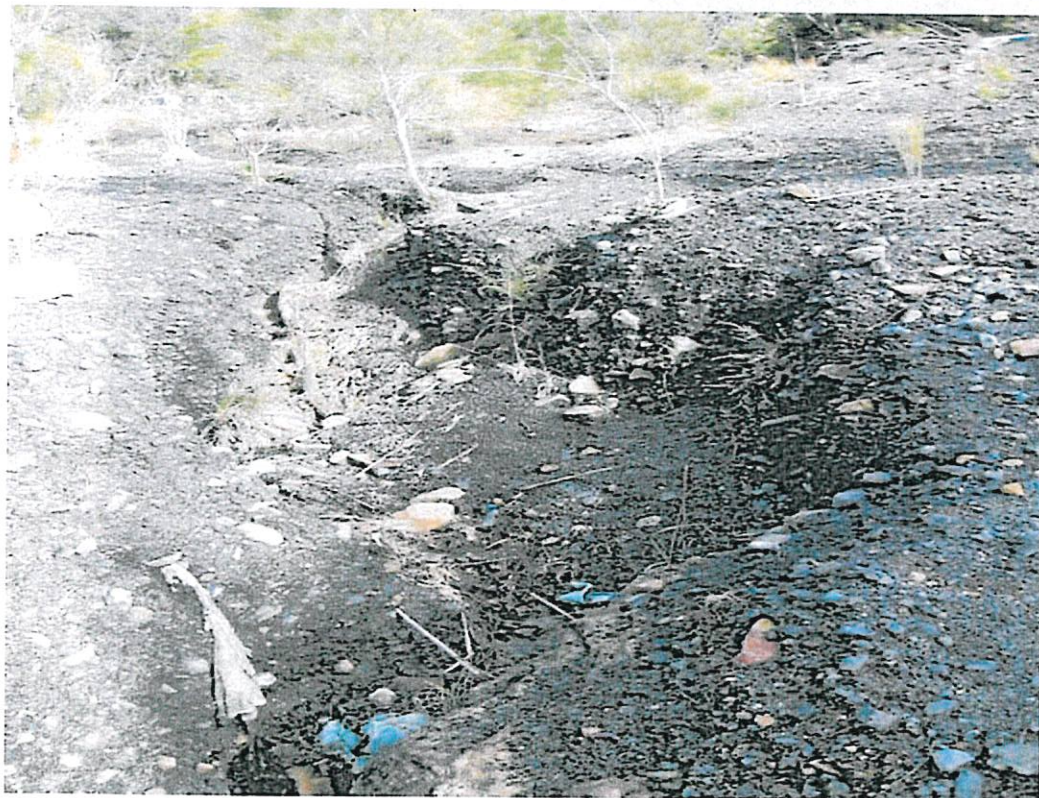
**Figure 13-** Gully erosion within the coal wash layer used for road construction on the road

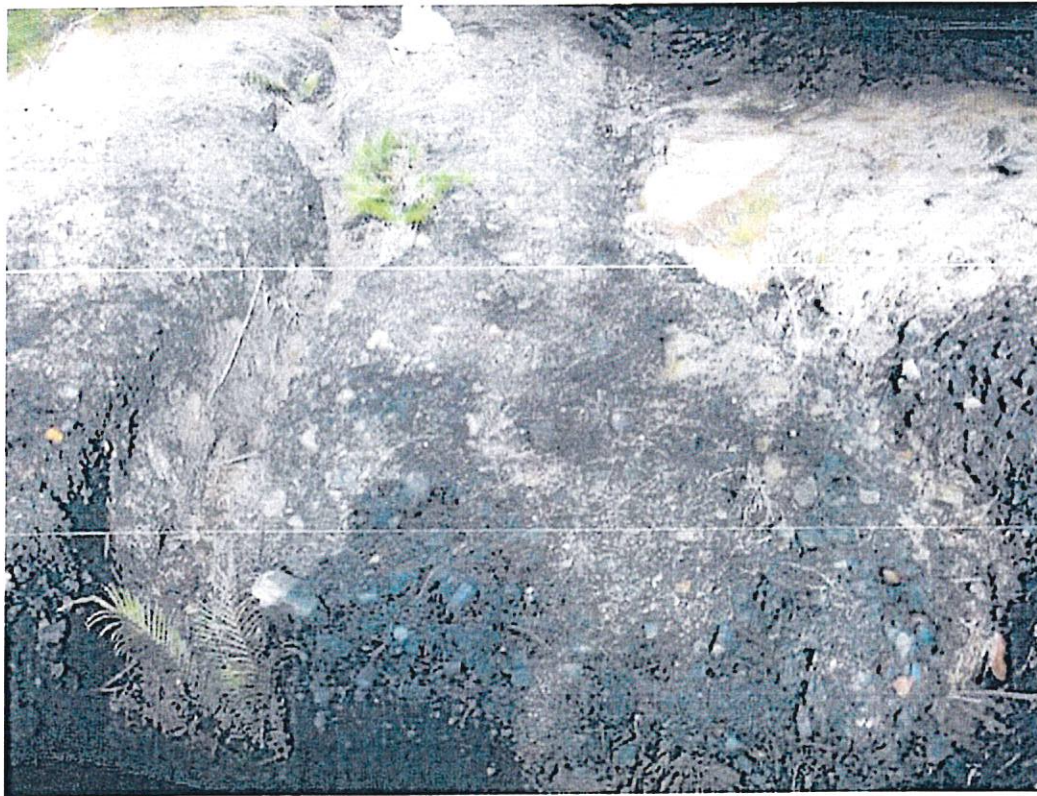
Figure 14- Close up picture of erosion pathway along the road shoulder, where coalwash was used.

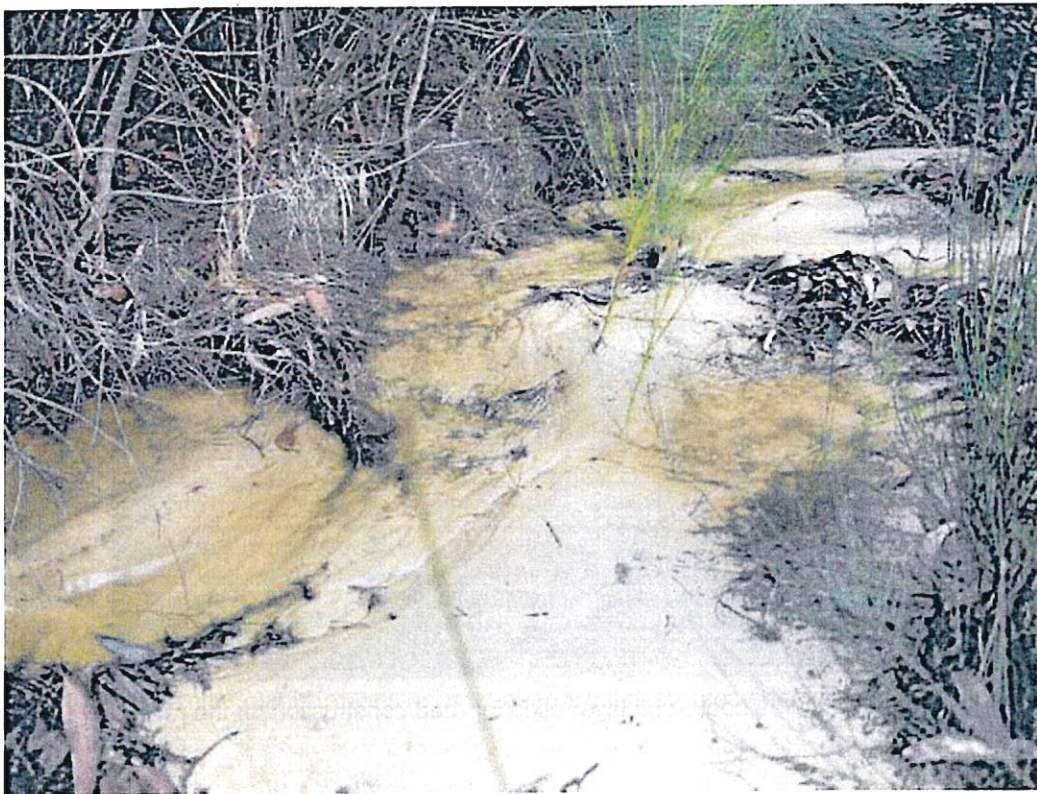
**Figure 15-** Freshly deposited sediment in the drainage line along the recently upgraded road
