Remedial Action Plan

170 Reservoir Road

Arndell Park, New South Wales

Paynter Dixon Constructions Pty Ltd

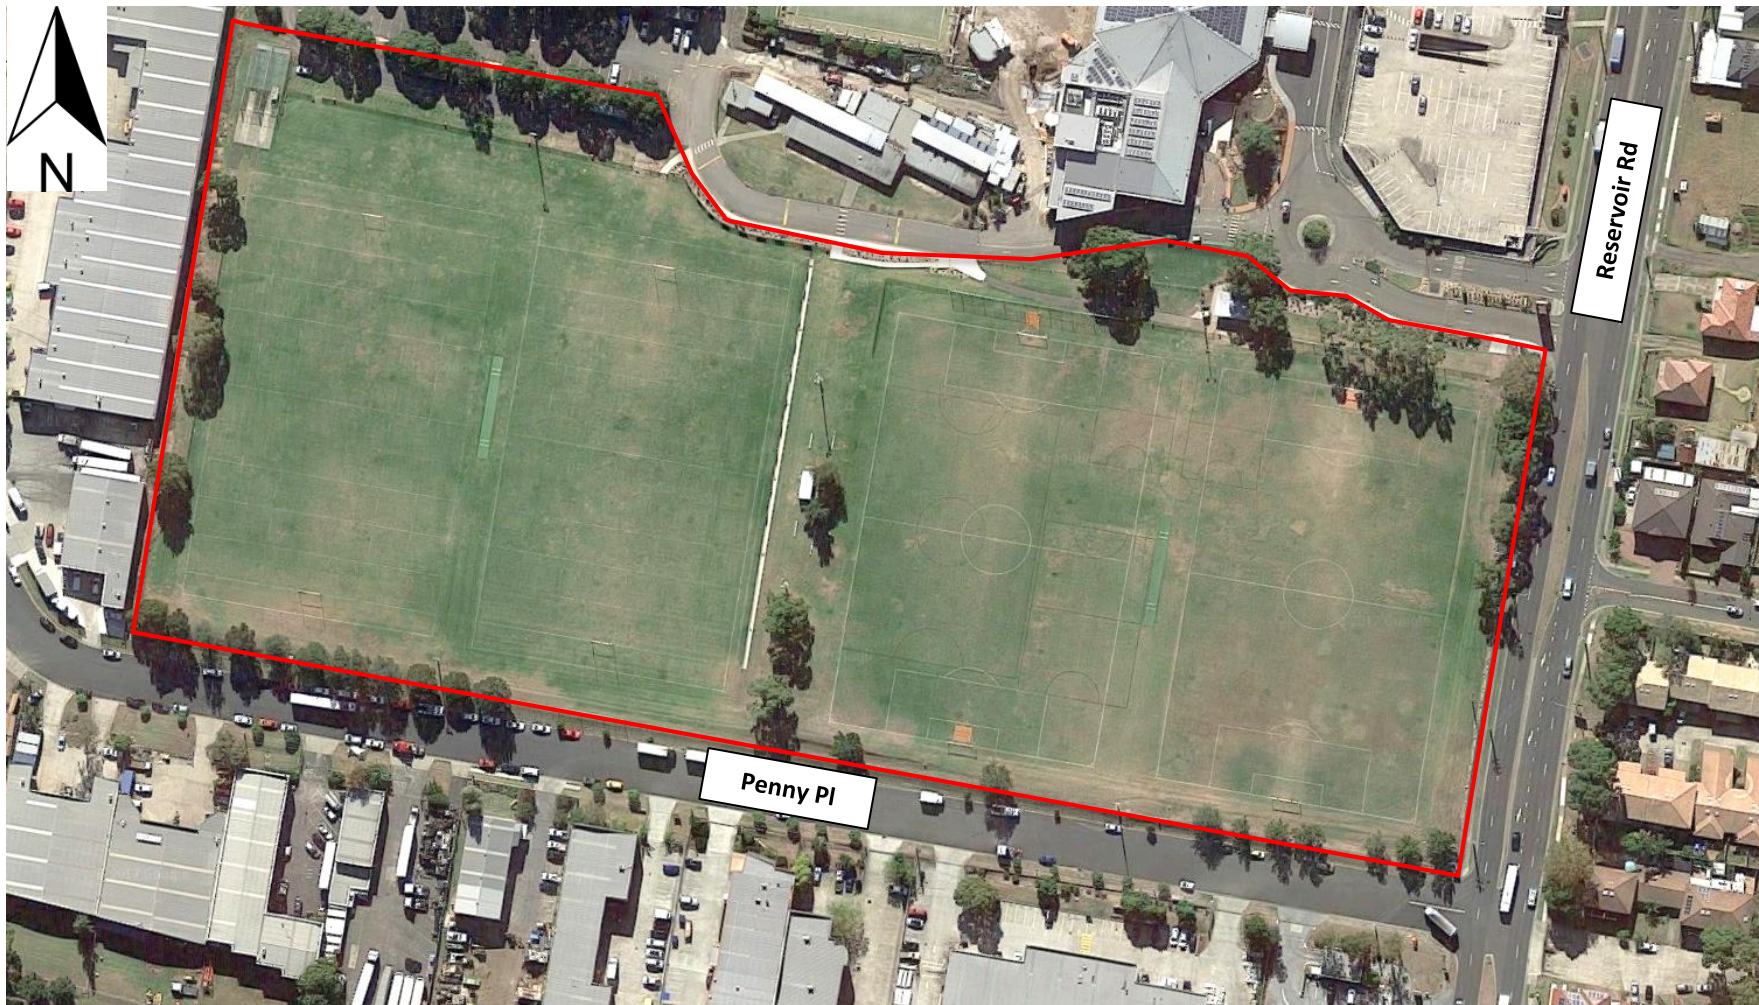
— Investigation Area Boundary

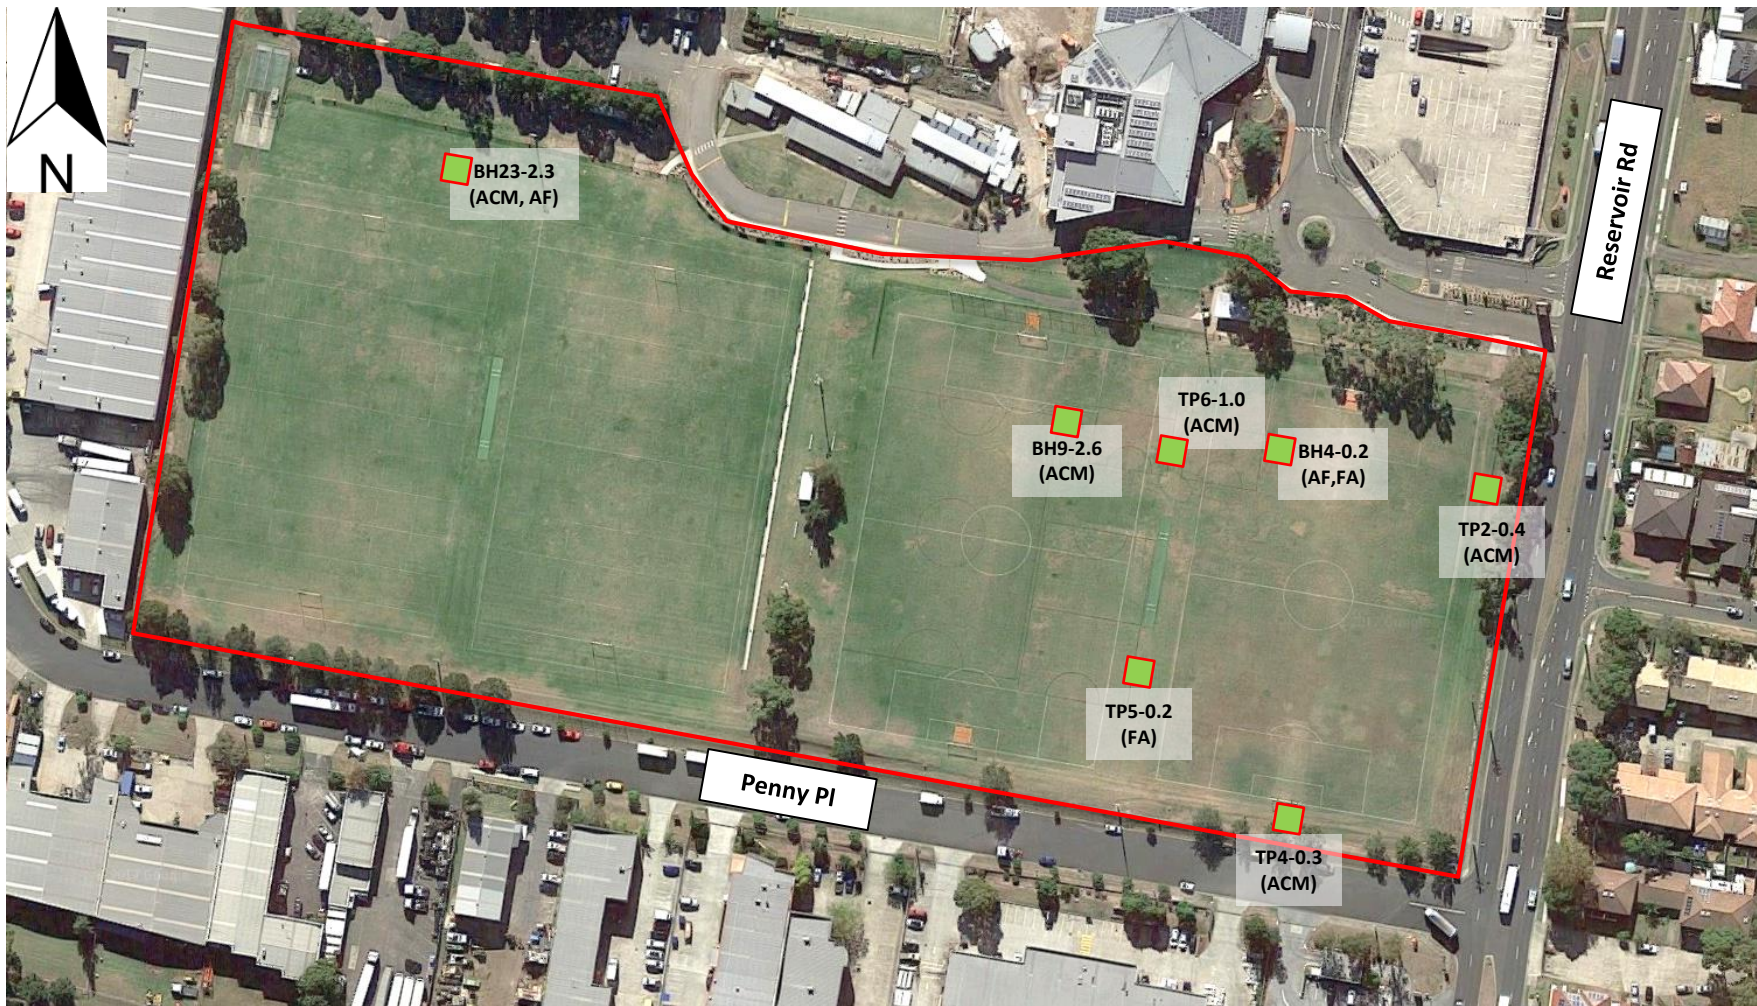
— Investigation Area Boundary

■ 10x10m remediation hotspot

As noted above in **Section 8.4.1**, remediation of asbestos impacted fill material at the site includes removal and validation of contamination hotspots that were identified during the recent TRACE Environmental DSI (2018) (**Figure 3**). The 'hotspots' should be assigned a remediation grid location (based on a 10m sampling grid) and soil validation samples will be collected from each 'hotspot' grid following excavation per the following ratios (which are based on frequencies outlined in WA DoH 2009 and per methodologies outlined below in **Table 8-2**):

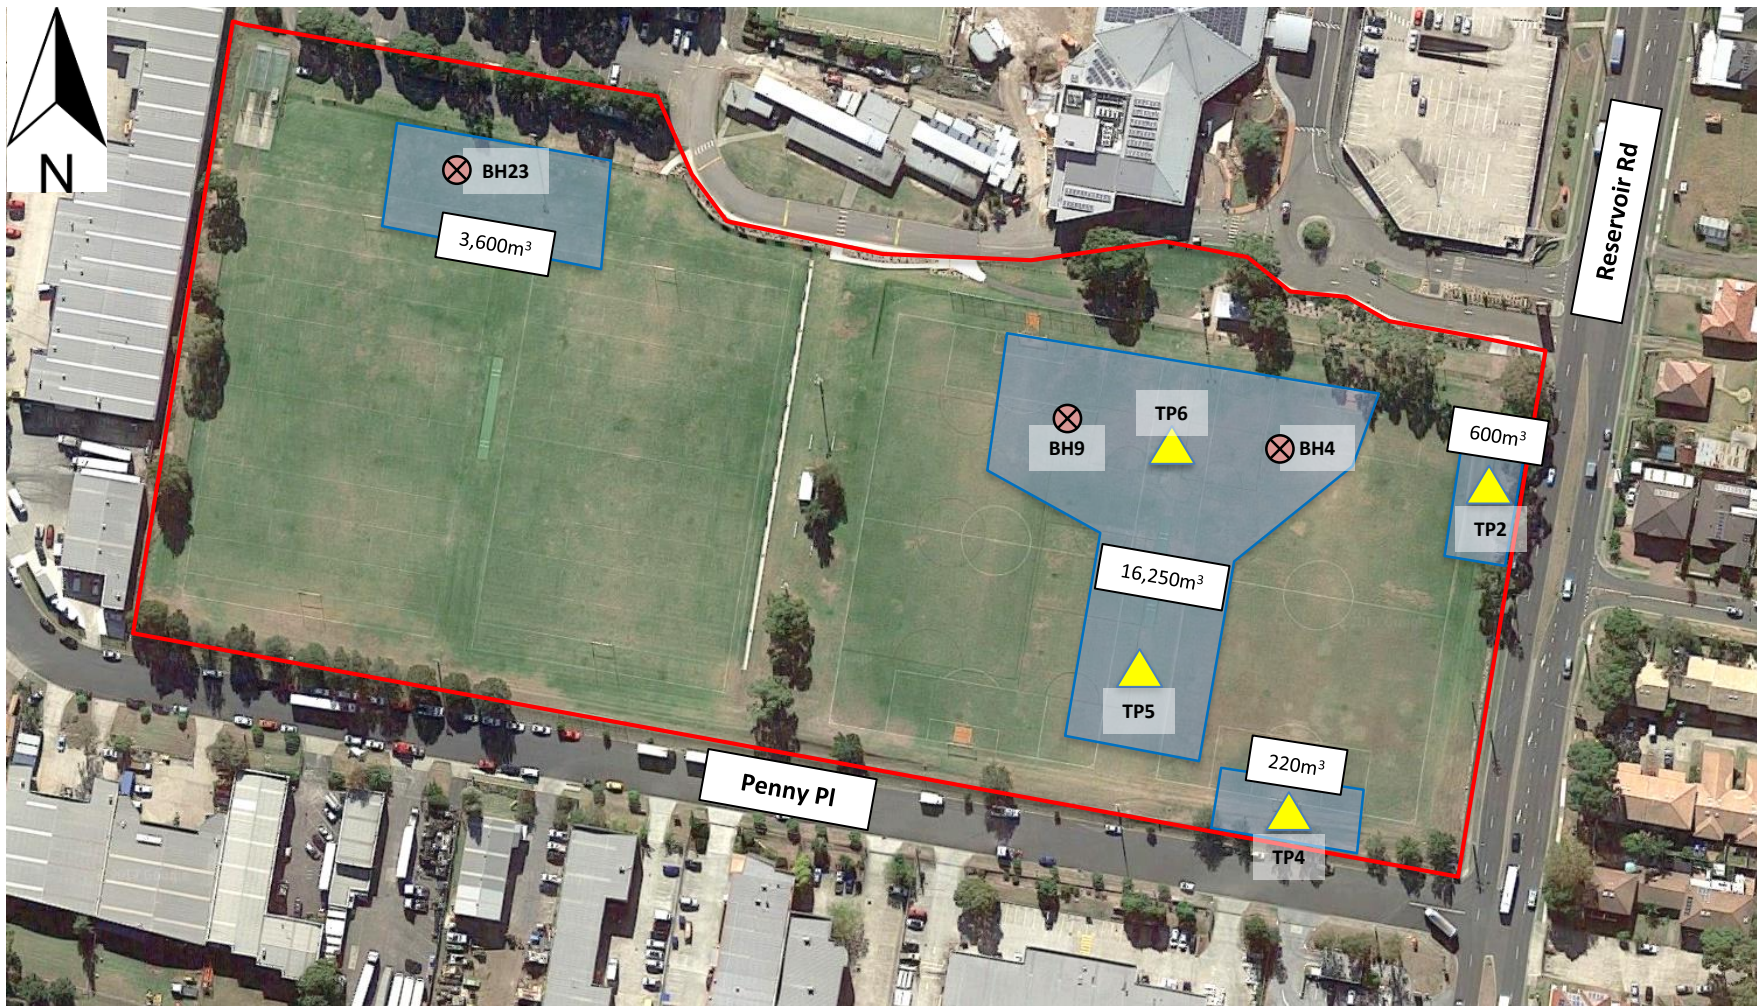
— Investigation Area Boundary ⊗ Borehole Location ▲ Test Pit Location
