Waterbrook Lifestyle Resort  
C/- Marchese Partners Engineering

# Geotechnical and Acid Sulfate Soils Assessment: Proposed Seniors Living Development, Cabbage Tree Road, Bayview, NSW

P1706099JR02V03  
August 2018

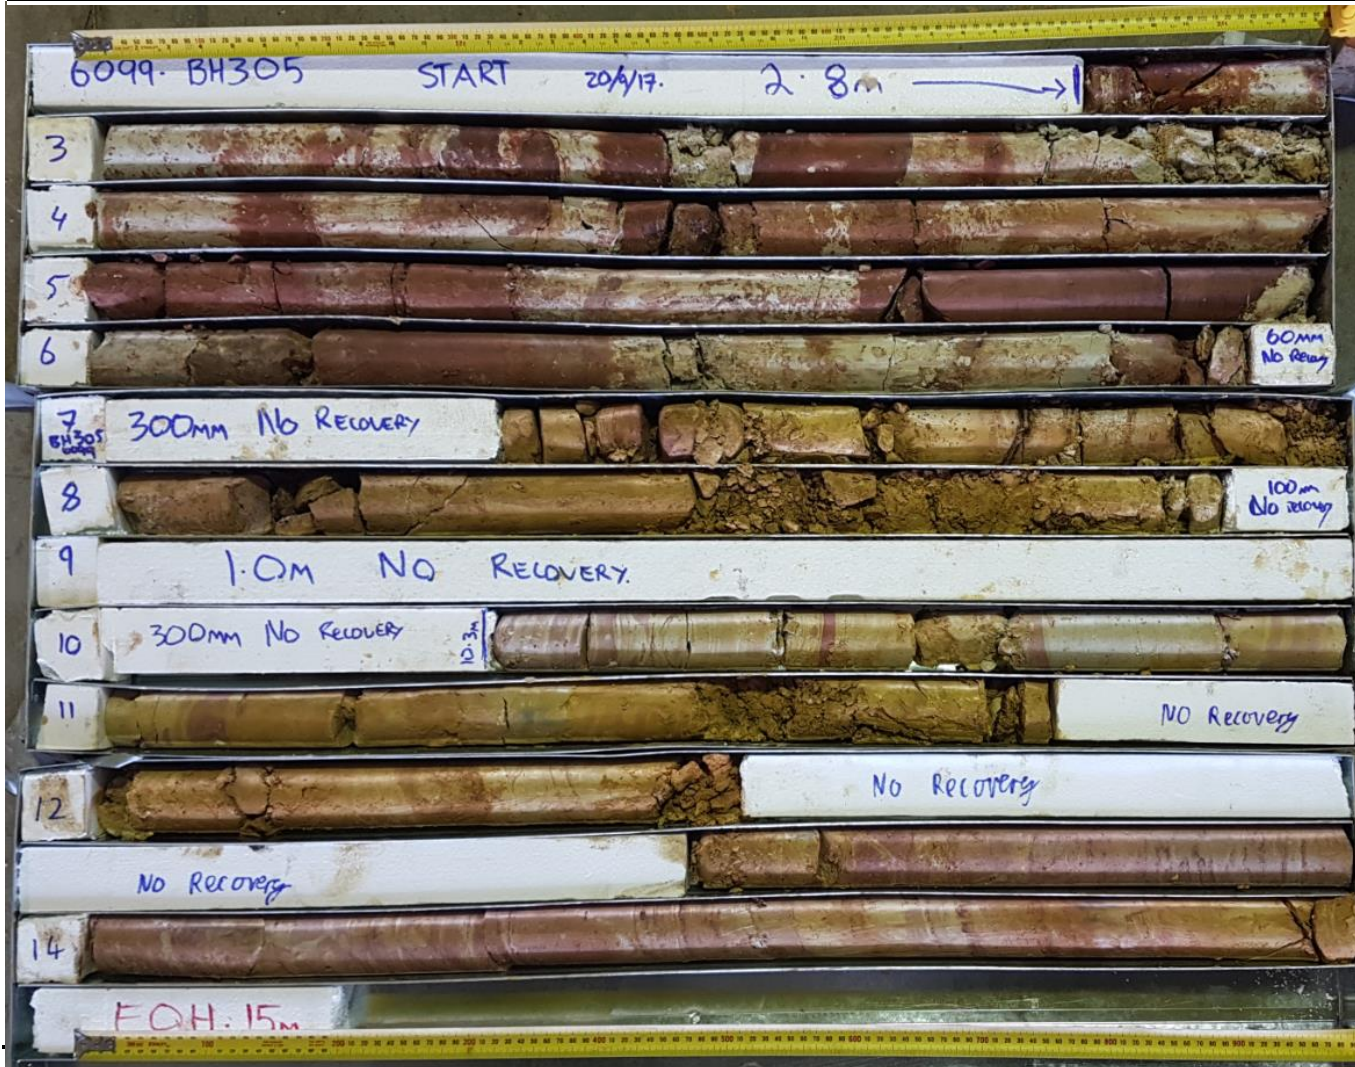
| Drawn: | HN | PHOTO OF ROCK CORE – BH305<br>Proposed Seniors Living Development, Cabbage Tree Road, Bayview, NSW | Drawing: |
