Waterbrook Lifestyle Resort
C/- Marchese Partners Engineering

Detailed Site Investigation:
Proposed Seniors Living Development,
Bayview Golf Course
Cabbage Tree Road, Bayview, NSW

P1706099JR01V02
November 2017

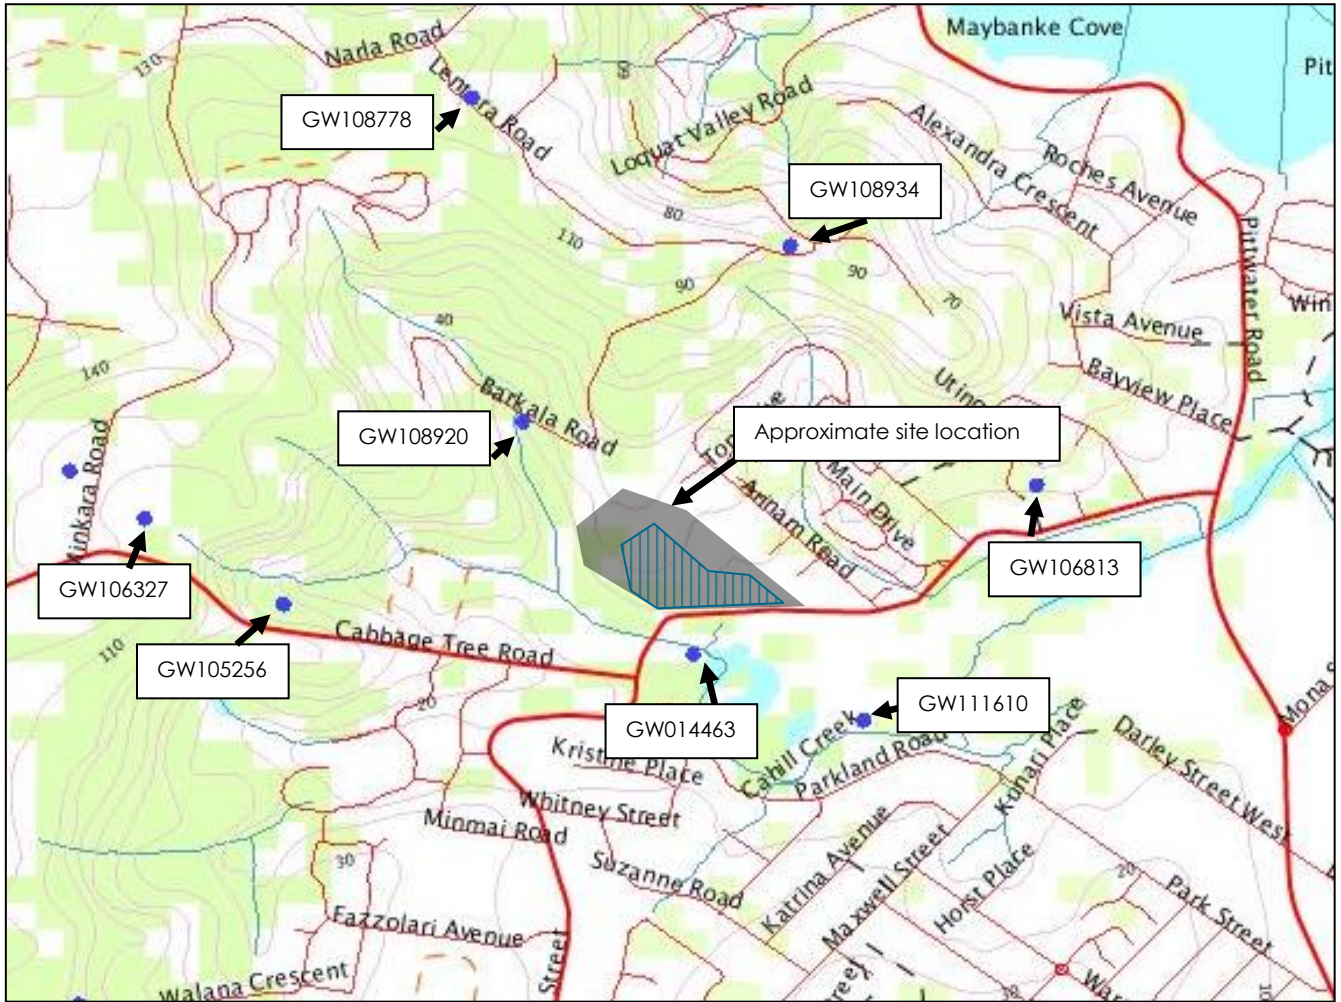
Groundwater inflow was encountered only during drilling of BH101 at 5.0 mBGL (RL 0.8 mAHD). This borehole is located on the lower slopes of the site (near Cabbage Tree Road) underlain by alluvial sediments (silty clay) to about 0.0 mAHD. Groundwater inflow was not encountered during drilling of other boreholes, which were drilled into the residual soil unit (except for BH314), up to 8.5 mBGL or observed below this depth due to the introduction of drilling fluids during rock coring.

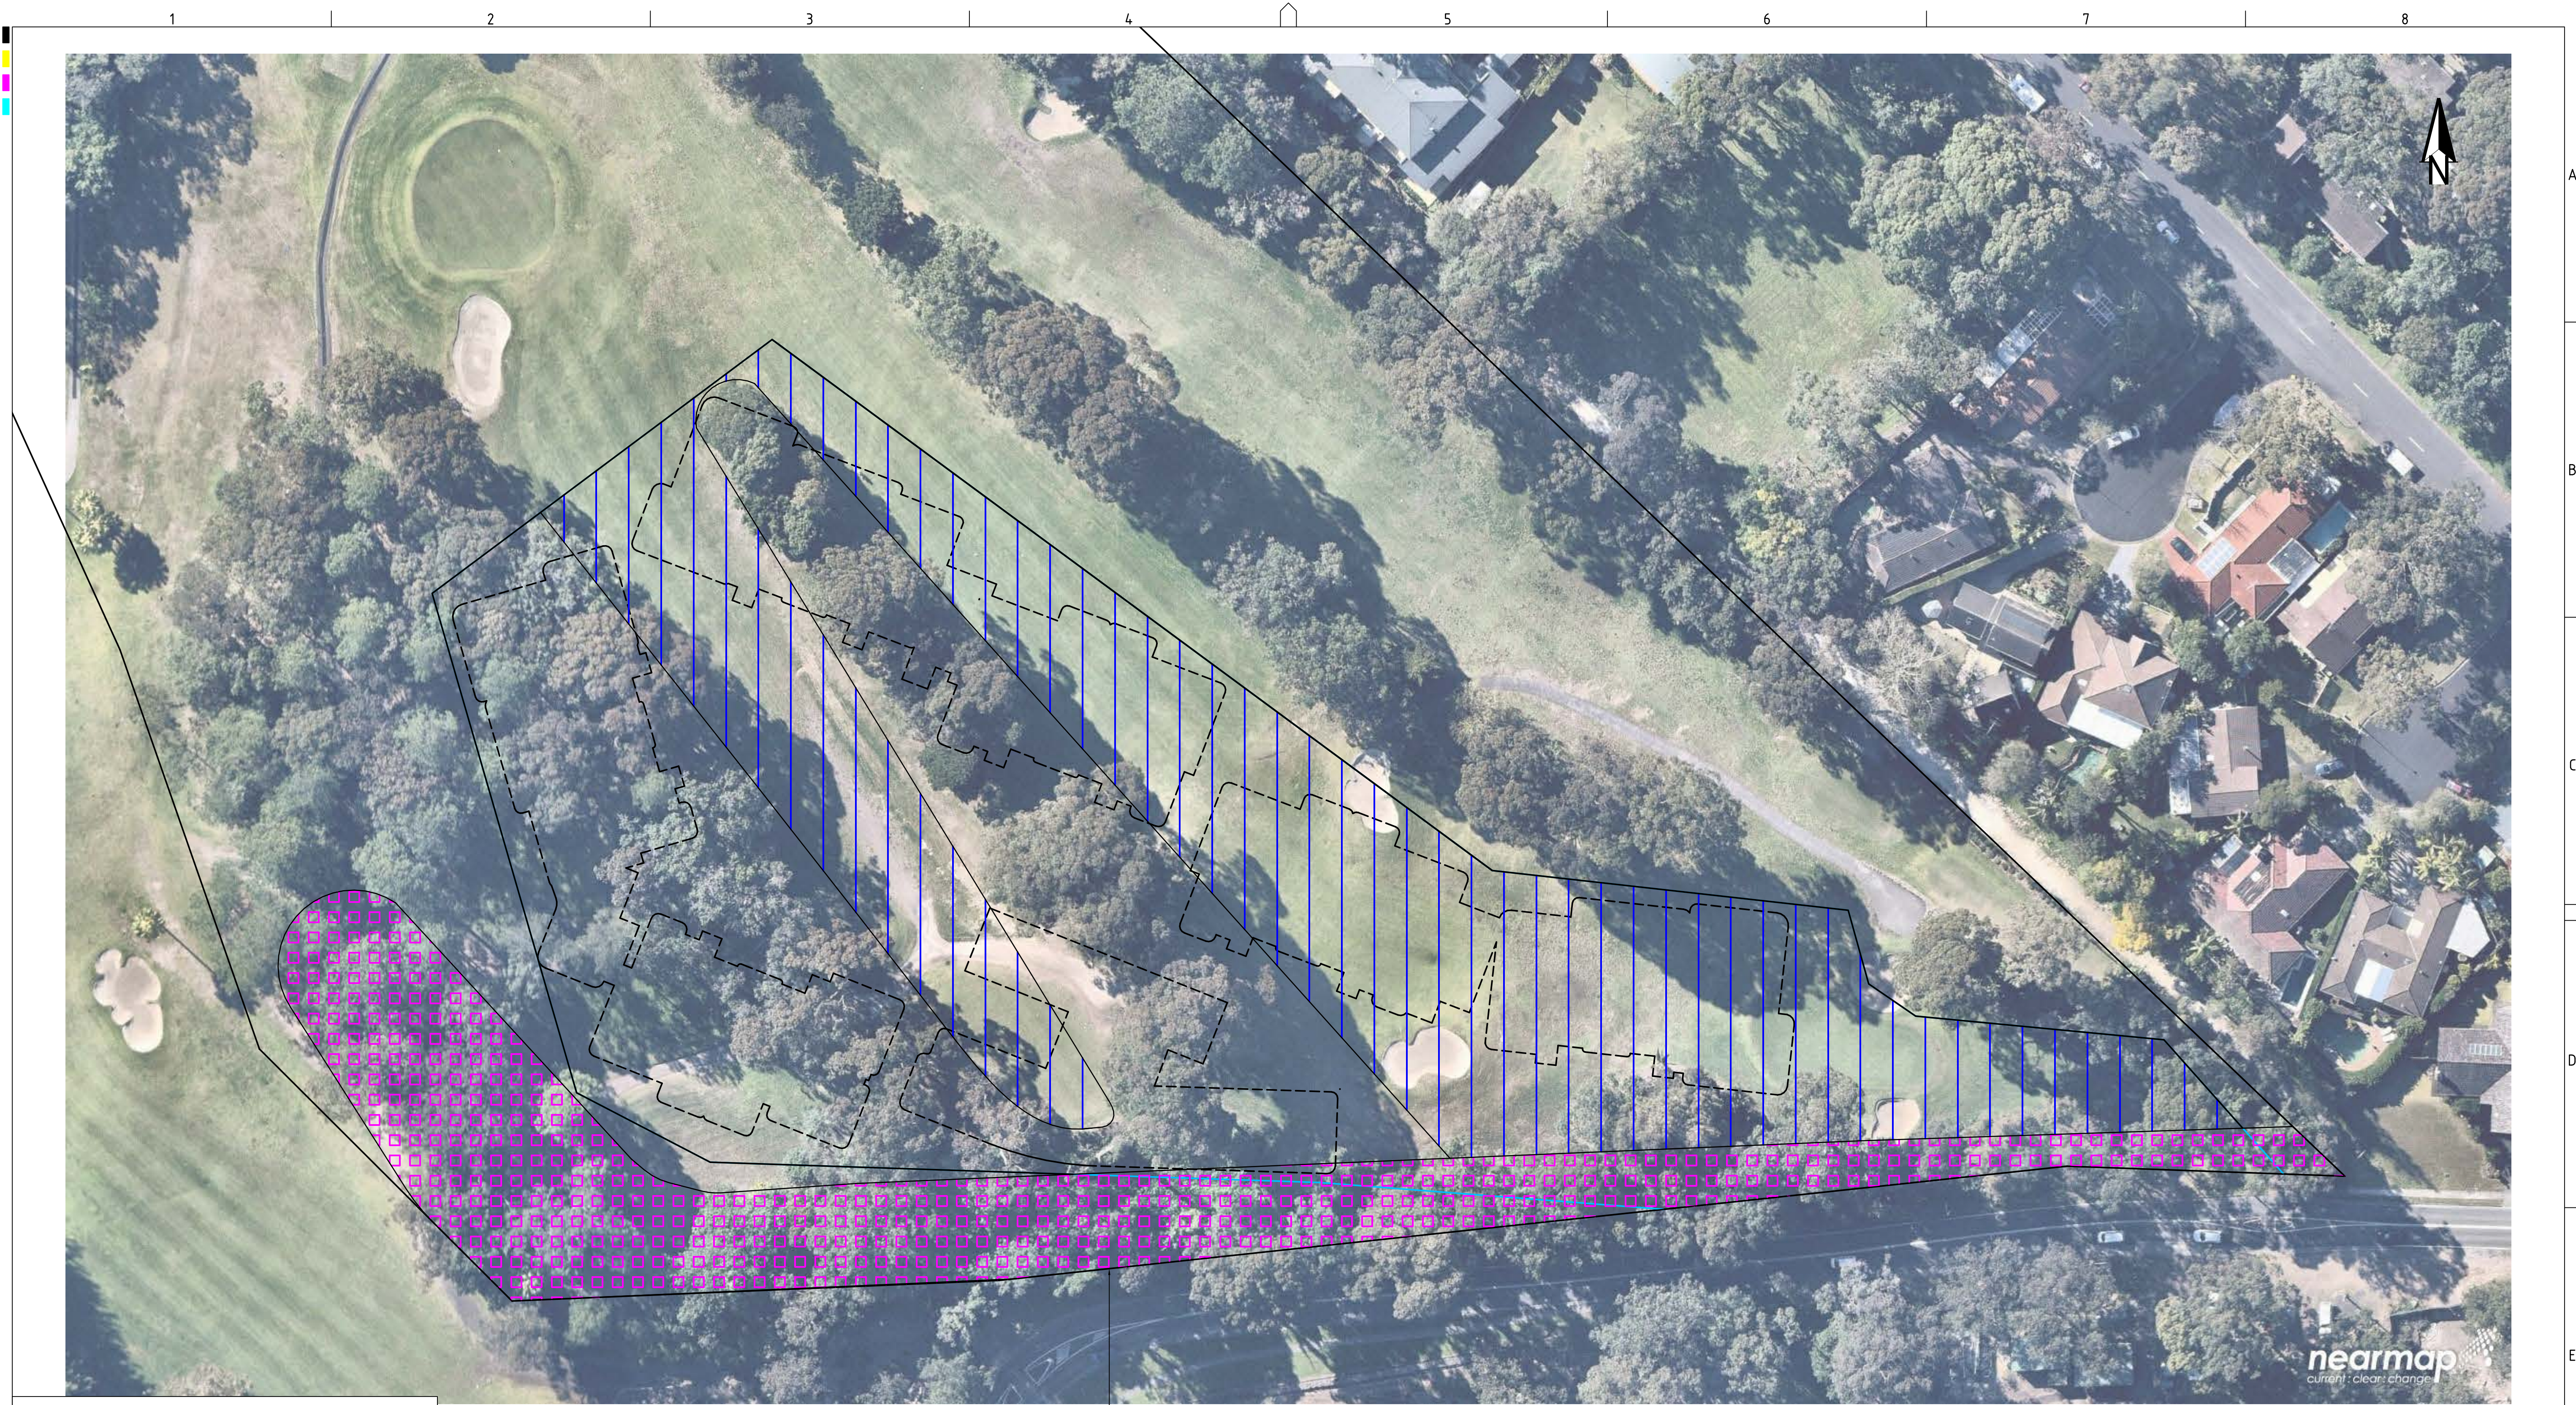
DRAWING TITLE
FIGURE 3: INVESTIGATION LOCATIONS & AEC MAP
PROJECT NO.
P1706099
PLANSET NO.
PS01
RELEASE NO.
R01
DRAWING NO.
PS01-J110
REVISION
A

AEC A- GOLF COURSE (FAIRWAYS)

BUILDING OUTLINE

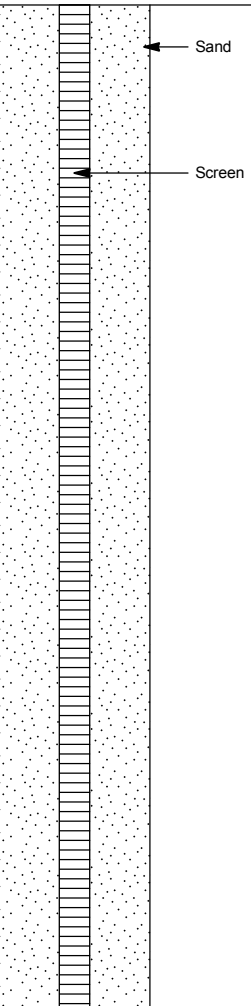
10	10.30 9.60					CLAYSTONE and SILTSTONE, light red/light grey/yellow-brown.				
			11	11.80 8.10 12.00 7.90					NO CORE				
			12	12.50 7.40					CLAYSTONE and SILTSTONE, red with light grey and yellow-brown.				
			13						NO CORE				
			14	13.45 6.45					CLAYSTONE and SILTSTONE, red with light grey and yellow-brown.				
			15	15.00					Hole Terminated at 15.00 m (Target depth reached)				
			16										
			17
