# **STAGE 1 PRELIMINARY CONTAMINATION ASSESSMENT**

Proposed Residential Subdivision and Seniors Housing

**49 Elouera Terrace, Bray Park NSW 2484  
(Lot 22, DP1170438 and Lot 18, DP627632)**

May 2019

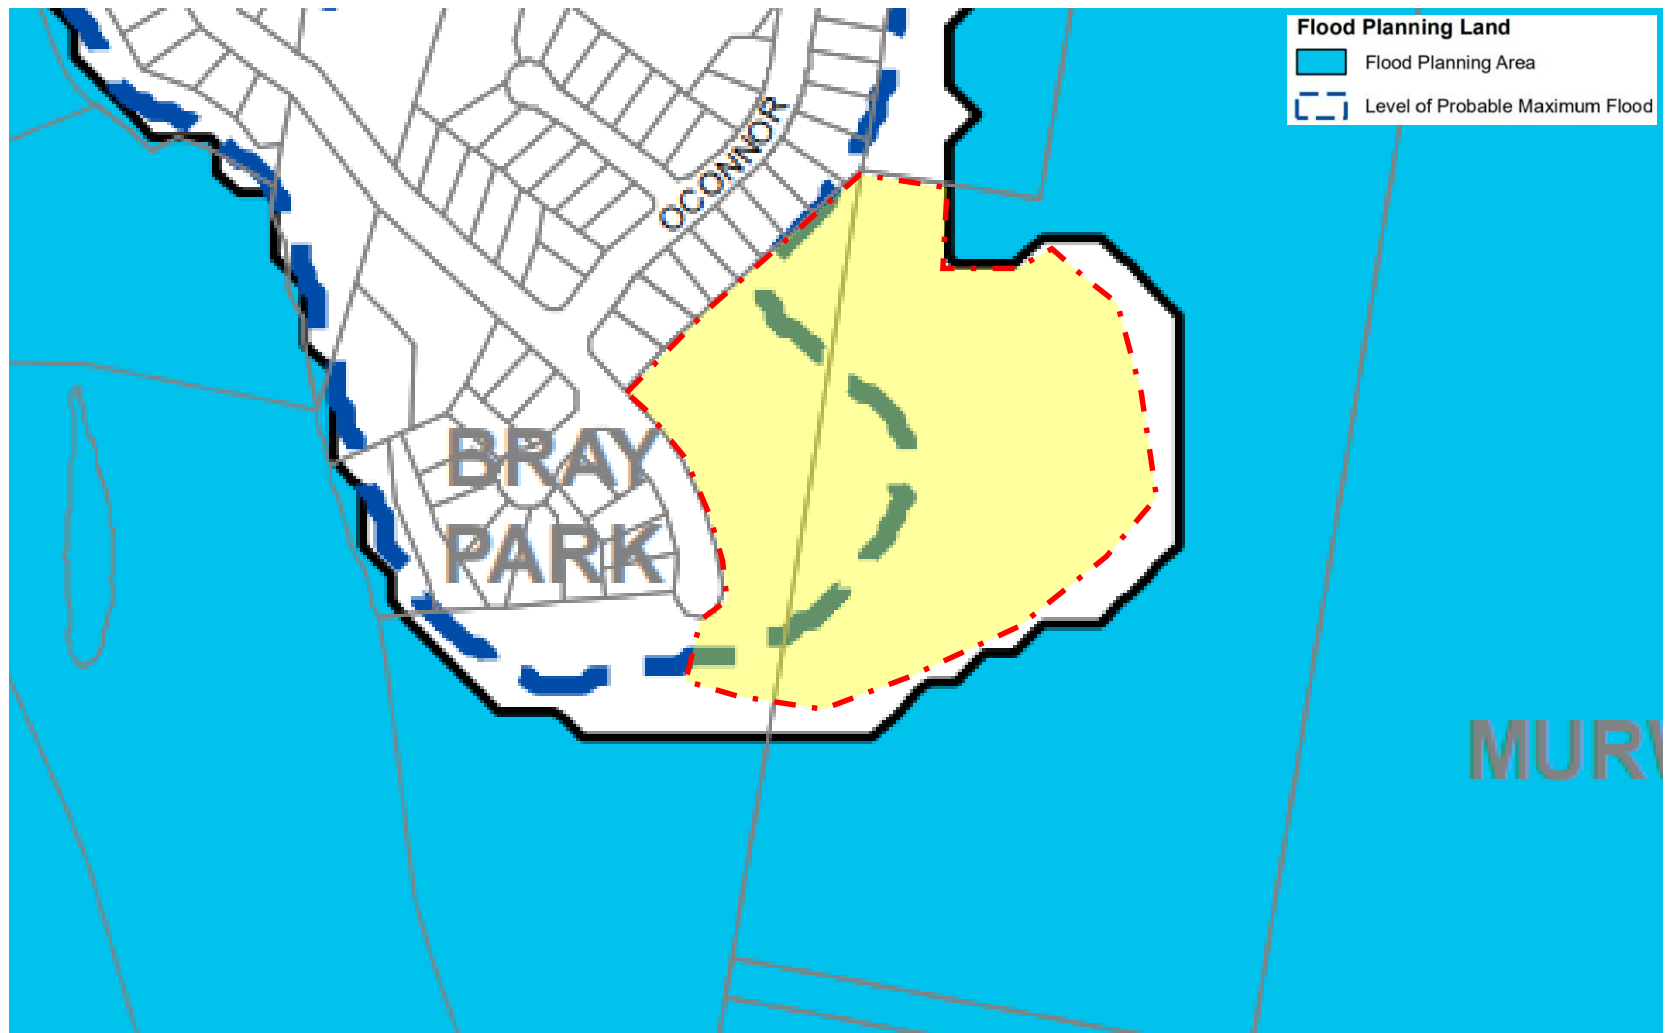
**Figure 3 – Flood Planning Area**  
49 Elouera Terrace, Bray Park NSW

There is a potential flooding risk associated with the maximum probable flood level in the areas of the proposed development. However, the proposed development area is not situated within Tweed Shire Council's flood planning area. The extent of the Tweed Shire Council LEP (2014) flood planning area, associated with Tweed River to the south, is shown on Figure 3, **Attachment 1**.

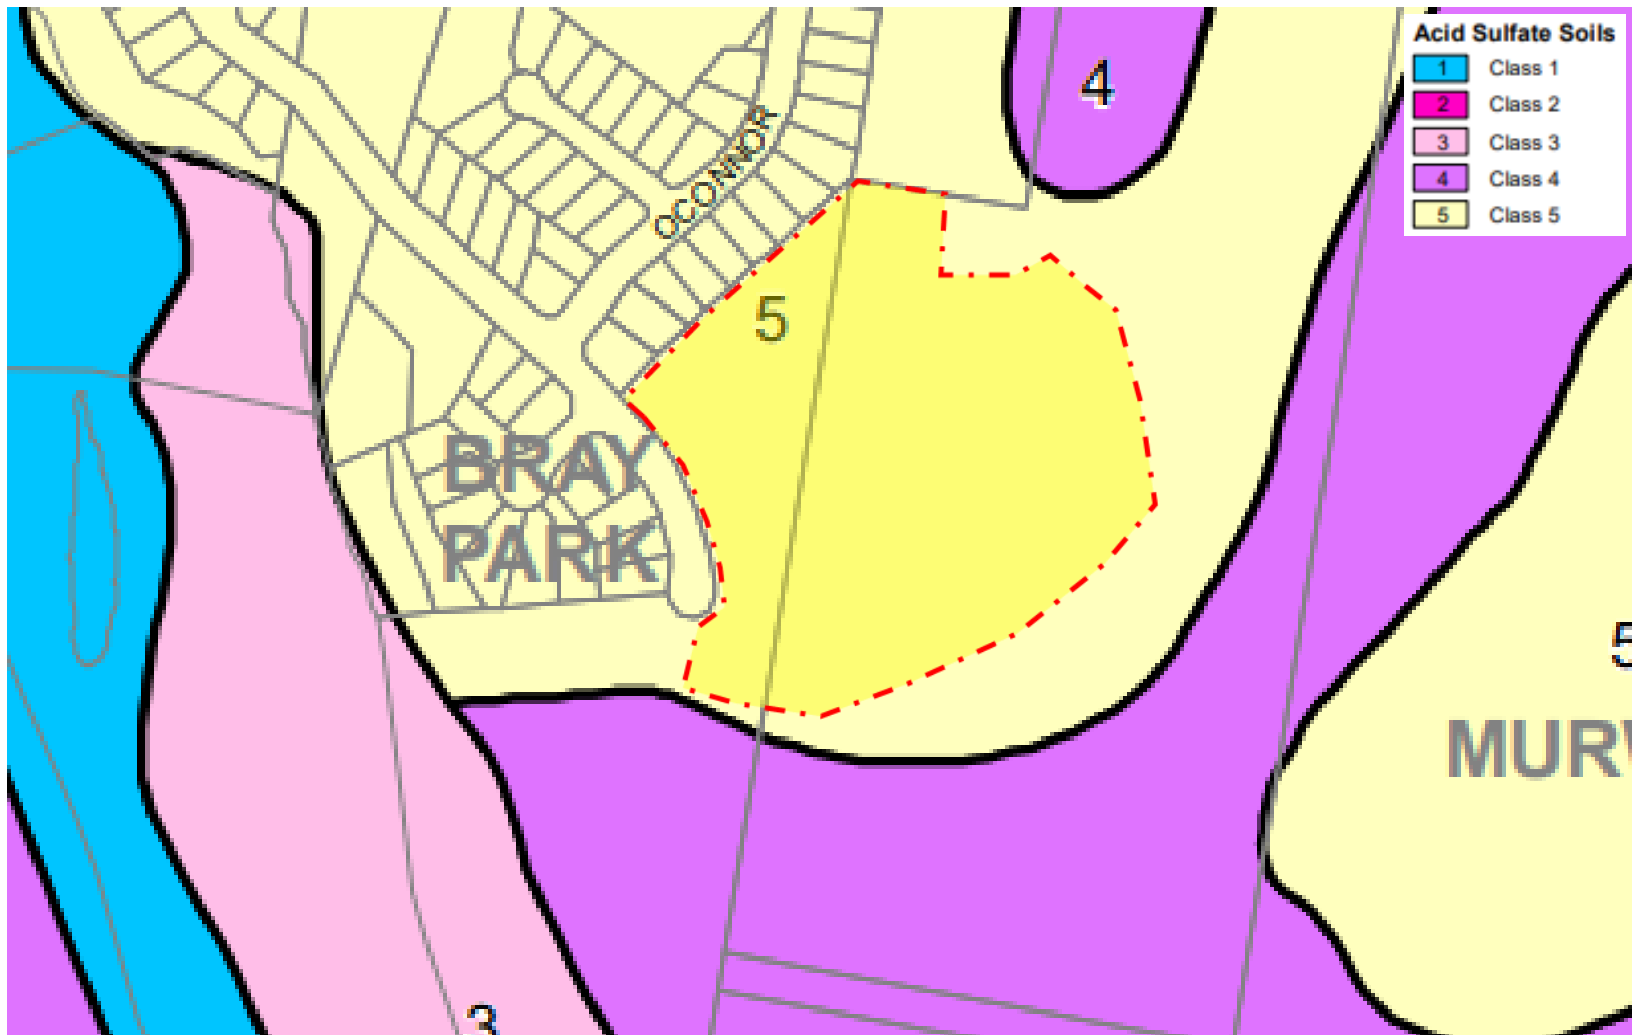
**Figure 4 – Acid Sulfate Soils Map: Tweed Shire Council LEP (2014)**  
49 Elouera Terrace, Bray Park NSW

The area of the proposed development is mapped as 'Class 5' acid sulfate soil (ASS) risk, with reference to the Tweed Shire Council LEP (2014). The ASS risk of soils in the vicinity of the site is illustrated on Figure 4, **Attachment 1**.

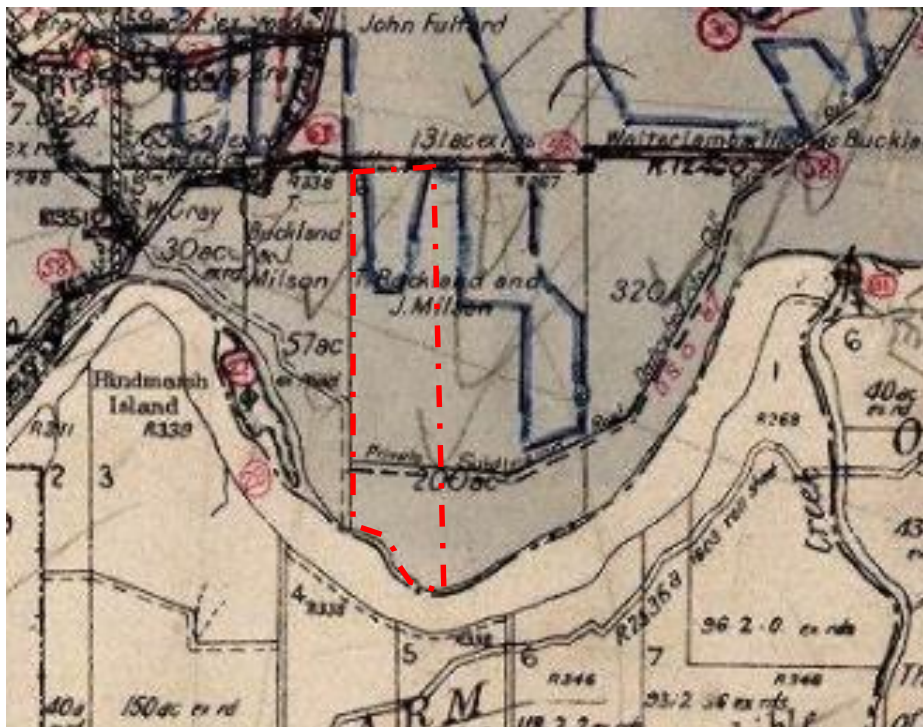
Three Parish Maps dating from 1916, 1923 and 1938 were available on the HLRV. The maps show that the subject property was encompassed within a larger allotment, which included the two separate land parcels located east of the site. The property was owned by T. Buckland and J. Milson.

An excerpt of each of the 1916 and 1938 maps are presented as Figures 6, **Attachment 1**.

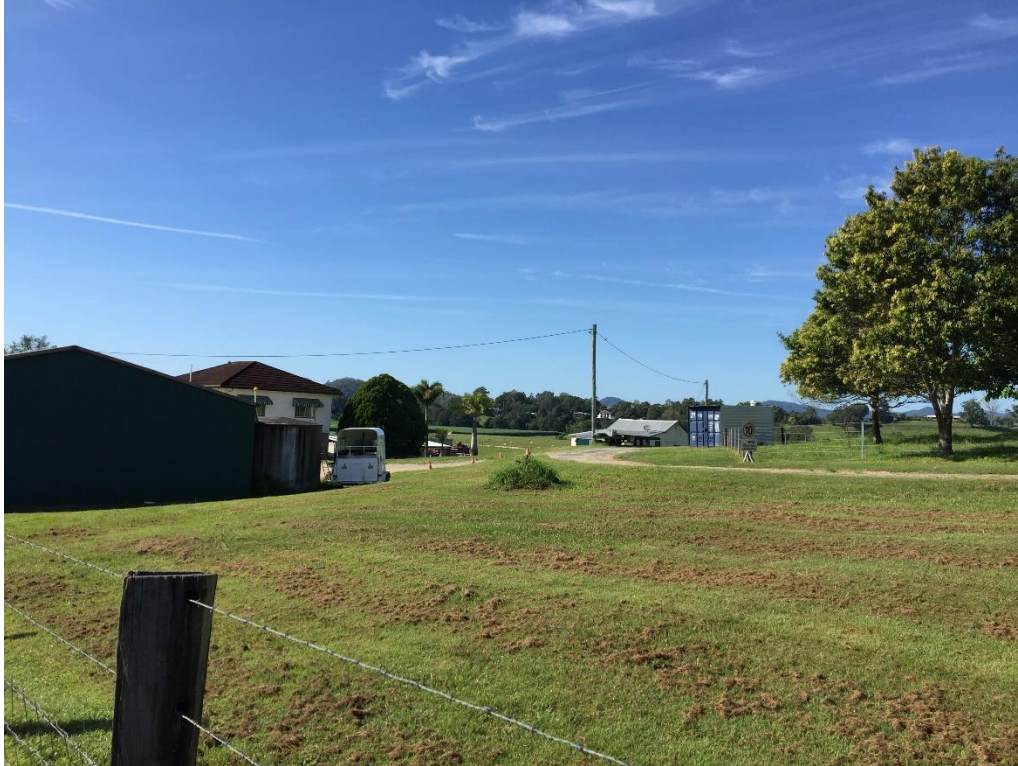
Photograph 1: Looking south-east at the area of the dwelling, mechanical shed and farm cottage. The driveway, grass ground cover of the area and nearby stands of trees are visible.

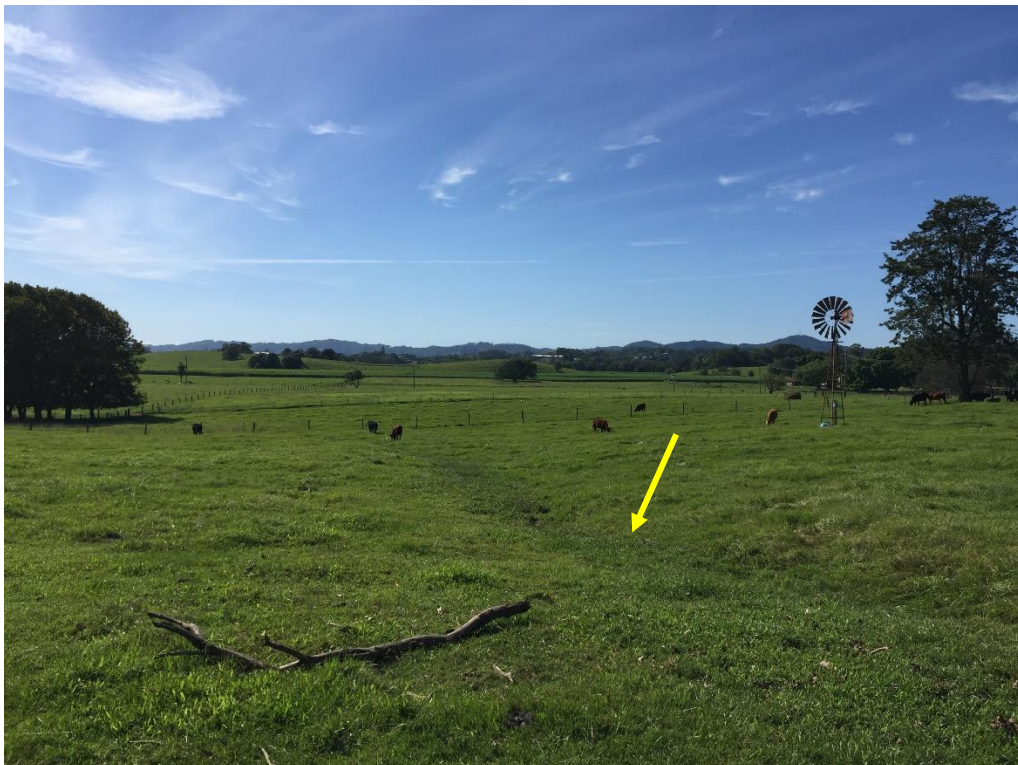
Photograph 2: Looking east toward the adjacent land parcel where the northern portion of development will be situated. The drain that enters the site is visible in the foreground before it flows north.

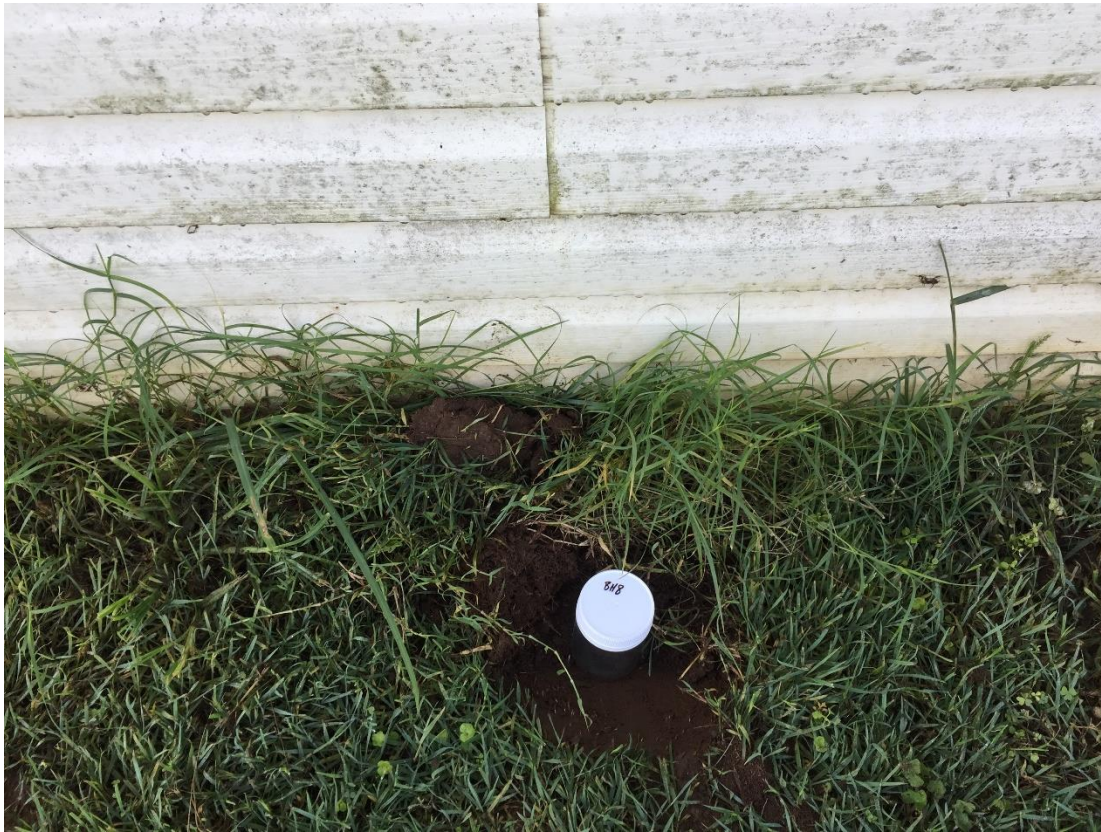
comprising these composite samples were then individually analysed for lead. The results indicated that concentrations of lead in sample 'BH8' marginally exceeded the adopted assessment criterion. A 95% upper confidence limit (UCL) of the arithmetic average of lead concentrations was calculated using the statistical software ProUCL 5.1.002. The results from the 95% Student's-t UCL test indicate the mean lead concentration at 95% confidence is less than the adopted assessment criterion (**Attachment 4**).

Photograph 3: Typical surface sample, showing 'BH8' collected from the perimeter of the farm cottage.

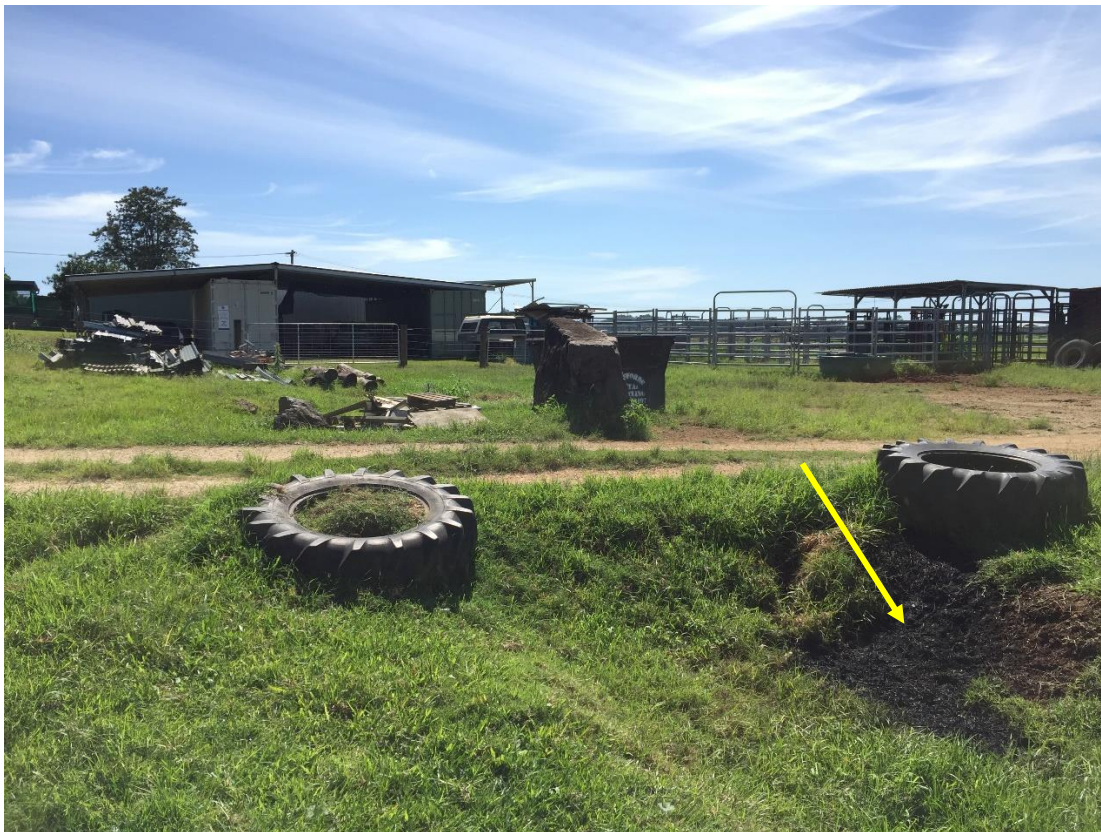
During the inspection, one additional AEC was noted where two small areas appeared to have mechanical oil staining. Two additional targeted samples were subsequently collected for laboratory analyses from the surficial soils in these areas. The vegetation within the proposed subdivision and seniors housing development envelope appeared to be healthy and not distressed by potential contamination in the soils.

Concentrations of TRH were reported to be greater than the adopted assessment criteria in samples 'BH7A' and 'BH16A' for TRH C16-C34, and 'BH16A' for TRH 34-C40, collected from surficial soils within areas of inferred oil staining on the ground surface in two locations. The reported concentrations exceeded the NEPM Management Limits for residential land use. However, given the composition of the hydrocarbons reported in these samples ('heavier' chain fractions), it is considered likely that the soil impacts associated with the staining are limited to relatively shallow soils.

Photograph 4: Looking north at the cattle yard, the mechanical oil staining and location of sample 'BH16A' visible in the foreground.

On the basis of the TRH results, if the areas represented by 'BH7A' and 'BH16A' (i.e. visibly stained soils) are developed as a garden area or other unsealed area where human contact may occur, surface soil at this location should be scraped and the material transported off-site to a suitably licensed landfill facility. From an aesthetic perspective (staining and odour), the soils may be unsuitable for the proposed development even if they are not within such areas. If the soils are removed, a remediation action plan (RAP) which details the

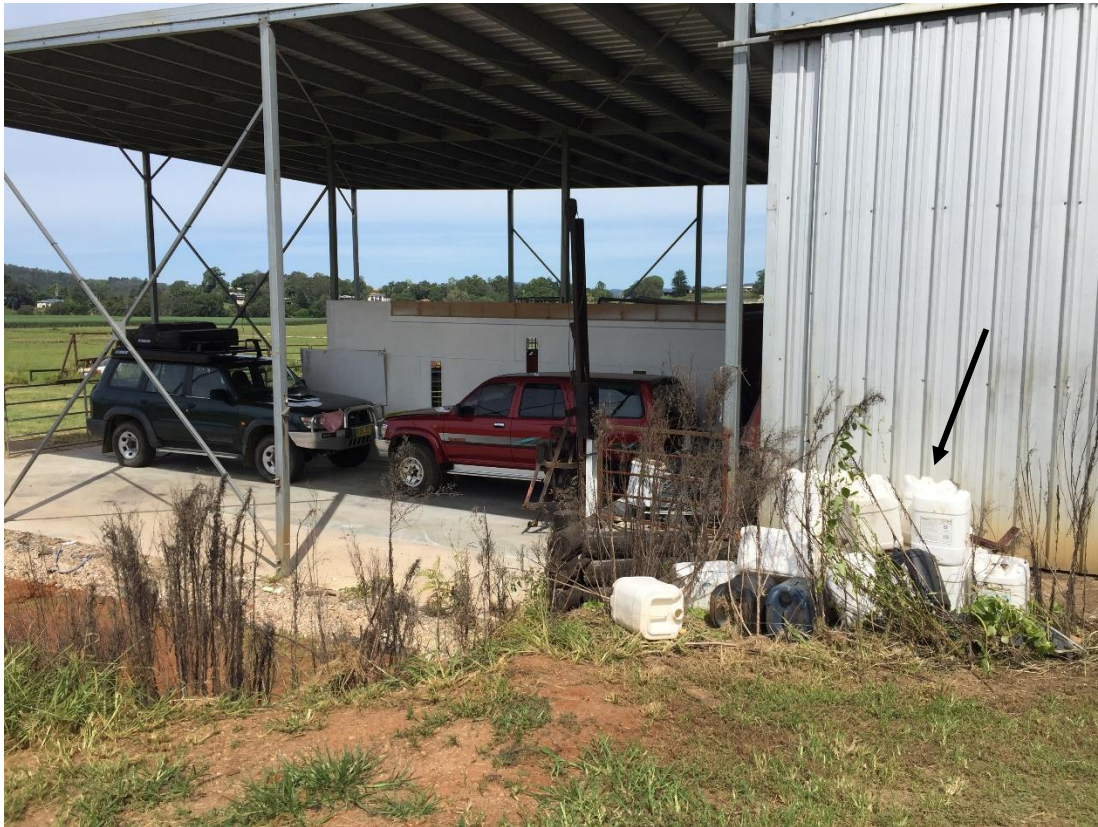
Photograph 5: Image of the chemical drums (herbicide) observed during the site inspection and location of sample 'BH39'.

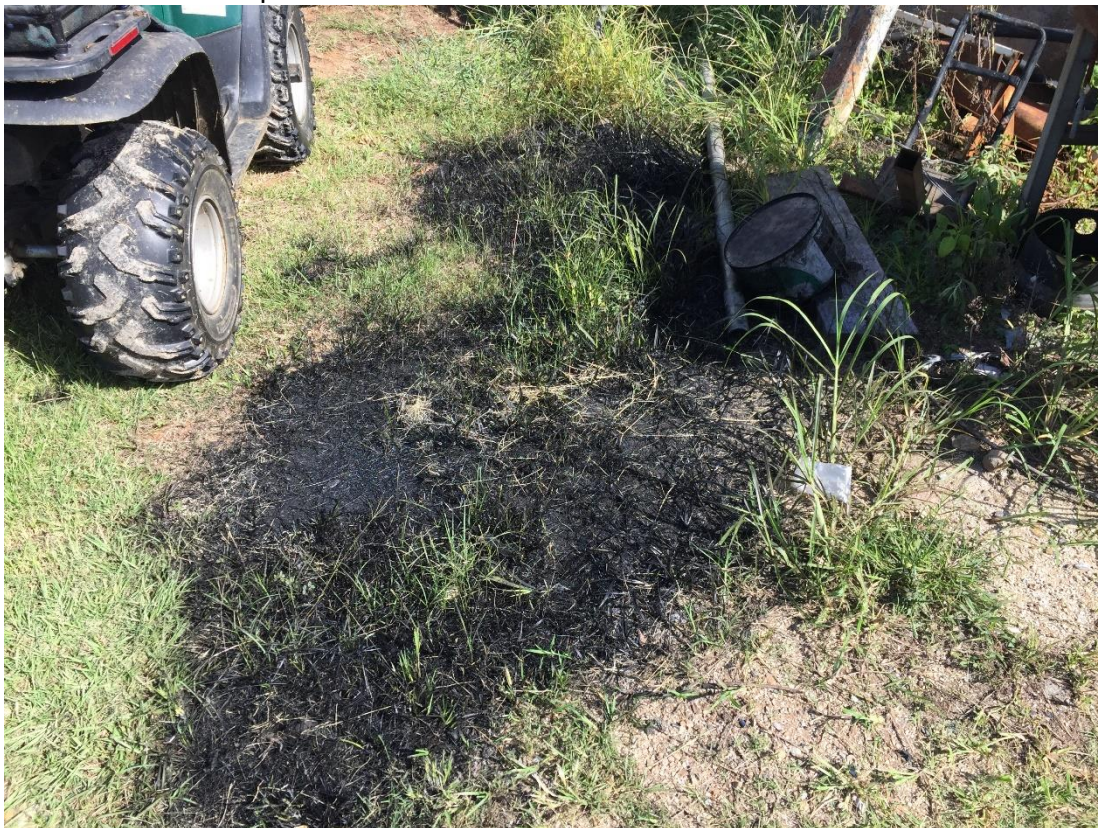
Photograph 6: Image of the mechanical oil staining next to the mechanical shed and the location of sample 'BH7A'.
