Report on
Preliminary Site Investigation (Contamination)

Proposed Helipad
89 - 151 Old Castlereagh Road, Penrith

Prepared for
Colliers International Pty Ltd

Project 204635.01
September 2021

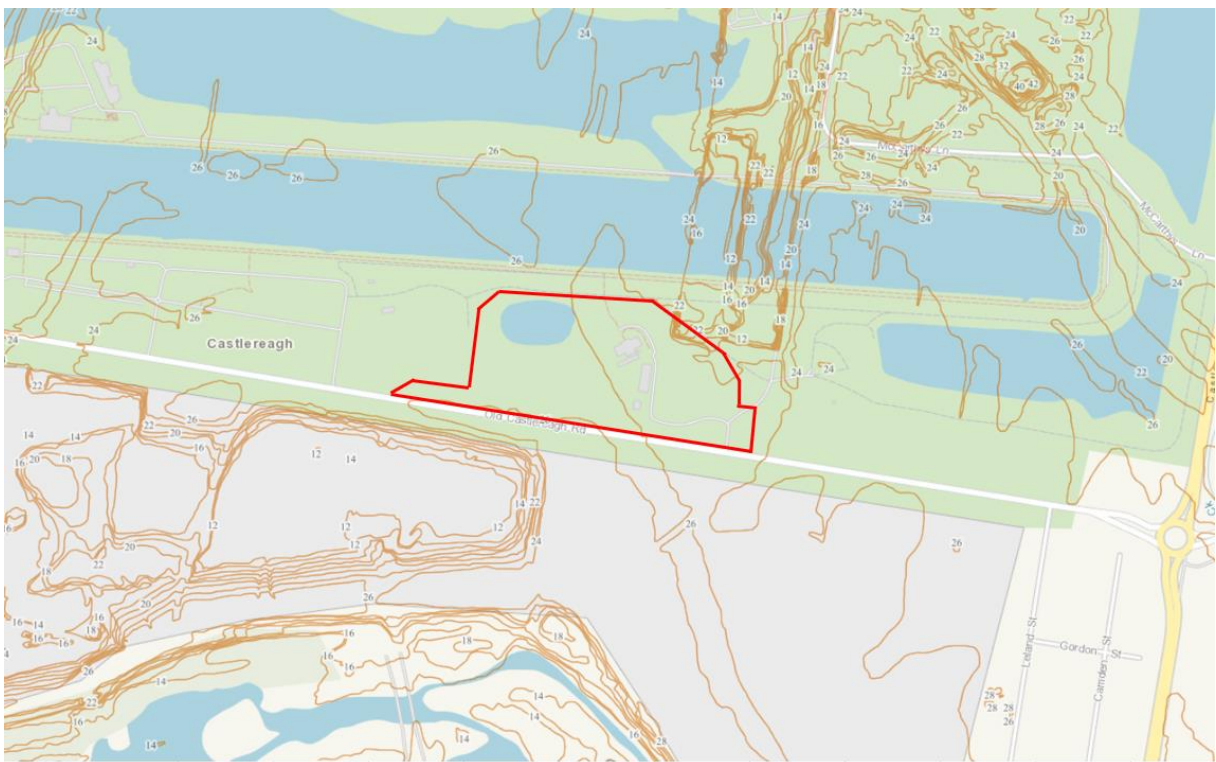
Figure 2: Regional Topography with 2 m Elevation Contours

Regional topography slopes downwards to the west and north-west. Regional topography is shown on Figure 2.

Based on the site regional topography, the anticipated flow direction of groundwater beneath the site is to the west and north-west, towards Duck Pond and the Rowing Lake north of the site, then the Hawkesbury River, the likely receiving surface water body for the groundwater flow path.

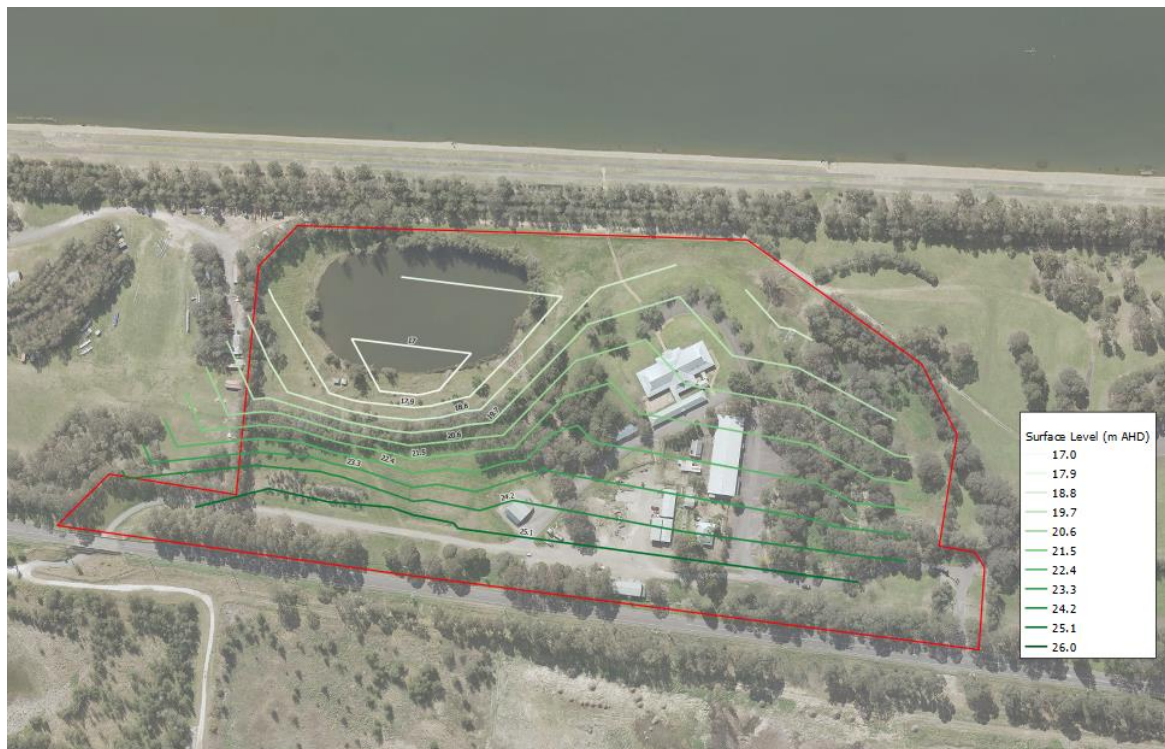
Figure 3: Site Topography (surface levels obtained using dGPS)

Site topography slopes downwards to the north, sitting at 25.4 m relatively to Australian Height Datum (AHD) at the south site boundary to 17.4 m AHD at the north site boundary. Site topography is shown on Figure 3.

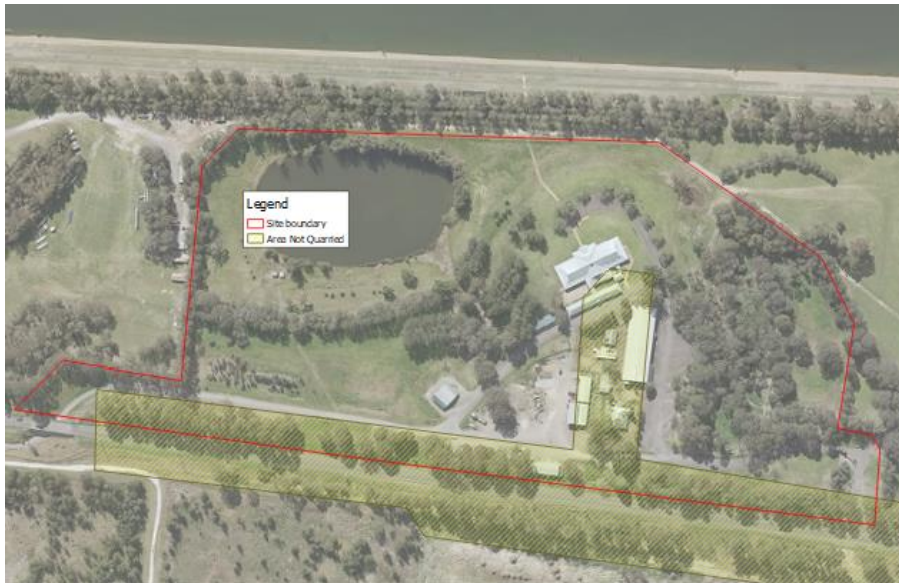
Figure 4: Historically Quarried Area of the Site [updated from Figure 2, Coffey (2014)]

A Landform Appraisal was undertaken by Coffey (2014) which included a review of site history. The report indicated that alluvial sand and gravel extraction (i.e., quarrying) commenced at the site in about 1965 with material being excavated to bedrock. The report also indicated that the quarrying ceased about 30 m north of Old Castlereagh Road, except for a finger of land about 50 m wide beneath the current Muru Mittigar Aboriginal Cultural and Education Centre, as shown on Figure 4.

The site history review found that backfilling of the quarried land commenced at the end of 1984 and the general landform profile at completion in March 1987 was summarised as scraper compacted fill (10 m - 13 m thick) over roller compacted fill (2 m - 4 m thick) over shale bedrock at about 11 m AHD. Previous intrusive investigations undertaken by Coffey at the site encountered fill that matched this profile. No records have been provided or reviewed which confirm the provenance or quality of the materials.
