Report on
Preliminary Geotechnical Investigation

Proposed Appin (Part) Precinct
Brooks Point Road, Appin

Prepared for
Walker Corporation Pty Ltd

Project 76589.06
October 2022

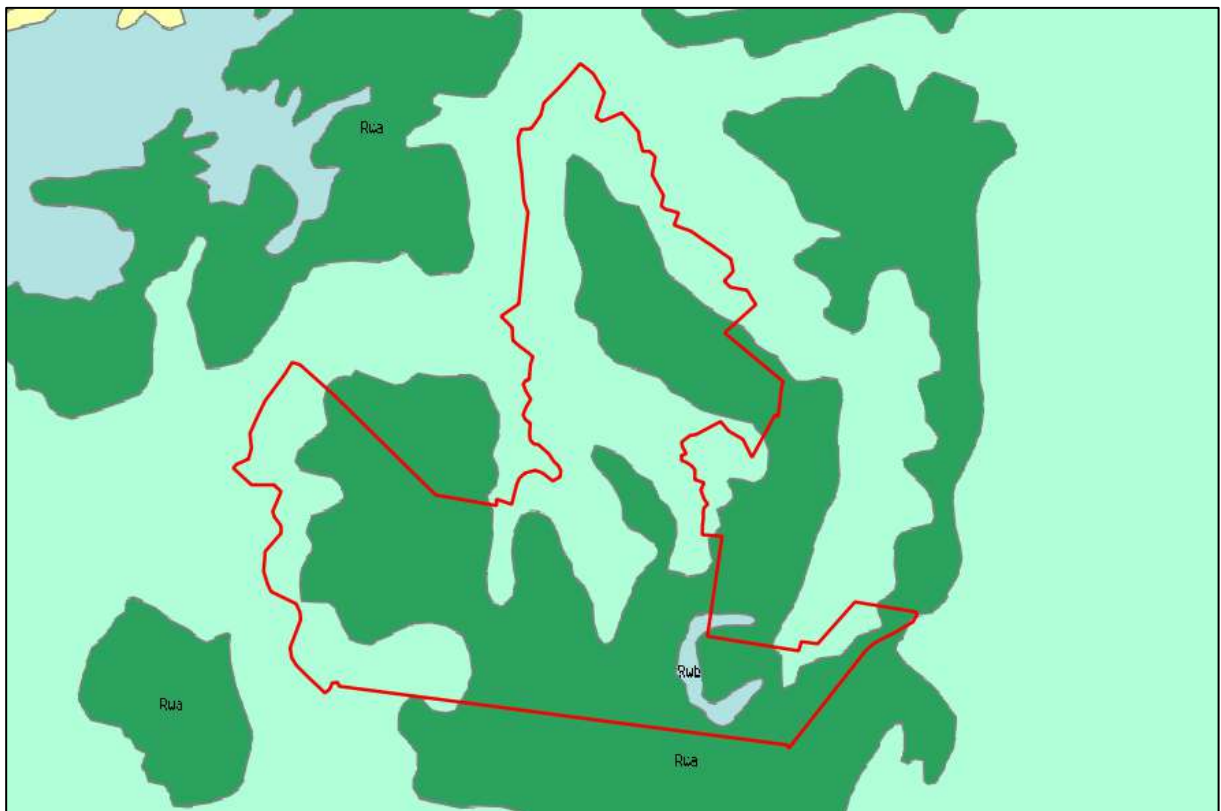
Figure 3: Regional geology mapping for the site (red boundary)

Regional geology mapping as presented and referenced above indicates that the majority of the site is underlain by Ashfield Shale of the Wianamatta Group (dark green) and Bringelly Shale in a small part of the site (light blue) comprising laminite and dark-grey siltstones primarily along ridges and topographical high-points through the site. Hawkesbury Sandstone (light green) comprising medium to coarse-grained quartz sandstone with very minor shale and laminite lenses are mapped as present around the site perimeter, including next to the Nepean River and topographical low-points across the site.

Soil conditions were relatively uniform across the site and were generally as indicated by the soil landscape map (refer Figure 2). Sandstone was present at lower elevations about the site perimeter, whereas shales were present in the central, elevated areas of the site. This is consistent with the geology map for the site (refer Figure 3).

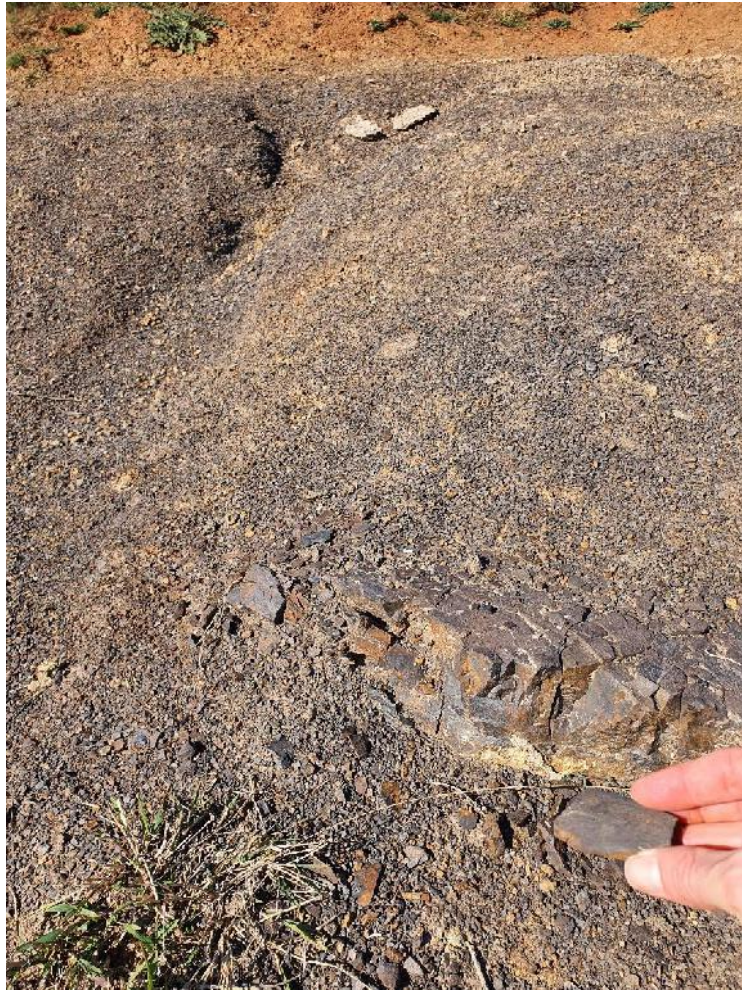
- The most consistent feature of the site, especially those parts underlain by Hawkesbury Sandstone, was the presence of outcropping rock. Outcropping rock was noted at the top of all creek banks, at the base of all dams and in numerous other locations within the paddocks. Exposed rock was typically high strength medium grained sandstone (multiple MRPs, refer photoplate and Drawing 3). Shale outcrops were also noted (MRP16, 20, 21 and 50).

Photo 21 - MRP21 rock exposure

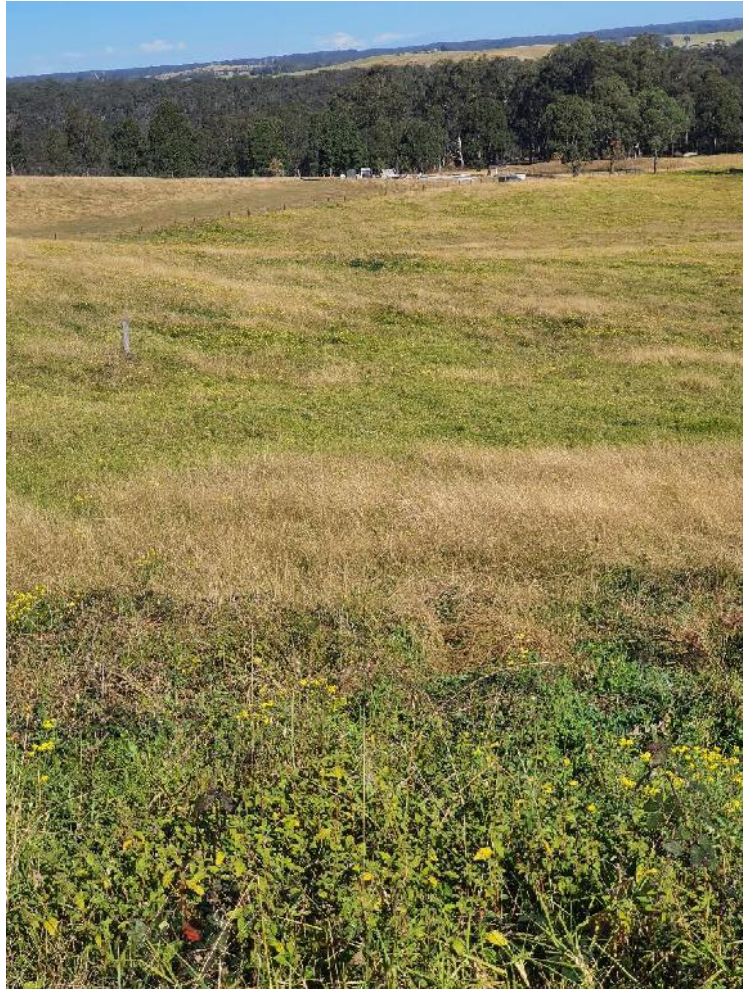
- Widespread erosion was not noted.
- Relatively minor gully erosion was noted at MRP22 and also surrounding a former shale pit in the southern portion of the site at MRP50.

Photo 22 - MRP22 gully erosion

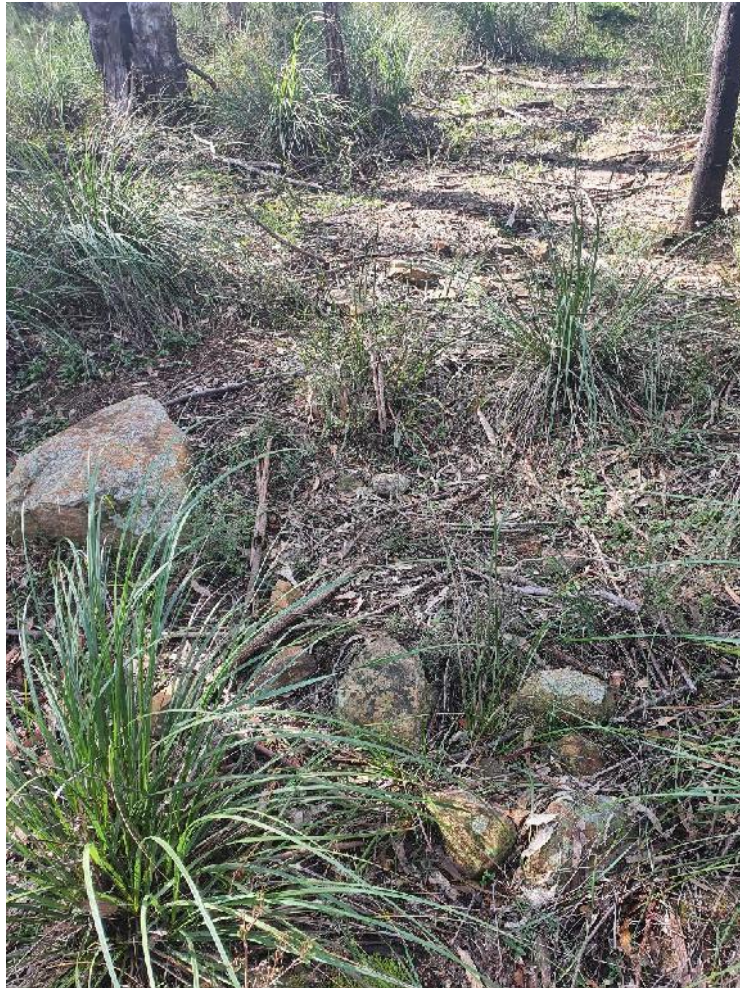
Photo 31 - MRP32 sandstone cobbles

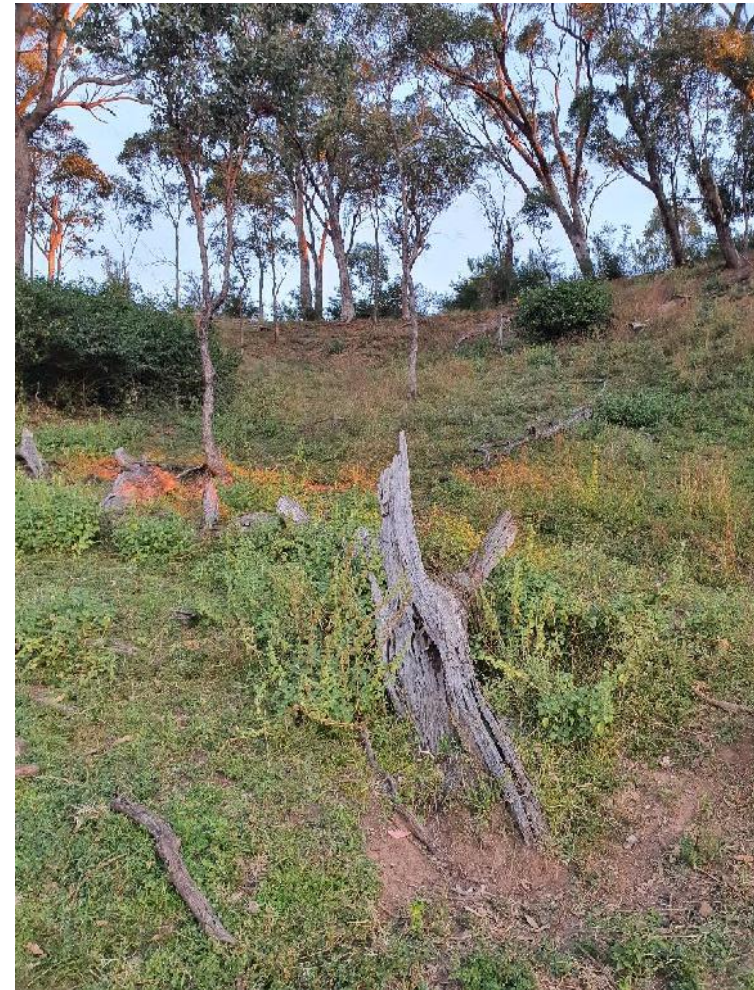
Photo 36 - MRP37 relic slide, sandstone blocks on surface

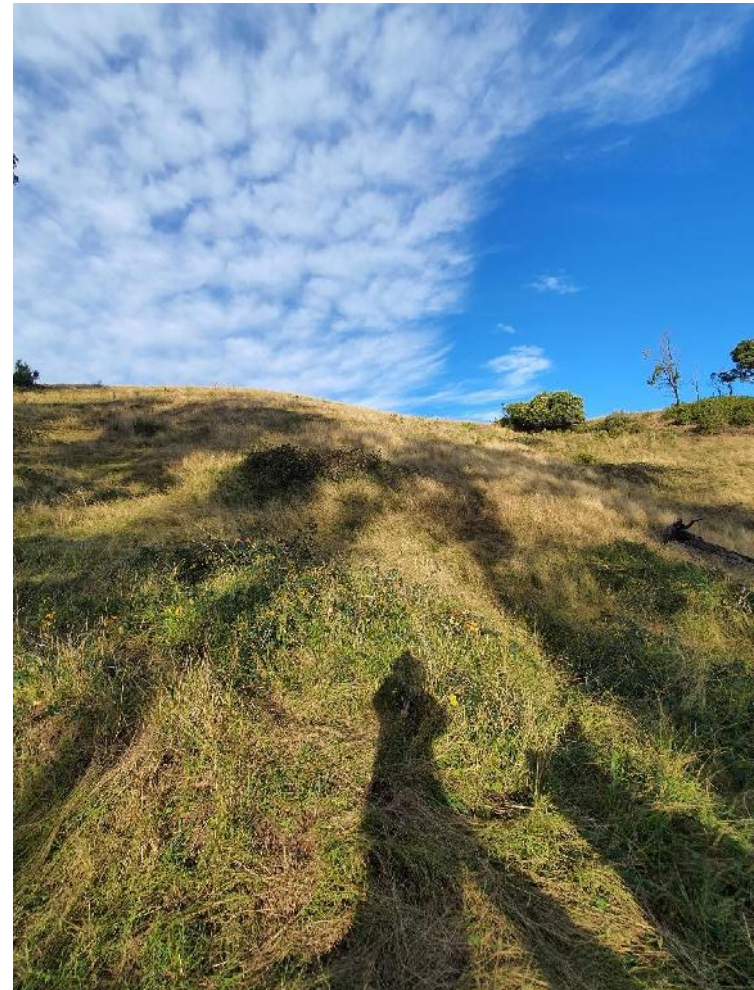
Photo 40 - MRP41 slumping (7)

- Two areas associated with ridgelines in the southern portion of the site – slumping of the surface soils have been noted in these areas. This instability is not expected to be a major constraint to development and should be easily managed by good earthworks practices at the time of subdivision construction (ie: earthworks, drainage). If some of these areas are not to be subject to earthworks, then consideration will need to be given to run out distances of any identified slides. Both areas should be further investigated to assess the depth and extent of instability and provision of recommendations for rectification.

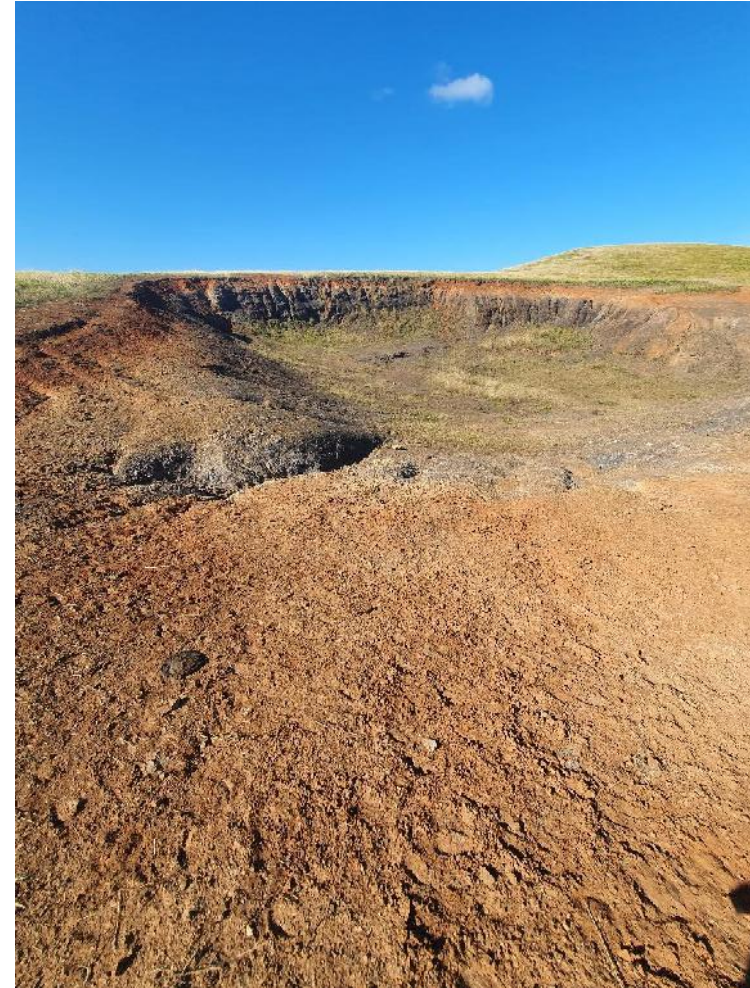
Photo 50 - MRP50 shale pit (1)
