Contract Properties Pty Ltd  
C/- Nordon Jago Architects

# Wastewater Management Plan: Proposed Eco-Tourism Development – 71 Fig Hill Lane, Dunmore, NSW

P1907197JR03V02  
October 2020

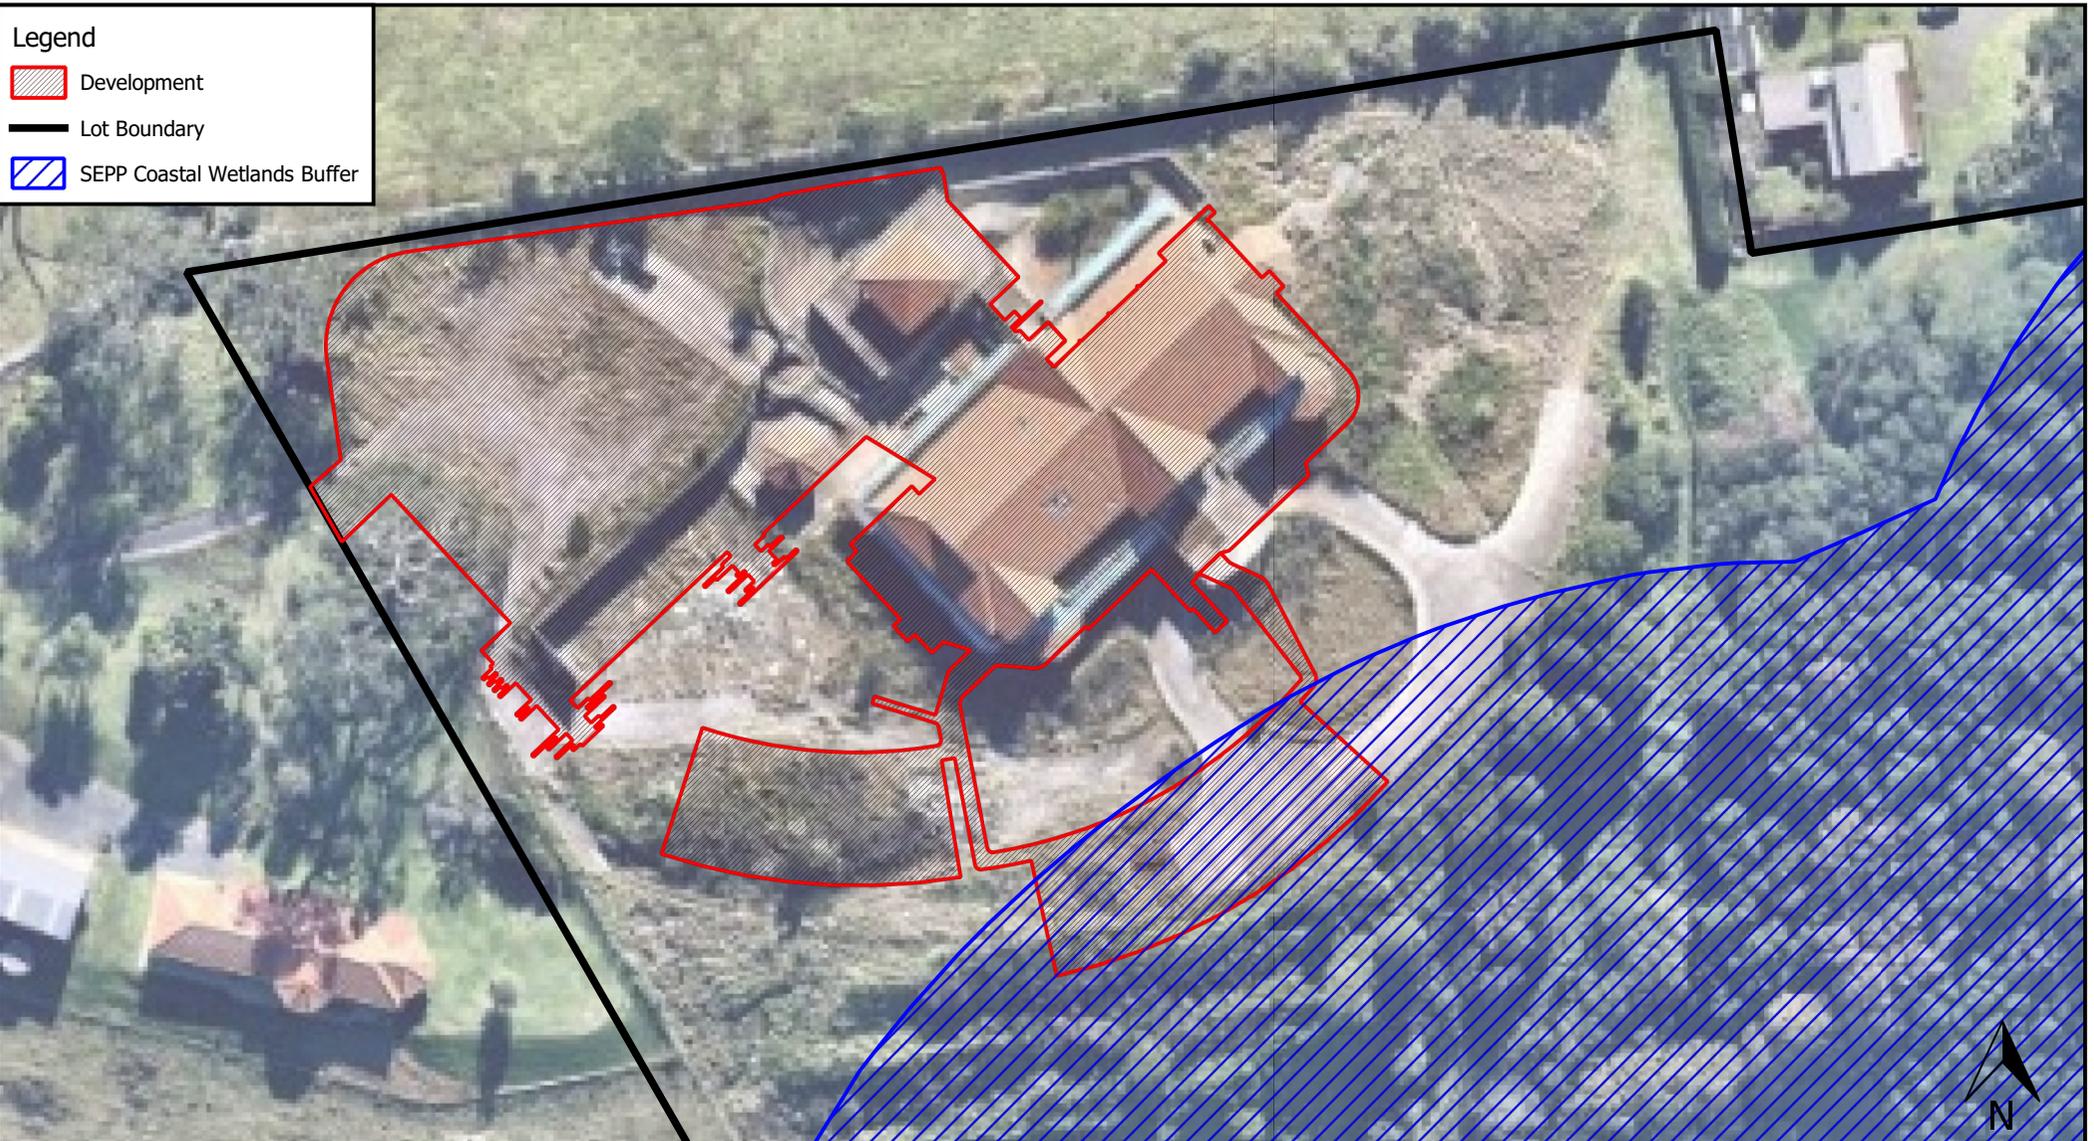
<p><b>Map 03</b></p> <p>71 Fig Hill Lane, Dunmore, NSW</p> <p>Eco-Tourism Development</p> <p>Wastewater Management Plan</p> <p>Contract Properties Pty Ltd</p> <p>21/10/2020</p>	<p>Map</p> <p>Site</p> <p>Project</p> <p>Sub-Project</p> <p>Client</p> <p>Date</p>
--	--

- Development
- Lot Boundary
- SEPP Coastal Wetlands Buffer

Map Title / Figure:  
**Coastal Wetlands**

Coastal wetlands and the proximity area for coastal wetlands are provided on Map 3. These areas are outside of the development footprint and therefore do not constrain the effluent disposal field.

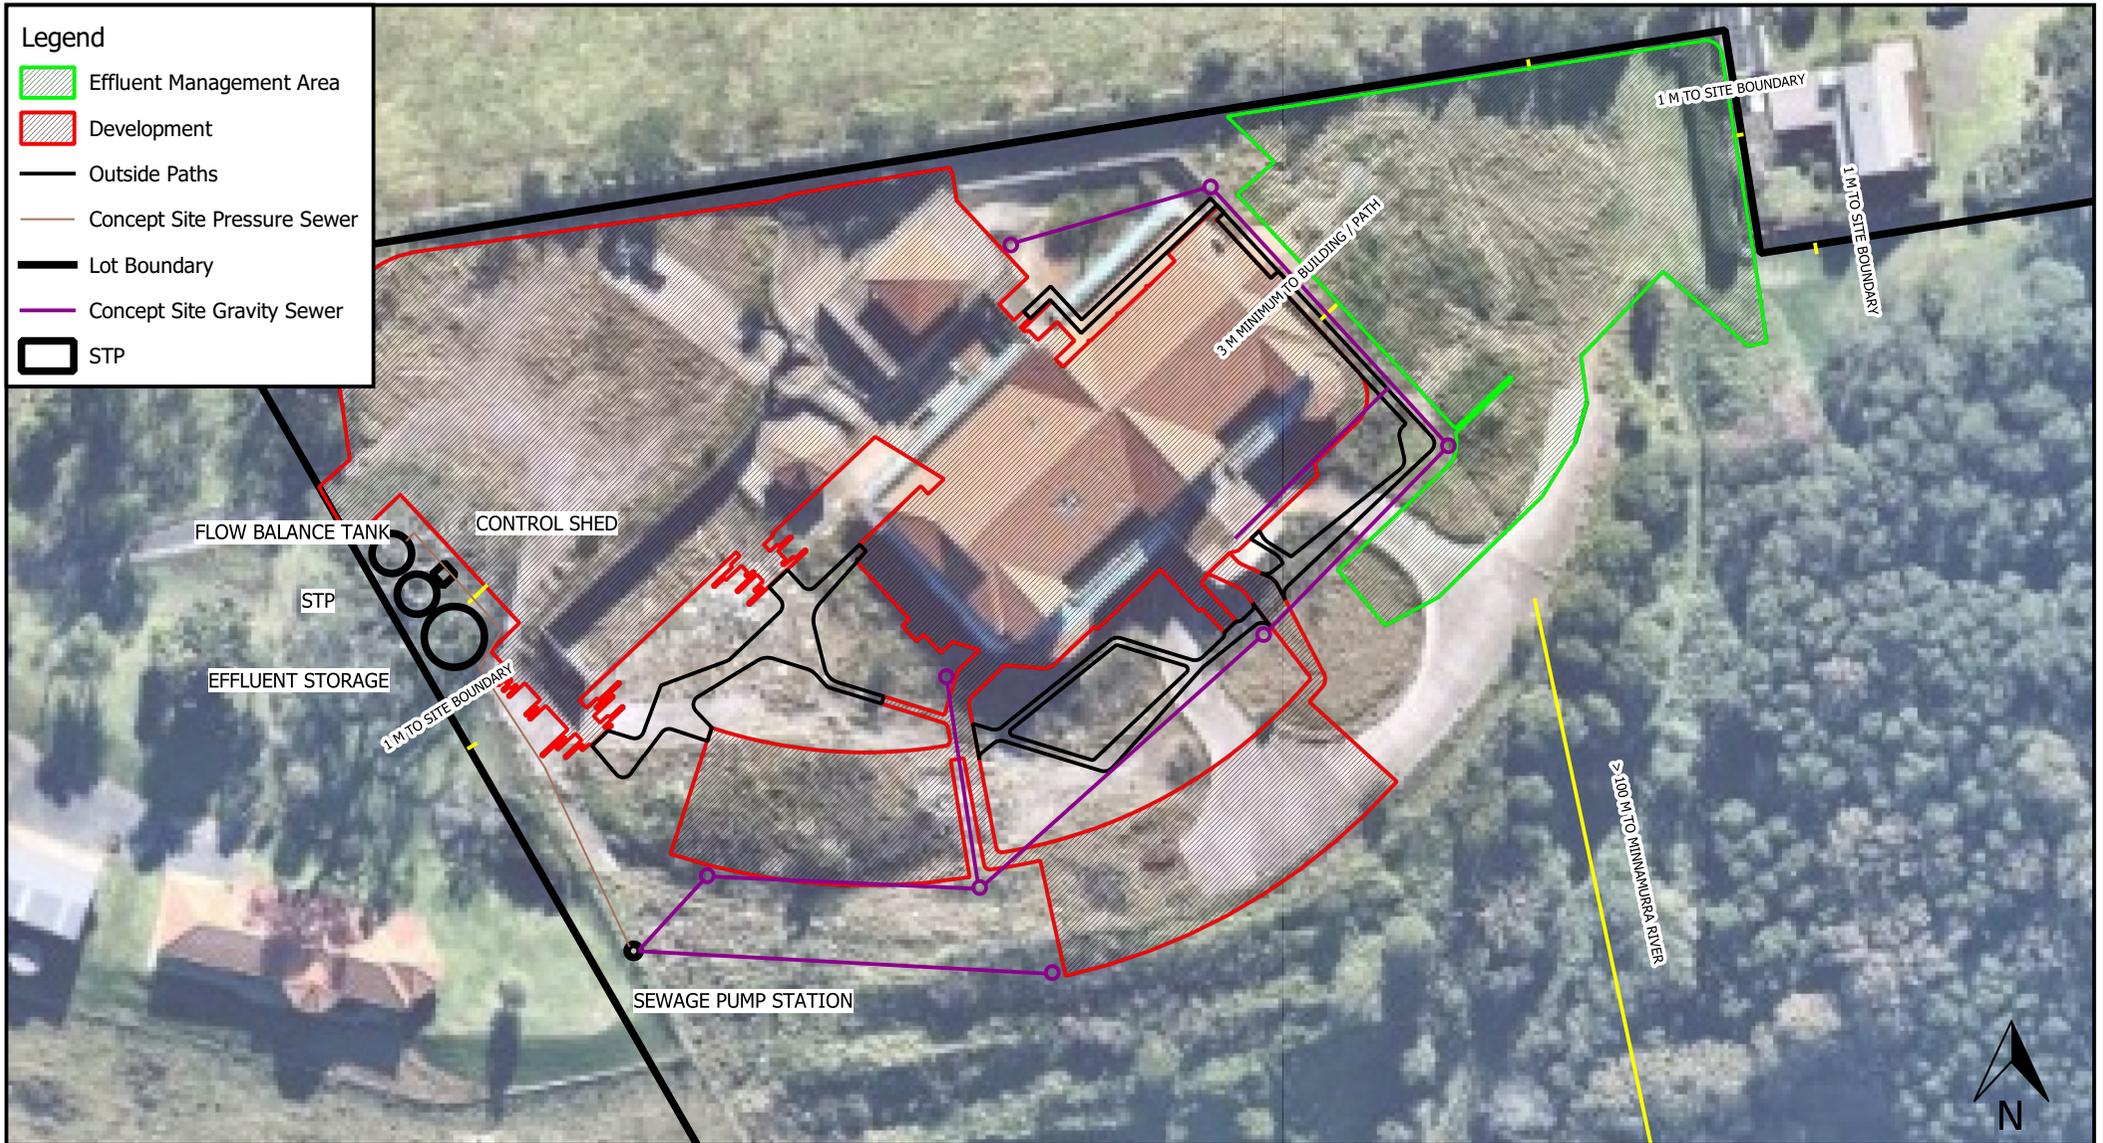
Map 06	Map
71 Fig Hill Lane, Dunmore, NSW	Site
Eco-Tourism Development	Project
Wastewater Management Plan	Sub-Project
Contract Properties Pty Ltd	Client
21/10/2020	Date

Map Title / Figure:  
**Wastewater Management Plan**

The total EMA is to be not less than 2,610 m<sup>2</sup> within the identified area shown on Map 6 in Attachment A.
