Health Infrastructure

Detailed Site Investigation

Wentworth Health Services
Wentworth, NSW

63097/147120 (Rev 0)

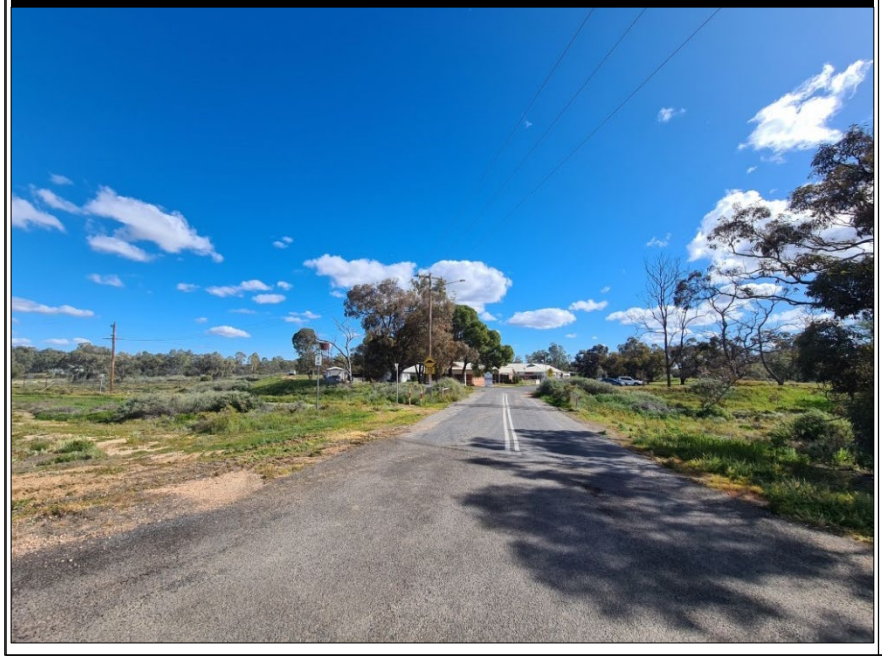
PHOTOGRAPH 8: RAISED LEVEE/MAINTENANCE TRACK ENCIRCLING BUILDING COMPLEX, FACING SOUTH WEST

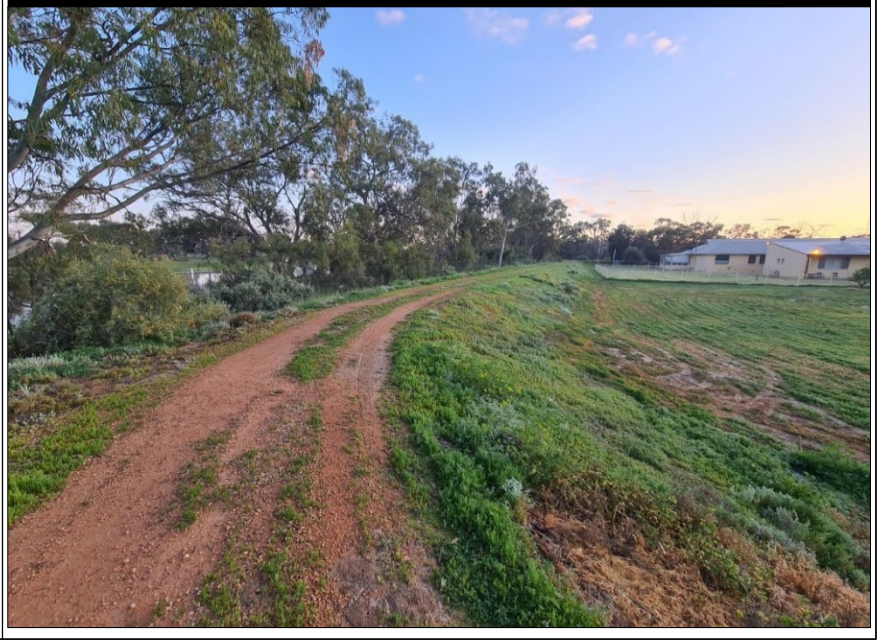
PHOTOGRAPH 12: DARLING RIVER AND RIPARIAN ZONE TO THE LEFT OF LEVEE, RECREATIONAL AREAS TO THE RIGHT, FACING NORTH

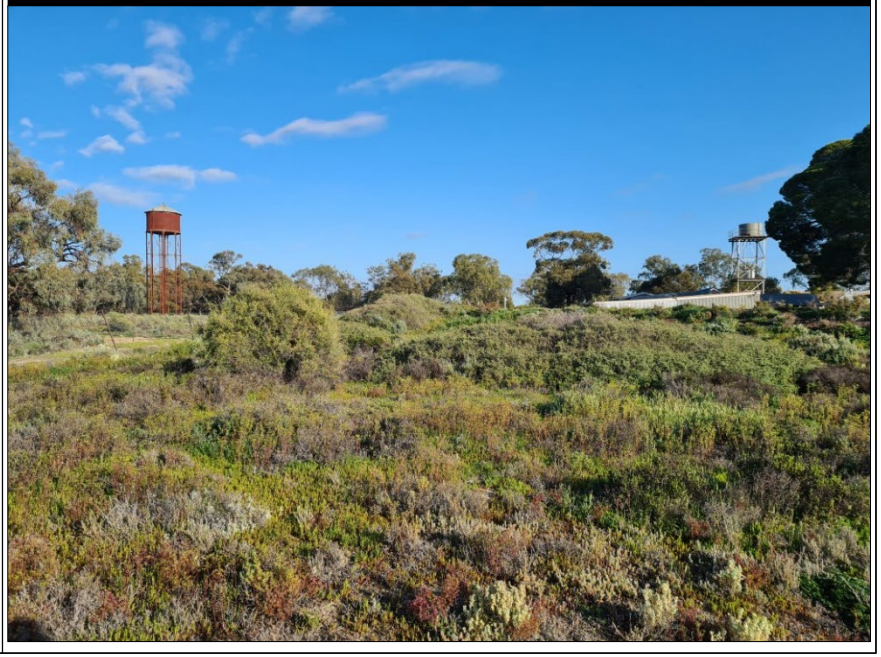
portion of the site also comprised of undeveloped vegetated areas (**Photograph 16**). Building and demolition waste, such as bricks, terracotta and porcelain, and scattered surficial ACM was observed in both areas (**Photographs 17** to **19**).

PHOTOGRAPH 16: UNDEVELOPED SCRUBLAND IN THE SOUTHEASTERN PORTION OF SITE, FACING WEST
