Southern Alps Ski Club Lodge Cooperative Limited
21 Dundas Street
Coogee NSW 2034

Project 205286.00
22 July 2021
R.001.Rev2
CMR

Report on Geotechnical Inspection
Proposed Additions and Alterations
4 Spencers Creek Road, Charlotte Pass

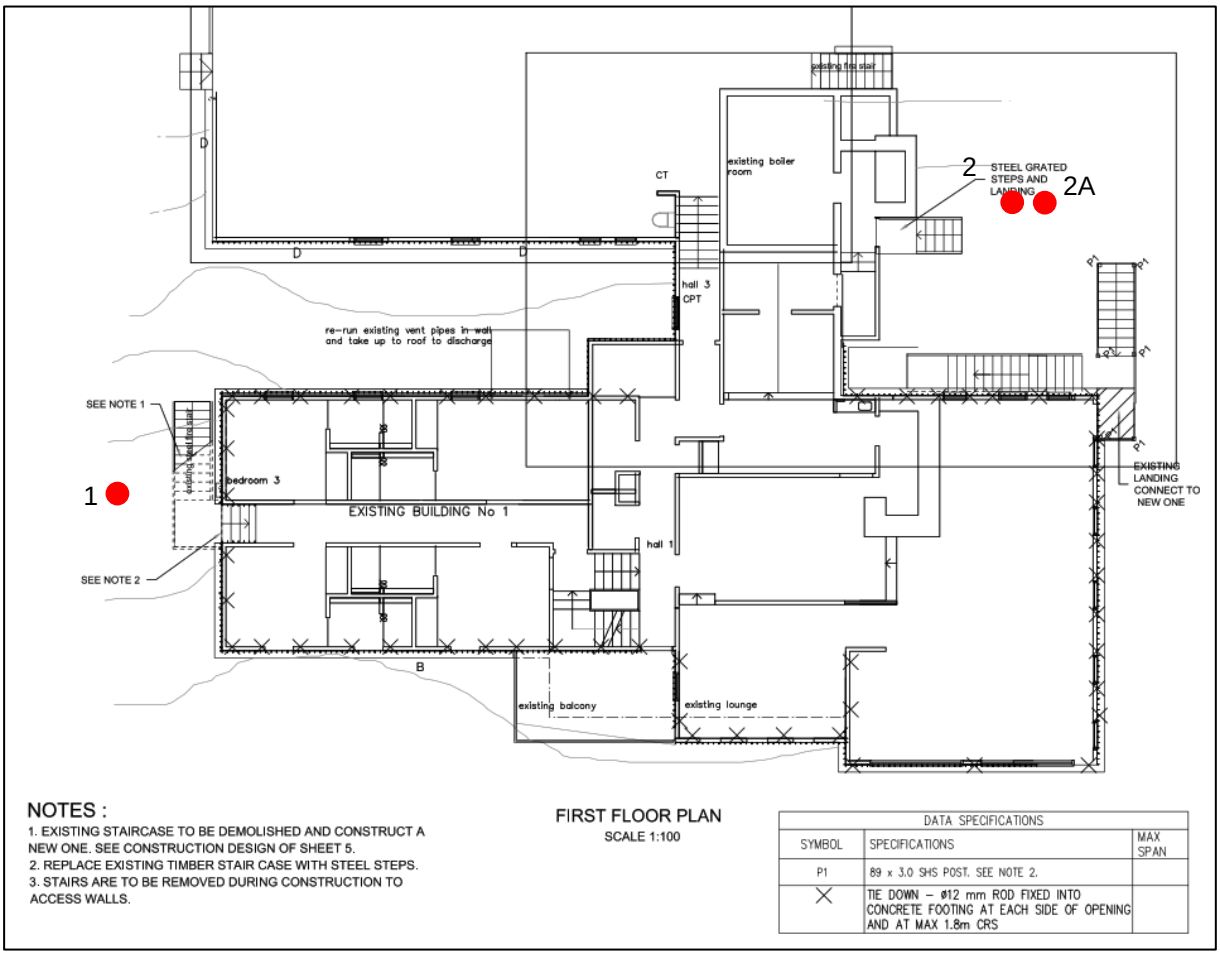
Figure 2: Proposed Additions and Alterations and Borehole Locations (Red Circles)

During the site inspection, three boreholes (Bores 1, 2 and 2A) were drilled using hand tools and a 75 mm diameter hand auger to refusal depths of 0.8 – 0.9 m. Dynamic cone penetrometer (DCP) testing was undertaken adjacent to each of the boreholes to assess the relative density condition of the strata. The locations of the boreholes are shown on Figure 2 above.
