# SELWYN SNOW RESORT REDEVELOPMENT

# KINGS CROSS ROAD, CABRAMURRA, NSW

**GEOTECHNICAL INVESTIGATION & SLOPE STABILITY RISK ASSESSMENT**

**JULY 2020**

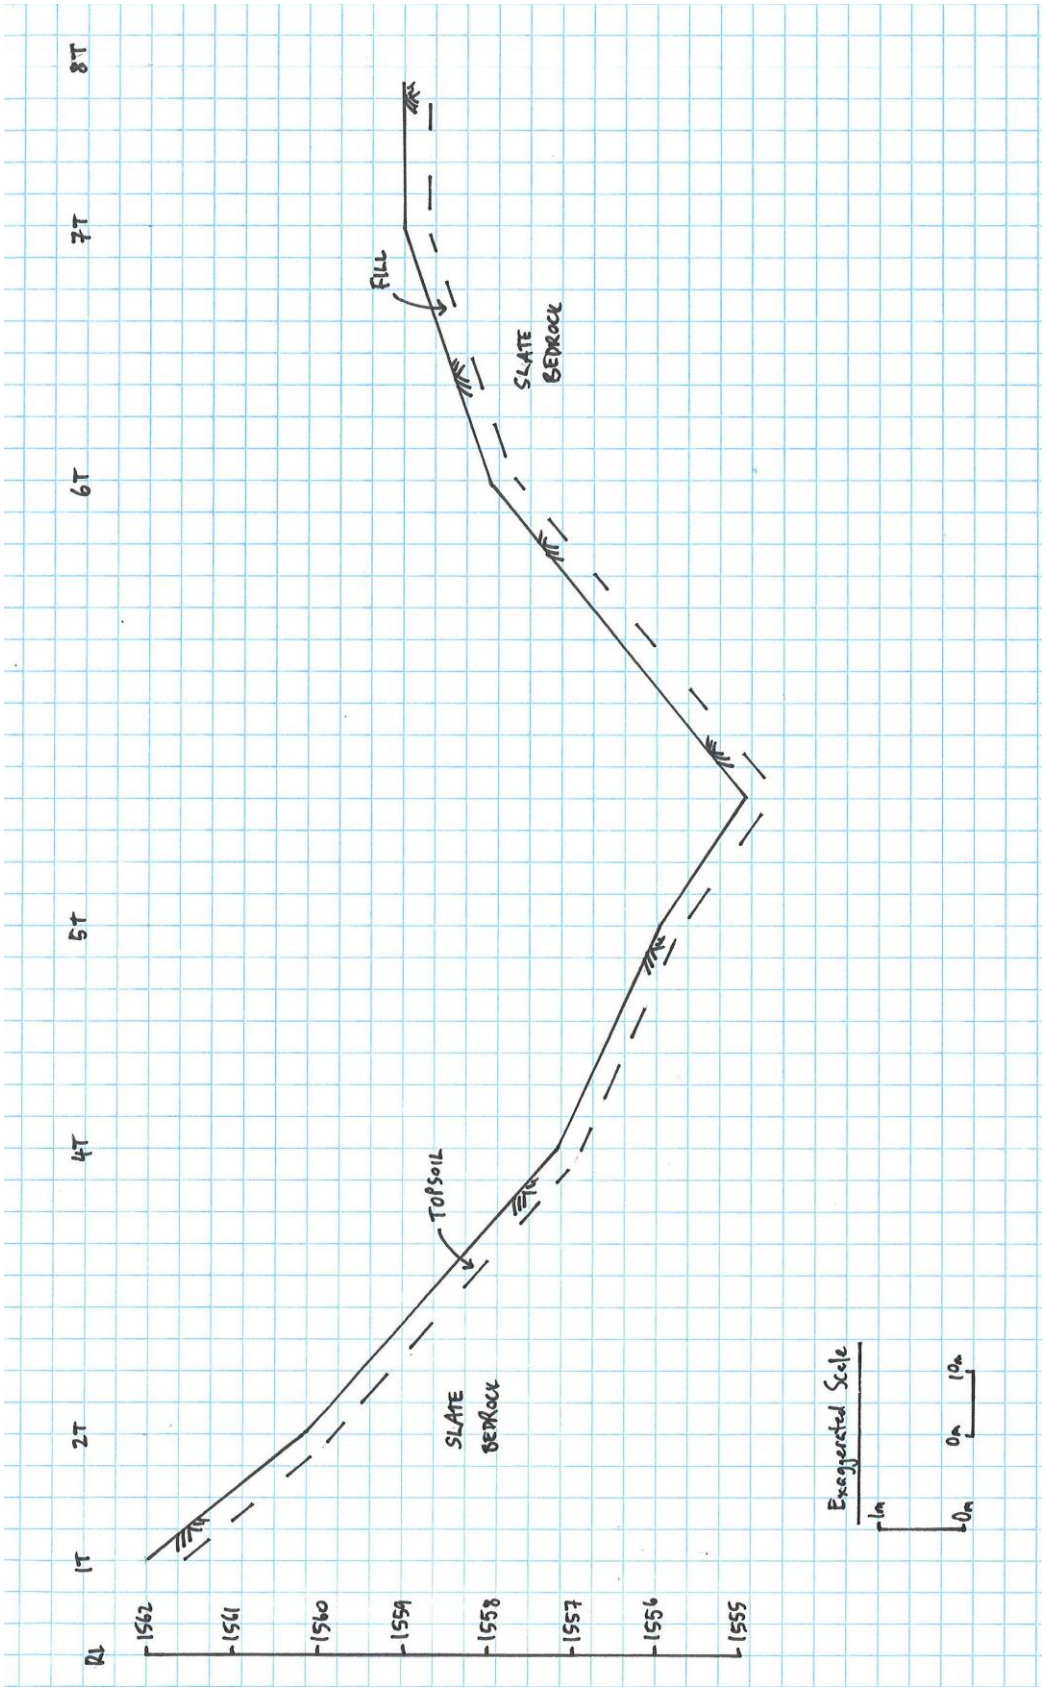
| **ACT Geotechnical Engineers Pty Ltd** | **C10872** | **FIGURE 6** |

Sections 4.1.1 to 4.1.4 detail the subsurface conditions for the Staff Accommodation building, Guest Facilities building, Work Shop, and Access Road. Figures 6 and 7 provide geotechnical models of the site, showing subsurface sections through the site, as found by the investigation test pits.
