Project 219536.00
22 November 2024
R.009.Rev0
JCL:kd

Results of Data Logger Download – November 2024
Proposed Manufactured Housing Estate
40-80 & 82 Chapmans Road, Tuncurry NSW

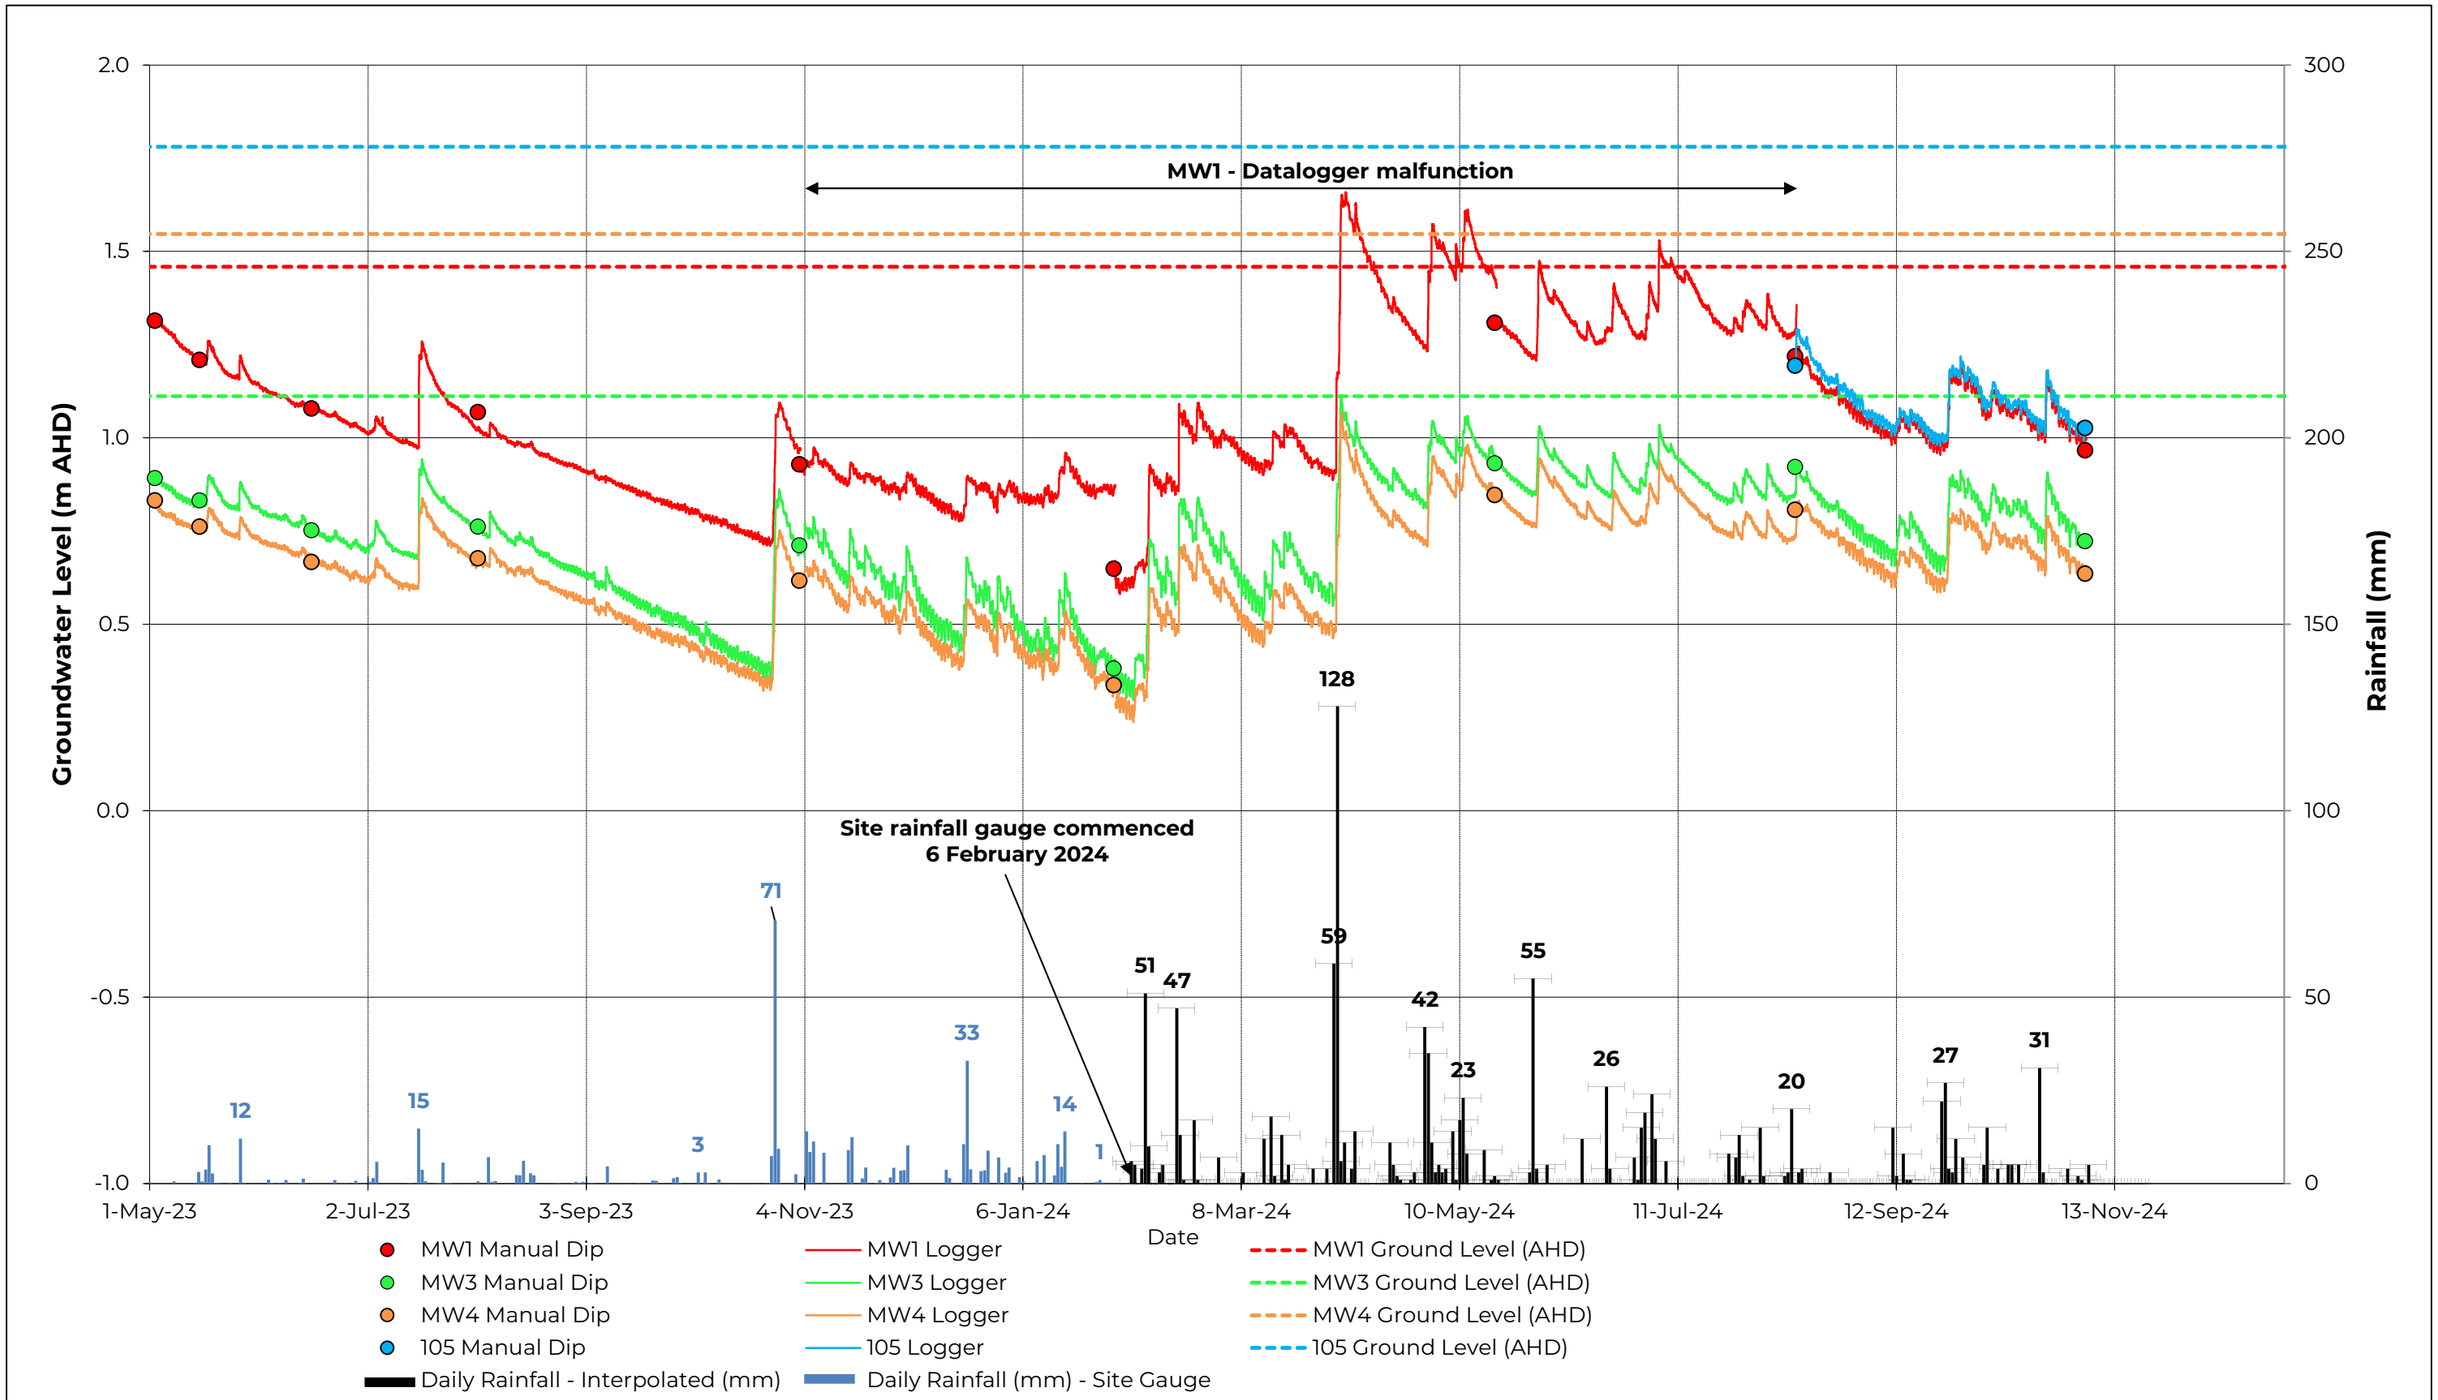
The results of the current monitoring event (August 2024) suggest that loggers MW3, MW4 and 101 to 105 are currently collecting data that is generally consistent with manual monitoring records, previous data values and typically expected trends.

A loan logger was installed in MW1 during this monitoring period only. Comparison of the groundwater level recorded at MW1 to groundwater level recorded at 105 indicates groundwater level at 105 is similar to groundwater level at MW1 (i.e. 105 is a suitable long term replacement for MW1).

Continued quarterly monitoring is recommended to supplement the existing data. Quarterly cleaning / maintenance program is also recommended based on advice provided by the logger suppliers to maximise the life of the logger and integrity of the data collection. Annotations regarding periods of probable erroneous data and data loss periods are provided on the corresponding graphs.
