LIMITED ENVIRONMENTAL AND HAZARDOUS MATERIALS ASSESSMENT

DUE DILIGENCE

122-128 & 130 PYRMONT BRIDGE ROAD AND 206 PARRAMATTA ROAD, ANNANDALE, NSW

Ref: E33770PArpt-DRAFT

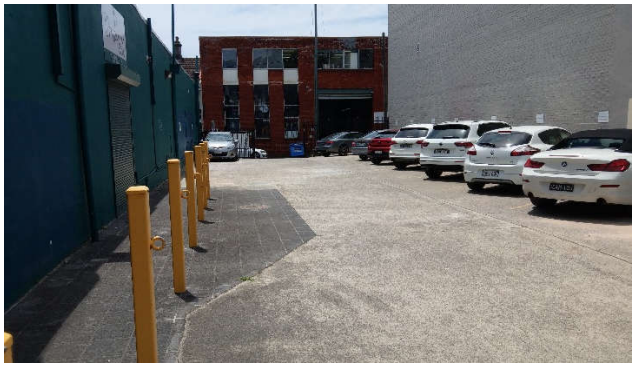
Photograph 1: View of the car parking area in the eastern part of the site (122-128 Pyrmont Bridge Road).

Photograph 2: View of the site building at 122-128 Pyrmont Bridge Road from Cahill Street.

Photographs 3: View of the site buildings at 130 Pyrmont Bridge Road and 206 Parramatta Road from Cahill Street.

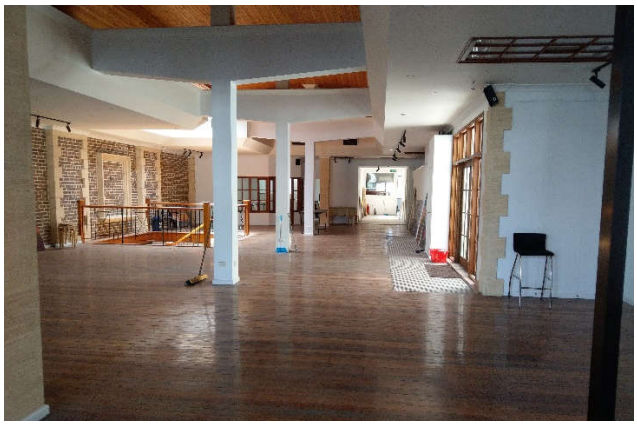
Photograph 4: View of the above-ground floor within the building at 130 Pyrmont Bridge Road.

Photograph 5: View of 206 Parramatta Road from the corner of Cahill Street and Mathieson Street.

Photograph 6: View of the internal car parking entrance to 206 Parramatta Road from Mathieson Street.

Photographs 7: "7-Eleven" service station site to the south / south-east across Pyrmont Bridge Road.

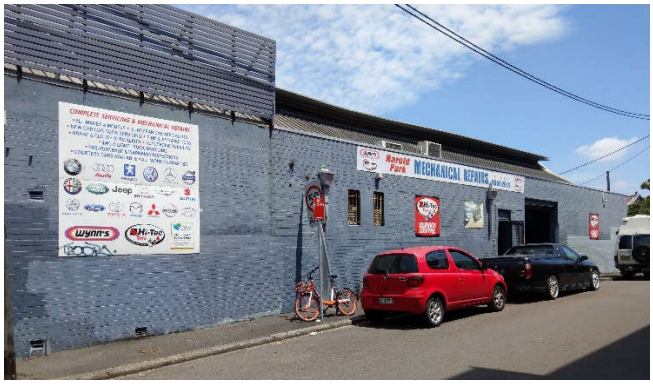
Photograph 8: "Harold Park Repairs" car servicing and mechanical repairs workshop to the west / south-west across Mathieson Street.

Photograph 9: Neighboring commercial tenancies along Cahill Street including "VG Group" car detailing premises.
