Preliminary Acid Sulfate Soil Assessment at 28 and 35 Sugarmill Road, Sapphire Beach

3 November 2021

For: Mr Keiran Grimley and Dr Ian Martyn

Ref	Ver	Date	Distribution
2021-165-04	A	3/11/21	Client, Planner

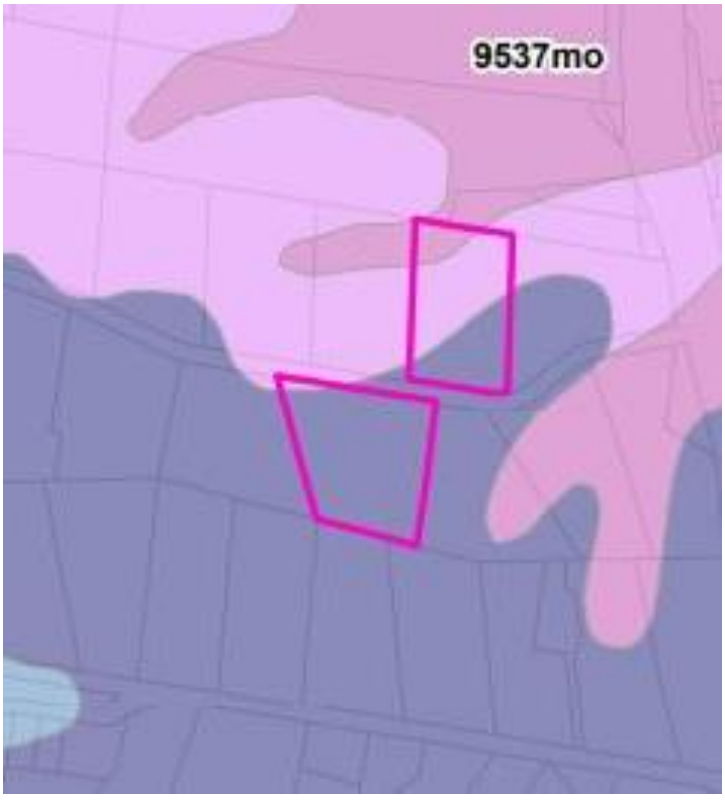
The properties are underlain by a combination of soils, which include the Ulong, Moonee and Megan soil landscapes. Generally, 28 Sugarmill Road is underlain by a combination of the Ulong (central portion) and Megan (southern portion) Soil Landscapes. Number 35 Sugarmill Road is almost entirely underlain by the Megan soil landscape, with a small section underlain by the Ulong landscape in the northwestern corner of the property.

Photograph 3. Mapped soil landscape and subject properties (pink).

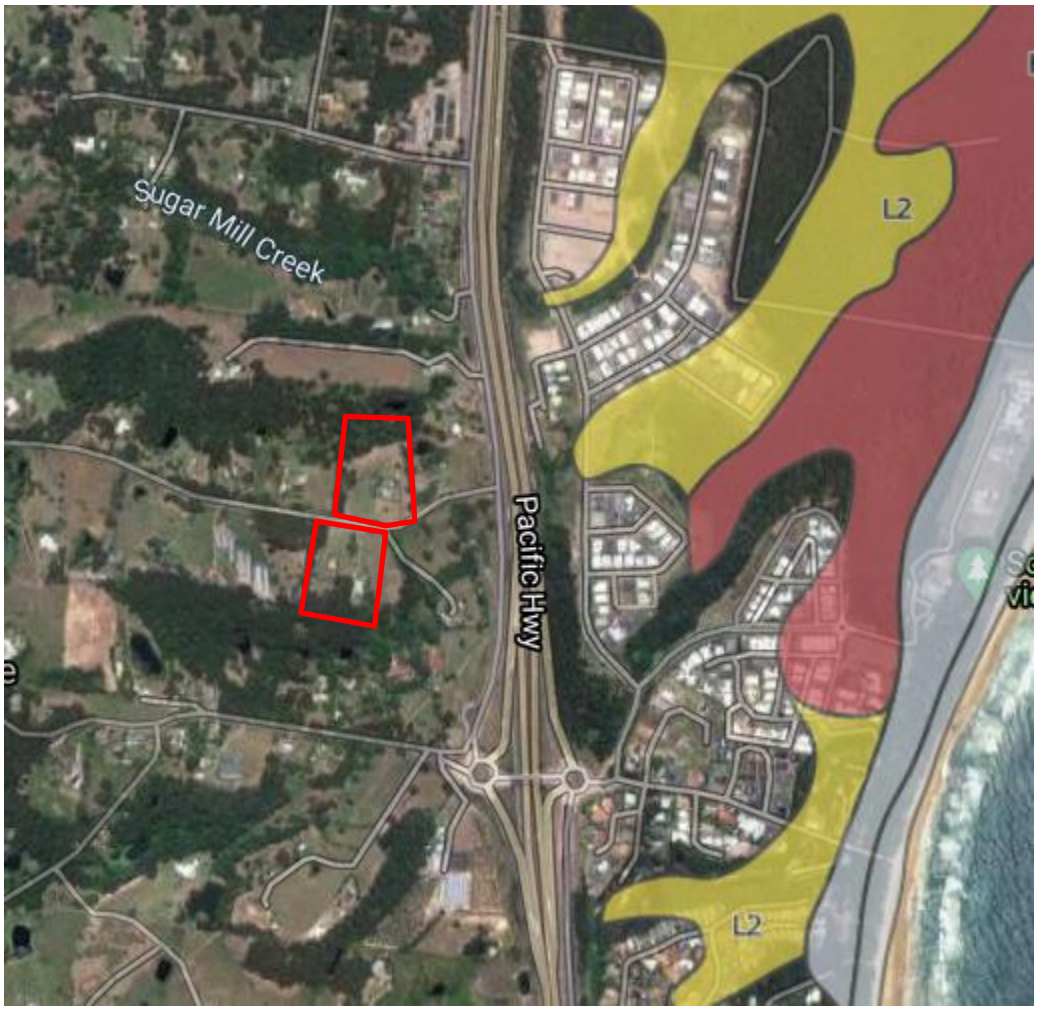
Mapped ASS probability mapping provided on eSpade 2.1m indicates that mapped low and high probably ASS soils are present east of the Pacific Highway only. The high probably pf ASS is at <1m below the groundsurface and low probability at 1-3m below the groundsurface.

Photograph 5. Published ASS probability mapping. Subject property's locations red outline.
