PRELIMINARY SITE INVESTIGATION REPORT

PROJECT: 13L Narromine Road Dubbo, NSW and Jannali Road, Dubbo, NSW 2830

DATE: 16 June 2022

REPORT NO: NE1295

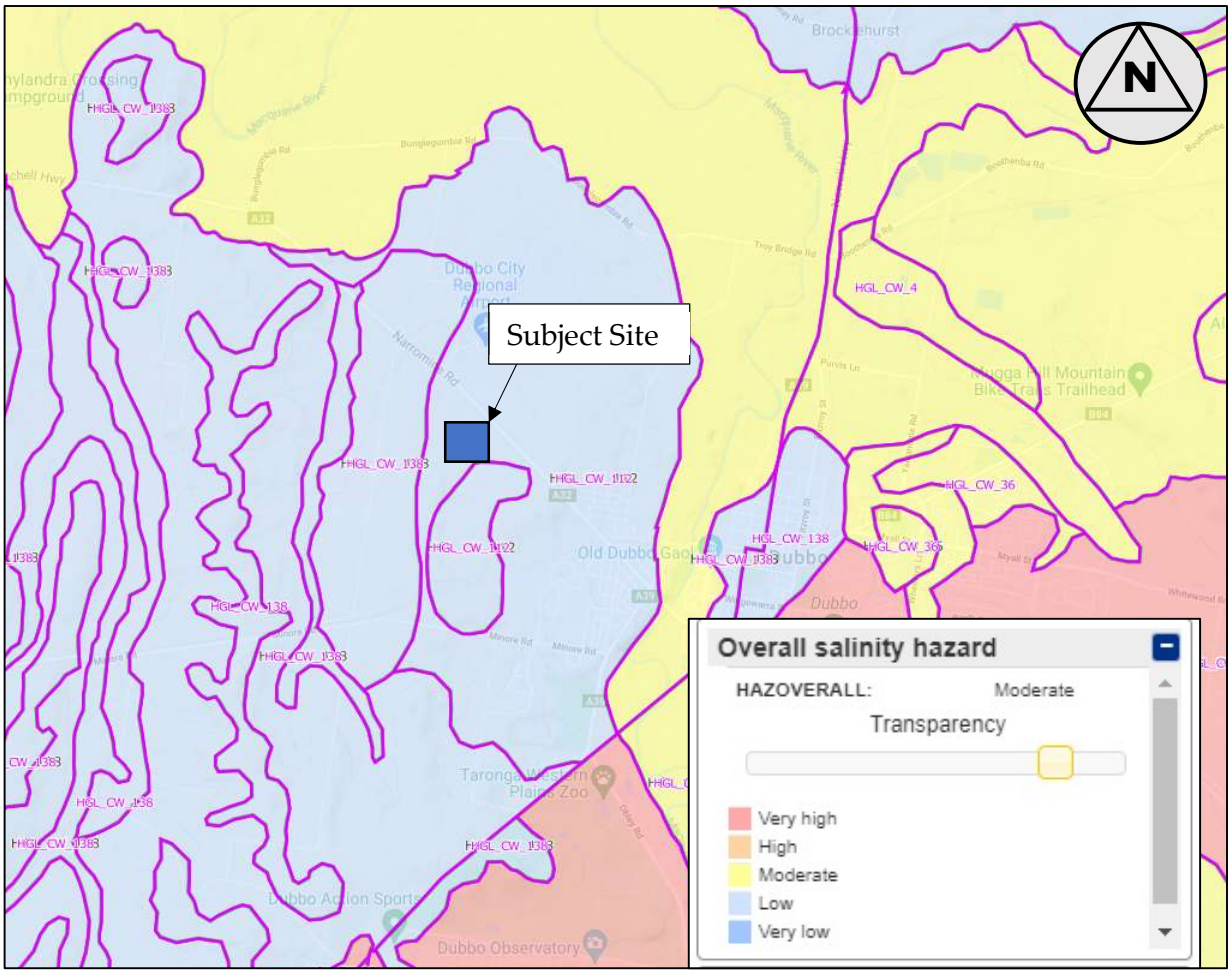
Figure 2. Salinity Potential Map

The eSPADE web app found at https://www.environment.nsw.gov.au/eSpade2WebApp indicated that the site is in an area of low salinity potential (see Figure 2).

- ✓ Vegetation growth appeared healthy throughout the site.
- ✓ No water marks or salt crystals observed on the ground surface

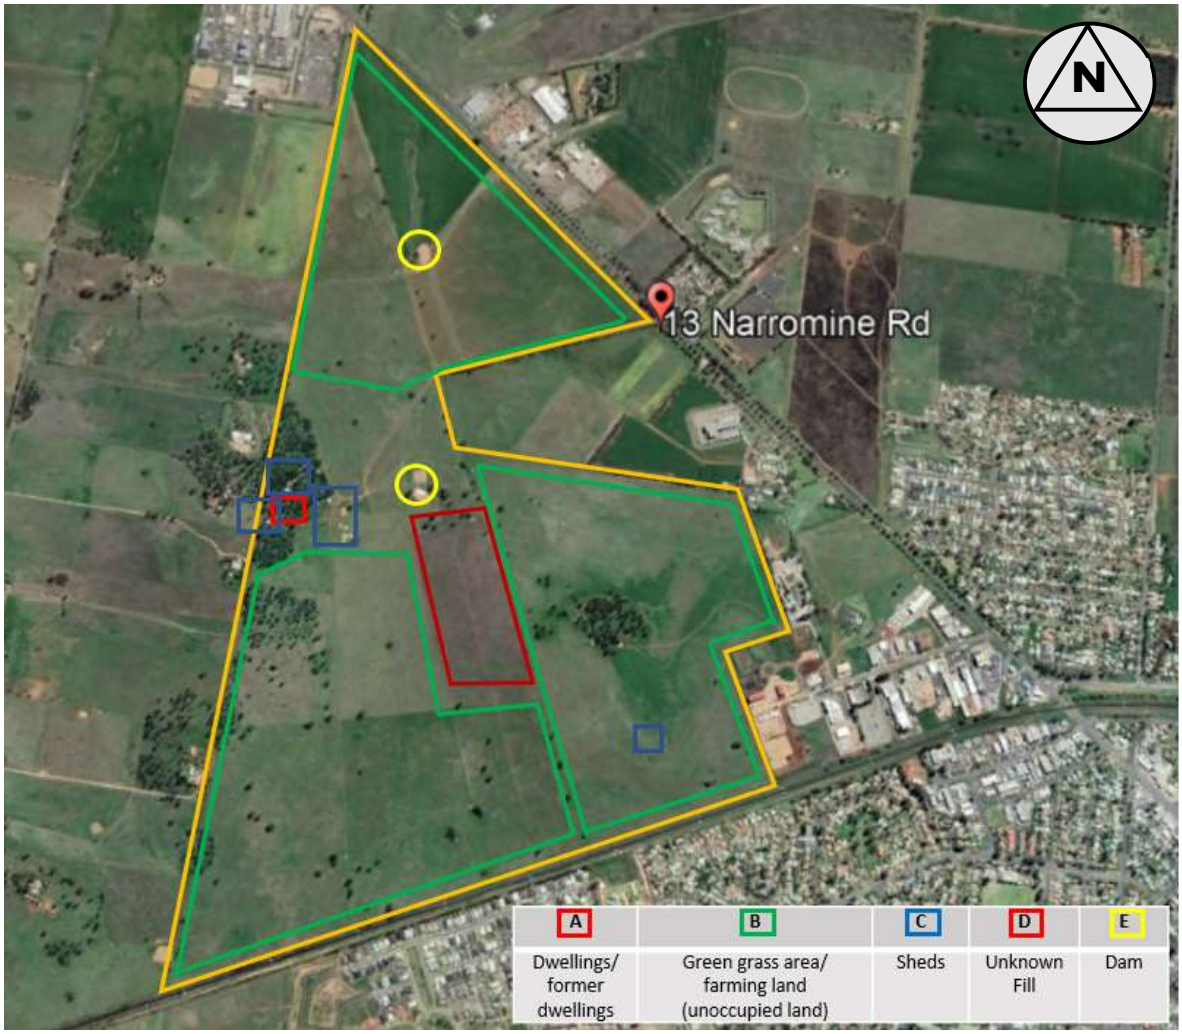
Figure 3: Areas of Environmental Concerns

- Areas of dwellings/sheds may currently (of have previously) stored fuel, oils, pesticides, zinc treated (galvanised) metals and/or lead based paints.
- Contaminants from the contents of the stockpiles, fuel barrels, oil storage tanks and heavy vehicles may have leaked, spilled or been distributed onto the underlying soil.
- Areas of possible cropping/farming activity may have introduced heavy metals or pesticides to the soil.
- Areas near mobile oil tanks and fuel storage tanks may have heavy metal, fuel and chemical contaminants leaked or spilled into the underlying soil.

To address identified AECs, intrusive soil/water sampling regime is recommended to determine what, if any, remediation is required to render the site fit for residential use. A soil sampling plan is to be developed based on a judgemental or systematic sampling pattern and risk-based assessment.

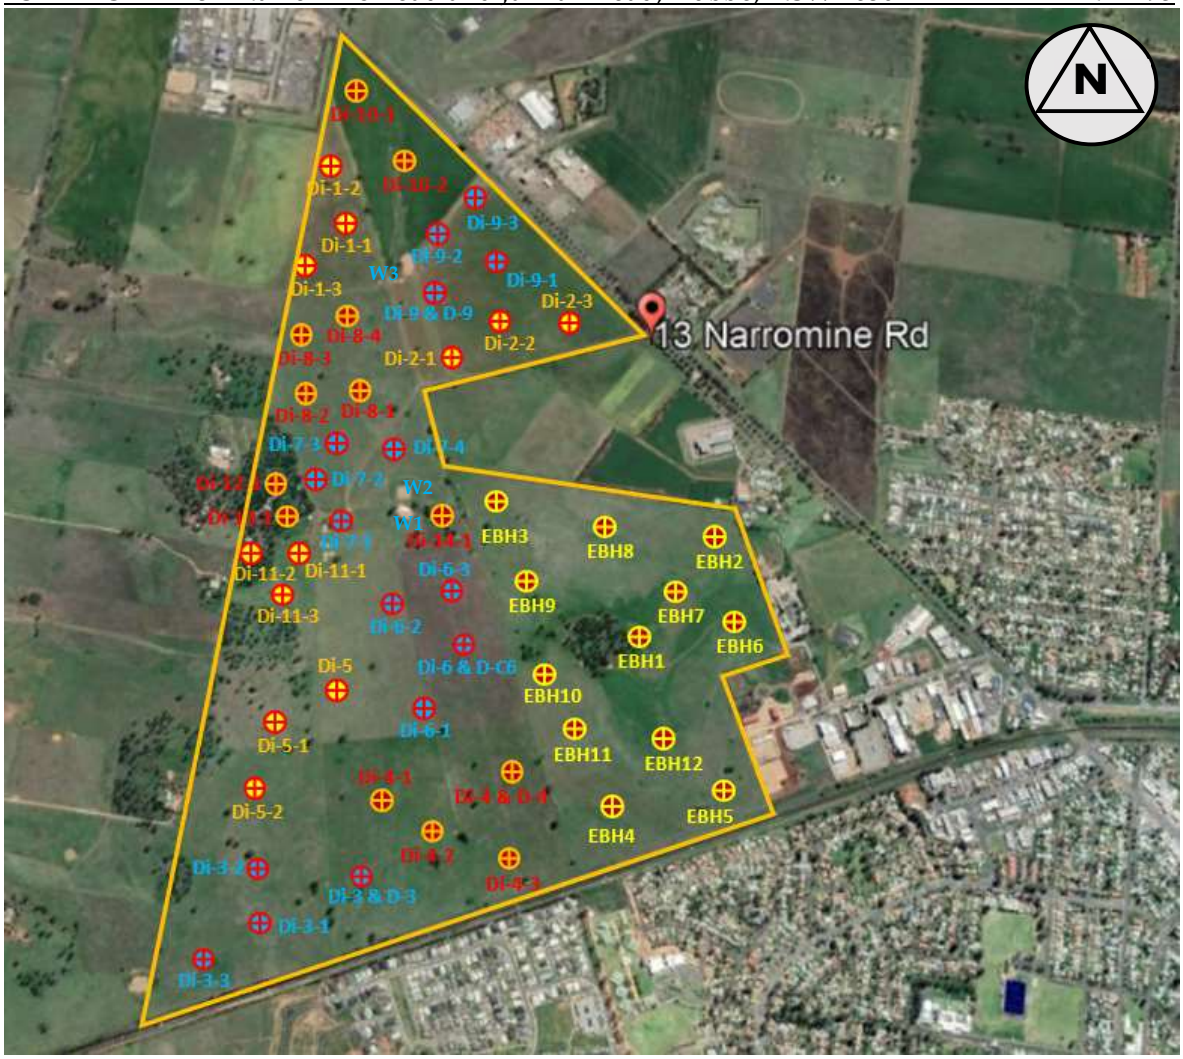
Figure 4: Soil Samples Location

All samples analysed, are found to have concentrations of TRH within the adopted Site Criteria (HSL, ESL and ML). With the exception of Sample# Di-11-2 where the concentration of TRH F3: C16-C34 exceeded the Ecological Screening Level (ESL), the Management Level was not exceeded.

Given that the sample was sampled in a tree lined area and there was no visual evidence or odours of hydrocarbon contamination within the soil such as oil staining. Geotesta Pty Ltd is of the opinion, the hydrocarbons were natural occurring, often associated with oils from eucalyptus trees and dropped leaves.

- A Delineation Assessment is recommended in the vicinity of the TRH Fraction F3: C16-34 concentration elevation at the location of Sample# DI-11-2
  - Any stockpiles and areas under stockpiled materials that were not assessed at the time of the PSI or are new to site, will require sampling as part of the Data Gap Assessment.
