Report on
Preliminary Site Investigation (Contamination)

Proposed Commercial Building 1
Proposed Lot 106 and Lot 107 Williamtown Drive,
Williamtown
Part Lot 11, DP 1036501

Prepared for
Cox Architecture Pty Ltd

Project 39728.27
February 2023

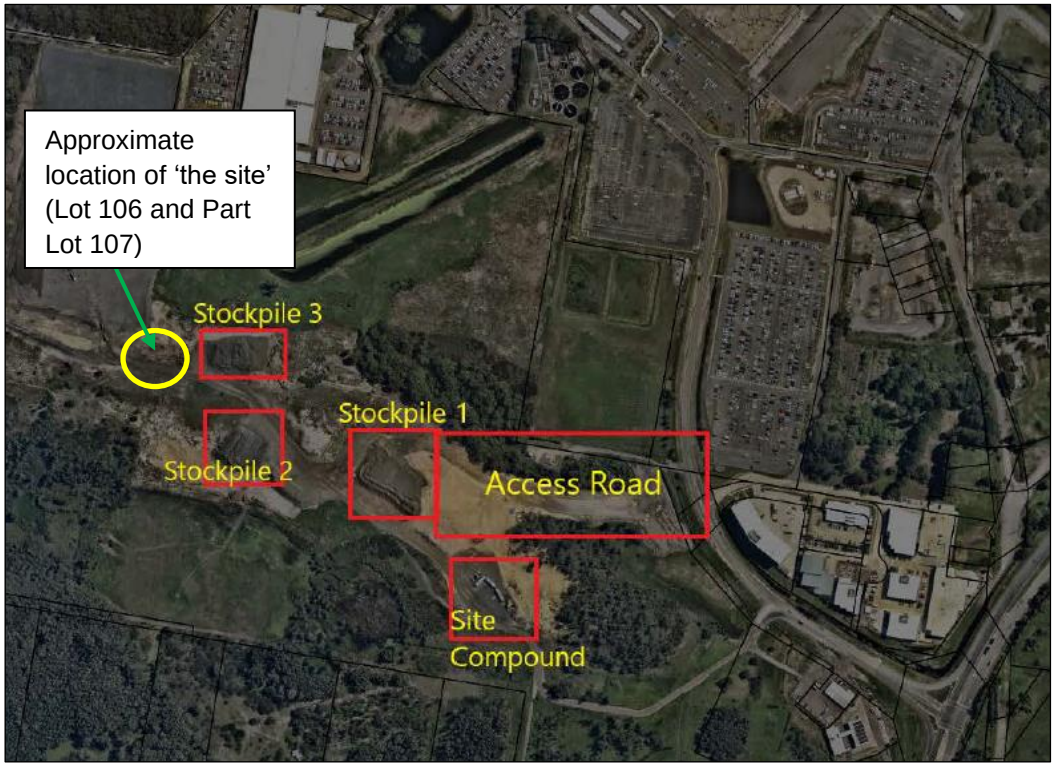
Figure 4: Approximate areas of fill and testing, Valley Civilab (2020)

It is noted, however, that the testing results provided in the report do not appear to cover all of the above areas, particularly Stockpile 2 and Stockpile 3 areas as indicated above. It is noted that the stockpile 3 area is immediately east of the current subject site.

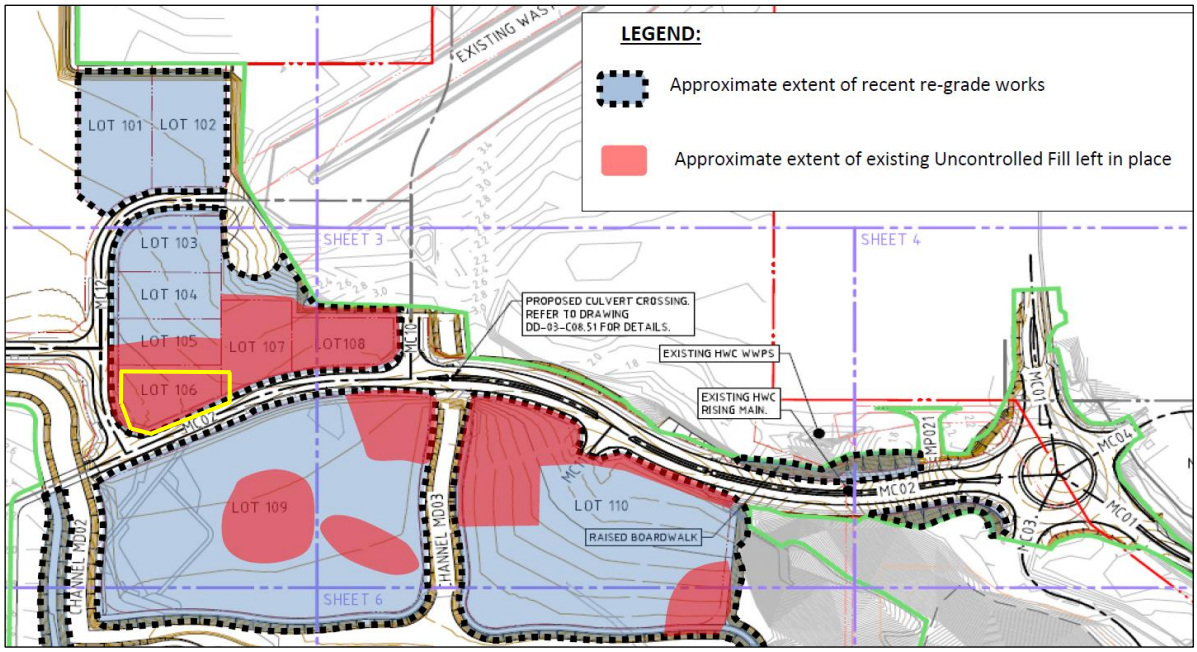
Figure 5: Approximate extent of Level 1 inspections and testing (blue) and areas where previously placed fill remained (red). 'The site' is shown in yellow

Qualtest (2020) included a plan showing the areas of regrading and testing conducted. The plan also shows the approximate extent of existing uncontrolled fill material previously placed by others, and left in place, as instructed by Newcastle Airport. The plan extract in Figure 5 indicates that existing fill was left in place within proposed Lot 106 and Lot 107.

It was noted in Qualtest (2020) that fill was placed within the proposed Lot 106 to a maximum thickness of 1.2 m.

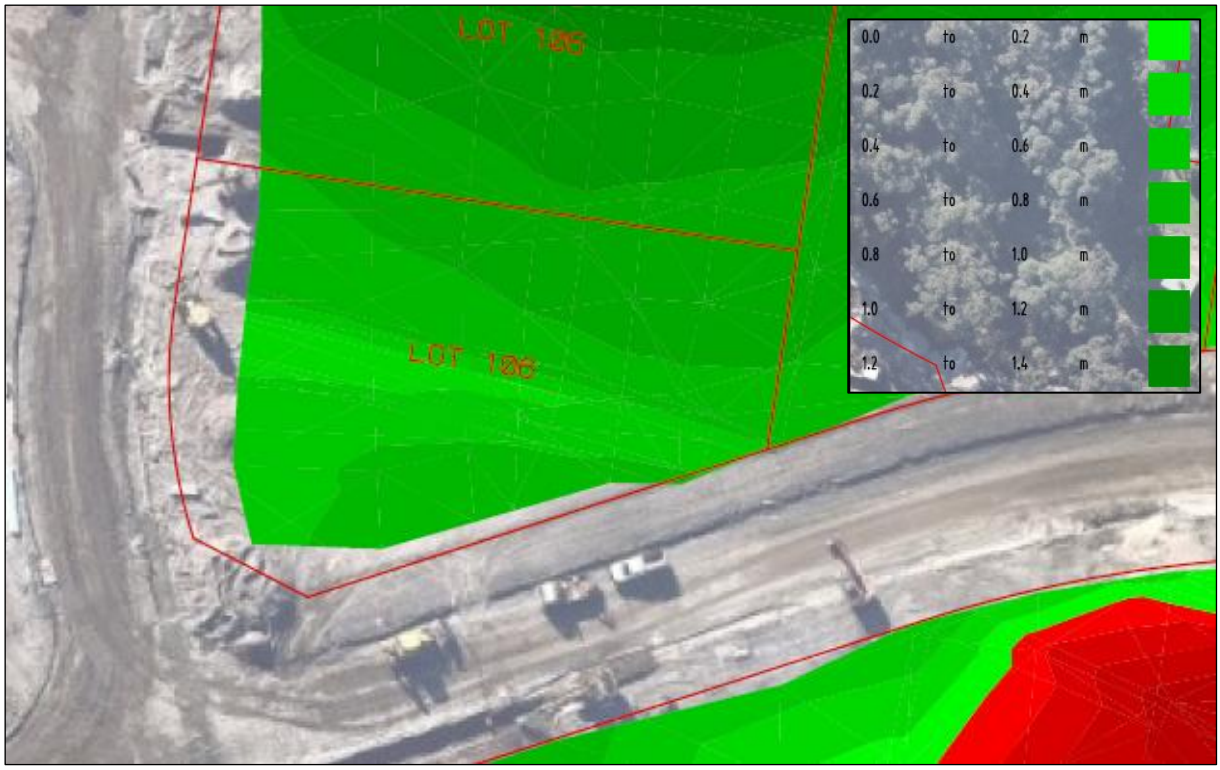
Figure 6: Approximate extent of fill on proposed Lot 106 (see legend insert)

The Qualtest (2020) report also indicates the approximate fill/cut for the site prior to and following regrading works. An extract of the plan for the proposed Lot 106 and western extent of Lot 107 is provided in Figure 6 below.
