Proposed Demolition of Sonnblick Lodge

Our ref: OB/C14191v3

Proposed Demolition of Sonnblick Lodge **10 Bobuck Lane, Thredbo, NSW** *Geotechnical Investigation & Landslide Risk Assessment*

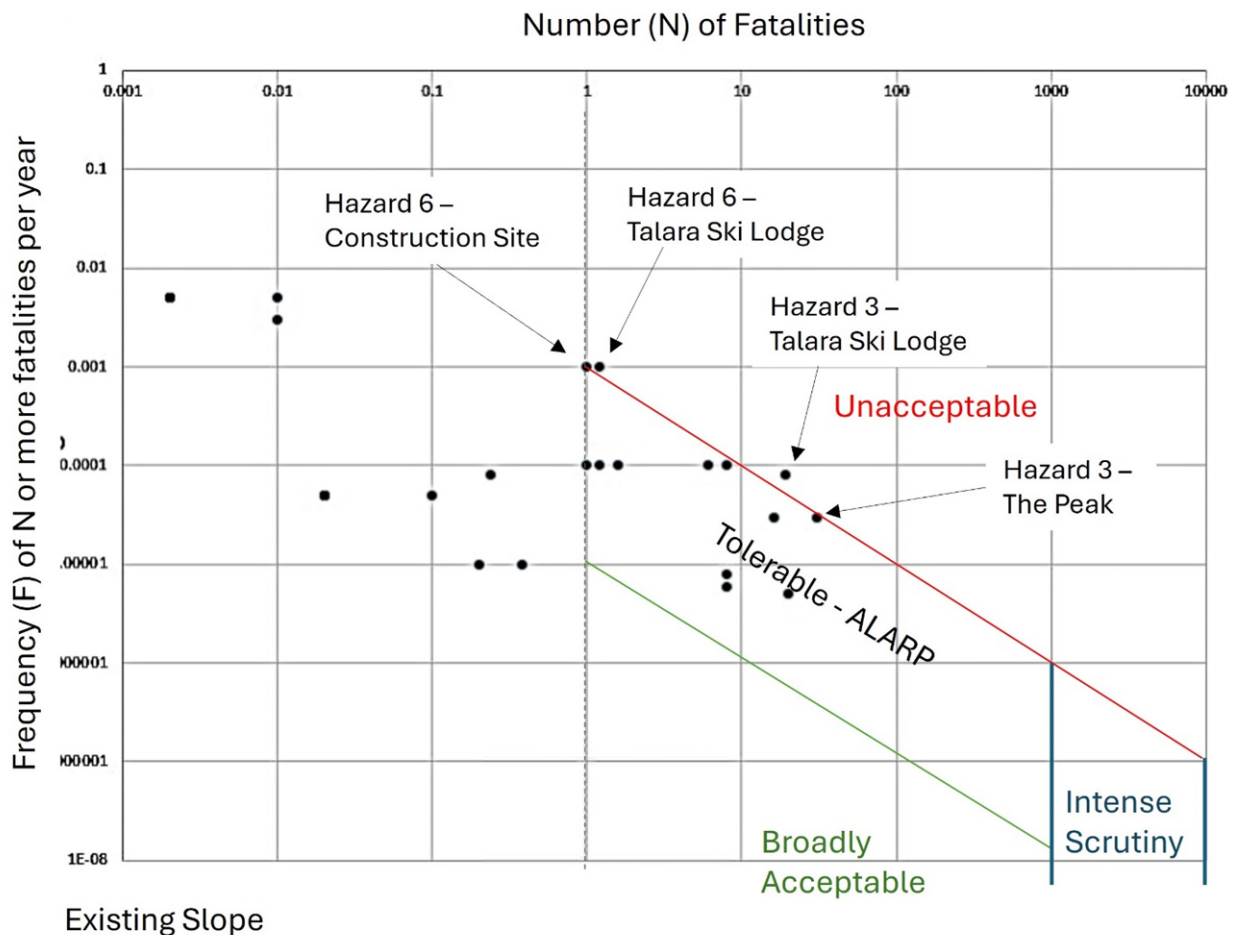
Plate 5: Societal Risk Assessment Plot (N-F) for Lot 802 and the vicinity – Existing Slope

Societal risk was calculated for the existing conditions, showing the assessment for a site and neighboring properties in the current condition (Plate 5). Most N-F pairs for hazards listed in Table 5-3 fall within the 'Tolerable' or the As Low As Reasonably Practical (ALARP) Zone. However, the societal risk for Hazards 3 (Deep-seated failure below Bobuck Lane) for Talara Ski Lodge is on the edge of the 'Unacceptable' Zone. Hazards 6 (Failure of the Unsupported Batter at the rear of Sonnblick Lodge) also lies on the boundary with unacceptable for the Talara Ski Lodge and during construction.

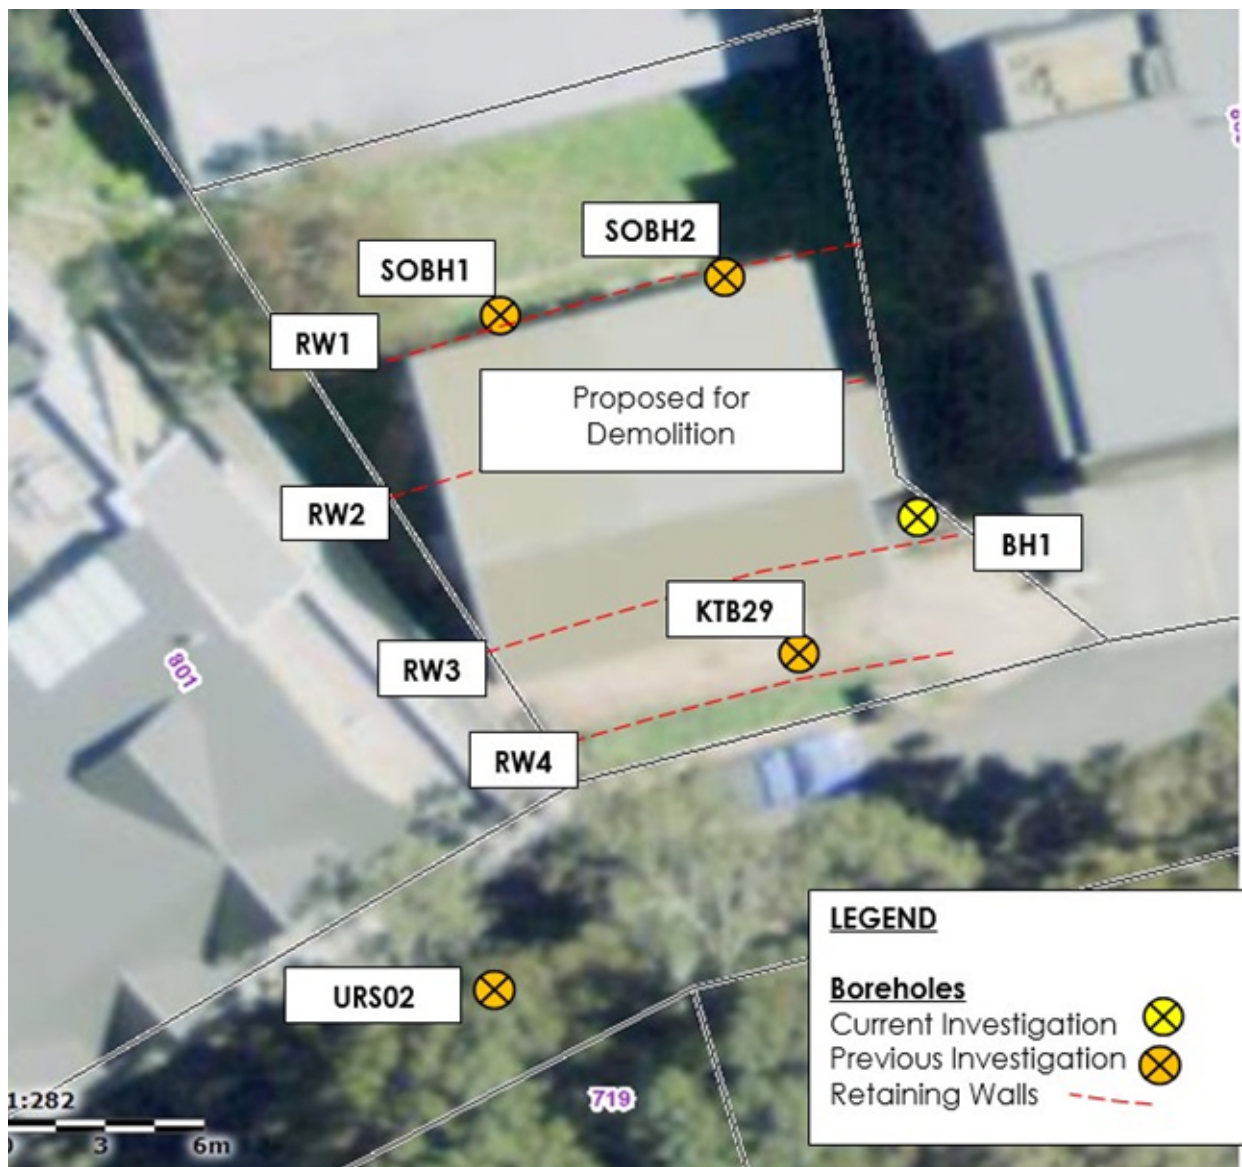
FIGURE 2: AERIAL PHOTOGRAPH & BOREHOLES LOCATIONS

The initial field investigation was carried out on 12 April 2023. It comprised one (1) borehole, designated BH1, using 50mm push-tube equipment. The borehole location is shown in Figure 2, and the borehole log is presented in Appendix A.

To assess the soil condition on-site, three (3) Dynamic Cone Penetrometer (DCP) tests were conducted on 13 June 2024, in accordance with AS1289.6.3.2 “determination of the penetration resistance of soil – 9kg dynamic cone penetrometer test”. Table 4-2 shows the DCP results. DCP test locations are shown in Figure 2. Table 4-3 summarises the depths of each borehole’s various soil and rock layers.

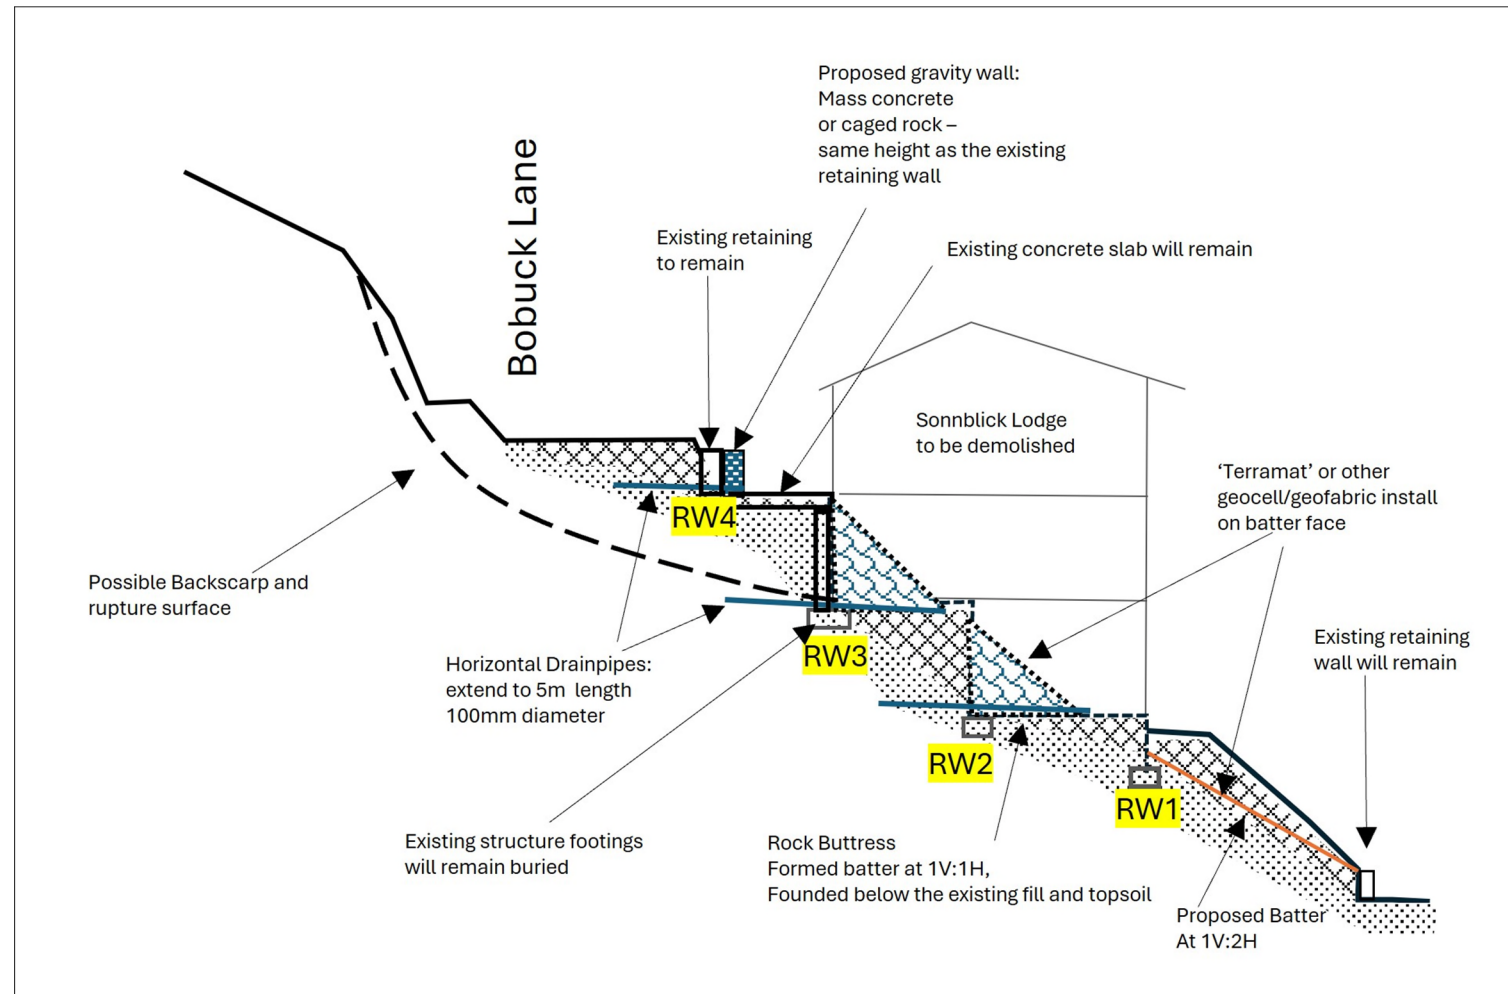
FIGURE 5: SKETCH OF THE PROPOSED STABILISATION MEASURES AFTER DEMOLITION

Properties to the west and east (Lot 801 & 803)		Insignificant: The failed retaining walls can expose the neighbouring services or structures, and some material may be transported to the neighbouring properties.	Very Low	The existing retaining walls will be buttressed (See Figure 5 for the conceptual sketch). Follow the proposed recommendations provided in Section 6.3. A new slope should be monitored for stability and movement regularly (before and after the snow season). If any signs of movement or instability are observed, a geotechnical engineer should be consulted immediately.		Insignificant	Very Low

Plate 4 shows the results of analysis that include additional permanent surcharge of 75kN/m^2 for the proposed buttressing of the retaining walls (Section 6.3). The gabion wall buttress was assumed for the surcharge calculation. The slope stability analysis results indicate a FOS of 1.54, which is acceptable.
