Supplementary Appendix P – Evidence of Works Required (DA23/907)

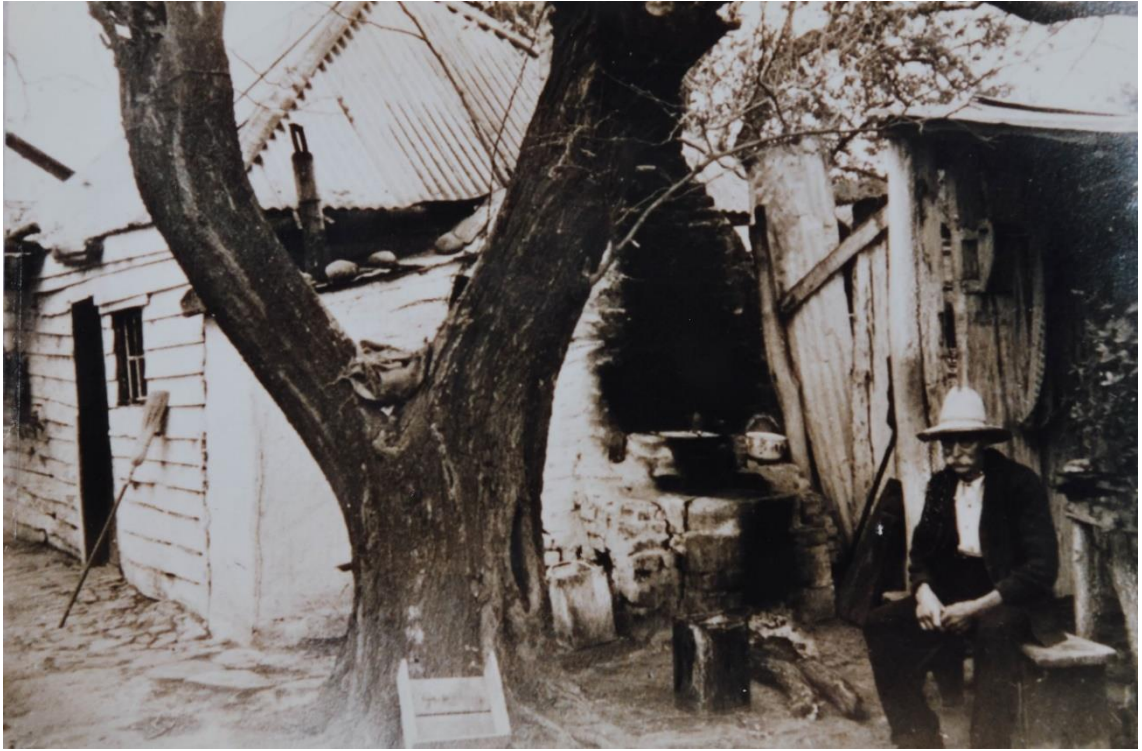
Figure 11. Photograph of William Charles Hadley Childs Circa 1930'2 to 1940's, providing insight and base information for the reconstruction (Source: JPA&D 2023)
