Asbestos Survey Report

**Corner Winbourne Street and Mulgoa
Way, Mudgee, NSW**

Housing Plus

22 December 2021

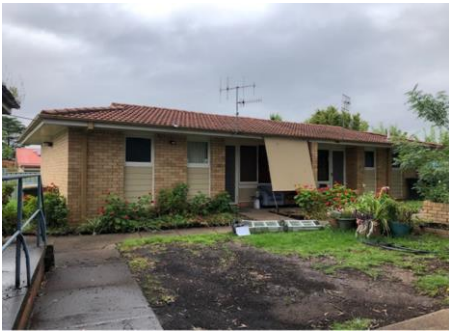
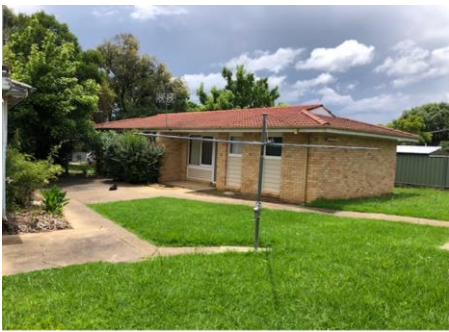
Site Location: Units 19 - 22 - Corner of Winbourne Street and Mulgoa Way, Mudgee, NSW

ASBESTOS BUILDING MATERIALS REGISTER																				
Building identification	Floor identification	Internal / external	Material Description	Primary location	Application	Surface treatment	Photographs	Sample identification	Laboratory results	Asbestos present	Friability	Material condition	Likelihood of disturbance	Risk	ACM control method	Labelling	Estimated quantity (m²)	Units	Comments	
Single bedroom unit - Two brick buildings with two units in each. Tile roof and timber frame on a concrete slab. Metal gutters and downpipes, plastic sewer vent. External infill panels below windows with the two front ones timber composite cladding and the rear and one front one fibre cement sheet. Internal walls and ceilings are plasterboard with the exception of the kitchen wall behind the sink and the bathroom/laundry walls. Floors are carpet, tile or modern vinyl planks over concrete. Roof space access is in kitchen and has yellow SMF insulation batts and sarking on underside of tiles. Electrical board is internal and modern. There was no access available to Units 19, 21 and 22. They are assumed to be identical to Unit 20.
