Arboricultural Development Assessment Report

Nepean Hospital Total Asset Management (TAM) Child & Adolescent Mental Health Services (CAMHS) project Kingswood NSW 2747 Updated May 2022 *Final*

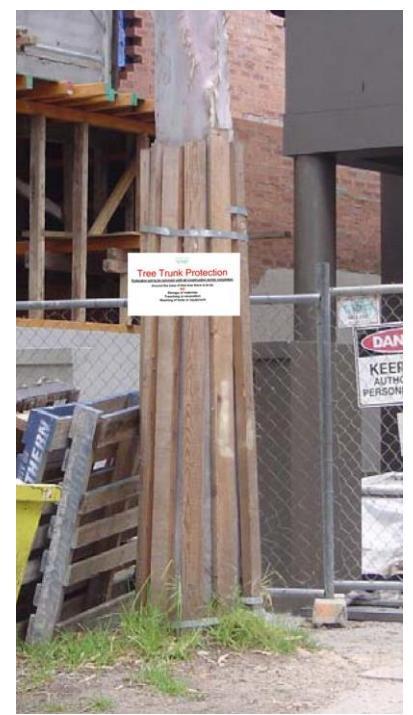
Image 1: Example of trunk protection with sign attached, recommended for Trees 78-81. P. Vezgoff.

- **5.3 Individual trunk protection:** Trees 78-81 will require trunk protection. This is achieved by attaching lengths of timber (75mm x 50mm x 2000mm) fastened around the trunk. Geotextile fabric or carpet underlay shall be wrapped around the trunk prior to the timbers being attached. These timbers are to be fastened with hoop iron strapping and not attached directly into the bark of the tree. These timbers are only to be removed when all construction is complete. See Image 1 for an example of trunk protection.
