# ARBORIST'S STAGE A REPORT

PROPERTY:	47 – 49 Curry Street and 38 Davis Avenue, Wallsend NSW
NUMBER OF SUBJECT TREES:	3 (38 Davis Avenue)
DATE OF REPORT:	27 October 2021
REQUESTED BY:	Sam Crawford Architects

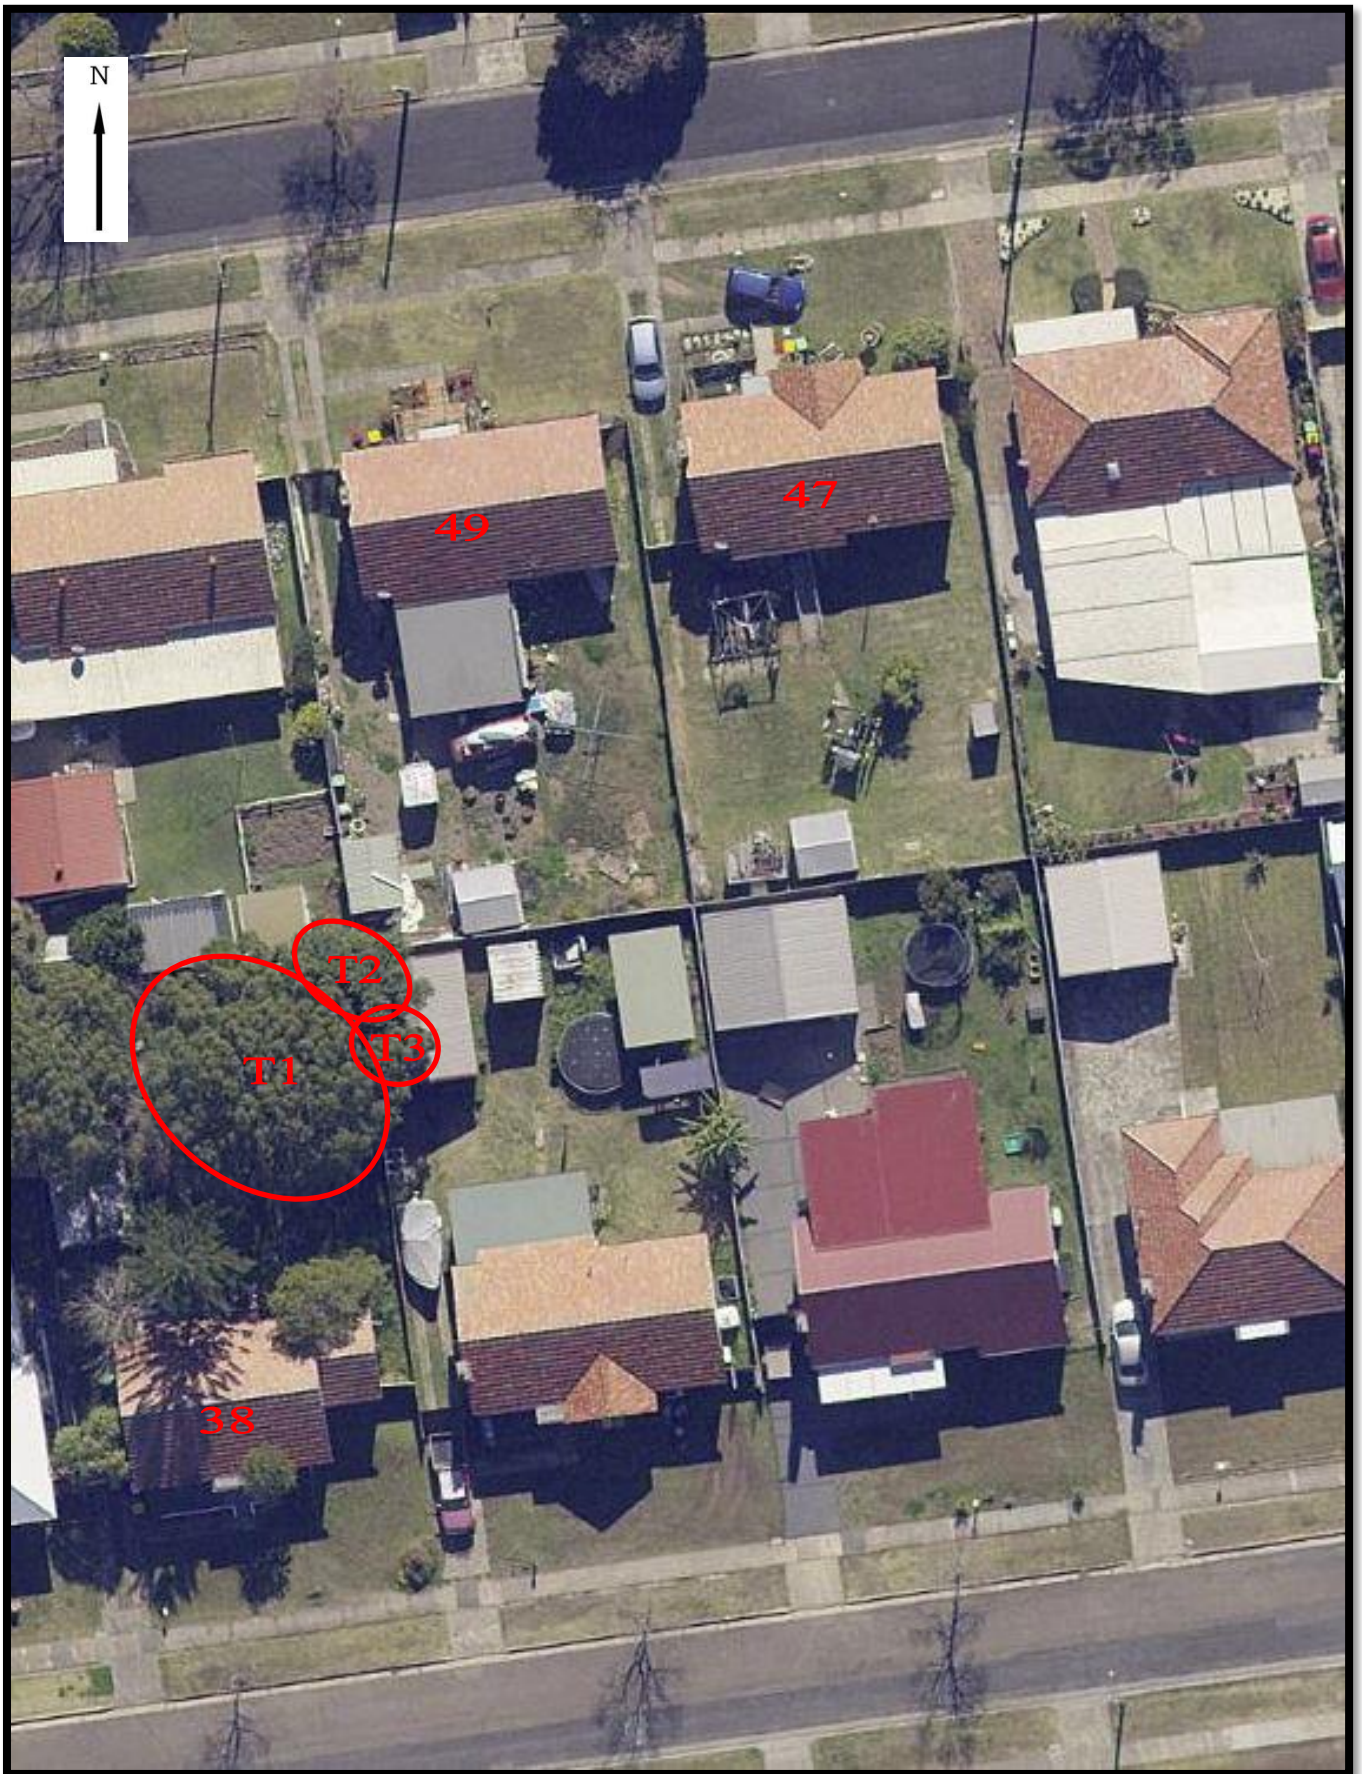
An aerial photograph (Six Maps) used as a site plan showing the position of the subject trees with approximate canopy extents.
