Arboricultural Impact Assessment and Tree Protection Plan and specification

Site: 13 Latty Street, Fairfield

Date: 27/10/2022

Reference: 13 Latt /AIA/020522 Rev 4

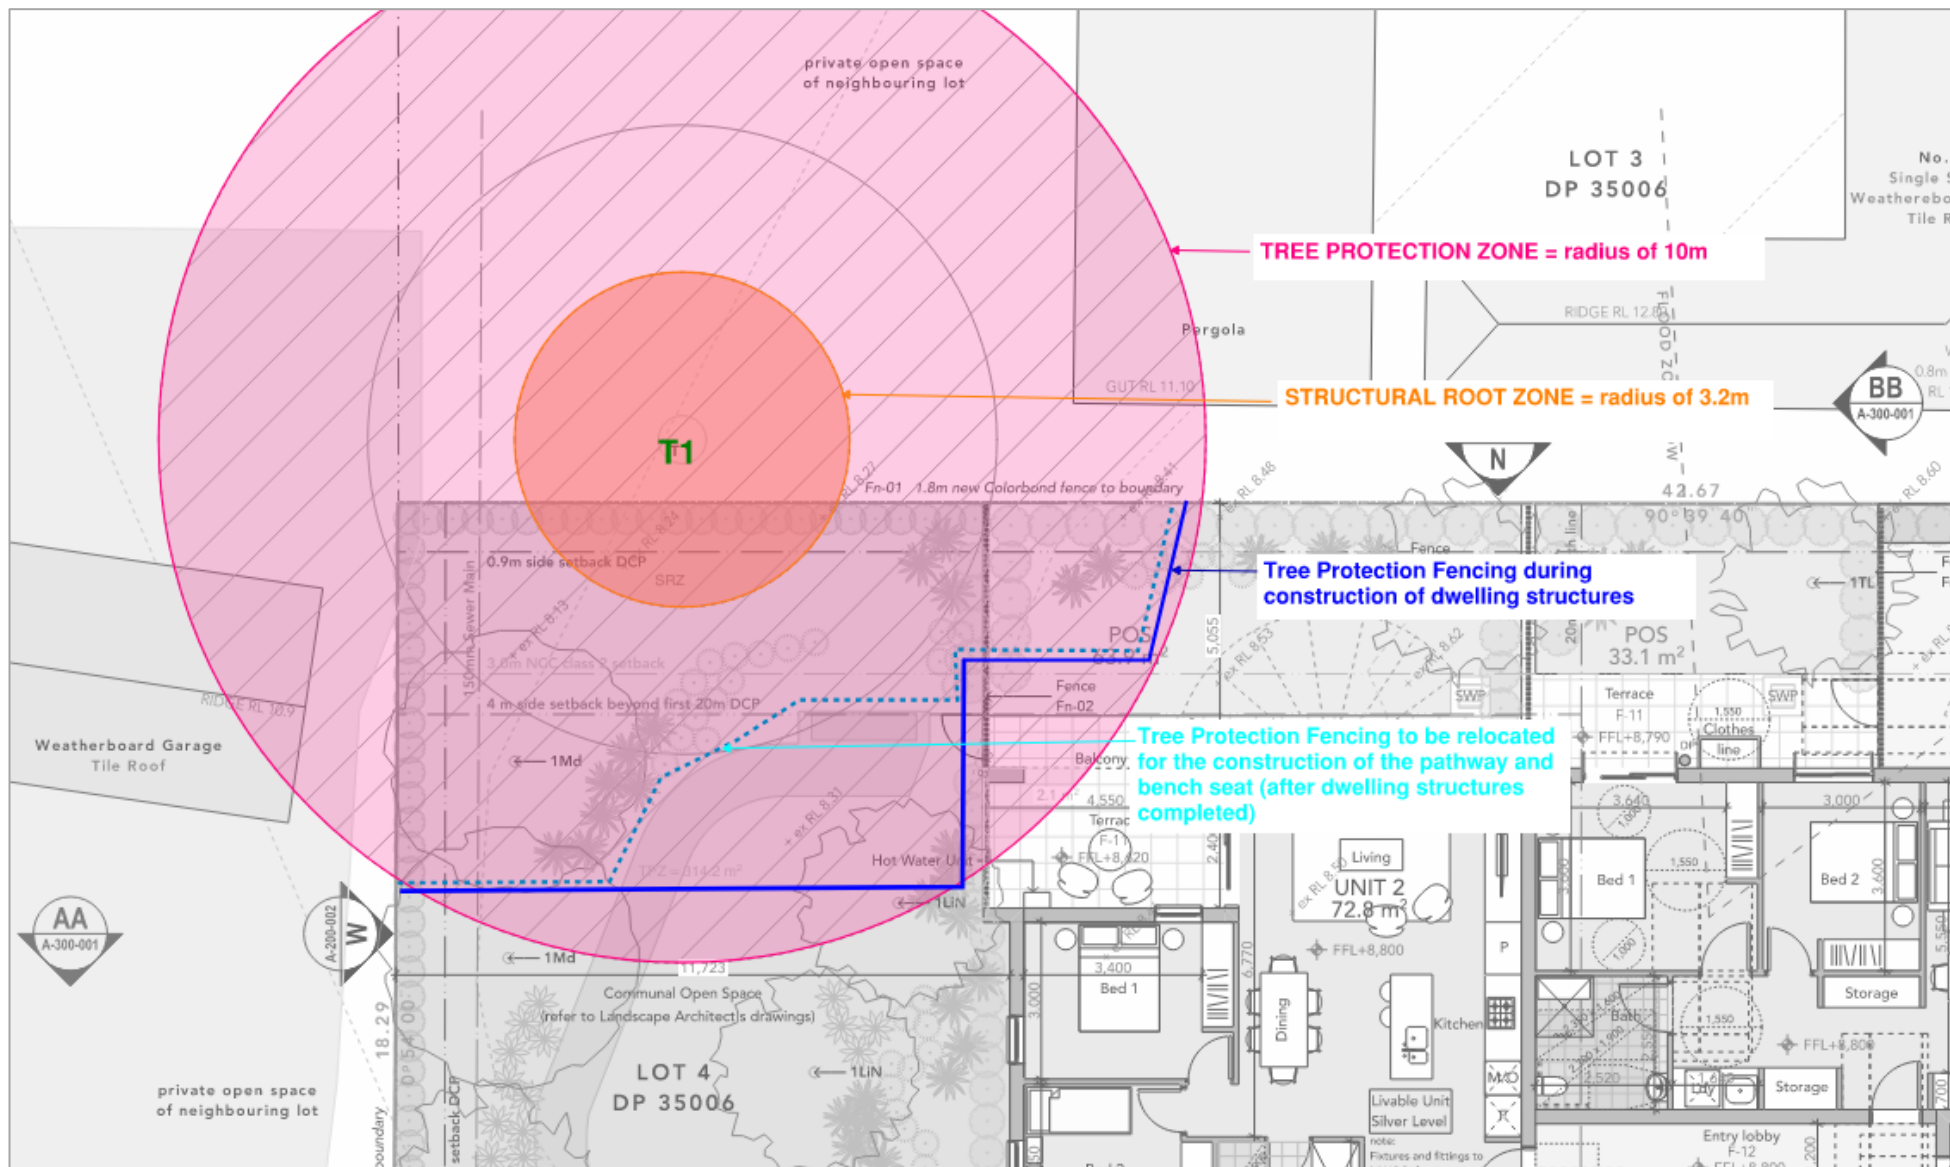
12 Appendix 1 - Tree Protection Plan

The tree protection fencing shall be erected prior to any works commencing on the site. The fencing shall be installed in the approx. location as shown by the blue lines on the Tree Protection Plan in Appendix 1 – exact placement to be determined by Project Arborist on site. The fencing shall be constructed from 1.8-metre-high galvanised steel framed (50mm) panels with chain link infills. The panels shall be clamped together to prevent sideways movement and shall be stabilized at the ground with concrete block ‘feet’. Refer to Image 3 below as an example.

- Tree Protection be installed in accordance with the Tree Protection Plan in Appendix 1 and the specification in Section 10.1. Tree protection must be installed prior to any work, including demolition, commencing and shall remain in place until all work is completed.
- All works are carried out as specified in Section 10.6.
- A Project Arborist is engaged to check that the tree protection is compliant with the recommendations within this report and certify related conditions of consent if imposed by the Council.
- The following specifications and methodologies are adhered to during the development works:
