19 September 2022

Arboricultural Impact Assessment (AIA) Report – Kingscliff Rural Ambulance Infrastructure Reconfiguration (RAIR) development

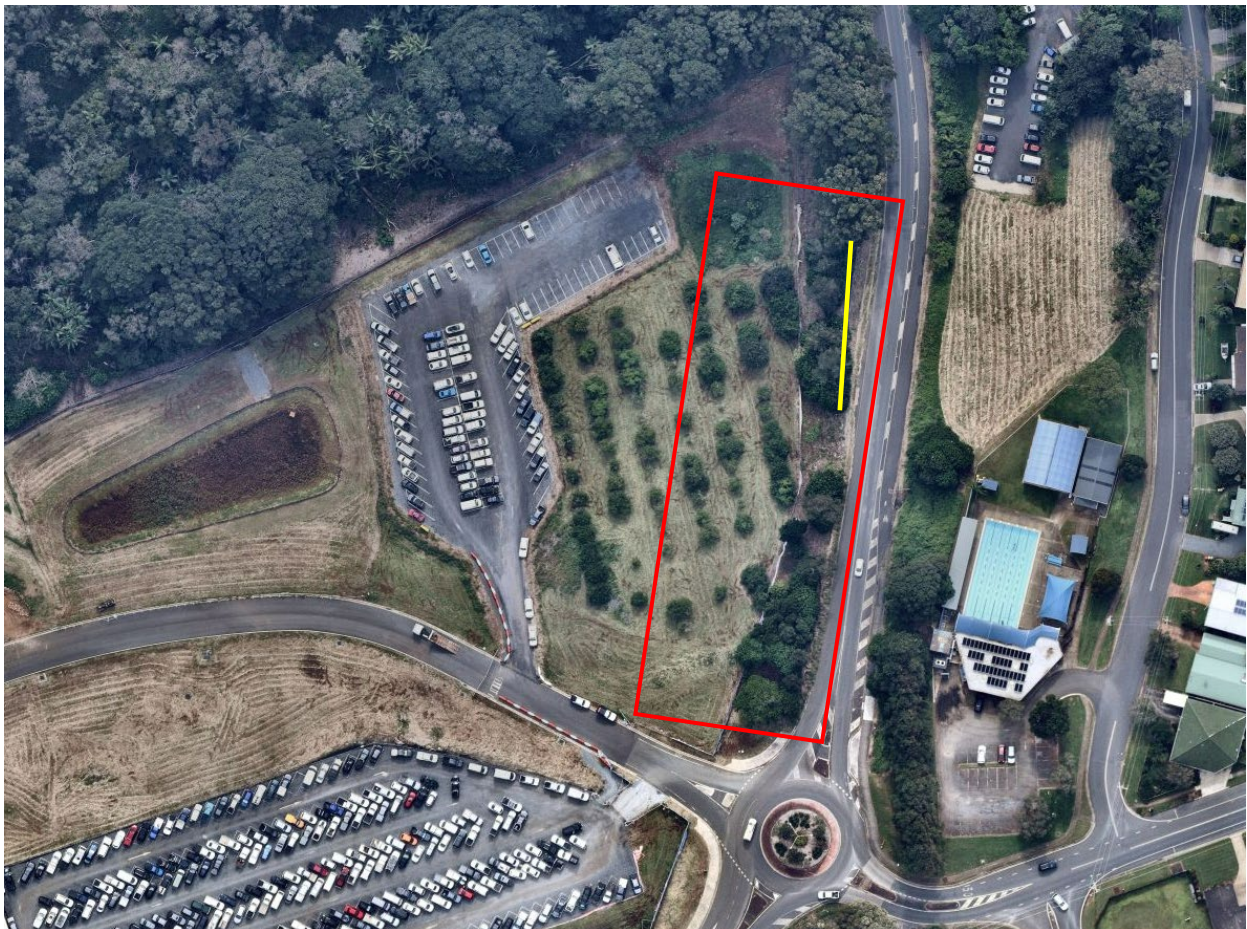
- 5.1.1 The proposed development site was located within the extended grounds of the Kingscliff Hospital (Figure 1). Usage surrounding the site was a mixture of cleared farmland, wetlands, hospital car parking to the north and west. Turnock Street, Council swimming pool and residential properties were to the east.

Figure 1. Whole site image (location). The red rectangle identifies the proposed development site and adjacent verge trees identified within this report. The yellow line shows the approximate location of the rock retaining wall. (Nearmap, June 2022).

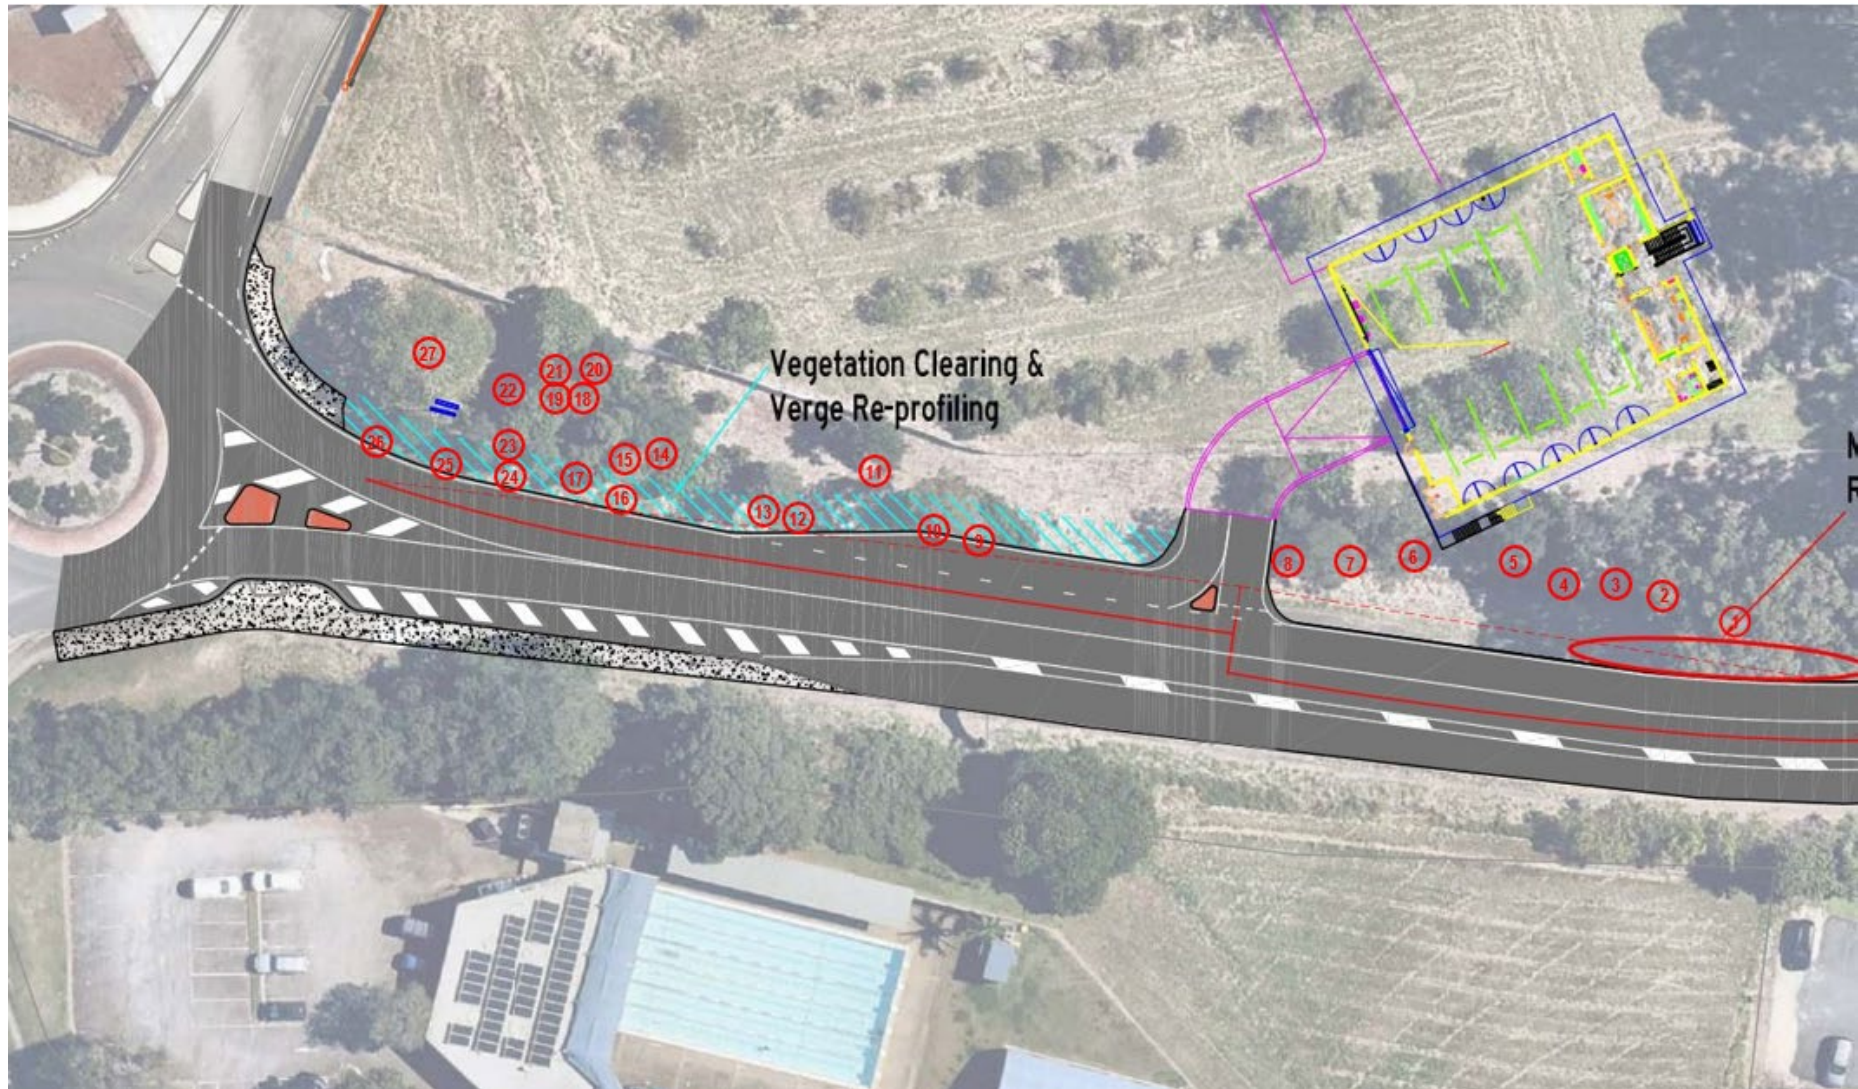
- 5.1.2 The site possessed a sloping aspect characterised by a high point located to the south dropping down to the wetland in the north. Turnock Street is level with the land at the southern roundabout and has been kept raised, with the use of a rock retaining wall, above the sloping area as it progresses north (refer to Figure 3).

Figure 3. Site map showing subject trees. Tree attributes are to be obtained from Appendix DD – Tree Assessment Data. (ArborSafe, November 2021).

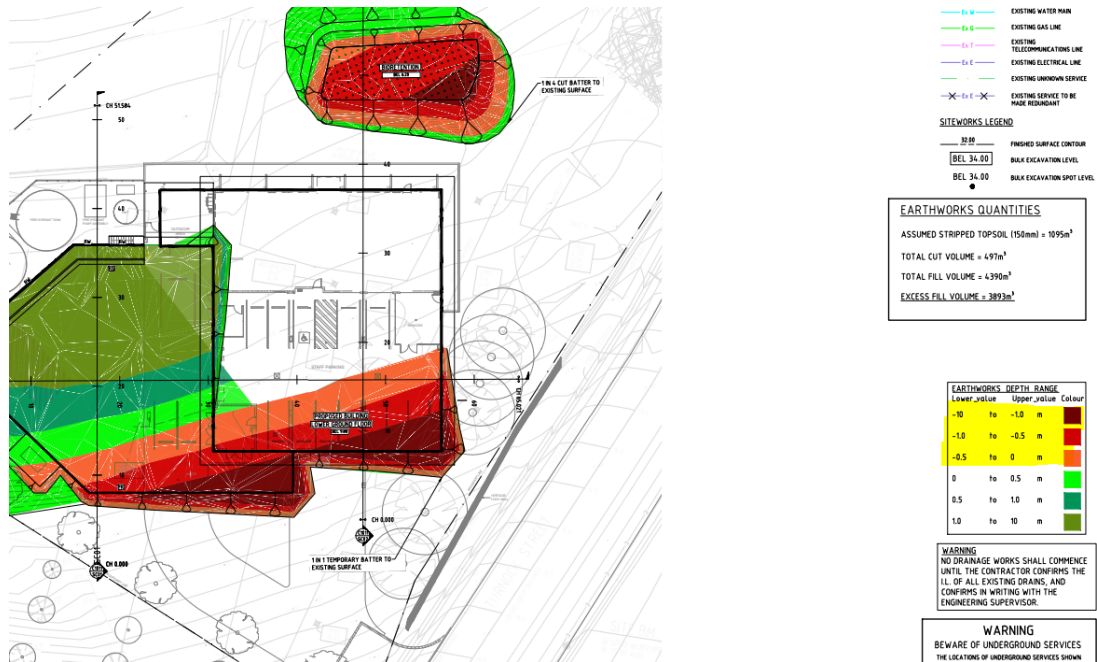
- 6.2.3 Cut and fill estimates (refer Figure 7) to facilitate finished building levels detail excavation of ranging between 0 and 10 meters increasing in southern portions, below the south-west corner and western boundary of the building footprint. The proposed addition of fill (soil) ranges from 0 and 10 metres increasing in as the site slope falls in western directions, below the proposed new link road affecting trees within the degraded orchard only.

Figure 7. Cut and Fill estimates provided by email. (Client, 12 September 2022).

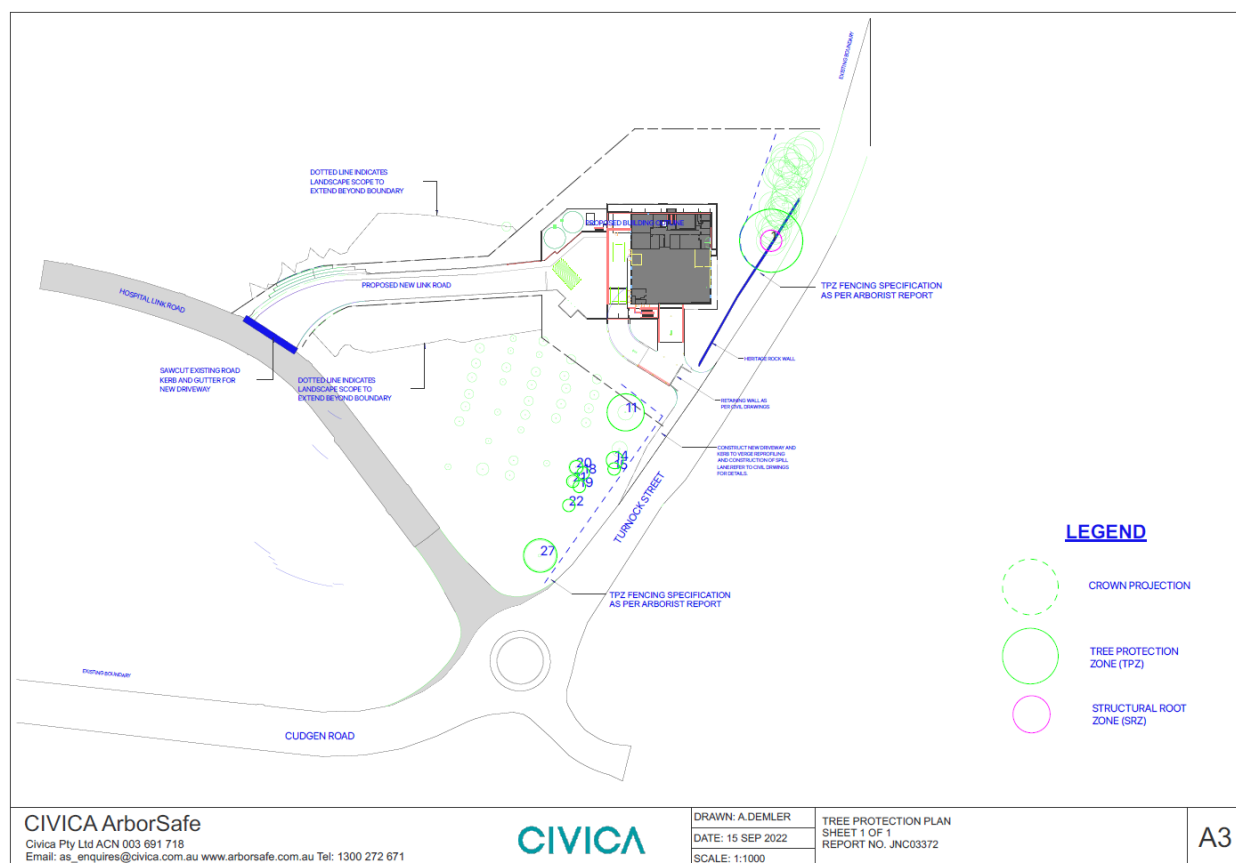
Figure 12. Site map showing tree requiring generic protection measures. (ArborSafe, September 2022).

7.3.1 All retained trees require generic protection measure (Figure 12). Refer to Section 7.4–7.7 for further detail.

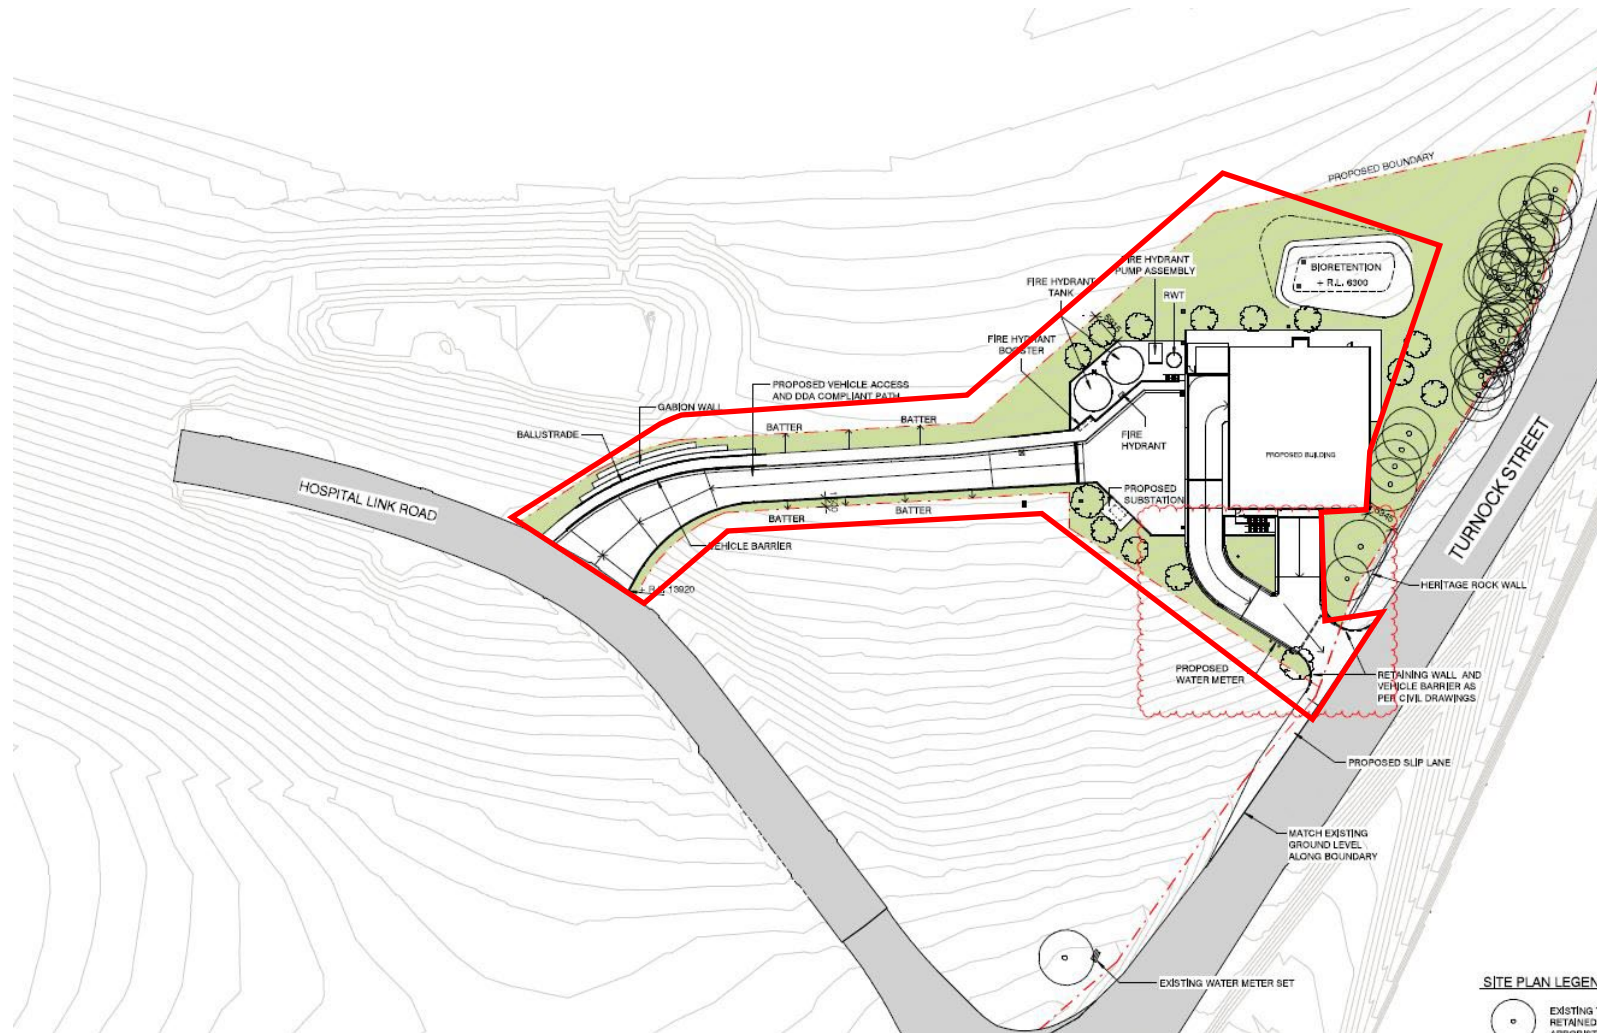
Figure 16. Site map showing retained trees with suggested Tree Protection Fence locations. (ArborPlan, July 2022).
