HAZMAT Survey Report

Prepared for	Ben Matarranz ADCO Constructions Pty Ltd
Site	Admin Building and Adjacent Complex Buildings Bowral Hospital 97-103 Bowral St, Bowral NSW 2576
Prepared by	Jeffrey Yu Principal Environmental Consultant & Occupational Hygienist CEnvP (#1516) Licensed Asbestos Assessor (#001366) PhD (EnvEng), PhD (MediChem)
Date of field work	01/12/2021
Reference No.	JDRYU060_V1_HAZMAT

07 December 2021

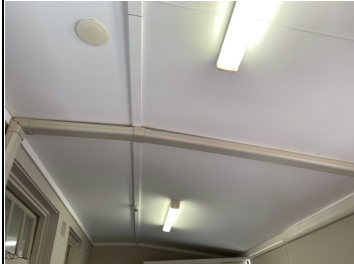
8	Non-Friable	NA	NA	NA	NA	NA	NA		NO access; Live. Inspection required during demolition.	
No PCB containing capacitors were identified to the exterior of the building at the time of the survey. All live, sealed or encapsulated, or inaccessible capacitors containing or suspected as containing PCB should be inspected prior to demolition.																		
Interior																		
Admin Building	Interior	Admin building, exterior, Level 1, northern elevation, Front Verandah rooms, wall claddings	Asbestos	FC sheeting	7	NAD
