CIVICA

20 February 2023

Arboricultural Impact Assessment Report regarding eighteen (18) trees located within the vicinity of the proposed Tamworth Hospital - Banksia Unit development

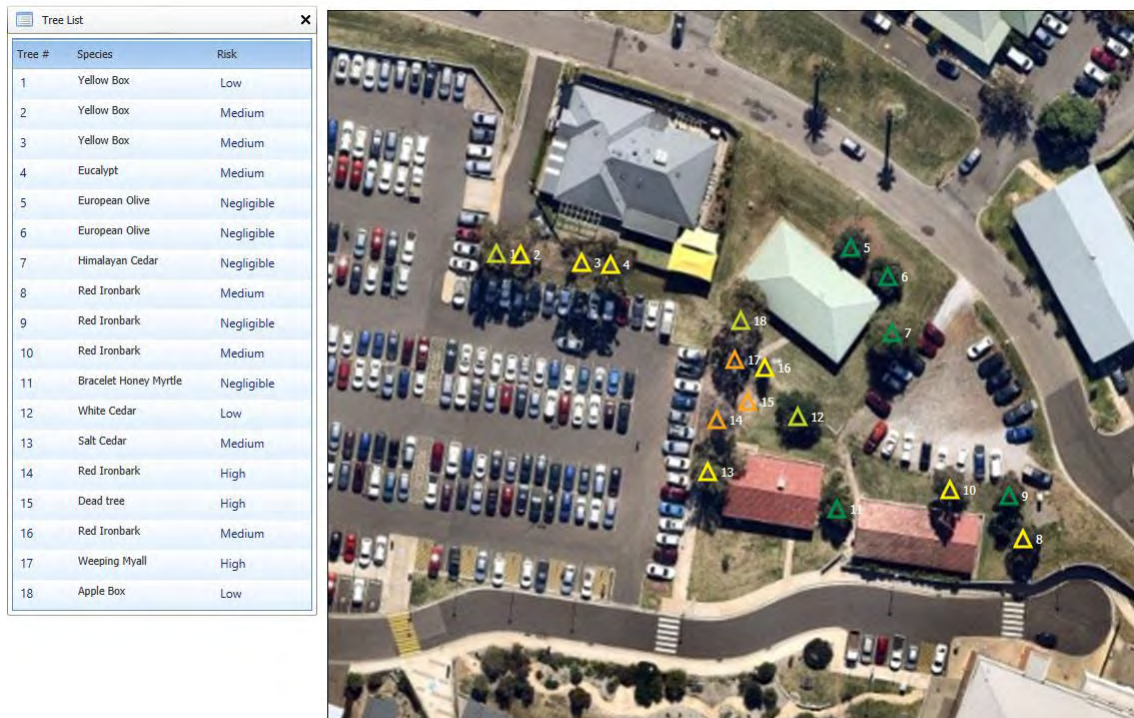
Figure 2. Site map showing subject trees. Note that icon colour indicates trees current risk rating (not Retention Value). Tree attributes are to be obtained from Appendix E – Tree Assessment Data. (ArborSite, May 2021).
