CIVICA

20 February 2023

Arboricultural Impact Assessment Report regarding forty-eight (48) trees located within the vicinity of the proposed carparking zones at Tamworth Hospital

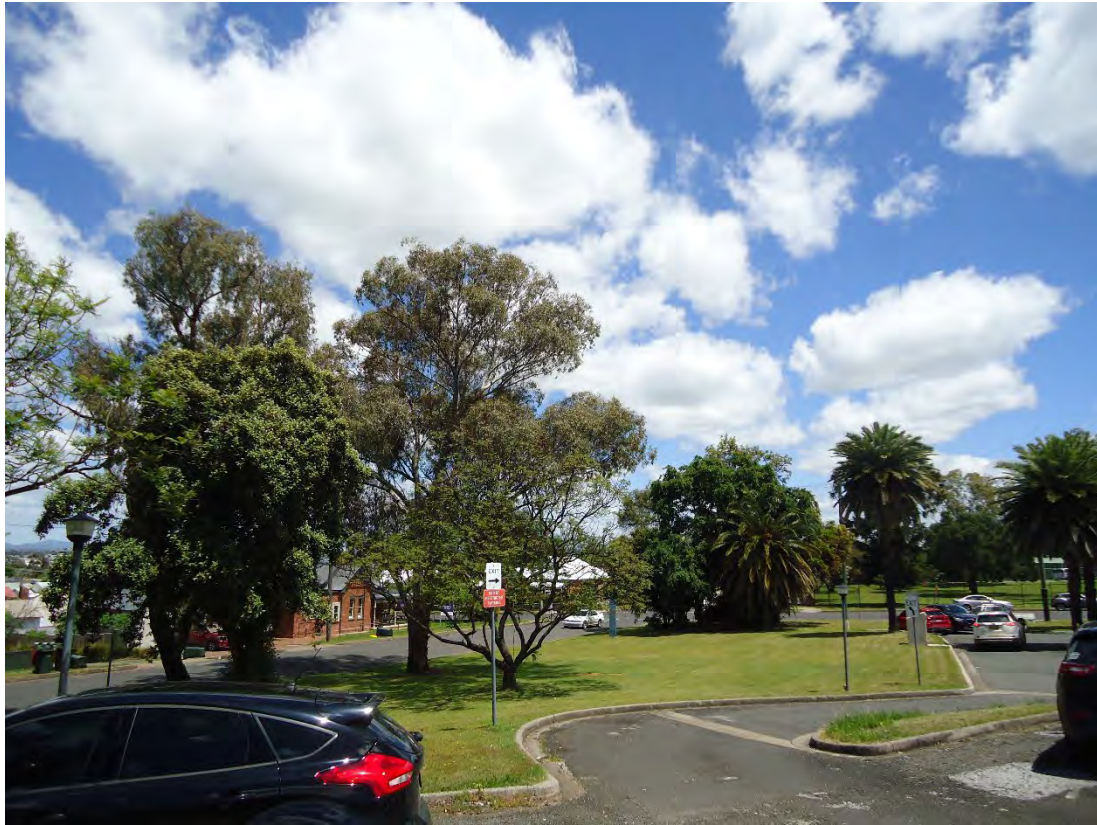
Figure 15. Overview image of carparking Zone 4. (ArborSafe, 28 October 2022).

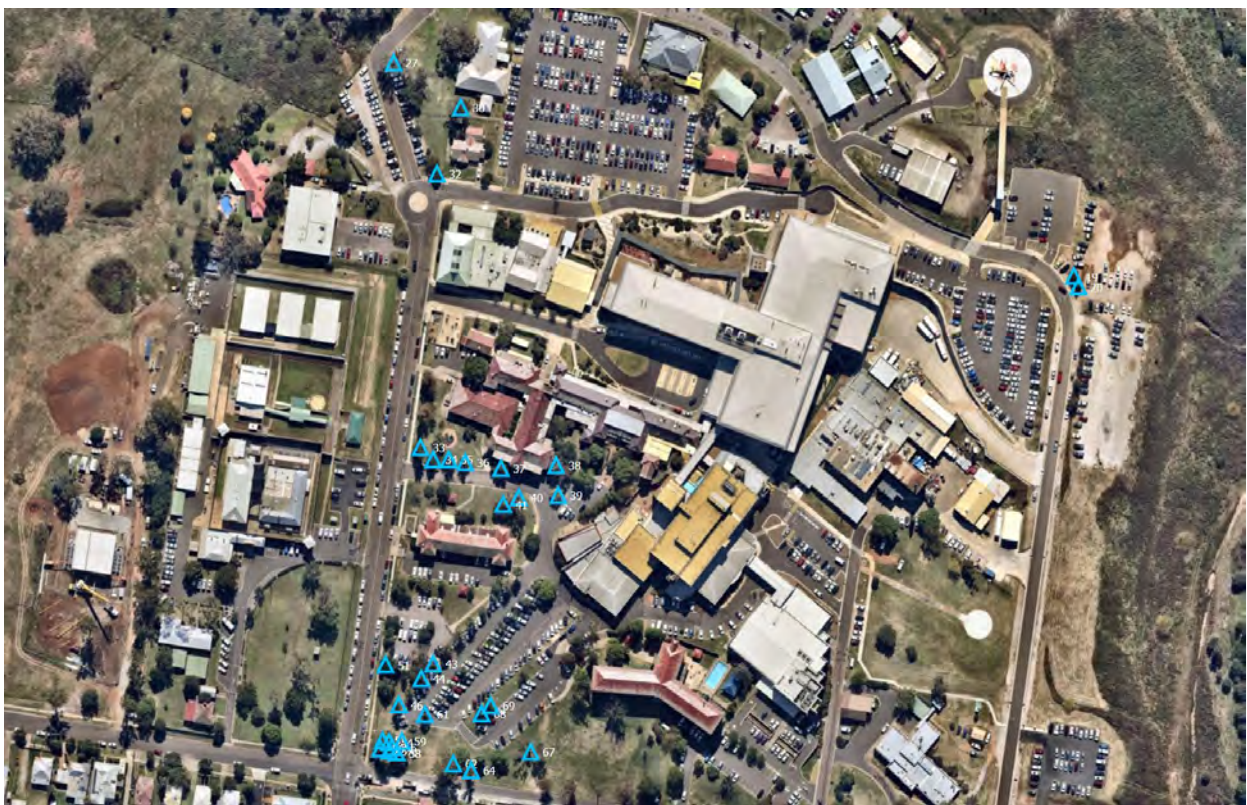
Figure 18. Site map showing tree requiring generic protection measures. (ArborSafe, October 2022).

7.5.1 All retained trees require generic protection measure (Figure 18). Refer to Section 7.6–7.12 for further detail.

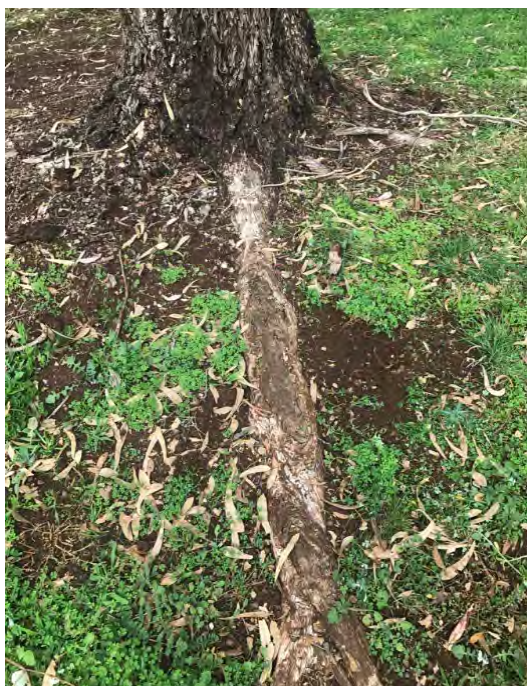
Damage to tree roots (Figure 24 and Figure 25) and the lower portion of a tree's trunk is a common and often unnecessary occurrence that can lead to the entry of decay fungi into a tree's structural framework. Once present, decay may develop in larger structural roots and/or the base of the trunk, which can result in a reduction in tree health and in severe cases even compromise stability.

Figure 24. An example of damage to tree roots caused via mowing. (Luke Dawson, June 2017).

Another advantage to mulching around the trunk and root crown is that it limits damage to both parts from mowing equipment. This in turn reduces mechanical damage and compaction.

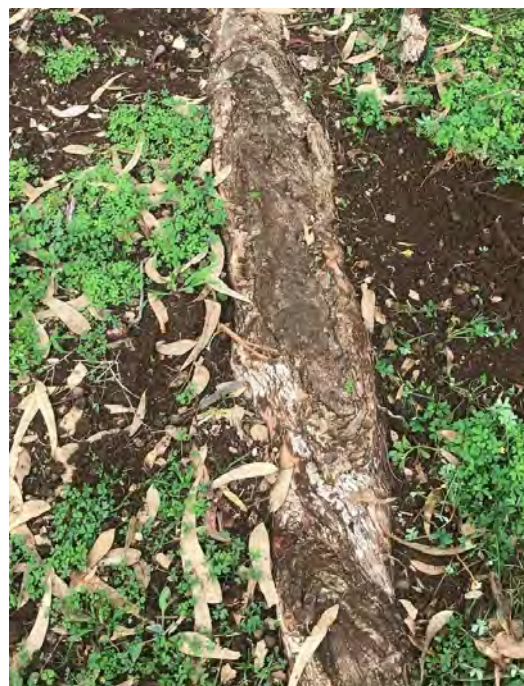
Everyday activities such as grass cutting via mowing or brush cutters can result in serious root damage or wounding to the lower trunk. Young trees with their trunks damaged by machinery often need replacing, while damage to the trunks and/or surface roots of established trees is not only detrimental to tree health but can also result in costly repairs to machinery.

Figure 25. Image showing wound caused to upper portion of surface root by mower. (Luke Dawson, June 2017).
