Hazardous Materials Management Survey and Register

Wyong Hospital- Building C, 664 Pacific Hwy, Hamlyn Terrace NSW 2259

JOB NUMBER: JN05003
ISSUED DATE: 11 April 2024
PREPARED FOR: Capital Insight Pty Ltd
CLIENT ADDRESS: 99 Walker St, North Sydney NSW 2060
INSPECTED BY: Alex Clark, Hazmat Team Leader
REPORT BY: Alex Clark, Hazmat Team Leader
APPROVED BY: Alex Thompson, Hazmat Manager
ISSUE NUMBER: Rev_0

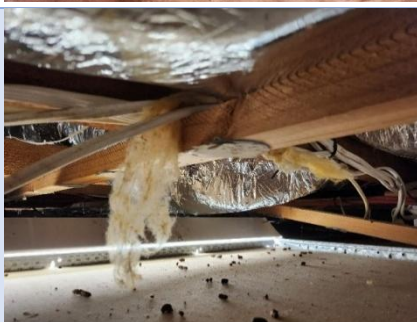
Material Identification		Risk Assessment					Risk Management & Corrective Actions	Photo
Location of Material	Description	Sample No.	Hazmat Detected / Identified	Quantity sqm, Lm, Unit	Friability	Risk Rating (H,M,L,N)		
All areas, walls	White paint system	Pb01	0.21% Lead	TH	NA	Negligible	This material it should be removed prior to the commencement of refurbishment works by competent person(s) under localised dust control conditions. Lead contaminated waste should be disposed of in accordance with EPA requirements. Sample taken from Bed Store.	 
All areas with original ceiling plaster lining, ceiling cavity	Batts insulation	SMF01	SMF	TH	F	Negligible	Remove under controlled conditions prior to refurbishment/demolition.	 
Bed Store, ceiling cavity, remanent pieces	Batts insulation	SMF01/R1	SMF	TH	F	Low	Remove under controlled conditions prior to refurbishment/demolition.

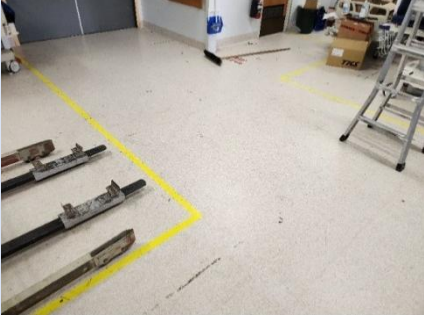
Material Identification		Risk Assessment					Risk Management & Corrective Actions	Photo
Location of Material	Description	Sample No.	Hazmat Detected / Identified	Quantity sqm, Lm, Unit	Friability	Risk Rating (H,M,L,N)		
Bed Store, beige & white mottled flooring	Vinyl sheeting	NAI	Presumed non-asbestos	TH	NA	-	No further action required. Presumed to continue under carpets.

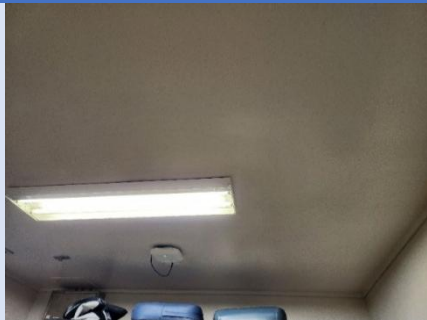
Material Identification		Risk Assessment					Risk Management & Corrective Actions	Photo
Location of Material	Description	Sample No.	Hazmat Detected / Identified	Quantity sqm, Lm, Unit	Friability	Risk Rating (H,M,L,N)		
Bed Store, northern store room, ceiling lining	Fibre cement sheeting	Asb03	CH	12 sqm	NF	Negligible	The item should be removed prior to commencement of refurbishment works by a Class A or B asbestos removalist. An asbestos clearance certificate should be gained following the completion of removal works. Consideration should be given to air monitoring during removal works.

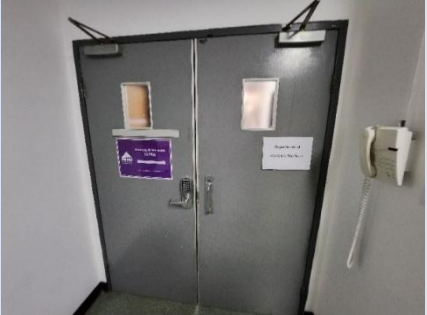
Material Identification		Risk Assessment					Risk Management & Corrective Actions	Photo
Location of Material	Description	Sample No.	Hazmat Detected / Identified	Quantity sqm, Lm, Unit	Friability	Risk Rating (H,M,L,N)		
Northern Wing, eastern end double doors "Cemac Associated Limited"	Fire door cores	Asb01/R4	AM	2 units	F	Low	The item should be removed prior to commencement of refurbishment works by a Class A asbestos removalist as intact units. Air monitoring should be undertaken during removal works. An asbestos clearance certificate should be gained following the completion of removal works.

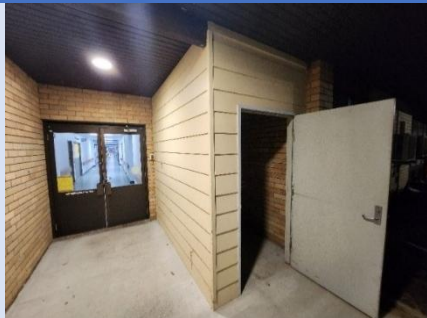
Material Identification		Risk Assessment					Risk Management & Corrective Actions	Photo
Location of Material	Description	Sample No.	Hazmat Detected / Identified	Quantity sqm, Lm, Unit	Friability	Risk Rating (H,M,L,N)		
Northern Wing, Cleaners, external cladding	Fibre cement sheeting	P5	Presumed asbestos	8 sqm	NF	Low	The item should be removed prior to commencement of refurbishment works by a Class A or B asbestos removalist. An asbestos clearance certificate should be gained following the completion of removal works. Consideration should be given to air monitoring during removal works. No sample taken at request of client.

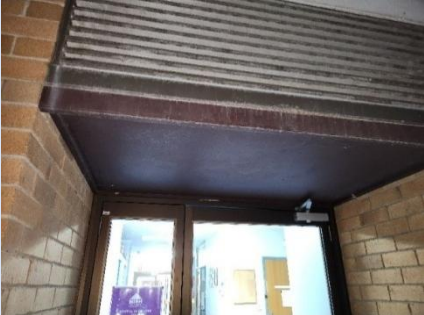
Material Identification		Risk Assessment					Risk Management & Corrective Actions	Photo
Location of Material	Description	Sample No.	Hazmat Detected / Identified	Quantity sqm, Lm, Unit	Friability	Risk Rating (H,M,L,N)		
Northern Wing, external, awning above western entrance	Fibre cement sheeting	P9	Presumed asbestos	2 sqm	NF	Low	The item should be removed prior to commencement of refurbishment works by a Class A or B asbestos removalist. An asbestos clearance certificate should be gained following the completion of removal works. Consideration should be given to air monitoring during removal works. No sample taken at request of client.
