85-91 Cowper Street, Warrawong NSW 2502 Warrawong Community Health Centre

December 2023
FINAL
Updated March 2024

Prepared for: Savills Australia, L25, Governor Phillip Tower

Prepared by: Paul Vezgoff

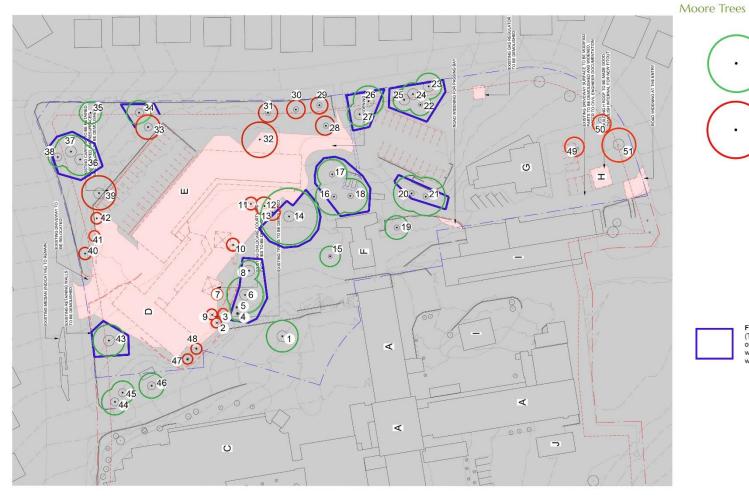
Plan 2

Based on the demolition plan provided, there will be impacts to trees numbered as 2, 3, 7, 9, 10, 11, 12, 13, 28, 29, 30, 31, 32, 33, 39, 40, 41, 49, 50 and 51. Trees located within the proposed building footprint that will be required to be removed are numbered as Trees 2, 3, 7, 9, 10, 11, 12, 13, 31, 32, 39, 40, 41, 42, 47 and 48. Trees 49, 50 and 51 near Building H will require removal due to the existing car park being enlarged.
