Hazardous materials audit

Blayney Multi Purpose Service, 3 Osman Street, Blayney NSW 2799

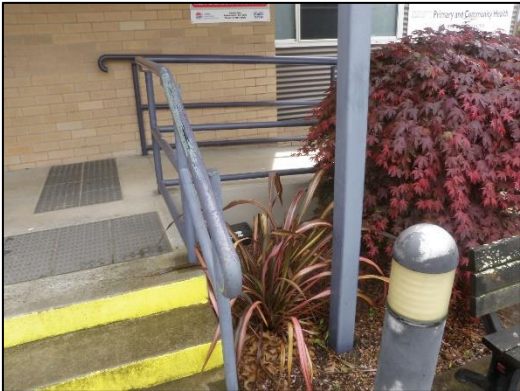
Job no	15064	Address	Blayney MPS, 248 Summer Street, Orange			
ID	23	Building	Building 1			
Location	External, entry, handrails	Material description	Grey paint	Extent (m²)	2

Identification	Visual <input type="checkbox"/>	Laboratory <input type="checkbox"/>	Field screening <input checked="" type="checkbox"/>	
		Lead	Yes (1) <input type="checkbox"/>	No (0) <input checked="" type="checkbox"/>	Possible (1) <input type="checkbox"/>	
		Condition:	Sound (1) <input type="checkbox"/>	Fair (2) <input type="checkbox"/>		
			Poor (3) <input type="checkbox"/>	Very poor to extreme (4) <input type="checkbox"/>		
		Accessibility:	Low (1) <input type="checkbox"/>	Medium (2) <input type="checkbox"/>	High (3) <input type="checkbox"/>	
		Risk rating:	-	1-2 – Very low to low, 3-4 – Moderate, 5-8 –high, 9-18 – very high		
		Concentration:	-			
		Recommendations:				
		Warning labels <input type="checkbox"/>	Remove/replace <input type="checkbox"/>

Monitor condition yearly <input type="checkbox"/>	Avoid mechanical damage <input type="checkbox"/>			
		Repair required <input type="checkbox"/>	Remove for renovations <input type="checkbox"/>			
		Restrict access <input type="checkbox"/>	Remove for demolition <input type="checkbox"/>			
		Comments	Negative results for field lead check swab test

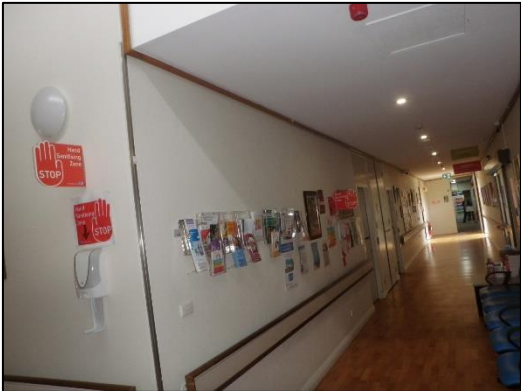
Job no	15064	Address	Blayney MPS, 248 Summer Street, Orange
ID	26	Building	Building 1, administration wing
Location	Internal, walls	Material description	Cream paint
		Extent (m²)	>200

Identification Visual ☐ Laboratory ☐ Field screening ☒

Lead Yes (1) ☐ No (0) ☒ Possible (1) ☐

Comments Negative results for field lead check swab test

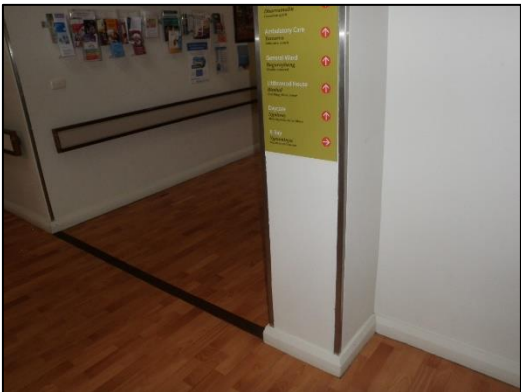
Job no	15064	Address	Blayney MPS, 248 Summer Street, Orange
ID	27	Building	Building 1, administration wing
Location	Internal, skirting boards	Material description	White paint
		Extent (m²)	>200

Identification Visual ☐ Laboratory ☐ Field screening ☒

Lead Yes (1) ☐ No (0) ☒ Possible (1) ☐

Comments Negative results for field lead check swab test

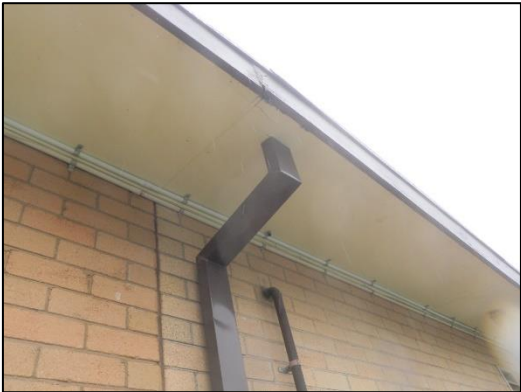
Job no	15064	Address	Blayney MPS, 248 Summer Street, Orange
ID	28	Building	Building 3
Location	External, eaves	Material description	Cream paint
		Extent (m²)	20

Identification Visual ☐ Laboratory ☒ Field screening ☐
(15034-102)

Lead Yes (1) ☒ No (0) ☐ Possible (1) ☐
