Arboricultural Impact Assessment Report

**64-70 Stapleton Avenue Casino NSW –Land &
Housing Corporation NSW**

Date: 17 October 2023

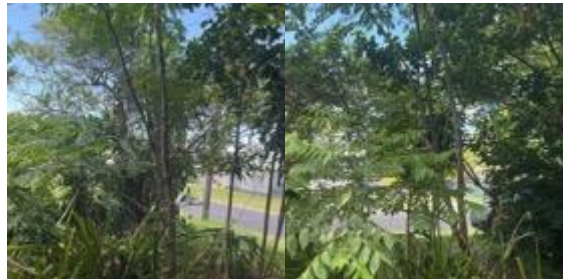
T14 Golden Rain Tree <i>Koelreuteria paniculata</i> Planted; Exotic ornamental tree, Environmental weed species TCV Very Low	9 11 2 1	Juvenile Fair Fair	2.0 1.5	REMOVE tree due to environmental weed status NA Spreading; Codominant stems with narrow V- shaped union at 1m, Moderate lean to E, Crown concentrated to E, Powerlines through crown, Low volume deadwood, regenerating seedlings throughout local area, Minimum SRZ and TPZ under AS4970

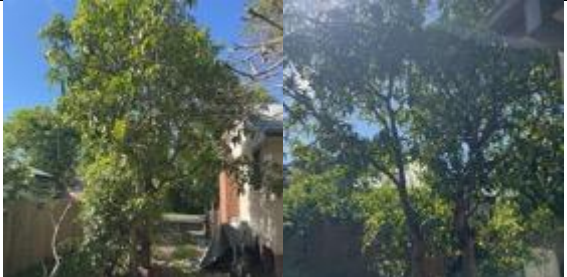
T35 & T36 Mango Tree <i>Mangifera indica</i> Planted; Exotic fruit tree TCV Low	29 35 5 5	Semi-Mature Fair Fair	3.5 2.1	REMOVE tree for construction Tree base is entirely within the construction footprint Upright; Multi-stemmed, Moderate tip dieback, Stunted, Low crown foliage density Southern Stem horizontal, Moderate volume deadwood~8cmØ

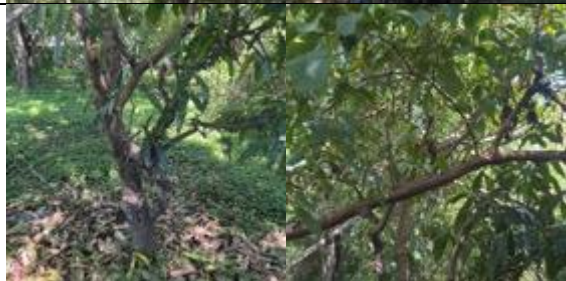
T42 Mango Tree <i>Mangifera indica</i> Planted; Exotic fruit tree TCV Low	15 19 5 3	Semi-Mature Fair Fair	2.0 1.7	REMOVE tree for construction Tree base is entirely within the construction footprint Spreading; Multi-stemmed, Moderate tip dieback, exotic Cats Claw weed infestation in crown, Moderate volume deadwood~5cmØ

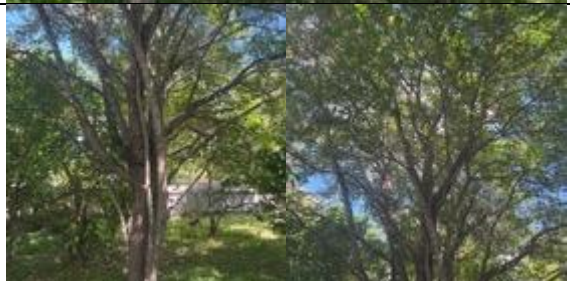
T45 Cheese Tree <i>Glochidion ferdinandi</i> Planted; Native rainforest tree TCV Moderate	36 42 6 8	Mature Good Fair	4.3 2.3	REMOVE tree for construction Tree base is entirely within the construction footprint Spreading; Multi-stemmed, Low volume deadwood

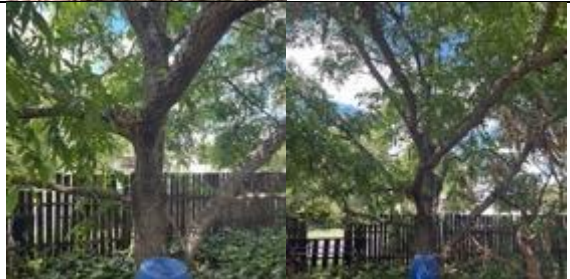
T66 Pecan Tree <i>Carya illinoensis</i> Planted; Exotic fruit tree TCV High	40 46 8 10	Mature Good Good	4.8 2.4	REMOVE tree for construction Major TPZ encroachment 2.0m within SRZ from retaining wall construction Spreading; Multi-stemmed, Crown dominating front yard, Low volume deadwood

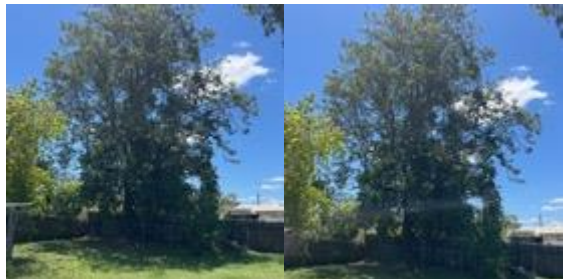
T72 Silky Oak <i>Grevillea robusta</i> Planted; Native forest tree TCV High	83 91 11 8	Mature Good Fair	10.0 3.2	RETAIN tree, install TPZ fence, Project Arborist to advise on tree impact avoidance and minimisation; and monitor excavation works within TPZ Major 22% TPZ encroachment marginally inside the SRZ from building construction and lesser from cut earthworks and installation of stormwater infrastructure Upright; Multi-stemmed, Low volume deadwood to ~5cmØ

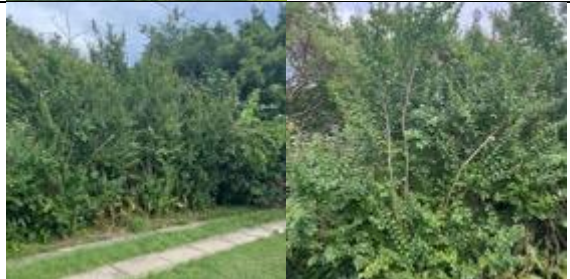
T75 - T77 Crepe Myrtle <i>Lagerstroemia indica</i> Planted; Exotic ornamental tree TCV Moderate	Average 11 15 3.5 1	Semi- Mature Good Good	2.0 1.5	REMOVE trees for construction T75 & T76 tree bases are entirely within the construction footprint. T77 has a Major TPZ encroachment 0.4m within the SRZ from building construction Spreading; Multi-stemmed, Low volume deadwood, Minimum SRZ and TPZ under AS4970
