Cessnock Hospital - Pre-Demolition Hazardous Materials Survey Report Summary

Asbestos and Hazardous Materials Pre-Demolition Assessment

Kitchen

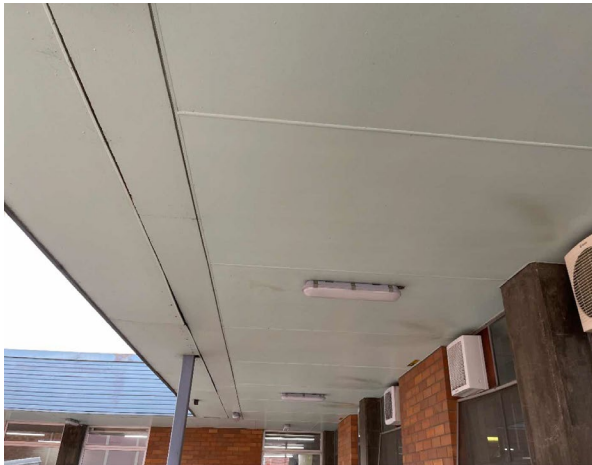
Line ID 1: External, GF, All Areas, Awning, Southeast Verandah, Fibre Cement Sheetting - Chrysotile Asbestos Detected

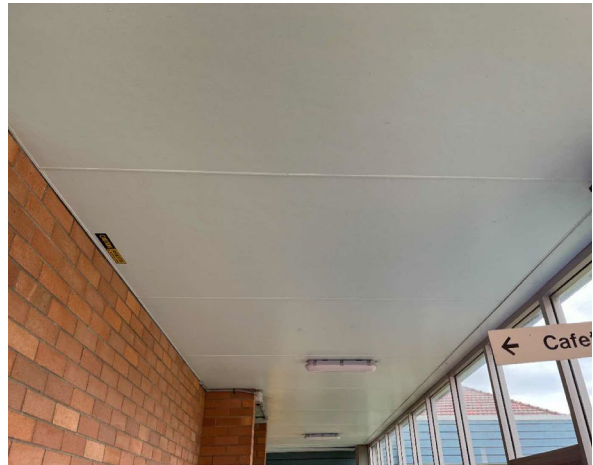
Line ID 1.1: External, GF, All Areas, Awning, Southeast Verandah, Fibre Cement Sheetting - Chrysotile Asbestos Detected

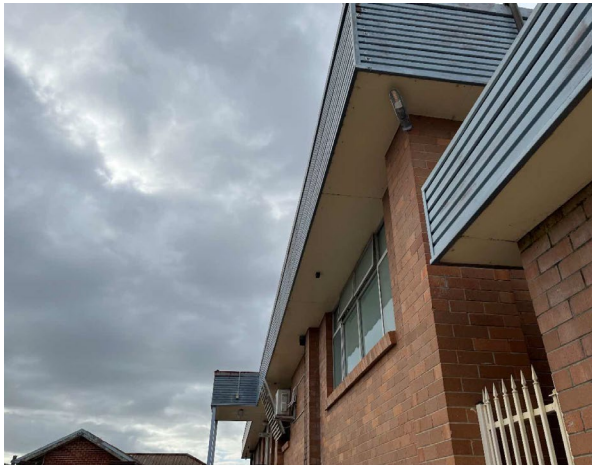
Line ID 2: External, GF, All Areas, Eaves, Throughout, Fibre Cement Sheetting - Chrysotile Asbestos Detected

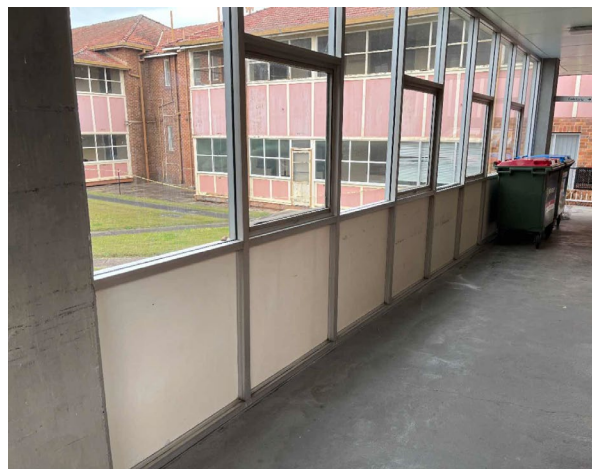
Line ID 4.1: External, GF, All Areas, Infill Panels, Below Windows, Fibre Cement Sheet - Chrysotile Asbestos Detected

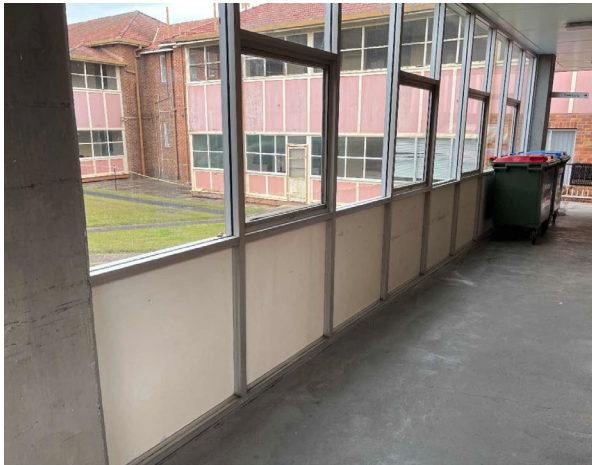
Line ID 5: External, GF, All Areas, Metal Windows, Throughout, Window Caulking - Chrysotile Asbestos Detected

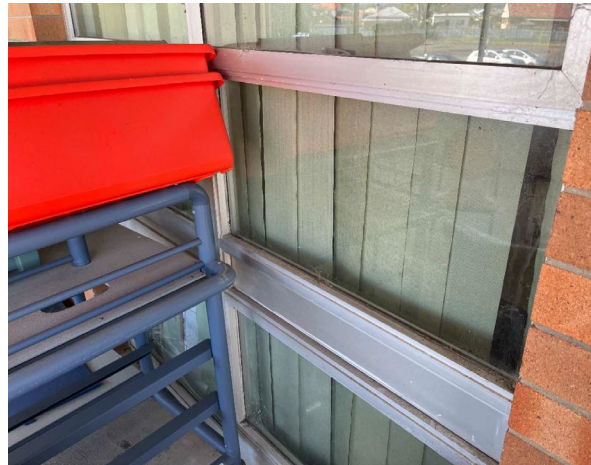
Line ID 6: External, GF, All Areas, Metal Windows, Throughout, Window Caulking - Chrysotile Asbestos Detected

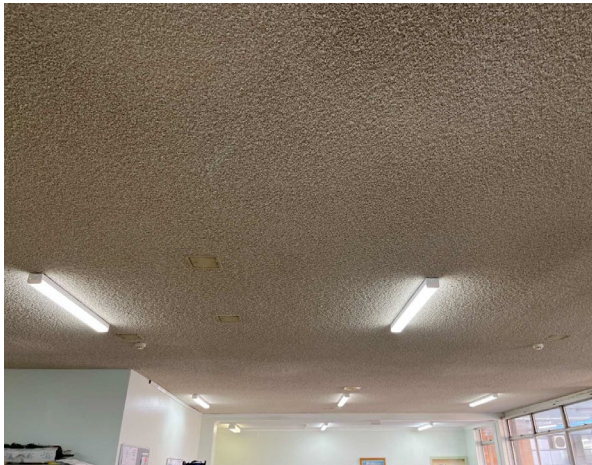
Line ID 7: Internal, GF, Cafeteria Ceiling Lining, Throughout, Vermiculite - No Asbestos Detected

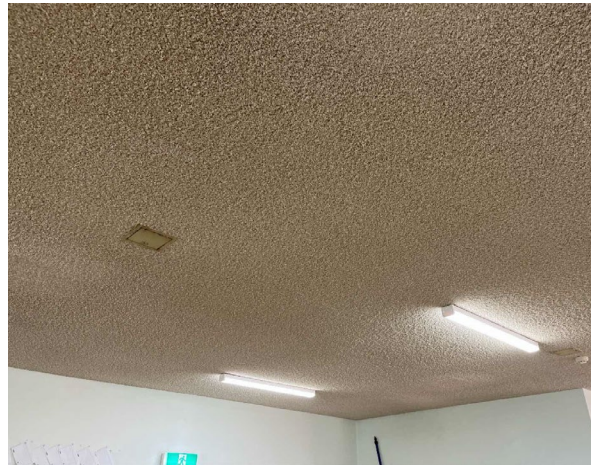
Line ID 8: Internal, GF, Kitchen Ceiling Lining, Throughout, Vermiculite - No Asbestos Detected

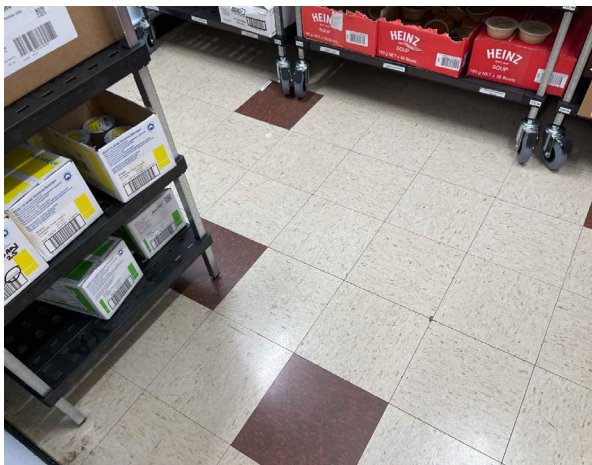
Line ID 9: Internal, GF, Kitchen, Cafeteria Floor Covering, Various Throughout, Vinyl Floor Tiles (brown) - Chrysotile Asbestos Detected

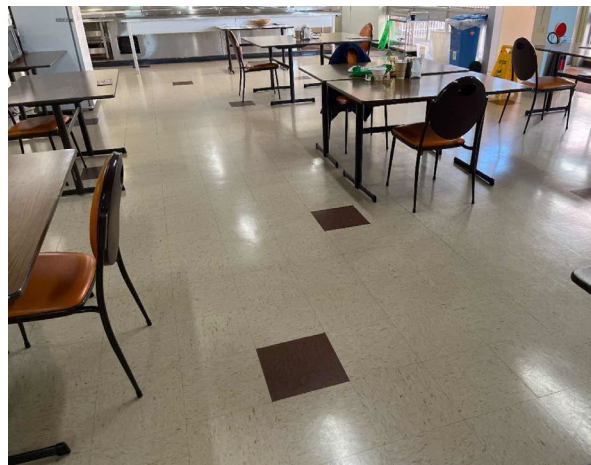
Line ID 10: Internal, GF, Kitchen, Cafeteria Floor Covering, Various Throughout, Vinyl Floor Tiles (brown) - Chrysotile Asbestos Detected

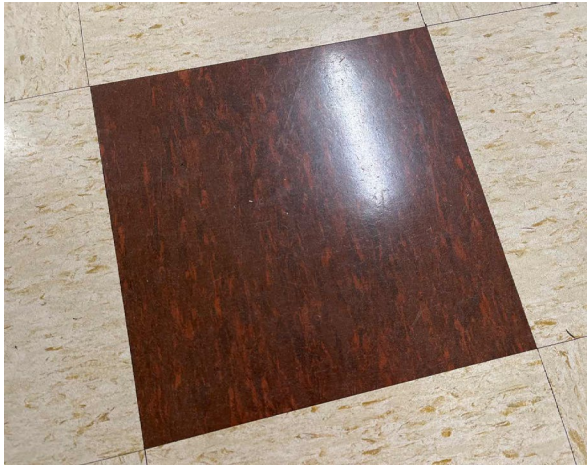
Line ID 10.1: Internal, GF, Kitchen, Cafeteria Floor Covering, Various Throughout, Vinyl Floor Tiles (brown) - Chrysotile Asbestos Detected

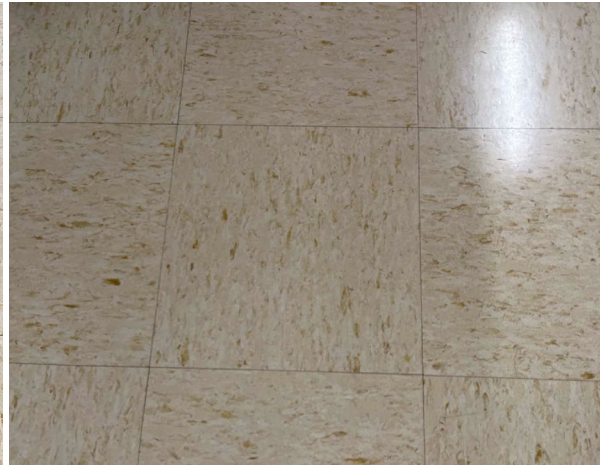
Line ID 11: Internal, GF, Kitchen, Cafeteria, Throughout, Vinyl Floor Tiles (white with brown specs) - Chrysotile Asbestos Detected

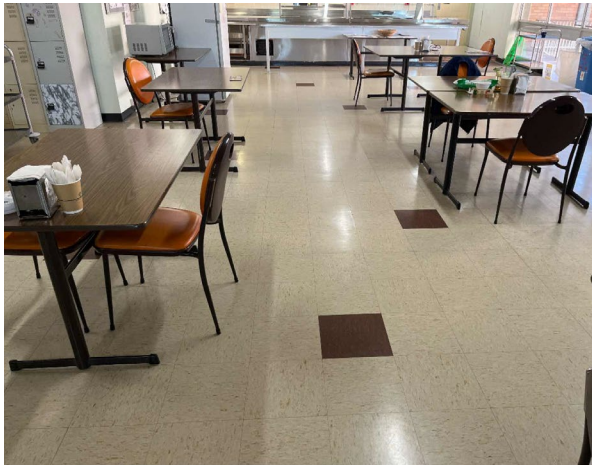
Line ID 11.1: Internal, GF, Kitchen, Cafeteria, Throughout, Vinyl Floor Tiles (white with brown specs) - Chrysotile Asbestos Detected

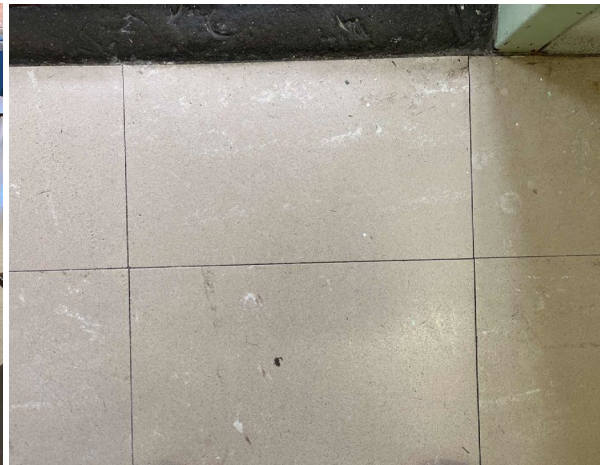
Line ID 12: Internal, GF, Kitchen, Room 1010 Cleaners Cupboard, Throughout, Vinyl Floor Tiles (white) - Chrysotile Asbestos Detected

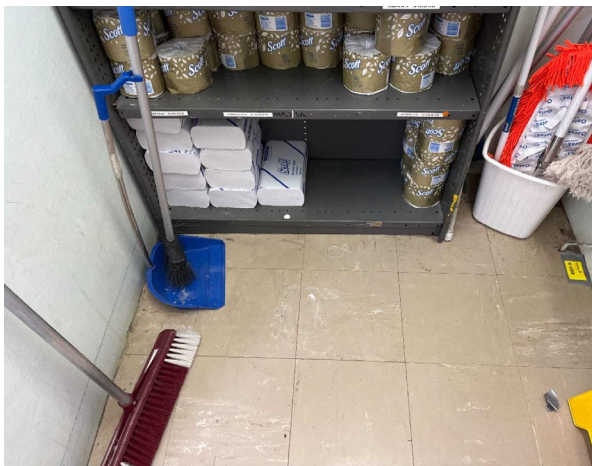
Line ID 12.1: Internal, GF, Kitchen, Room 1010 Cleaners Cupboard, Throughout, Vinyl Floor Tiles (white) - Chrysotile Asbestos Detected

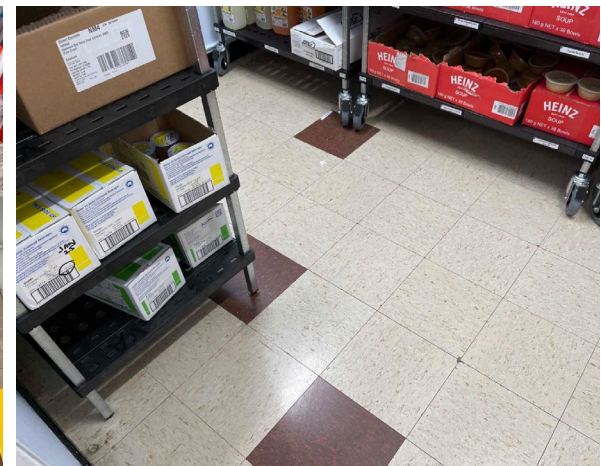
Line ID 13: Internal, GF, Kitchen, Room 1012, Throughout, Vinyl Floor Tiles (white with brown specs) - Chrysotile Asbestos Detected

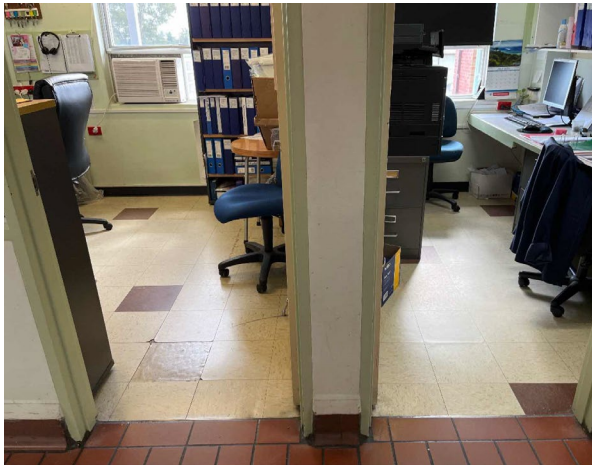
Line ID 14: Internal, GF, Kitchen, Rooms 1008 & 1007, Throughout, Vinyl Floor Tiles (white with brown specs) - Chrysotile Asbestos Detected

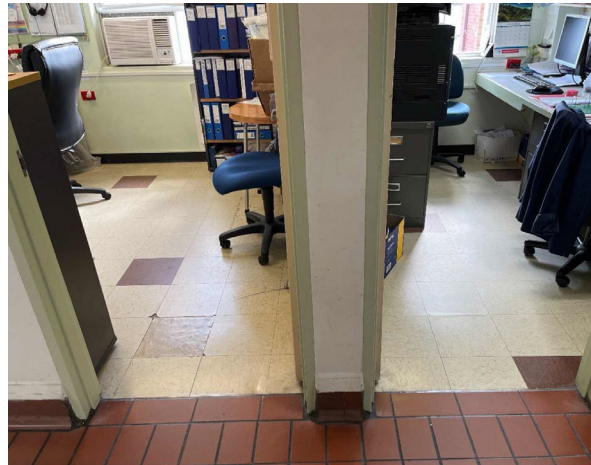
Line ID 15: Internal, GF, Kitchen, Rooms 1008 & 1007, Various Throughout, Vinyl Floor Tiles (brown) - Chrysotile Asbestos Detected

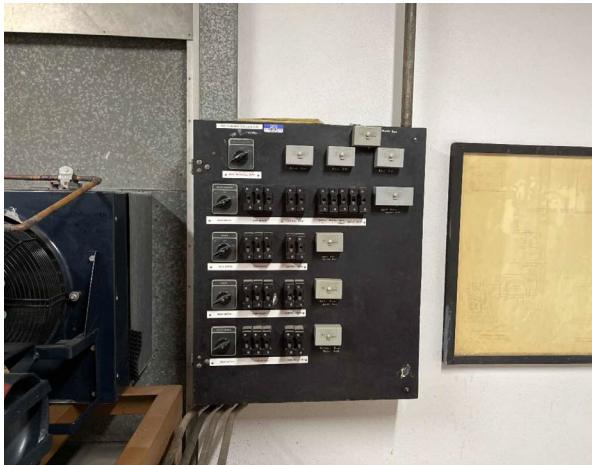
Line ID 16: Internal, Basement, Switchboard Room, 0003, Electrical Distribution Board, Southwest, Internal Components - Suspected Asbestos

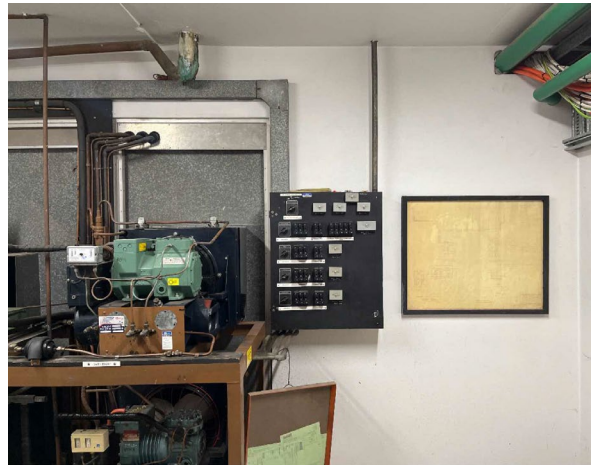
Line ID 17: Internal, Basement, Switchboard Room, 0003, Electrical Distribution Board, Southwest, Compressed Bituminous Panel - Suspected Asbestos

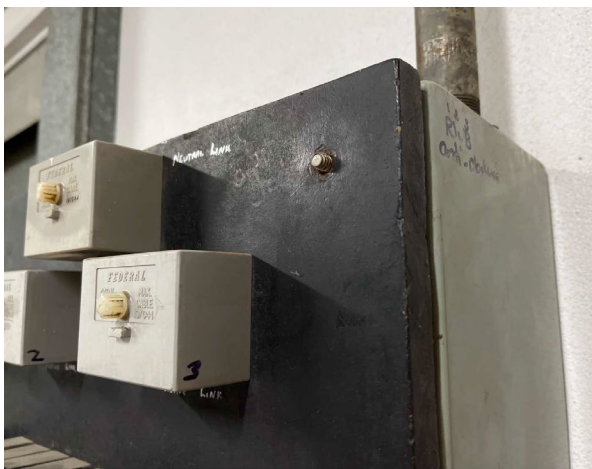
Line ID 17.1: Internal, Basement, Switchboard Room, 0003, Electrical Distribution Board, Southwest, Compressed Bituminous Panel - Suspected Asbestos

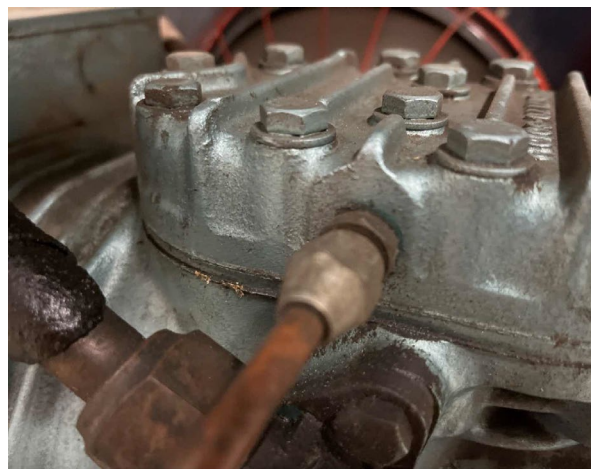
Line ID 18: Internal, Basement, Switchboard Room, 0003, Plant & Equipment, Gasket Material - Chrysotile Asbestos Detected

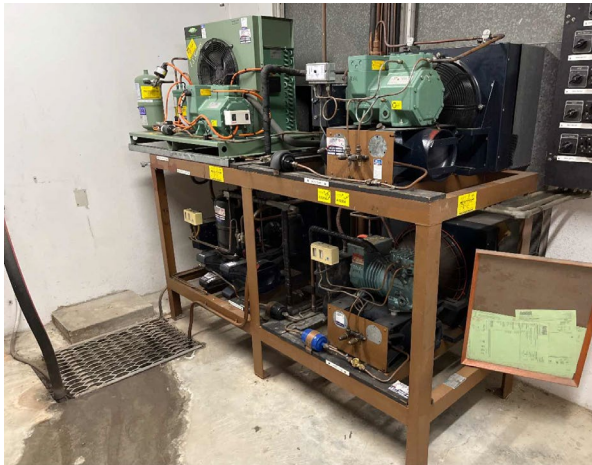
Line ID 18.1: Internal, Basement, Switchboard Room, 0003, Plant & Equipment, Gasket Material - Chrysotile Asbestos Detected

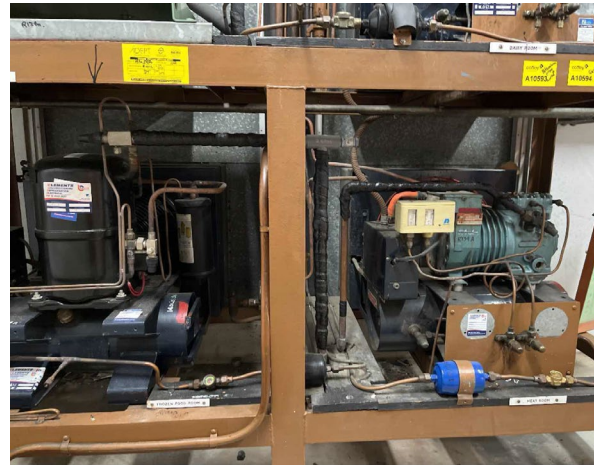
Line ID 19: Internal, Basement, Switchboard Room, 0003, Plant & Equipment Pipework, Central, Bituminous Wrap - No Asbestos Detected

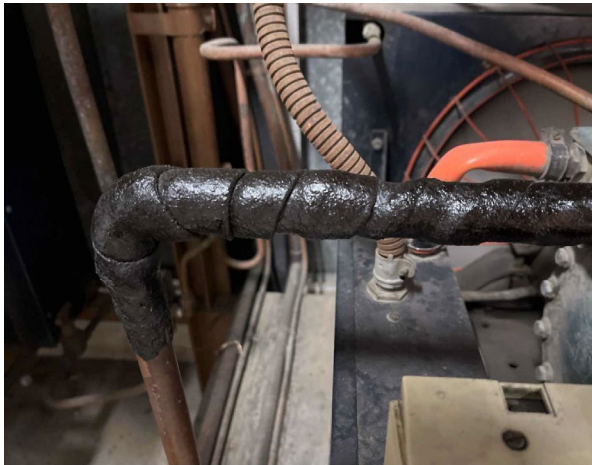
Line ID 19.1: Internal, Basement, Switchboard Room, 0003, Plant & Equipment Pipework, Central, Bituminous Wrap - No Asbestos Detected

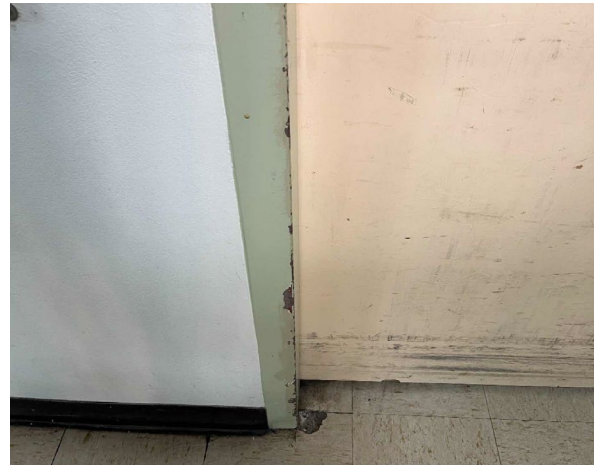
Line ID 20: Internal, GF, Kitchen, Door Frames, Throughout, Green (Light) Paint - Lead Detected (0.099% w/w)

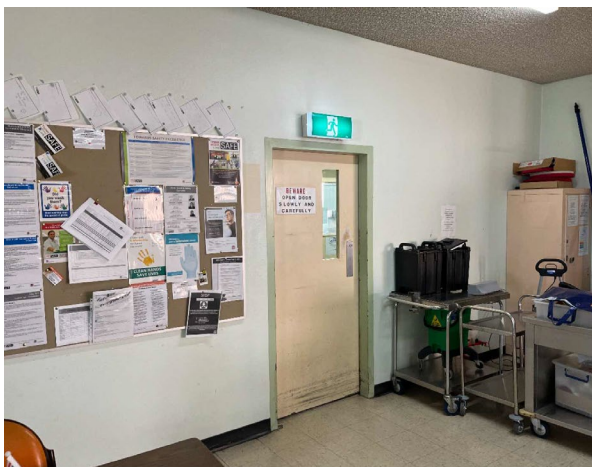
Line ID 20.1: Internal, GF, Kitchen, Door Frames, Throughout, Green (Light) Paint - Lead Detected (0.099% w/w)

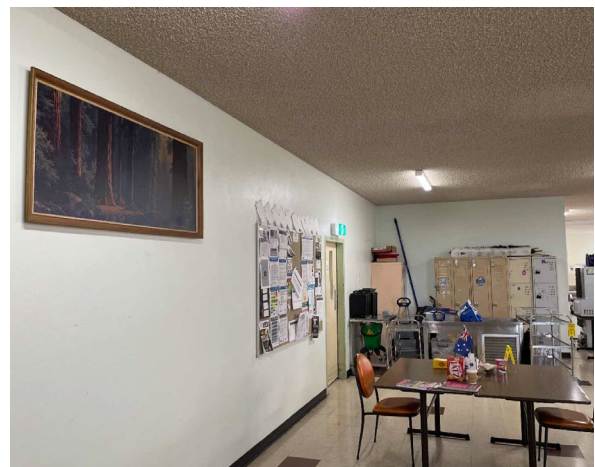
Line ID 21: Internal, GF, Kitchen, Wall lining, Throughout, Blue (Light) Paint - Lead Detected (0.02% w/w)

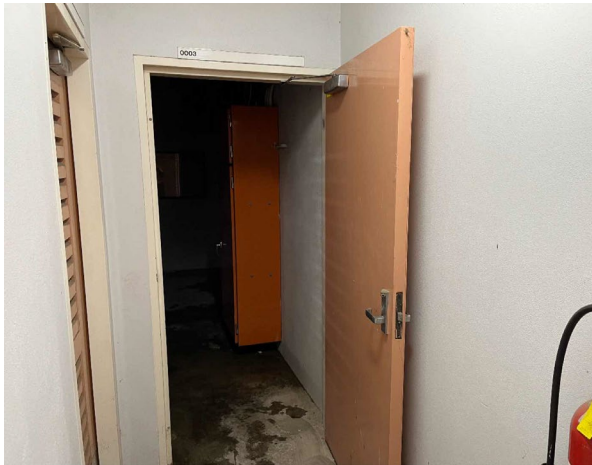
Line ID 22: Internal, Basement, Switchboard Room, 0003, Doors, Throughout, Brown (Light) Paint - Lead Detected (0.03% w/w)

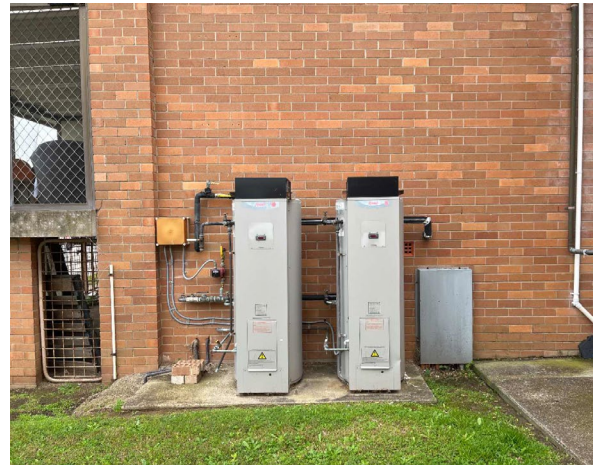
Line ID 23: External, GF, All Areas, Hot Water Heater, Adjacent Roof Access, Insulation Material - Suspected SMF

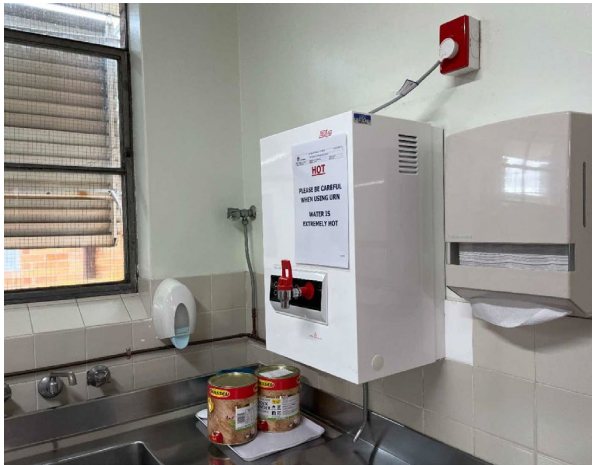
Line ID 24: Internal, GF, Kitchen, Hot Water Heater, Adjacent Dishwasher, Insulation Material - Suspected SMF

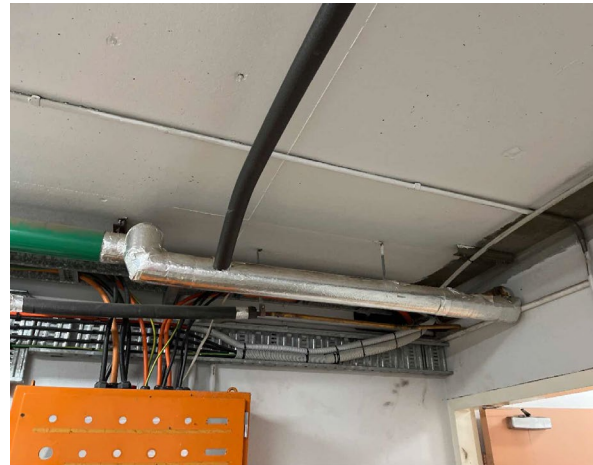
Line ID 25: Internal, Basement, Switchboard Room, 0003, Pipework, Throughout, Insulation Material - Suspected SMF

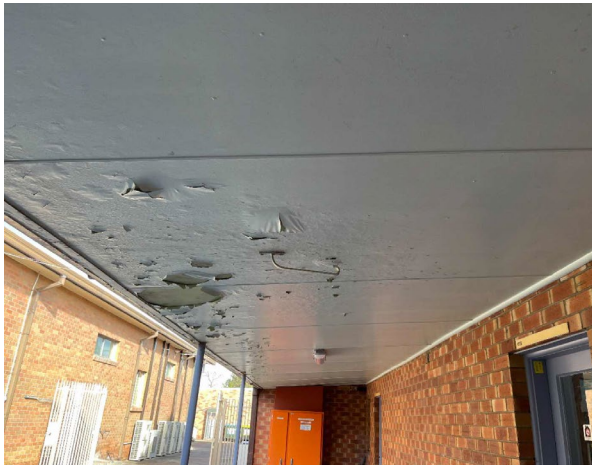
Line ID 1: External, GF, Adjacent Clinical Information Department Entrance, Awning, Fibre Cement Sheetting - Chrysotile Asbestos Detected

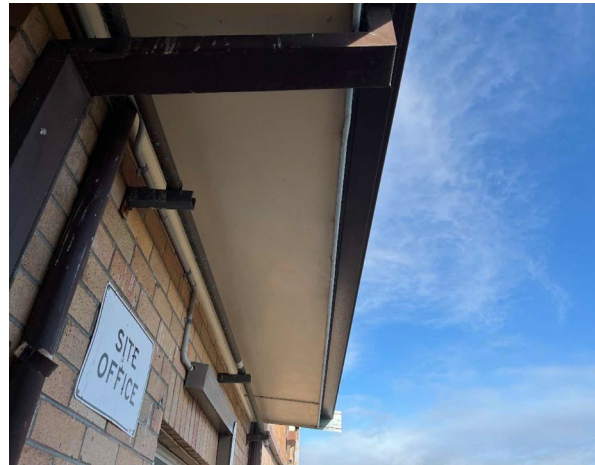
Line ID 2: External, GF, All Areas, Eaves, Throughout, Fibre Cement Sheetting - Chrysotile Asbestos Detected

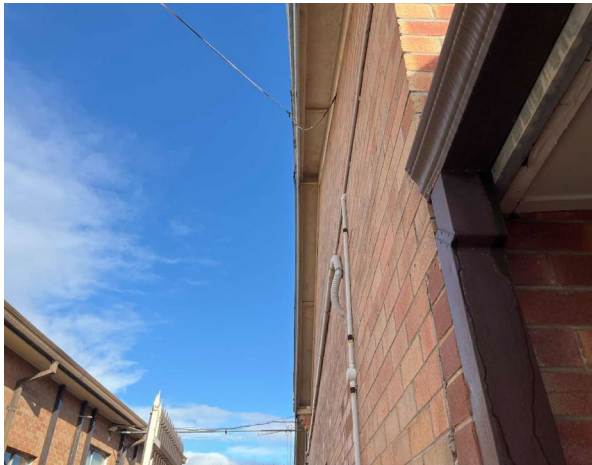
Line ID 2.1: External, GF, All Areas, Eaves, Throughout, Fibre Cement Sheetting - Chrysotile Asbestos Detected

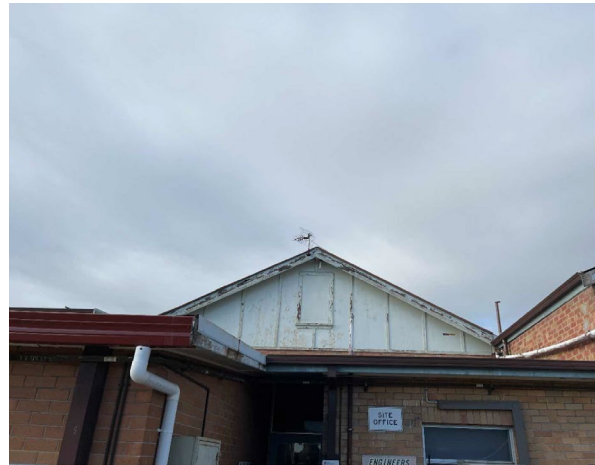
Line ID 3: External, GF, Gable End, Site Office Entrance, Roof, Fibre Cement Sheetting - Chrysotile Asbestos Detected

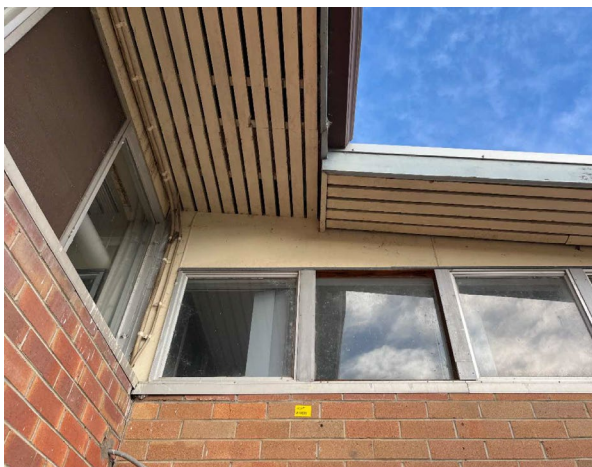
Line ID 4: External, GF, All Areas, Infill Panel, Above windows, Throughout, Fibre Cement Sheetting - Chrysotile Asbestos Detected

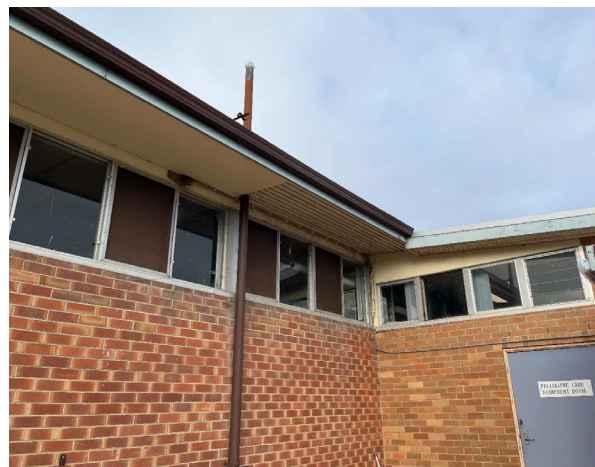
Line ID 4.1: External, GF, All Areas, Infill Panel, Above windows, Throughout, Fibre Cement Sheetting - Chrysotile Asbestos Detected

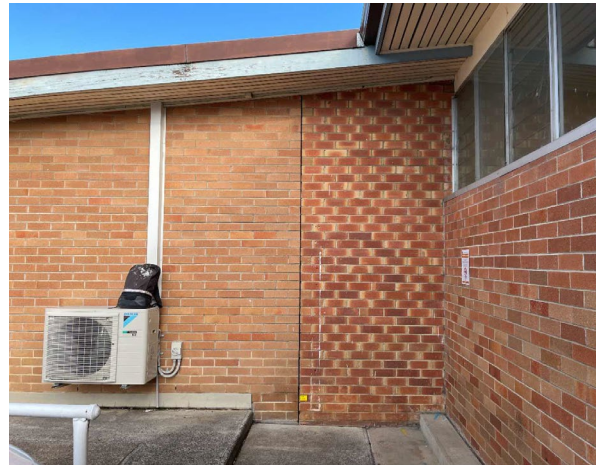
Line ID 5: External, GF, Infill Panel, Adjacent Site Office Roller Door, Above Window, Fibre Cement Sheeting - Chrysotile Asbestos Detected

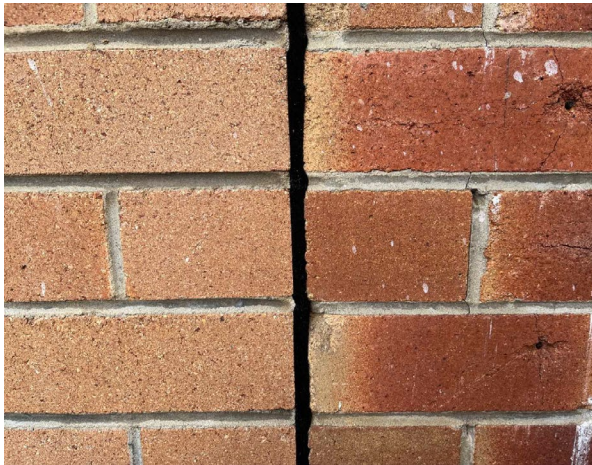
Line ID 6: External, GF, Southwest, Between Brick, Adjacent Doctor Parking Spot, Construction Joint Mastic - No Asbestos Detected

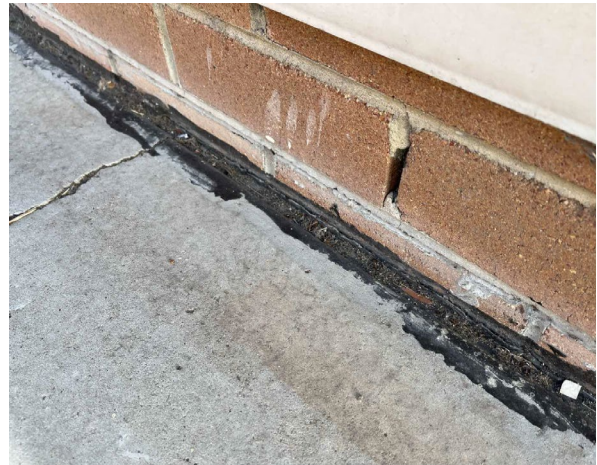
Line ID 6.1: External, GF, All Areas, Southwest, Between Brick, Adjacent Doctor Parking Spot, Construction Joint Mastic - No Asbestos Detected

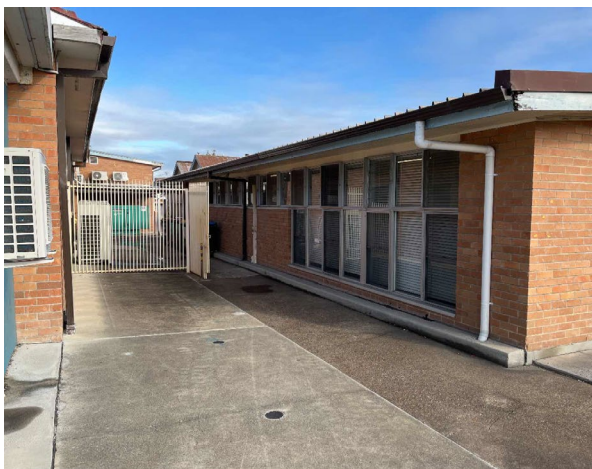
Line ID 7: External, GF, All Areas, Walkway Between Palliative Storage and Emergency, Below Window, Construction Joint Mastic - No Asbestos Detected

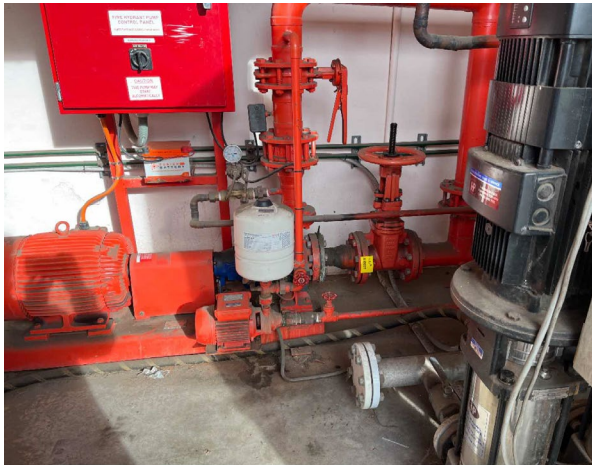
Line ID 8: External, GF, Fire Hydrant Pump Room, Fire Hydrant, Gasket Material - No Asbestos Detected

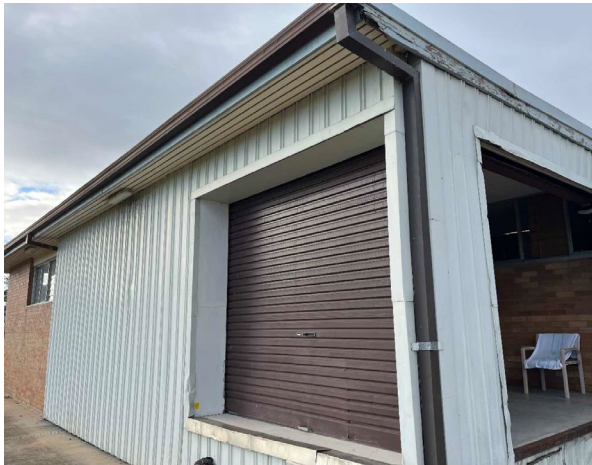
Line ID 9: External, GF, Palliative Care Equipment Room, Wall Lining, Roller door, Fibre Cement Sheeting - No Asbestos Detected

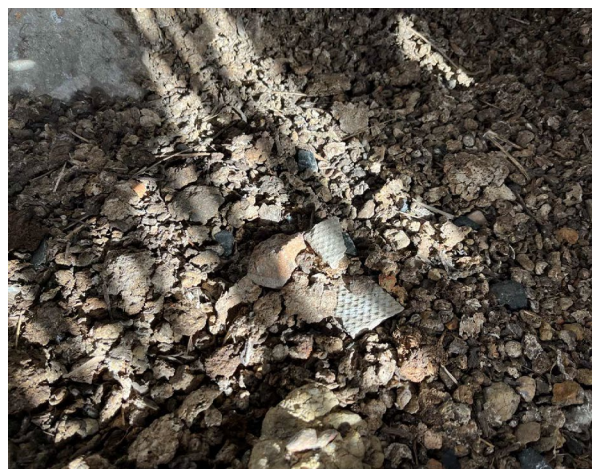
Line ID 10: External, GF, Room 1040, Old Coal Bunker, Floor, Throughout, Fibre Cement Debris - Chrysotile, Amosite and Crocidolite Asbestos Detected

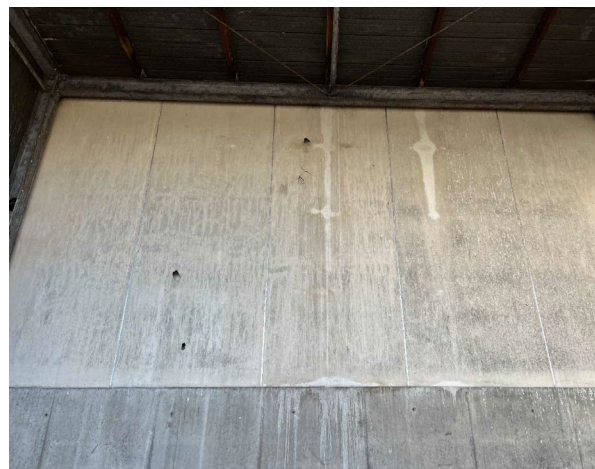
Line ID 10.1: External, GF, Room 1040, Old Coal Bunker, Floor, Throughout, Fibre Cement Debris - Chrysotile, Amosite and Crocidolite Asbestos Detected

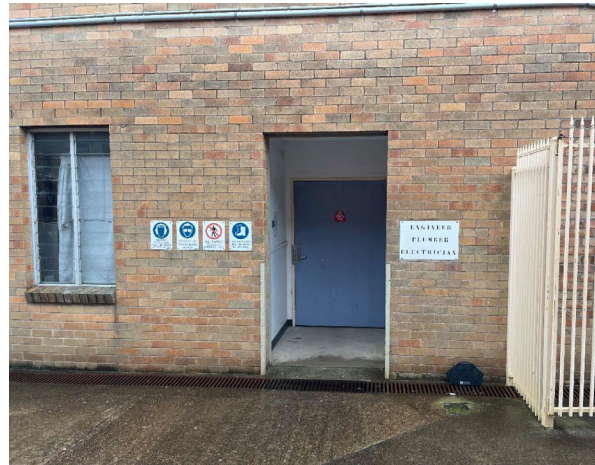
Line ID 12: External, GF, Workshop Entrance, Wall Lining, Fibre Cement Sheeting - Chrysotile Asbestos Detected

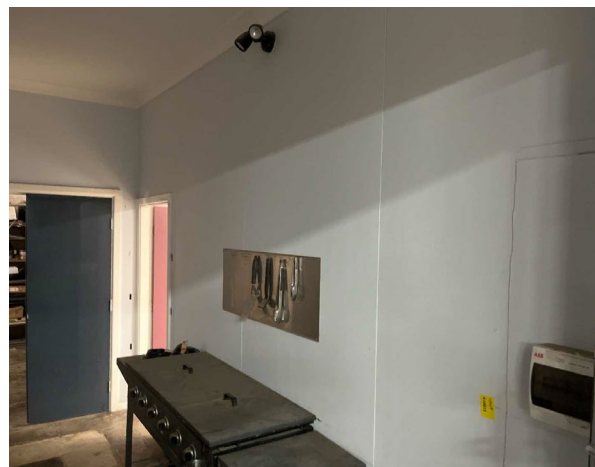
Line ID 15: Internal, GF, Dryer Room, Wall Lining, Fibre Cement Sheeting - No Asbestos Detected

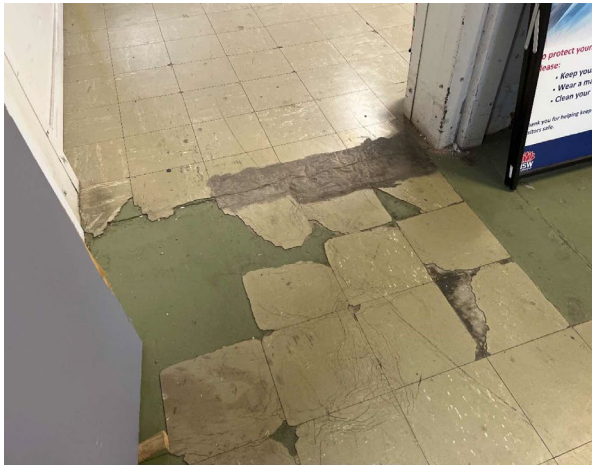
Line ID 18: Internal, GF, Laundry, Floor covering, Throughout, Vinyl Floor Tiles (grey with white specs) - Suspected Asbestos

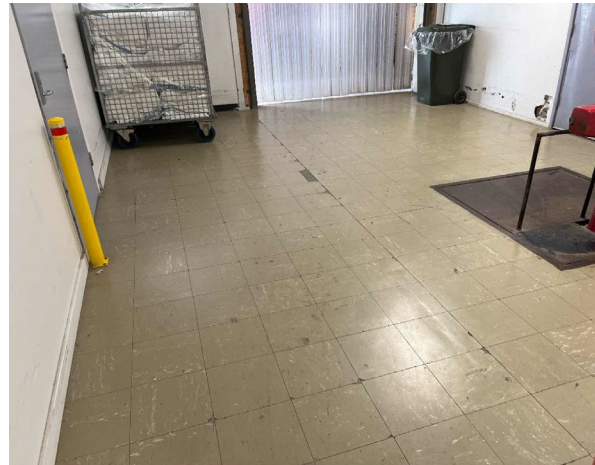
Line ID 19: Internal, GF, Laundry, Floor Covering, Throughout, Vinyl Floor Tiles (grey with white specs, large squares) - Chrysotile Asbestos Detected

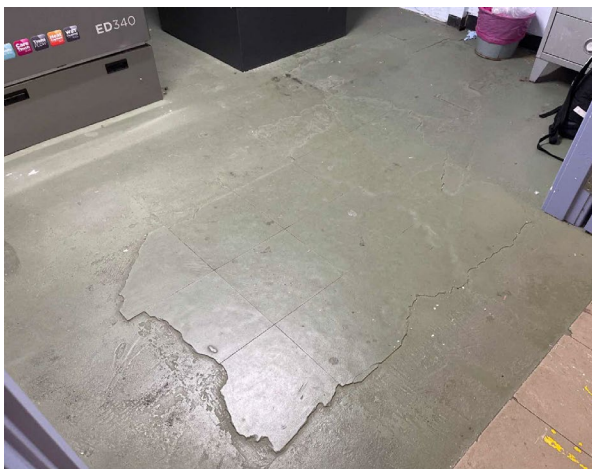
Line ID 19.1: Internal, GF, Laundry, Floor Covering, Throughout, Vinyl Floor Tiles (grey with white specs, large squares) - Chrysotile Asbestos Detected

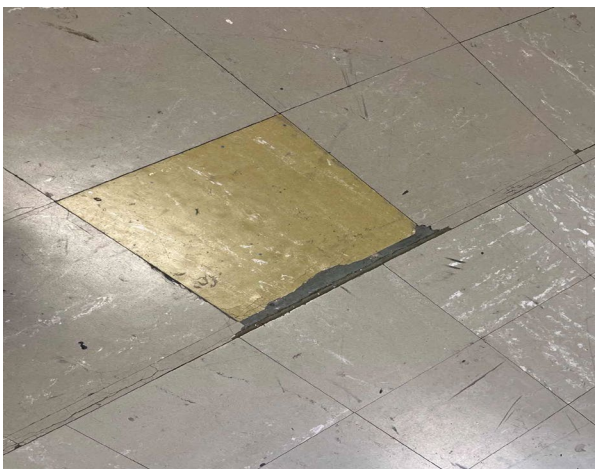
Line ID 20: Internal, GF, Laundry, Floor Covering, Throughout, Vinyl Floor Tiles (grey with white specs, large squares) - Painted green - Chrysotile Asbestos Detected

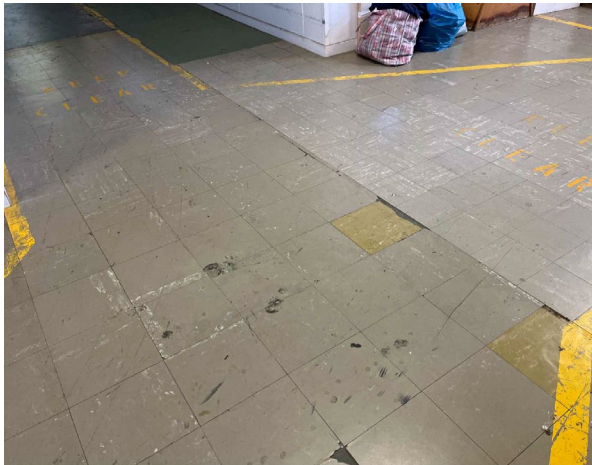
Line ID 21: Internal, GF, Laundry, Floor Covering, Various Throughout, Vinyl Floor Tiles (khaki green with white specs) - Chrysotile Asbestos Detected

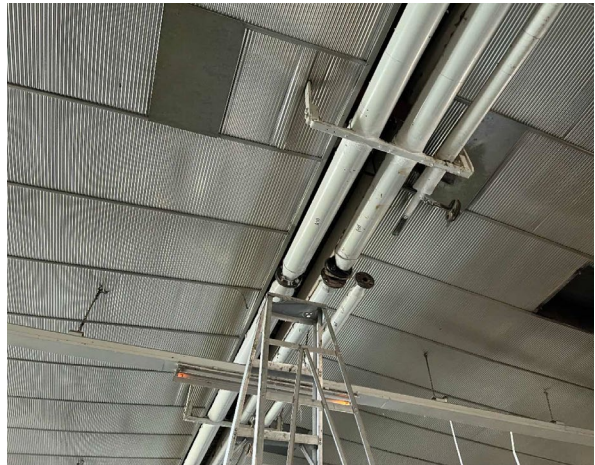
Line ID 23: Internal, GF, Laundry, Pipework, Central, Gasket Material - Chrysotile Asbestos Detected

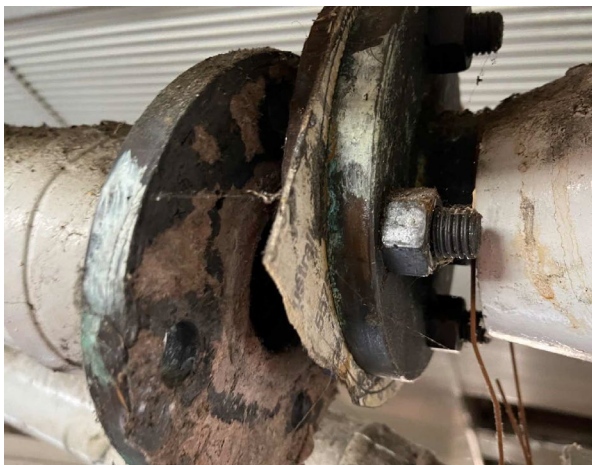
Line ID 23.1: Internal, GF, Laundry, Pipework, Central, Gasket Material - Chrysotile Asbestos Detected

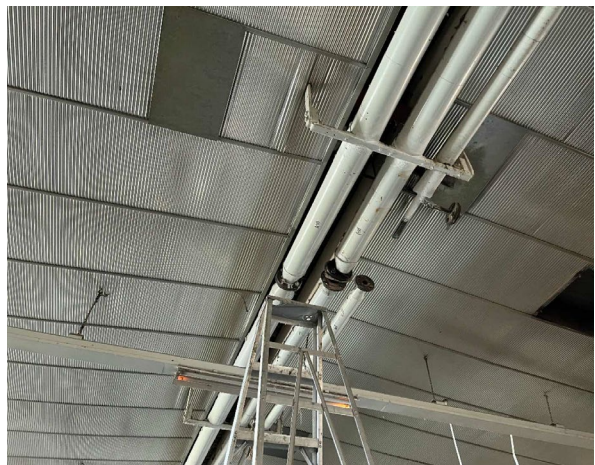
Line ID 24: Internal, GF, Laundry, Pipework, Central, Gasket Material - Chrysotile Asbestos Detected

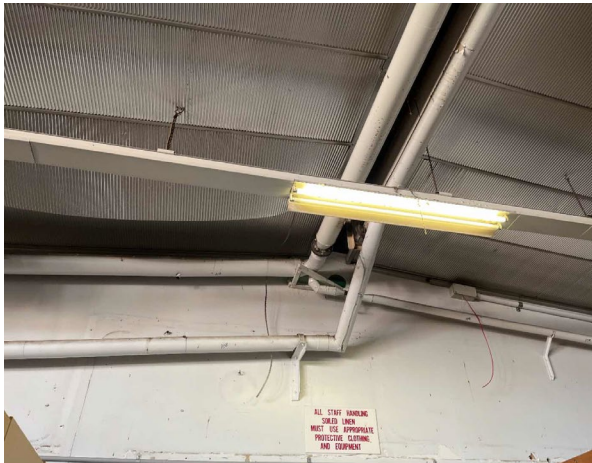
Line ID 24.1: Internal, GF, Laundry, Pipework, Central, Gasket Material - Chrysotile Asbestos Detected

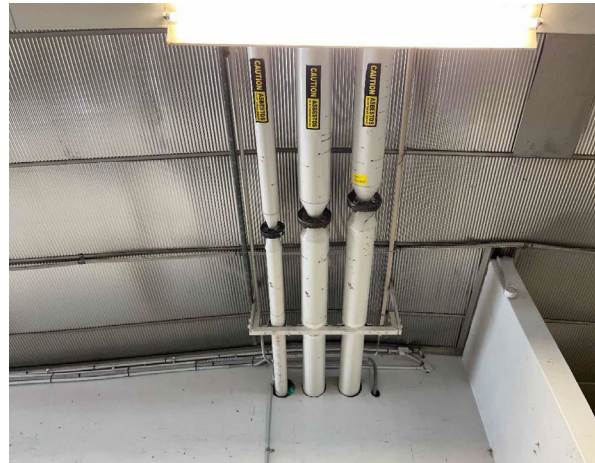
Line ID 25: Internal, GF, Laundry, Pipework, North East, Gasket Material - Chrysotile Asbestos Detected

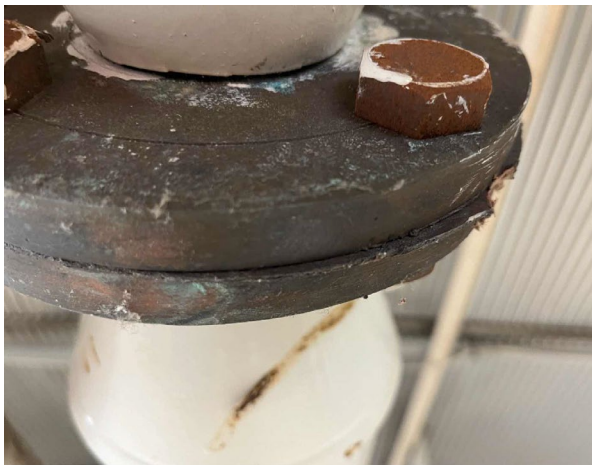
Line ID 26: Internal, GF, Laundry, Pipework, Southwest, Gasket Material - Chrysotile Asbestos Detected

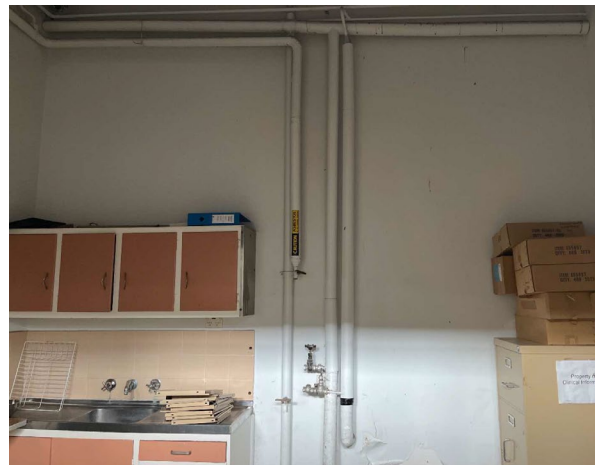
Line ID 26.1: Internal, GF, Laundry, Pipework, Southwest, Gasket Material - Chrysotile Asbestos Detected

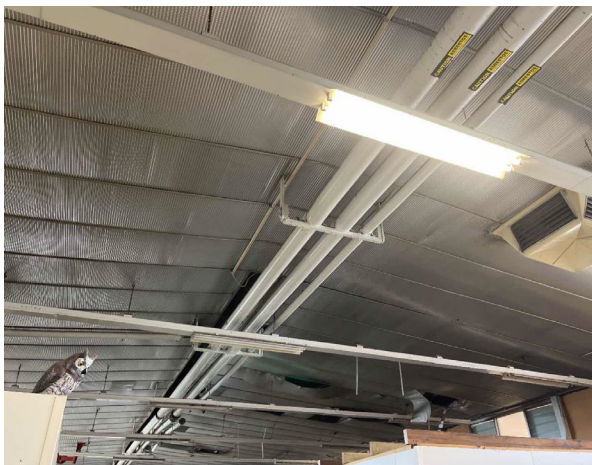
Line ID 27: Internal, GF, Laundry, Pipework, Throughout, Lagging - Amosite Asbestos Detected

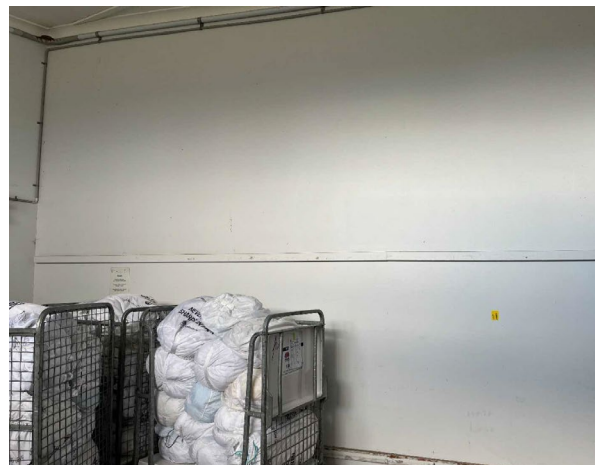
Line ID 27.1: Internal, GF, Laundry, Pipework, Throughout, Lagging - Amosite Asbestos Detected

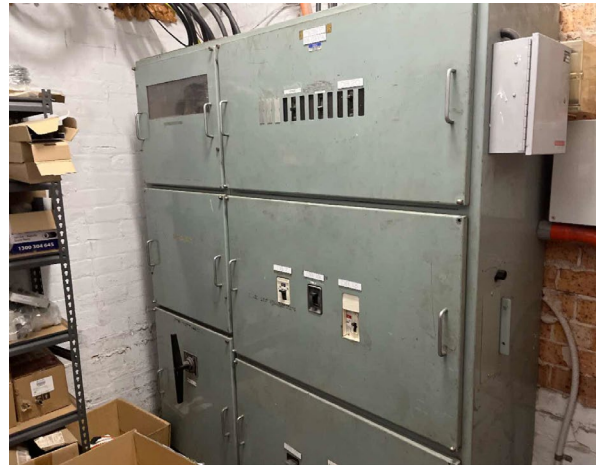
Line ID 29: Internal, GF, Main Switchboard Room, Electrical Distribution Board 1, Internal Electrical Components - Suspected Asbestos

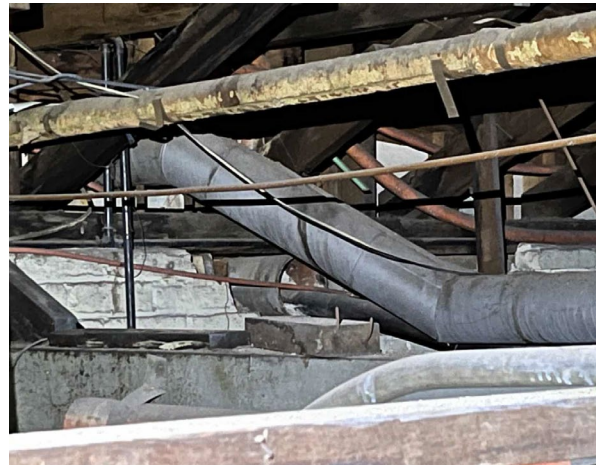
Line ID 31: Internal, GF, Main Workshop Area, Ceiling Space, All Surfaces, Throughout, Dust - No Asbestos Detected

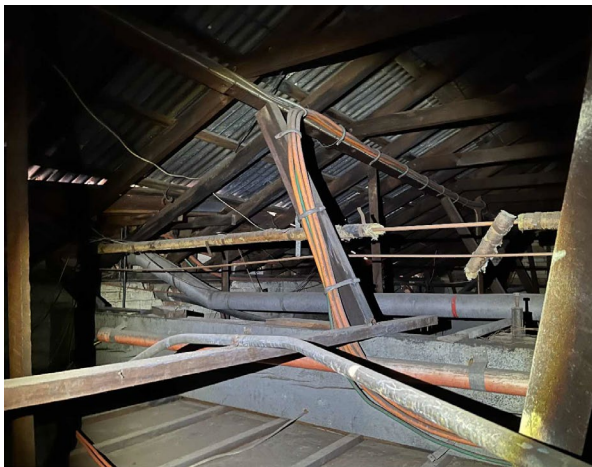
Line ID 32: Internal, GF, Main Workshop Area, Ceiling Space, Central, Lagging (metal encased material) - Suspected Asbestos

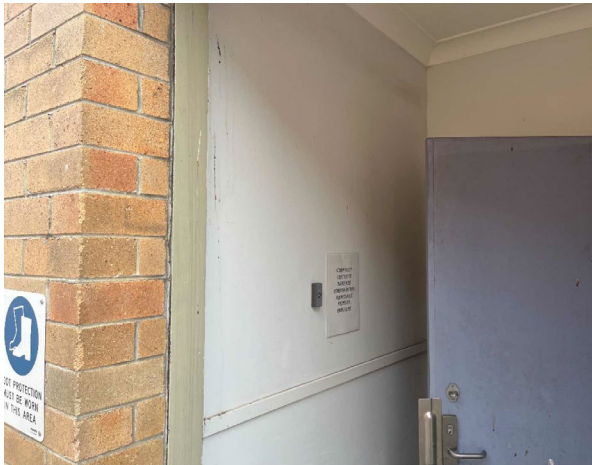
Line ID 33: Internal, GF, Main Workshop Area, Entrance Adjacent Toilet, Wall Lining, Fibre Cement Sheetting - No Asbestos Detected

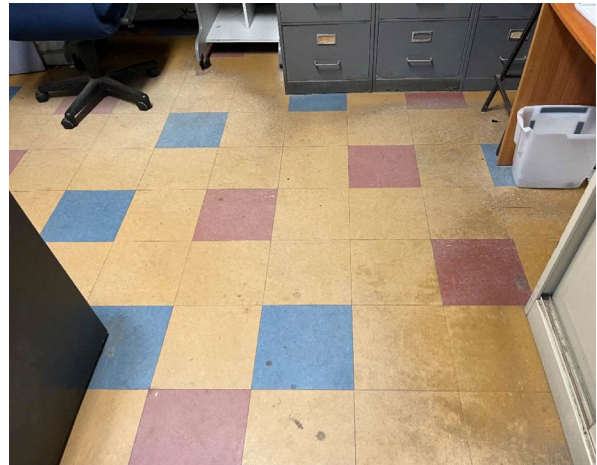
Line ID 35: Internal, GF, Maintenance Office, Floor Covering, Throughout, Vinyl Floor Tiles (yellow) - Chrysotile Asbestos Detected

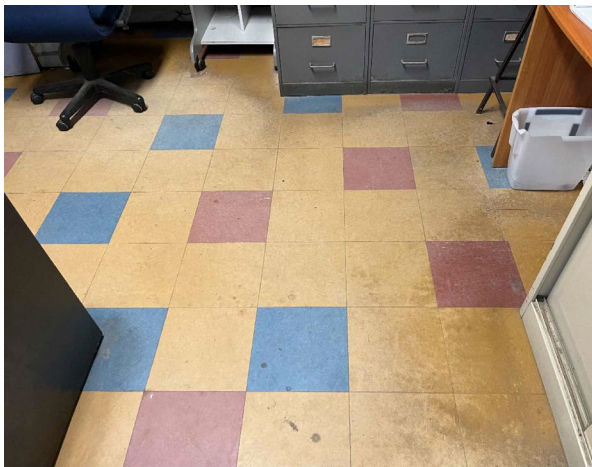
Line ID 36: Internal, GF, Maintenance Office, Floor Covering, Various Throughout, Vinyl Floor Tiles (red) - Chrysotile Asbestos Detected

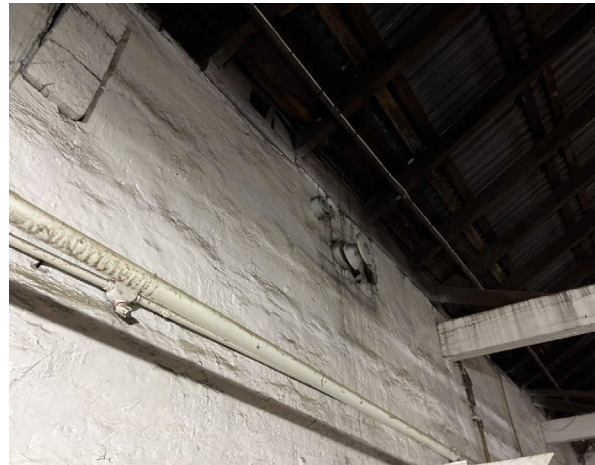
Line ID 39: Internal, GF, Painters Shop, Pipework Penetration, Northeast Adjacent Generator, Lagging - Amosite Asbestos Detected

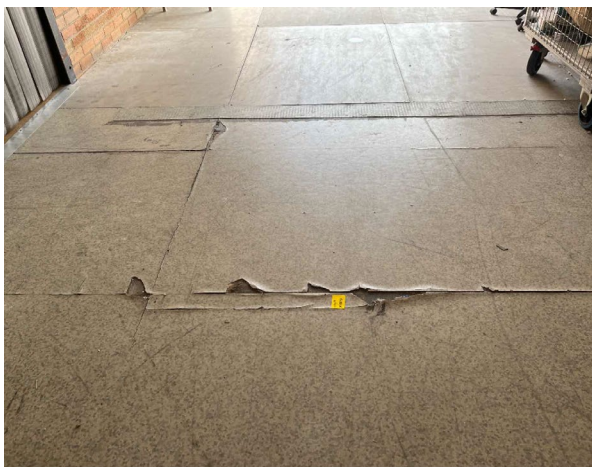
Line ID 41: Internal, GF, Palliative Care Storage Loading Dock, Floor Covering, Throughout, Vinyl Sheet (white) - No Asbestos Detected

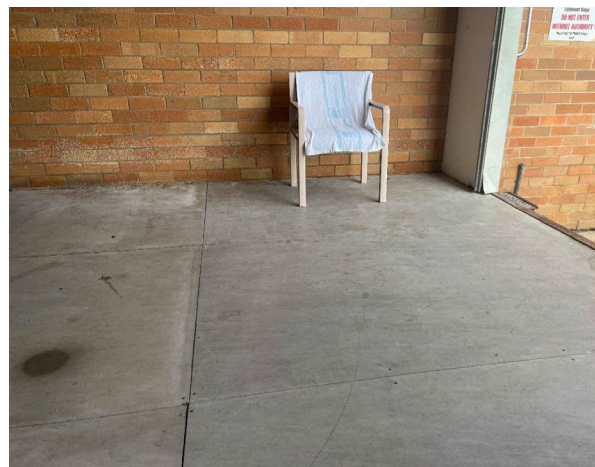
Line ID 41.1: Internal, GF, Palliative Care Storage Loading Dock, Floor Covering, Throughout, Vinyl Sheet (white) - No Asbestos Detected

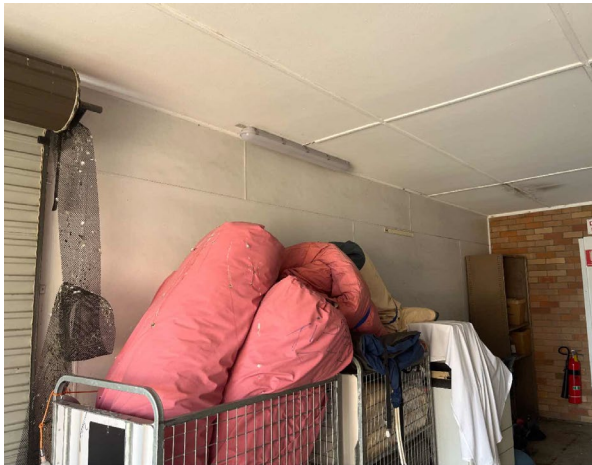
Line ID 42: Internal, GF, Palliative Care Storage Loading Dock, Floor Covering, Throughout, Compressed Cement Sheeting - No Asbestos Detected

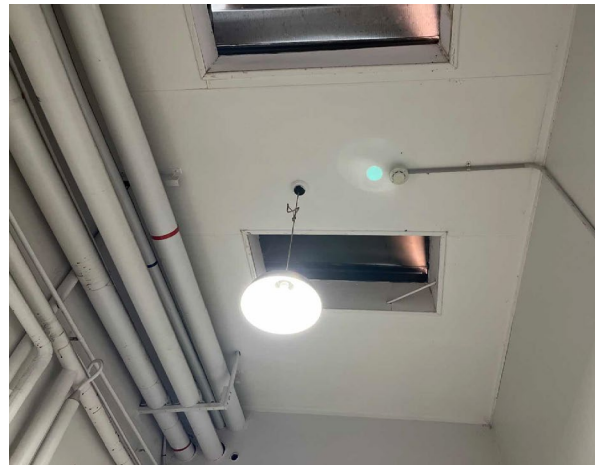
Line ID 43: Internal, GF, Palliative Care Storage Loading Dock, Wall lining, Throughout, Fibre Cement Sheetting - No Asbestos Detected

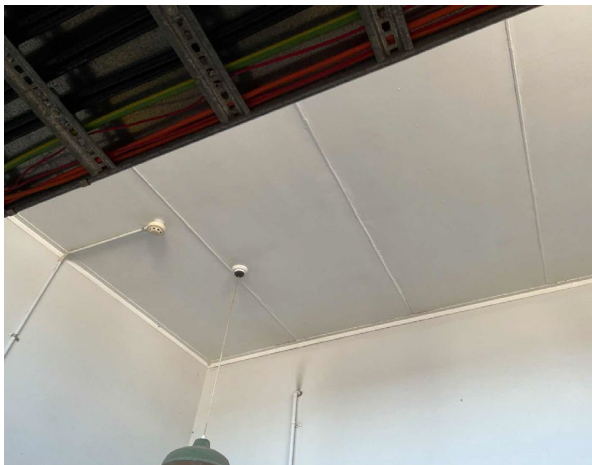
Line ID 44: Internal, GF, Room 1021 & 1022, Ceiling Lining, Throughout, Fibre Cement Sheetting - Chrysotile and Amosite Asbestos Detected
