Cessnock Hospital - Pre-Demolition Hazardous Materials Survey Report Summary

Asbestos and Hazardous Materials Pre-Demolition Assessment

Kitchen

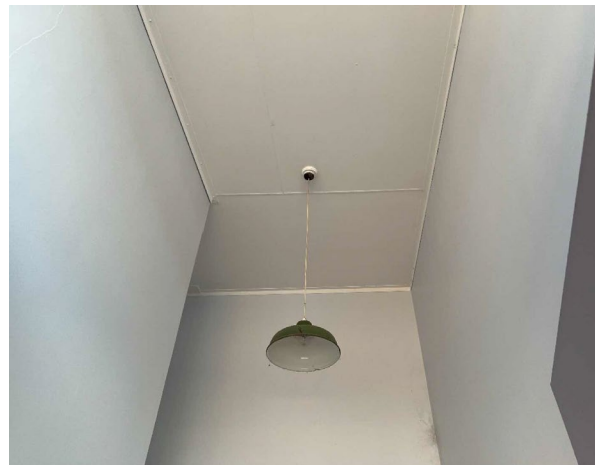
Line ID 44.1: Internal, GF, Room 1021 & 1022, Ceiling Lining, Throughout, Fibre Cement Sheetting - Chrysotile and Amosite Asbestos Detected

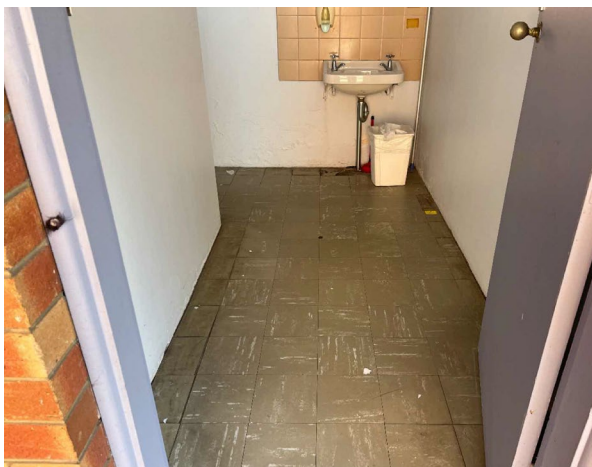
Line ID 45: Internal, GF, Room 1032, Toilet, Ceiling, Throughout, Fibre Cement Sheet - Chrysotile and Amosite Asbestos Detected

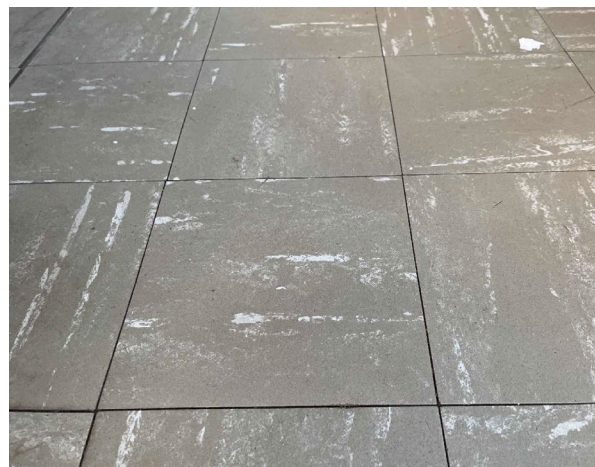
Line ID 46: Internal, GF, Room 1032, Toilet, Floor Covering, Throughout, Vinyl Floor Tiles (grey with white specs) - Chrysotile Asbestos Detected

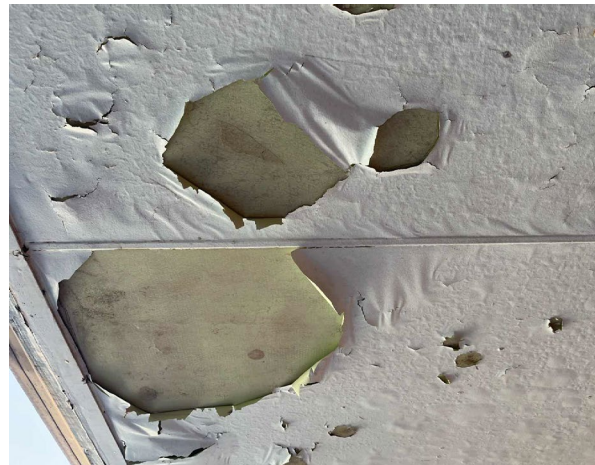
Line ID 47: Internal, GF, Room 1034, Storage, Packer/Ceiling Lining, South West, Fibre Cement Sheetting - Chrysotile and Amosite Asbestos Detected

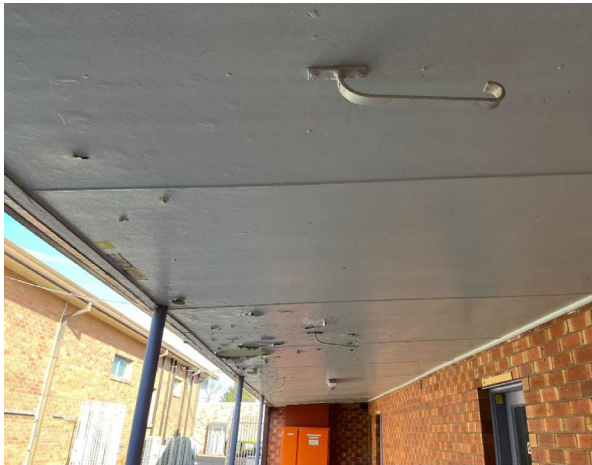
Line ID 48: External, GF, All Areas, Ceiling lining, Adjacent Clinical Information Department Entrance, White Paint - Lead Detected (0.14% w/w)

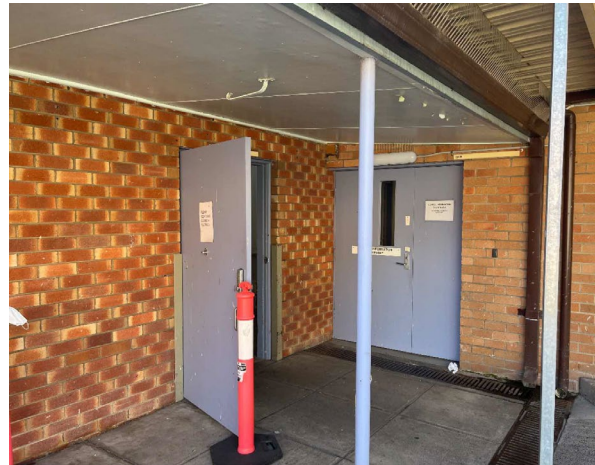
Line ID 48.1: External, GF, All Areas, Ceiling lining, Adjacent Clinical Information Department Entrance, White Paint - Lead Detected (0.14% w/w)

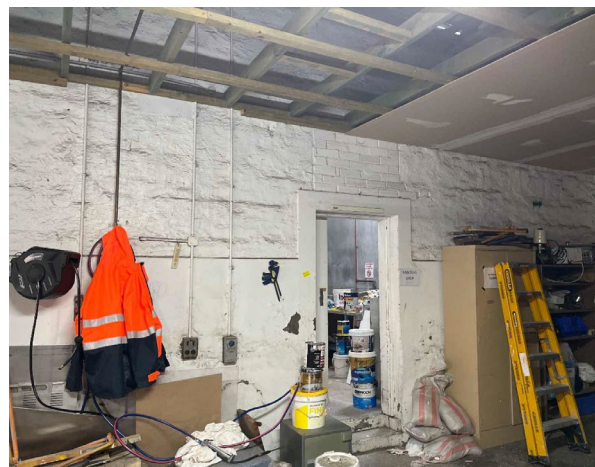
Line ID 51: Internal, GF, All Areas, Wall Lining, Throughout, White Paint - Lead Detected (0.04% w/w)

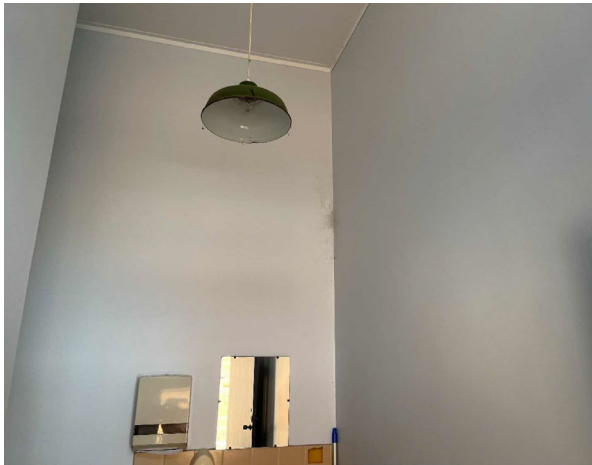
Line ID 52: Internal, GF, Painters Shop, Wall Lining, Throughout, White Paint - Lead Detected (0.04% w/w)

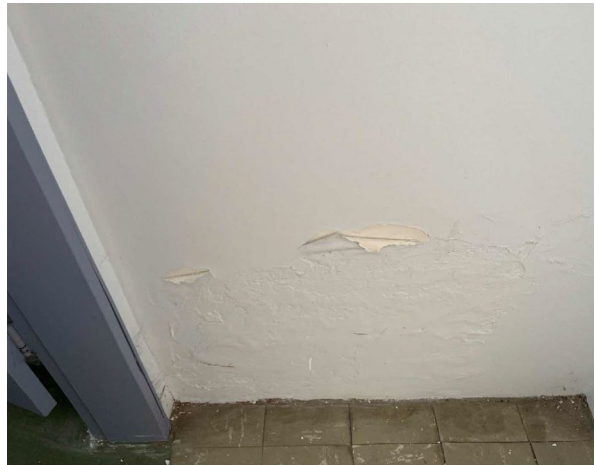
Line ID 53: Internal, GF, Room 1032, Toilet, Wall lining, Throughout, White Paint - Lead Detected (<0.005% w/w)

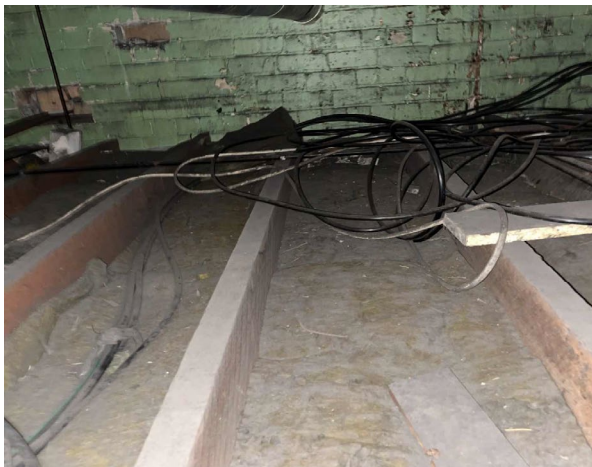
Line ID 55: Internal, GF, Painters Shop, Ceiling Space, Throughout, Dust - Lead Detected (220mg/kg)

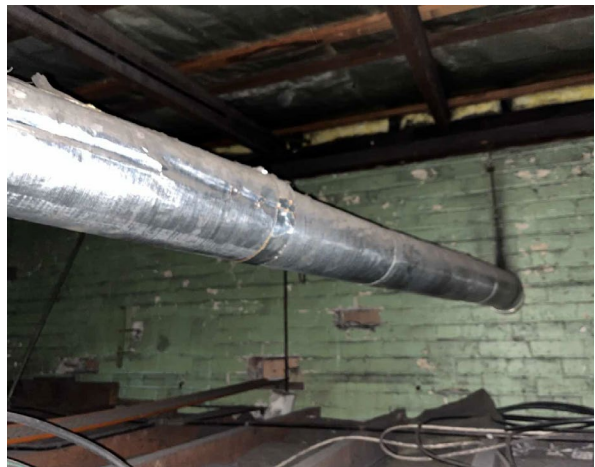
Line ID 57: Internal, GF, 1044, Painters Room, Ceiling Space, Insulation Batts - Suspected SMF

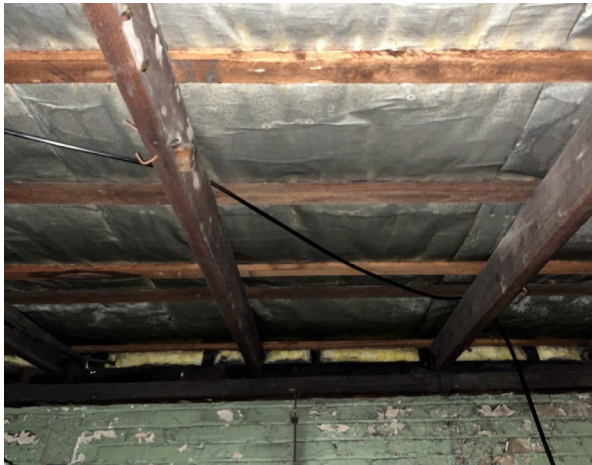
Line ID 58: Internal, GF, 1044, Painters Room, Ceiling Space, Pipework, Insulation Material - Suspected SMF

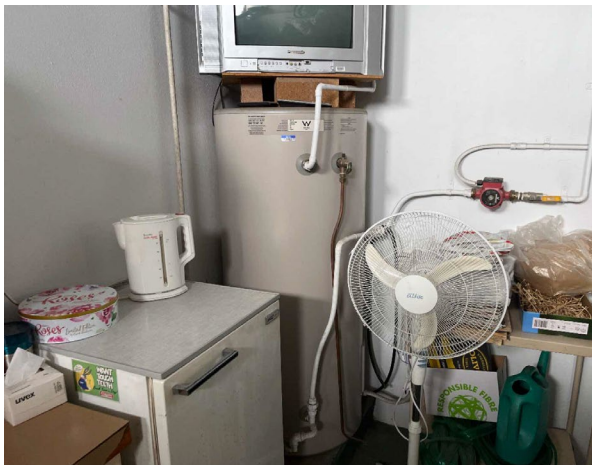
Line ID 60: Internal, GF, Kitchen, Hot Water Heater, Above Sink, Internal Insulation Material - Suspected SMF

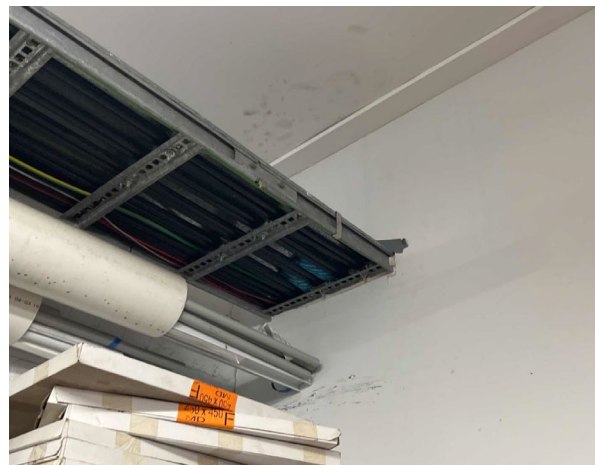
Line ID 64: Internal, GF, Main Workshop Area, Ceiling Space, Pipework, Central, Insulation Material - Suspected SMF

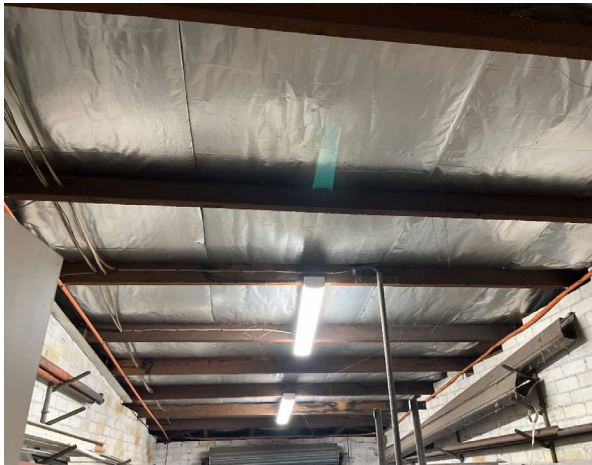
Line ID 65: Internal, GF, Main Workshop Area, Pillow Insulation, Cable Penetration, East, Insulation Material - Suspected SMF

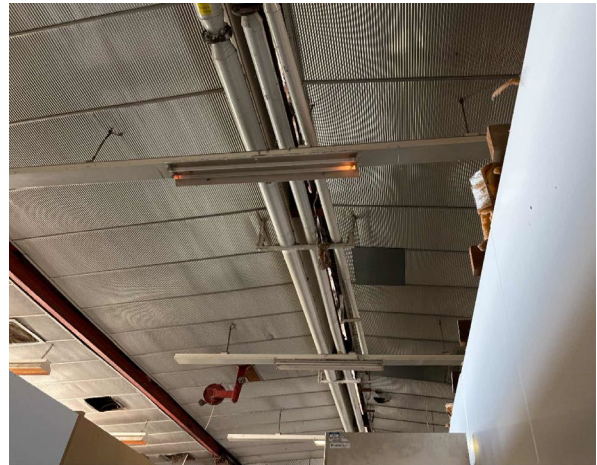
Line ID 68: Internal, GF, Room 1034, Storage, Sarking, Roof Lining, Insulation Material - Suspected SMF

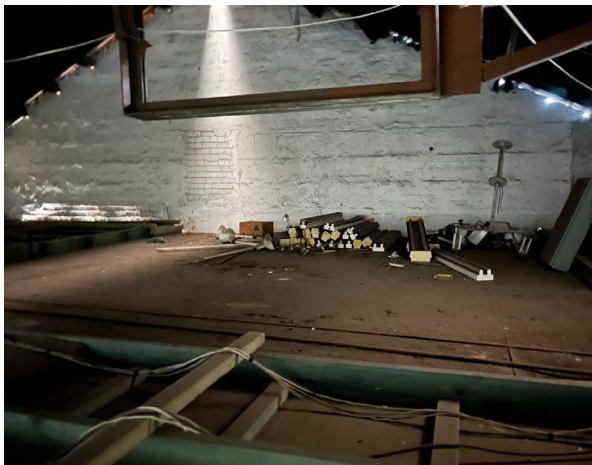
Line ID 70: Internal, GF, Painters Shop, Ceiling Space, Stored Item, Fluorescent Light Fitting, Capacitor(s) - Suspected PCB

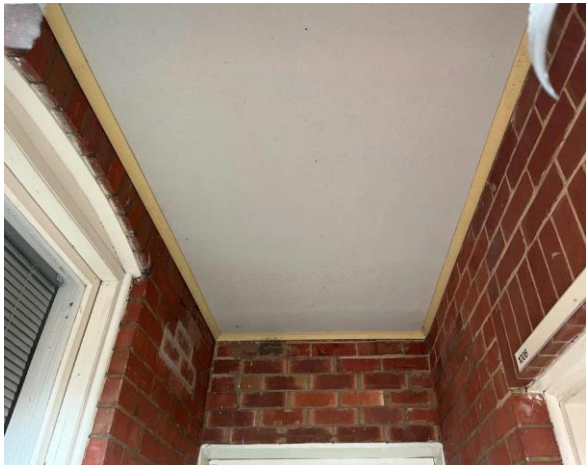
Line ID 1: External, GF, 1006 Entrance, Ceiling Lining, Throughout, Fibre Cement Sheet - No Asbestos Detected

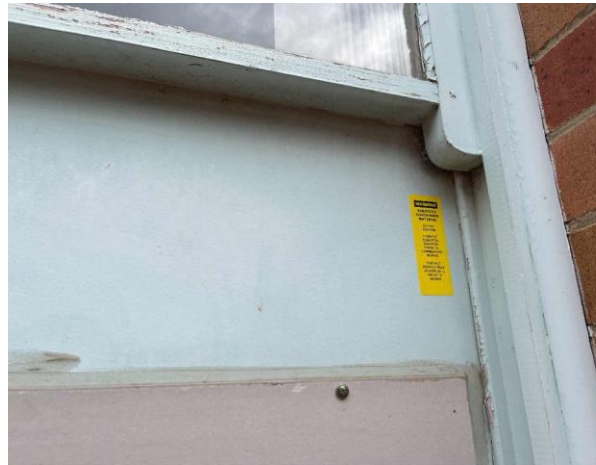
Line ID 2: External, GF, All Areas, Infill Panels, Below Windows, Fibre Cement Sheet - Chrysotile, Amosite and Crocidolite Asbestos Detected

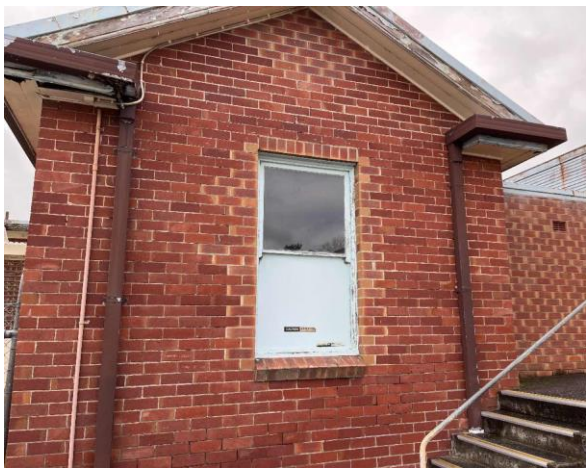
Line ID 2.1: External, GF, All Areas, Infill Panels, Below Windows, Fibre Cement Sheet - Chrysotile, Amosite and Crocidolite Asbestos Detected

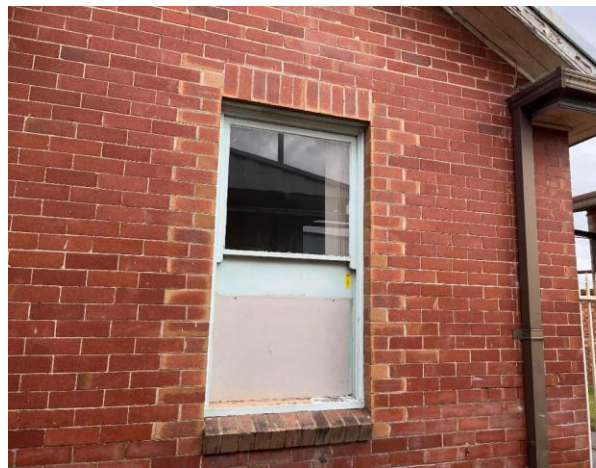
Line ID 2.2: External, GF, All Areas, Infill Panels, Below Windows, Fibre Cement Sheet - Chrysotile, Amosite and Crocidolite Asbestos Detected

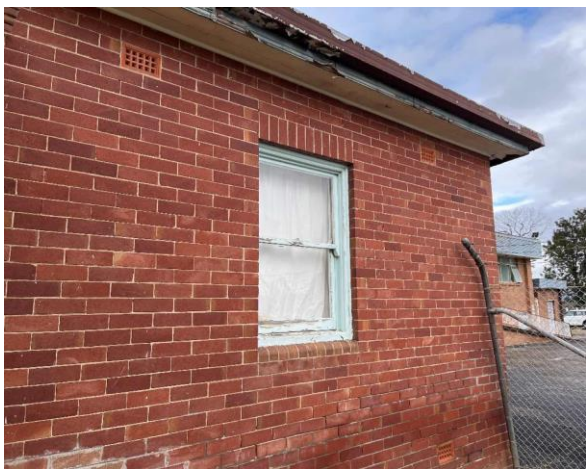
Line ID 3: External, GF, All Areas, Windows, Throughout, Window Caulking - No Asbestos Detected

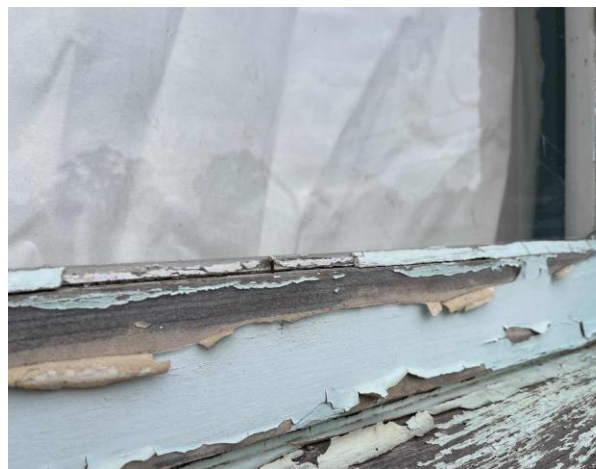
Line ID 3.1: External, GF, All Areas, Windows, Throughout, Window Caulking - No Asbestos Detected

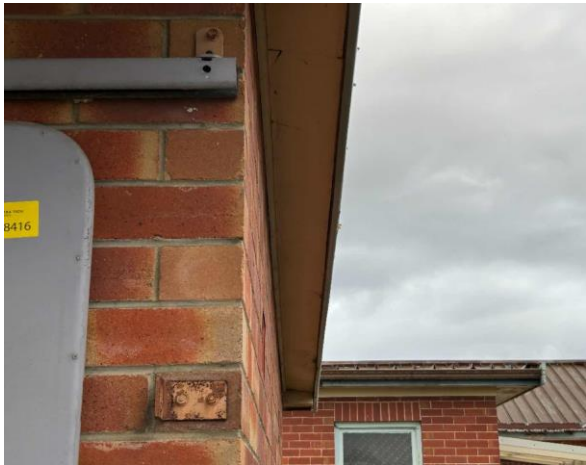
Line ID 4: External, GF, Dangerous Goods Store, North and South, Eaves, Fibre Cement Sheeting - Chrysotile, Amosite and Crocidolite Asbestos Detected

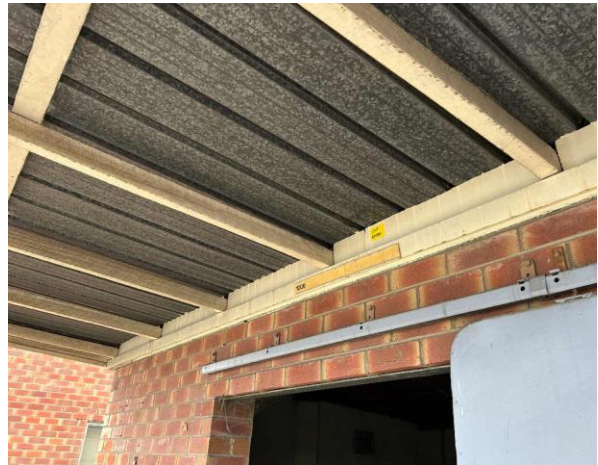
Line ID 5: External, GF, Dangerous Goods Store, West, Fascia, Fibre Cement Sheeting - Chrysotile, Amosite and Crocidolite Asbestos Detected

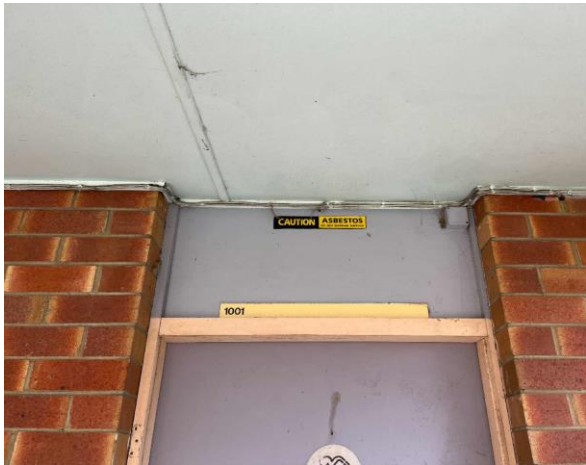
Line ID 6: External, GF, Front Entrance, Infill Panel, Above Door 1001, Fibre Cement Sheet - Chrysotile, Amosite and Crocidolite Asbestos Detected

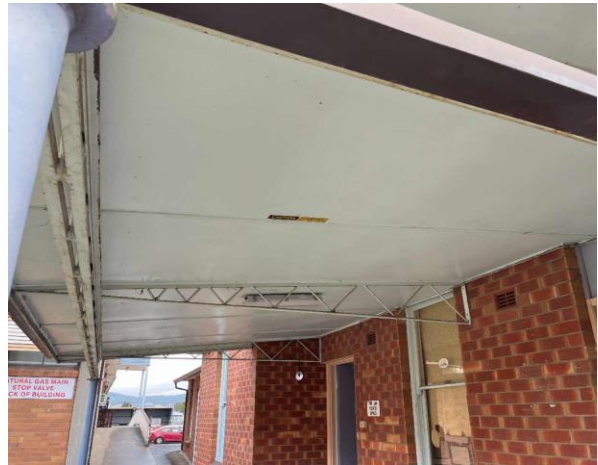
Line ID 7: External, GF, Front Entrance, Verandah, Awning, Fibre Cement Sheet - Chrysotile, Amosite and Crocidolite Asbestos Detected

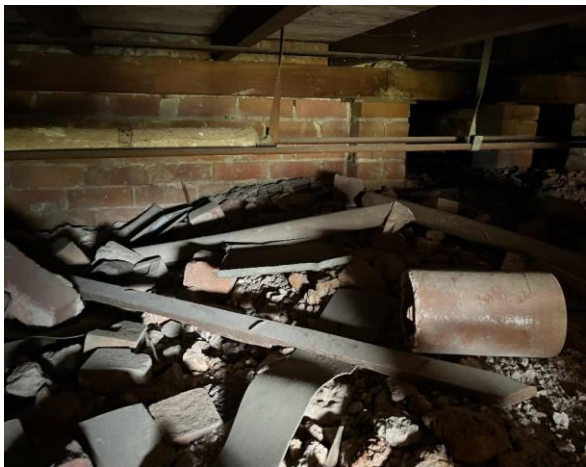
Line ID 8: External, GF, Subfloor Entrance, New Style Sheet Vinyl, Various Throughout, Debris - No Asbestos Detected

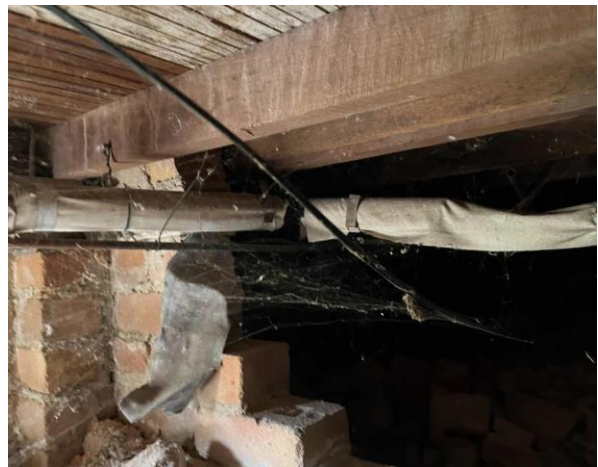
Line ID 9: External, GF, Subfloor Entrance, Pipework Lagging, Throughout, Lagging - Amosite Asbestos Detected

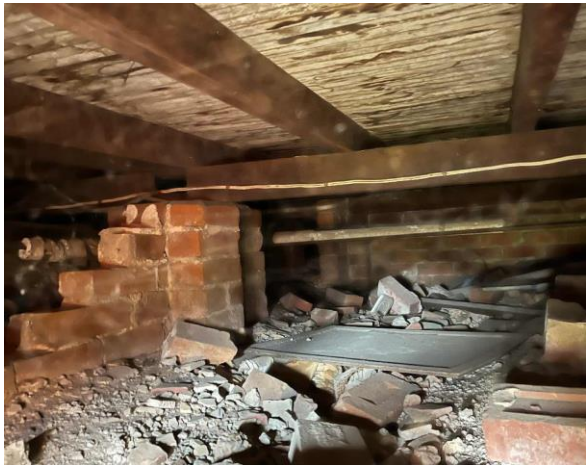
Line ID 9.1: External, GF, Subfloor Entrance, Pipework Lagging, Throughout, Lagging - Amosite Asbestos Detected

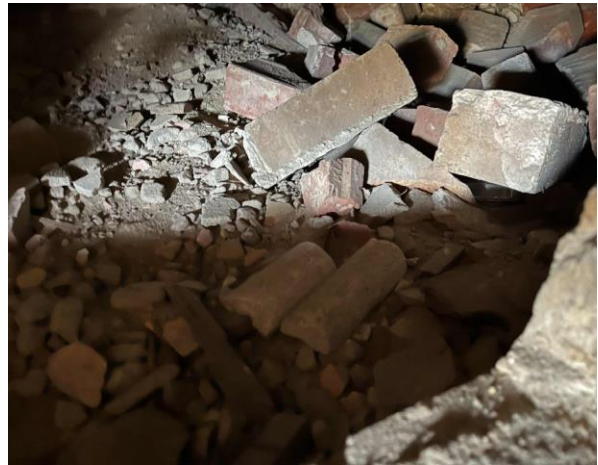
Line ID 10: External, GF, Subfloor Entrance, Pipework Lagging, Throughout, Lagging Debris - Amosite Asbestos Detected

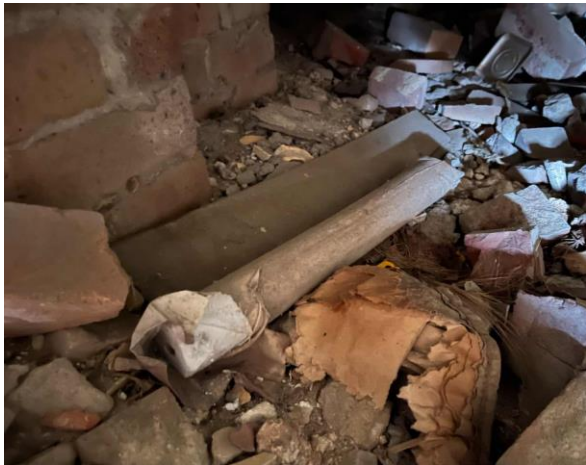
Line ID 10.1: External, GF, Subfloor Entrance, Pipework Lagging, Throughout, Lagging Debris - Amosite Asbestos Detected

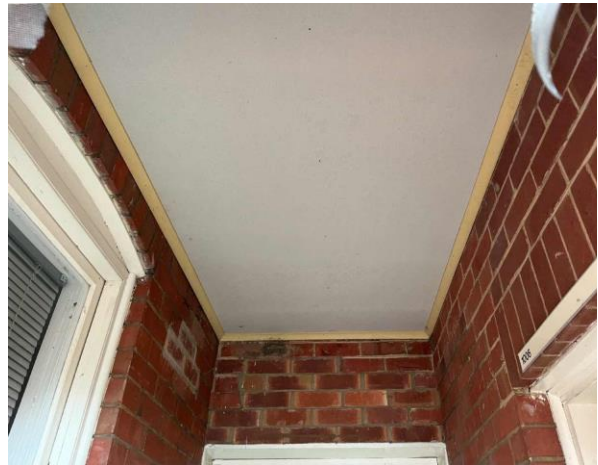
Line ID 11: External, GF, Verandah to Laundry, Ceiling Lining, Adjacent Toilet, Fibre Cement Sheet - No Asbestos Detected

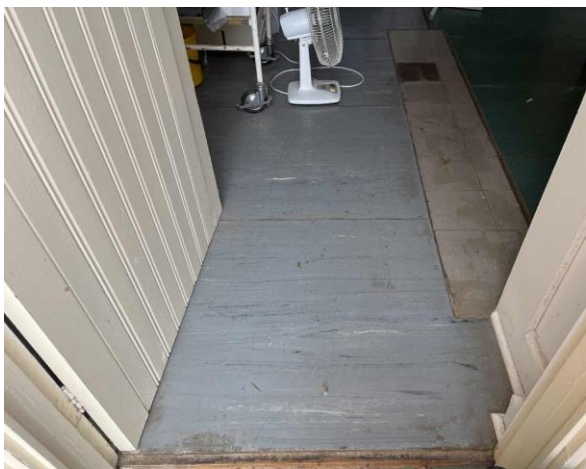
Line ID 12: Internal, GF, Dining/Laundry, Floor covering, Adjacent Entrance, Sheet Vinyl (grey) - No Asbestos Detected

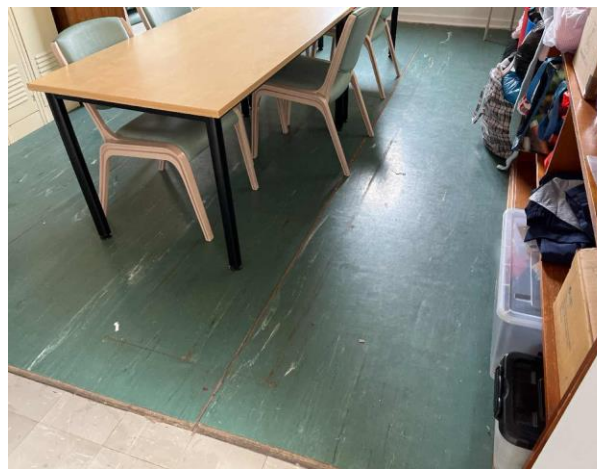
Line ID 13: Internal, GF, Dining/Laundry, Floor covering, Throughout, Sheet Vinyl (green) - No Asbestos Detected

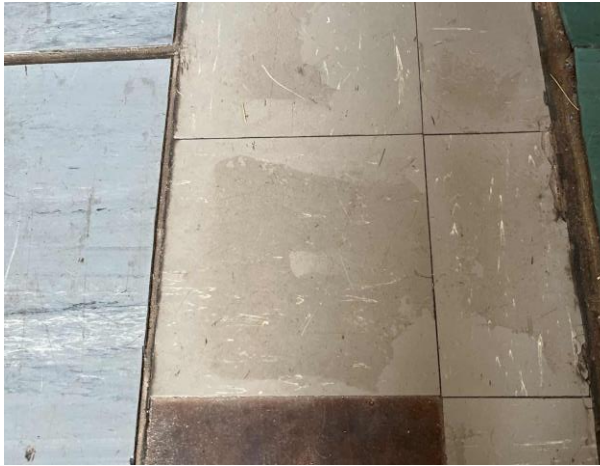
Line ID 14: Internal, GF, Dining/Laundry, Floor Covering, Various Throughout, Vinyl Floor Tiles - Chrysotile Asbestos Detected

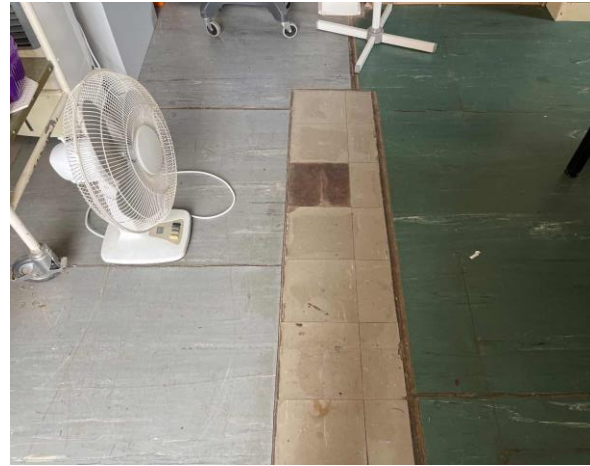
Line ID 14.1: Internal, GF, Dining/Laundry, Floor Covering, Various Throughout, Vinyl Floor Tiles - Chrysotile Asbestos Detected

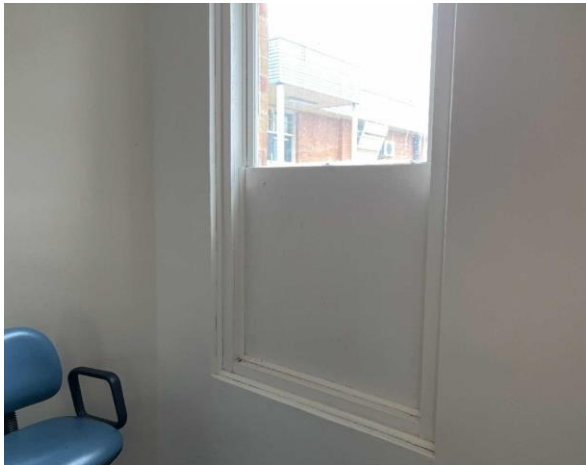
Line ID 15: Internal, GF, Dining/Laundry, Infill panel, Below Window, Fibre Cement Sheet - Chrysotile Asbestos Detected

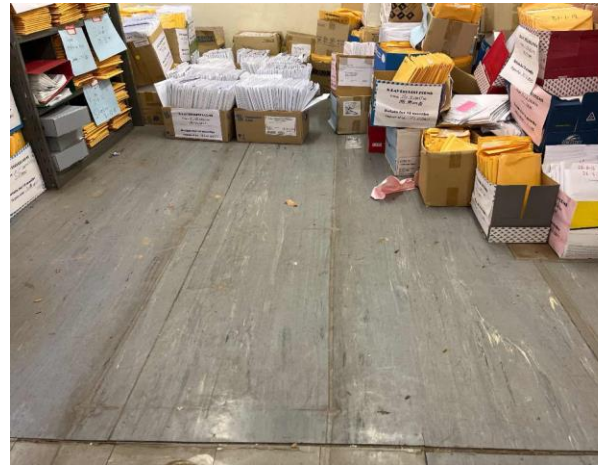
Line ID 16: Internal, GF, Document Storage Area, Floor covering, Adjacent entrance, Sheet Vinyl (grey) - No Asbestos Detected

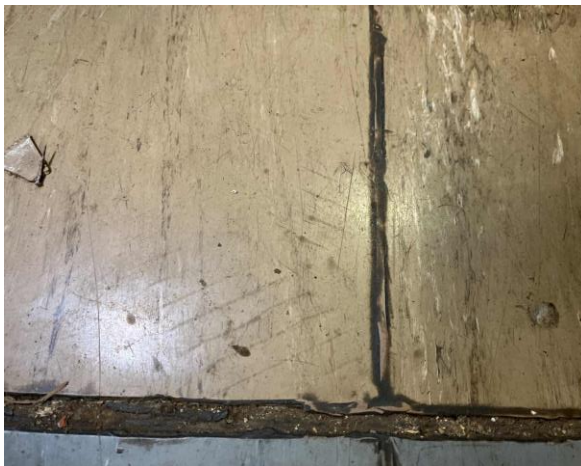
Line ID 17: Internal, GF, Document Storage Area, Floor covering, Throughout Entry, Sheet Vinyl (brown) - No Asbestos Detected

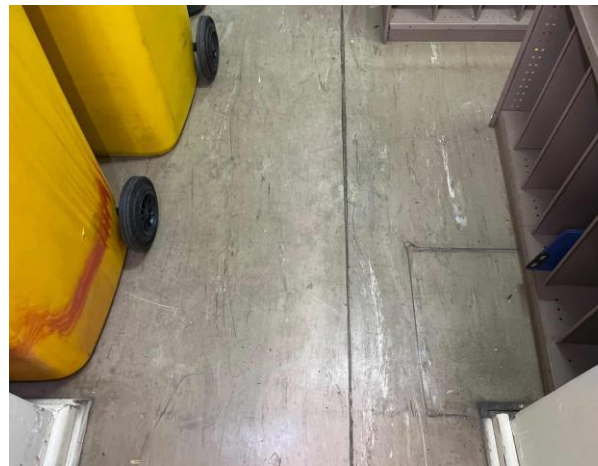
Line ID 17.1: Internal, GF, Document Storage Area, Floor covering, Throughout Entry, Sheet Vinyl (brown) - No Asbestos Detected

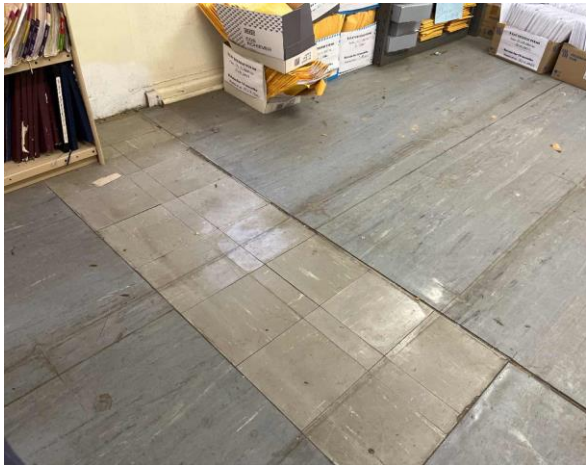
Line ID 18: Internal, GF, Document Storage Area, Floor Covering, Various Throughout, Vinyl Floor Tiles - Chrysotile Asbestos Detected

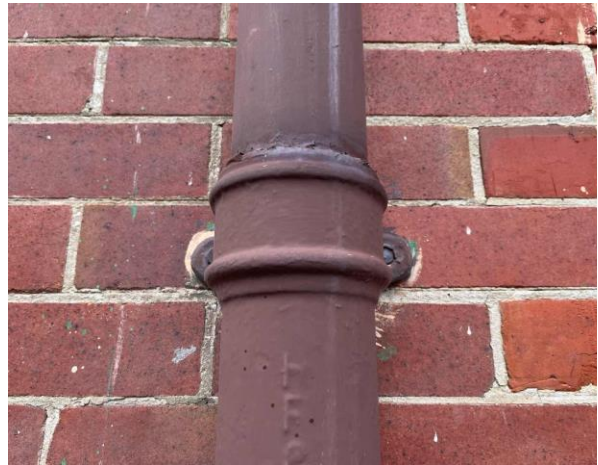
Line ID 20: External, GF, All Areas, Roof & Metal Work, Throughout, Brown Paint - Lead Detected (0.29% w/w)

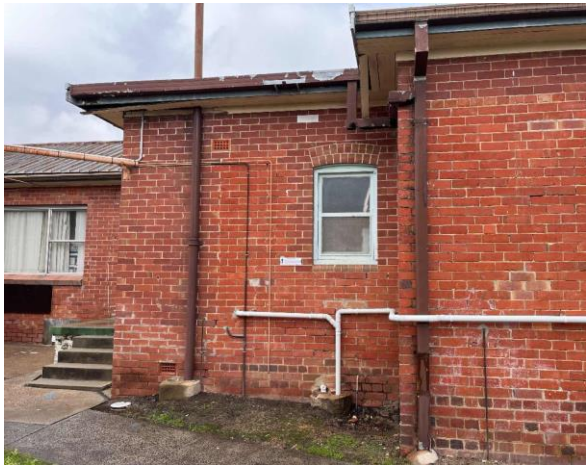
Line ID 20.1: External, GF, All Areas, Roof & Metal Work, Throughout, Brown Paint - Lead Detected (0.29% w/w)

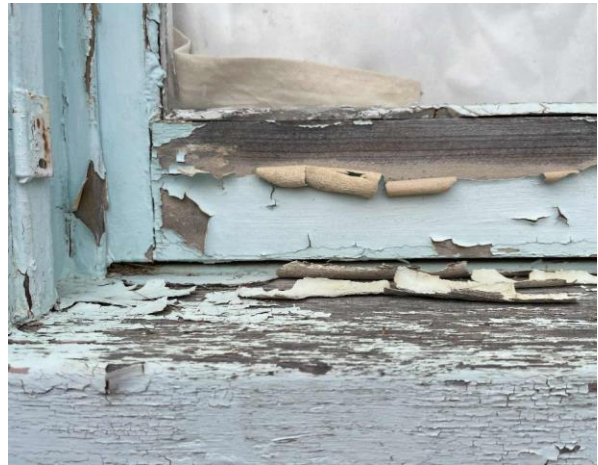
Line ID 21: External, GF, All Areas, Windows & frames, Throughout, Blue (Light) Paint - Lead Detected (2.4% w/w)

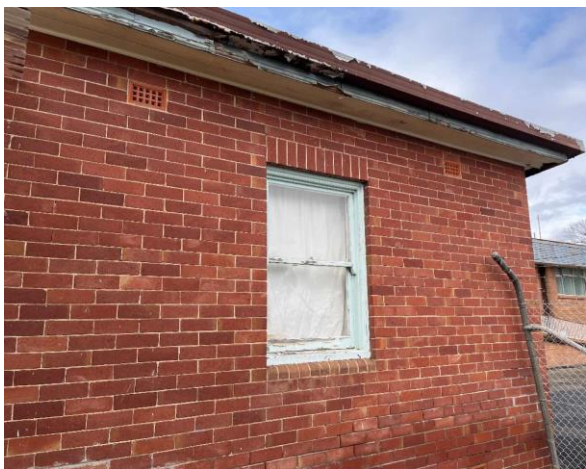
Line ID 21.1: External, GF, All Areas, Windows & frames, Throughout, Blue (Light) Paint - Lead Detected (2.4% w/w)

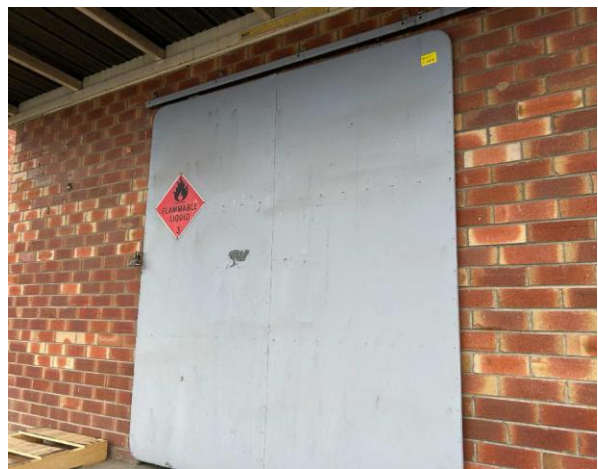
Line ID 22: External, GF, Dangerous Goods Store, Sliding Door, Purple Paint - Lead Detected (3.4% w/w)

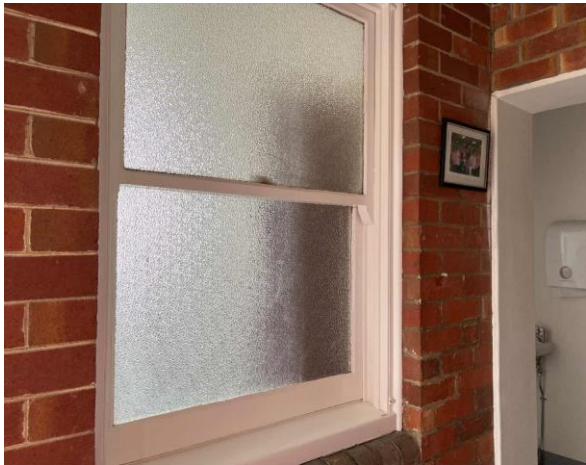
Line ID 23: Internal, GF, All Areas, Windows & frames, Throughout, White Paint - Lead Detected (0.34% w/w)

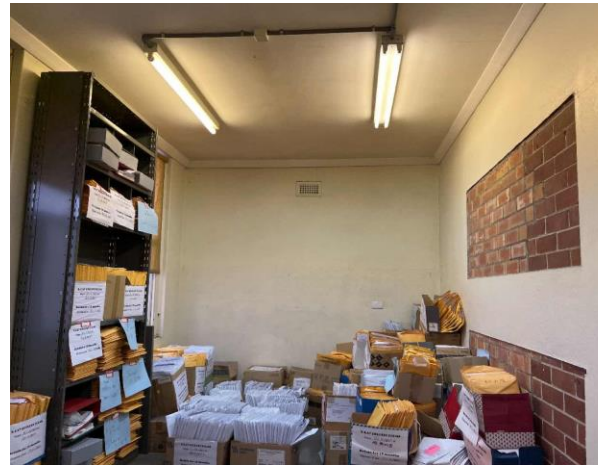
Line ID 24: Internal, GF, Document Storage Area, Wall lining, Throughout, Cream Paint - Lead Detected (0.24% w/w)

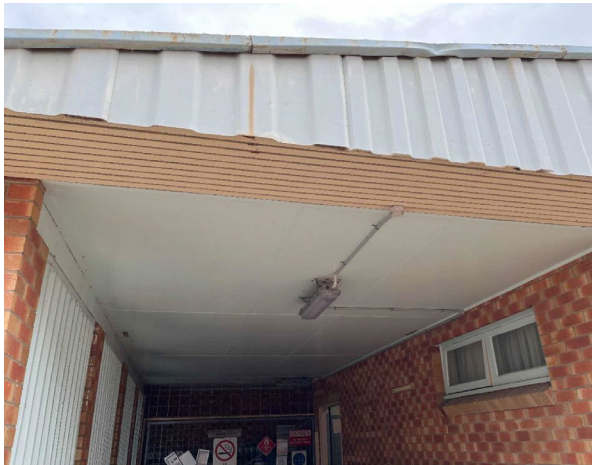
Line ID 1: External, GF, Mortuary, All Areas, Awning, Entrance, Fibre Cement Sheeting - Chrysotile Asbestos Detected

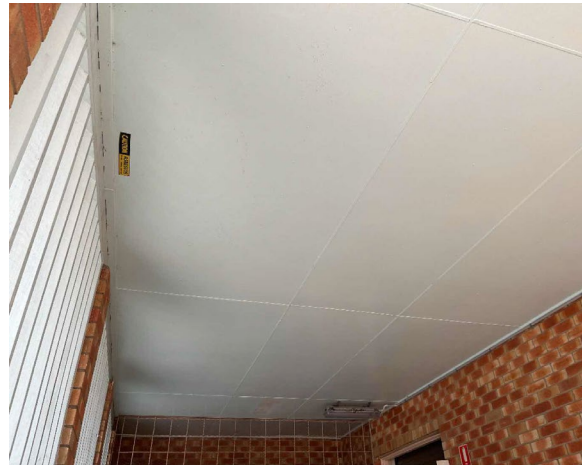
Line ID 1.1: External, GF, Mortuary, All Areas, Awning, Entrance, Fibre Cement Sheeting - Chrysotile Asbestos Detected

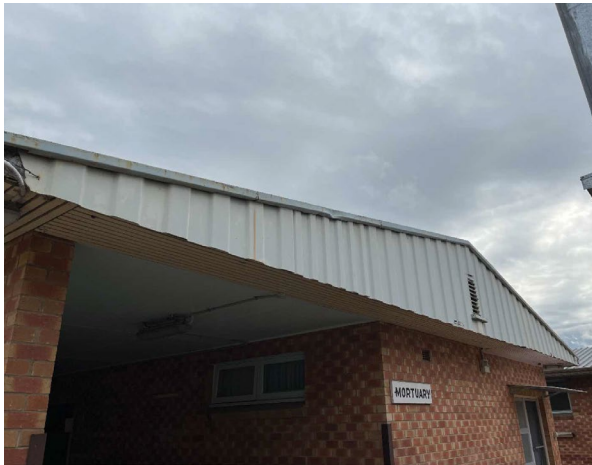
Line ID 2: External, GF, Mortuary, All Areas, Gable End, North & South, Moulded Fibre Cement - Chrysotile and Amosite Asbestos Detected

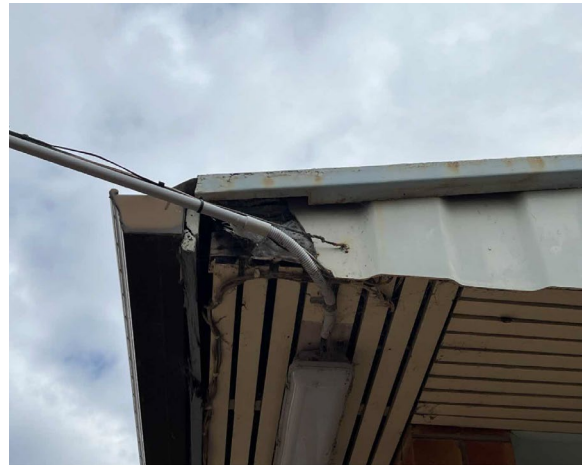
Line ID 2.1: External, GF, Mortuary, All Areas, Gable End, North & South, Moulded Fibre Cement - Chrysotile and Amosite Asbestos Detected

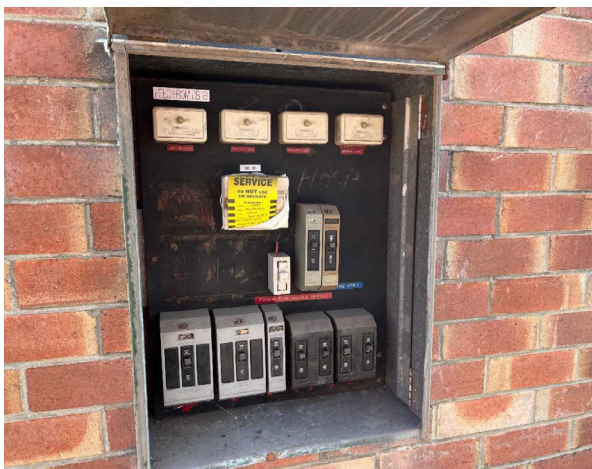
Line ID 3: External, GF, Storeroom Driveway, Electrical Distribution Board, Northern Boundary, Compressed Bituminous Panel - Suspected Asbestos

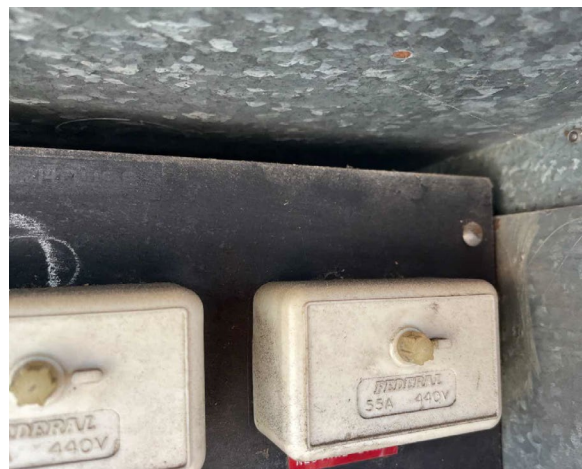
Line ID 3.1: External, GF, Storeroom Driveway, Electrical Distribution Board, Northern Boundary, Compressed Bituminous Panel - Suspected Asbestos

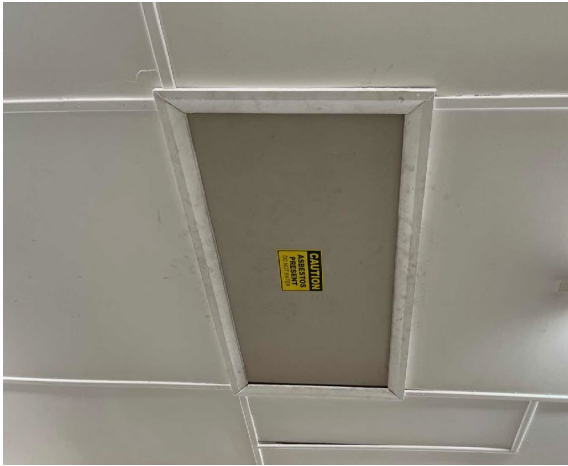
Line ID 4: Internal, GF, Storeroom, Access Hatch, Central, Non-Suspect Material - No Asbestos Suspected

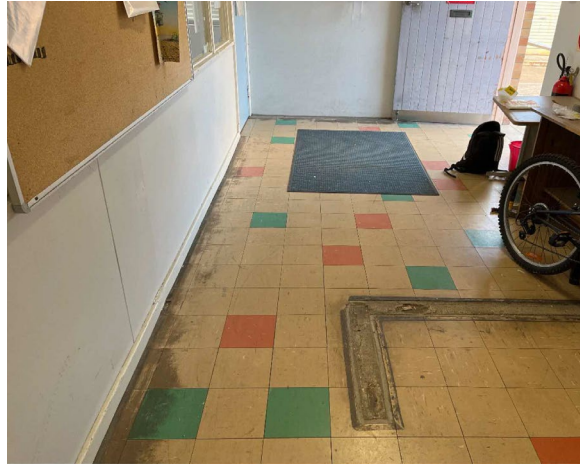
Line ID 5: Internal, GF, Storeroom, Main Foyer & Offices, Throughout, Vinyl Floor Tiles (cream with white specs) - Chrysotile Asbestos Detected

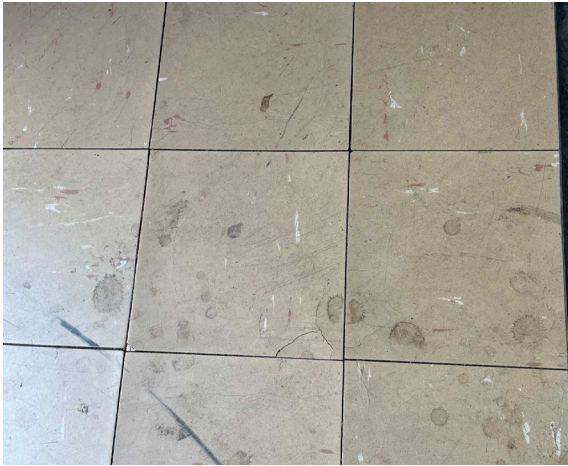
Line ID 5.1: Internal, GF, Storeroom, Main Foyer & Offices, Throughout, Vinyl Floor Tiles (cream with white specs) - Chrysotile Asbestos Detected

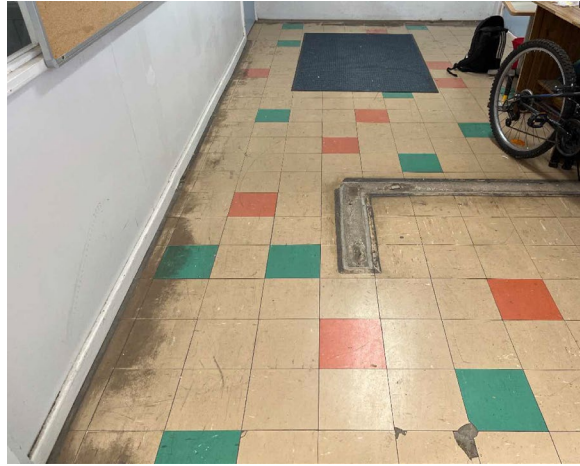
Line ID 6: Internal, GF, Storeroom, Main foyer & Offices, Various Throughout, Vinyl Floor Tiles (green) - Chrysotile Asbestos Detected

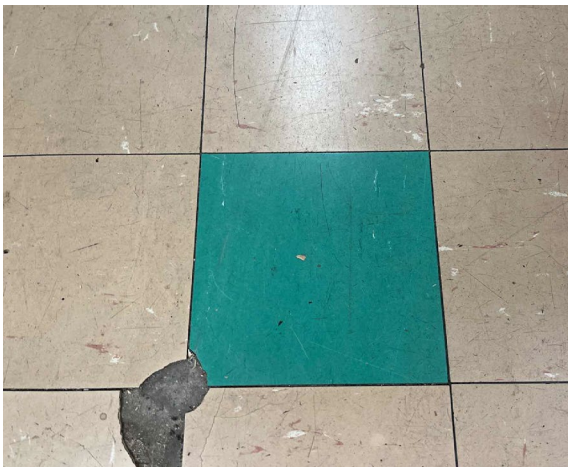
Line ID 6.1: Internal, GF, Storeroom, Main foyer & Offices, Various Throughout, Vinyl Floor Tiles (green) - Chrysotile Asbestos Detected

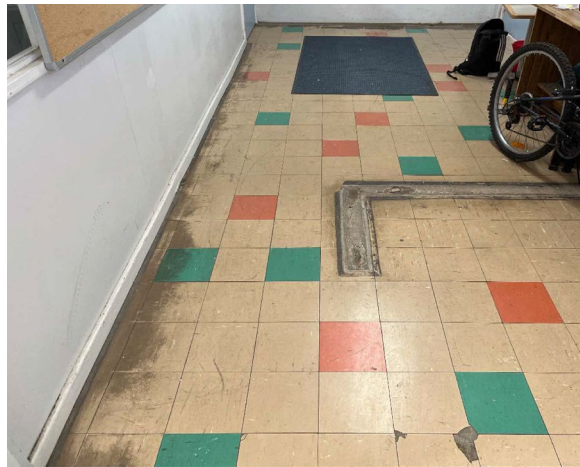
Line ID 7: Internal, GF, Storeroom, Main Foyer & Offices, Various Throughout, Vinyl Floor Tiles (red) - Chrysotile Asbestos Detected

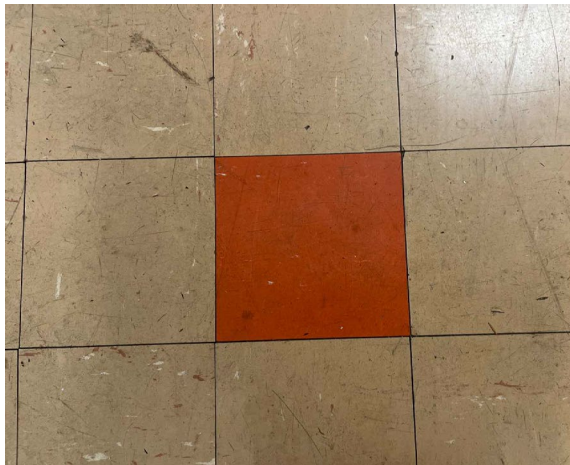
Line ID 7.1: Internal, GF, Storeroom, Main Foyer & Offices, Various Throughout, Vinyl Floor Tiles (red) - Chrysotile Asbestos Detected

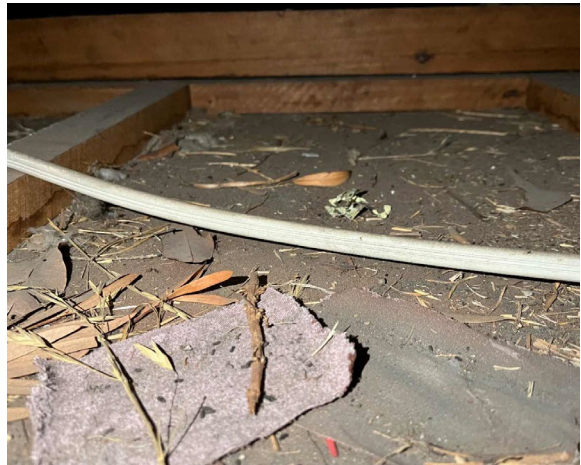
Line ID 8: Internal, GF, Storeroom Ceiling Space, On Top of Ceiling, Throughout, Dust - No Asbestos Detected

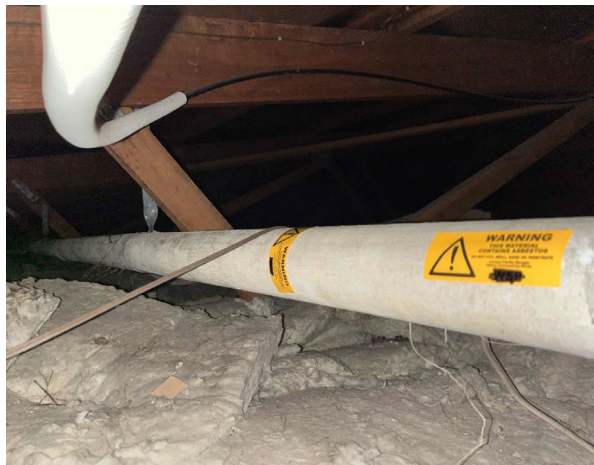
Line ID 9: Internal, GF, Storeroom Ceiling Space, Pipework, Throughout, Lagging - Amosite Asbestos Detected

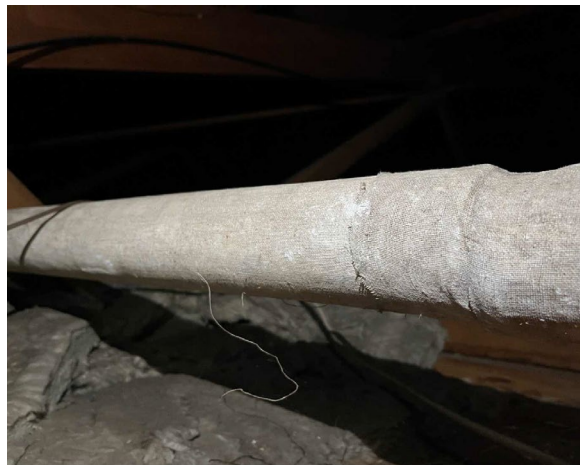
Line ID 9.1: Internal, GF, Storeroom Ceiling Space, Pipework, Throughout, Lagging - Amosite Asbestos Detected

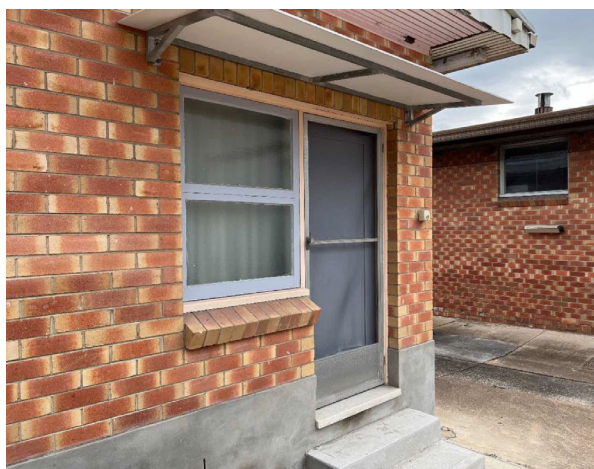
Line ID 10: External, GF, Mortuary, All Areas, Door & Frames, Throughout, Pink (Light) Paint - Lead Detected (0.18% w/w)

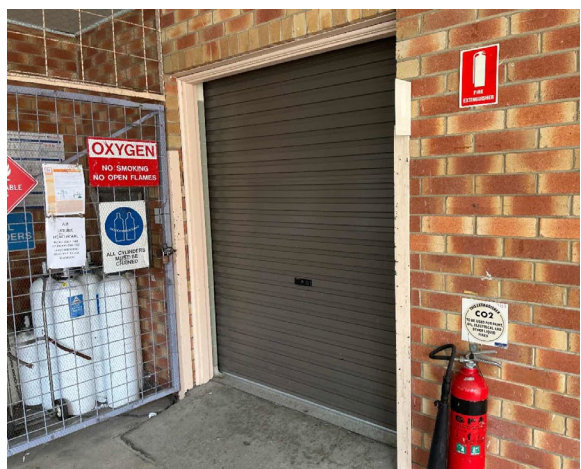
Line ID 10.1: External, GF, Mortuary, All Areas, Door & Frames, Throughout, Pink (Light) Paint - Lead Detected (0.18% w/w)

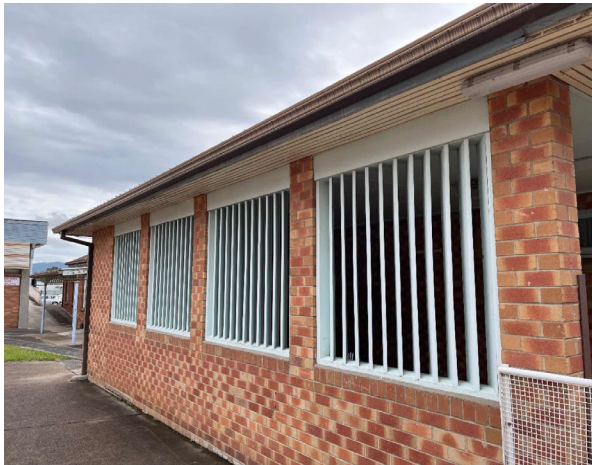
Line ID 11: External, GF, Mortuary, All Areas, Timber Works, Adjacent Entrance, Blue (Light) Paint - Lead Detected (0.23% w/w)

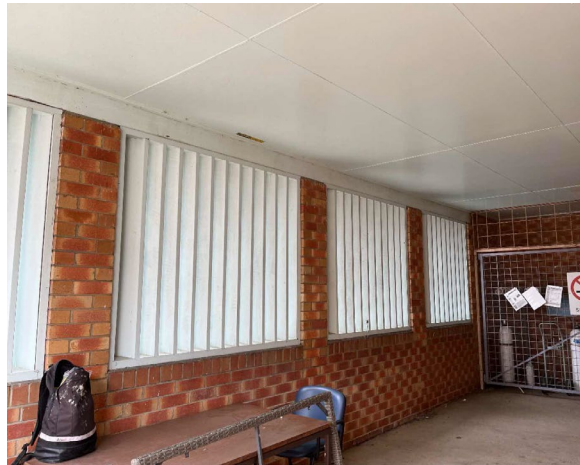
Line ID 11.1: External, GF, Mortuary, All Areas, Timber Works, Adjacent Entrance, Blue (Light) Paint - Lead Detected (0.23% w/w)

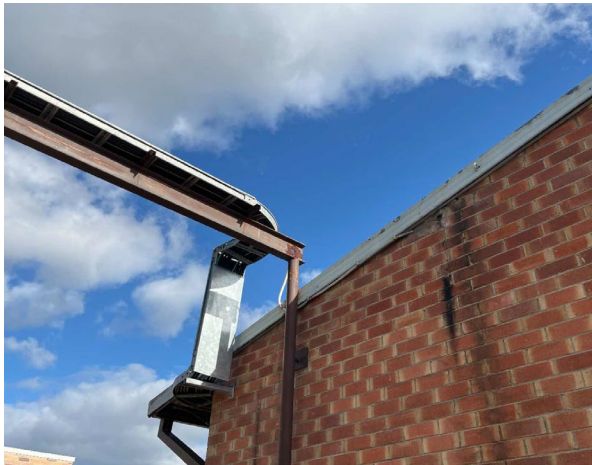
Line ID 12: External, GF, Storeroom Driveway, Metal Works, Various Throughout, Blue (Light) Paint - Lead Detected (0.10% w/w)

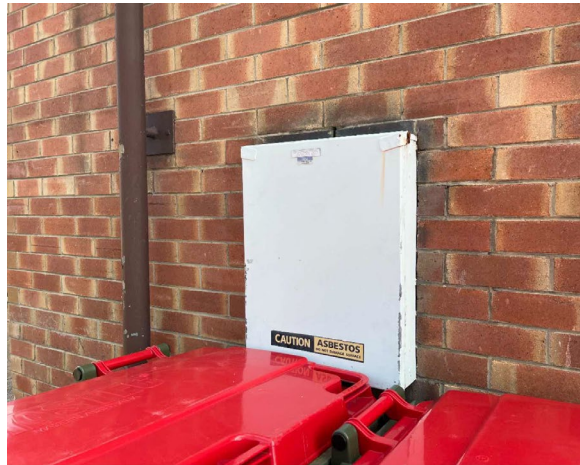
Line ID 12.1: External, GF, Storeroom Driveway, Metal Works, Various Throughout, Blue (Light) Paint - Lead Detected (0.10% w/w)

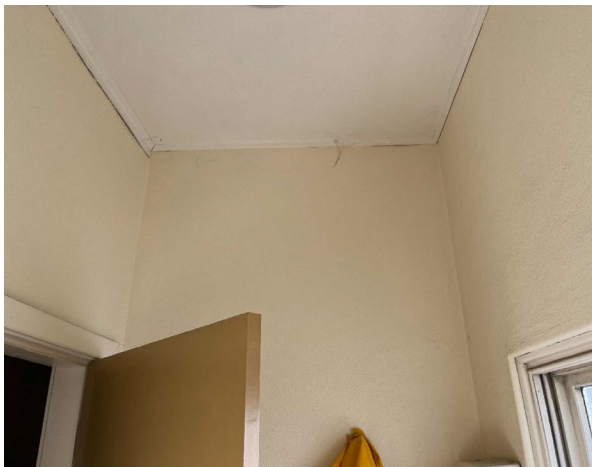
Line ID 13: Internal, GF, Storeroom, Wall Lining, Throughout, Cream Paint - Lead Detected (0.03% w/w)

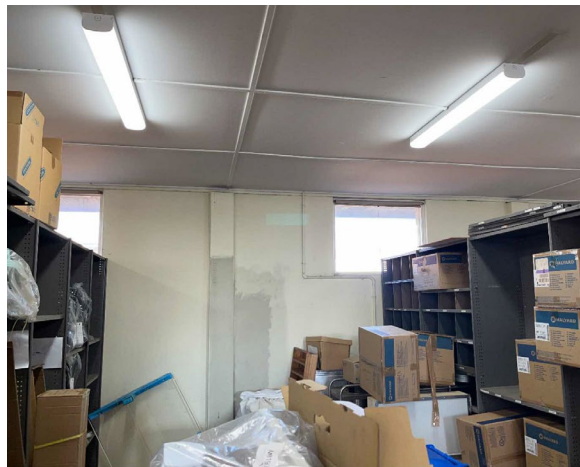
Line ID 13.1: Internal, GF, Storeroom, Wall Lining, Throughout, Cream Paint - Lead Detected (0.03% w/w)

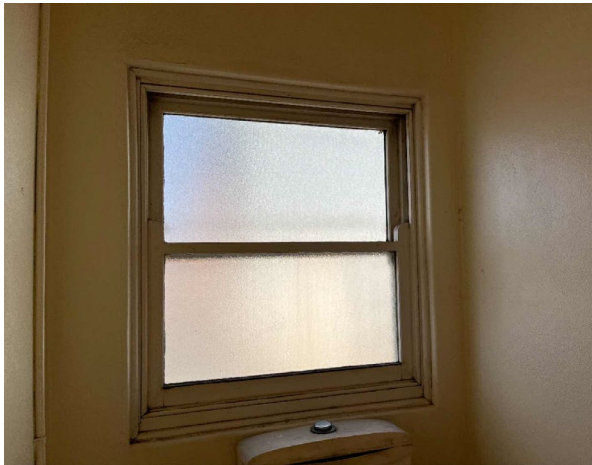
Line ID 14: Internal, GF, Storeroom, Windows & Frames, Various Throughout, White Paint - Lead Detected (0.21% w/w)
