Cessnock Hospital - Pre-Demolition Hazardous Materials Survey Report Summary

Asbestos and Hazardous Materials Pre-Demolition Assessment

Kitchen

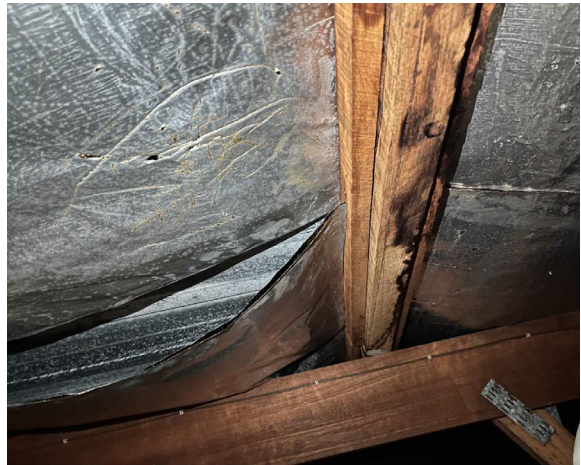
Line ID 16: Internal, GF, Storeroom Ceiling Space, Roof Lining, Sarking Insulation - Suspected SMF

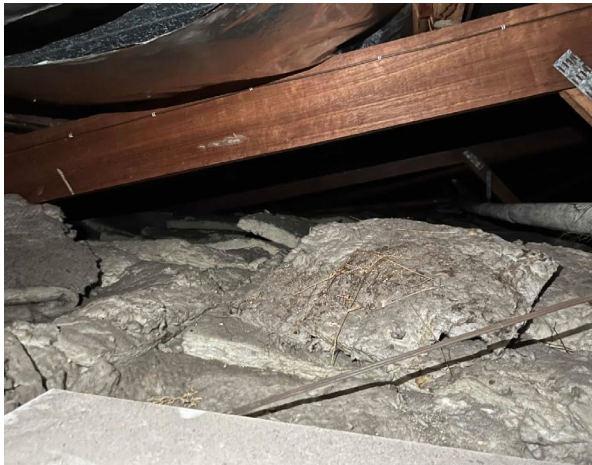
Line ID 17: Internal, GF, Storeroom Ceiling Space, Throughout, Insulation Batts - Suspected SMF

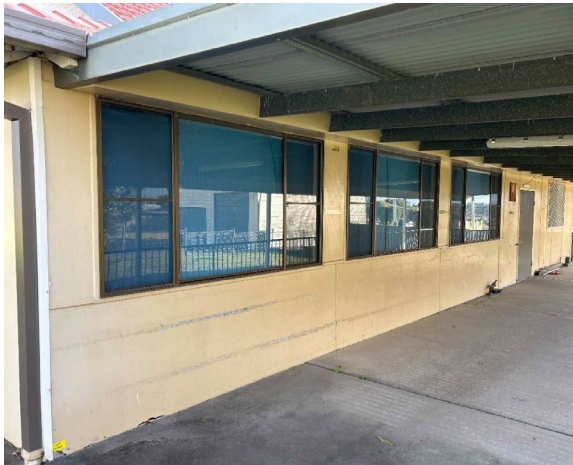
Line ID 1: External, GF, Cessnock House, East Wing, North Wall, Fibre Cement Sheeting - No Asbestos Detected

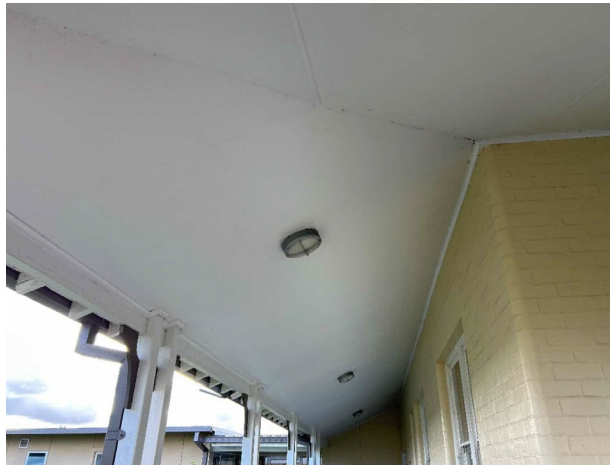
Line ID 2: External, GF, Cessnock House, East Wing, Veranda Ceiling, Fibre Cement Sheeting - No Asbestos Detected

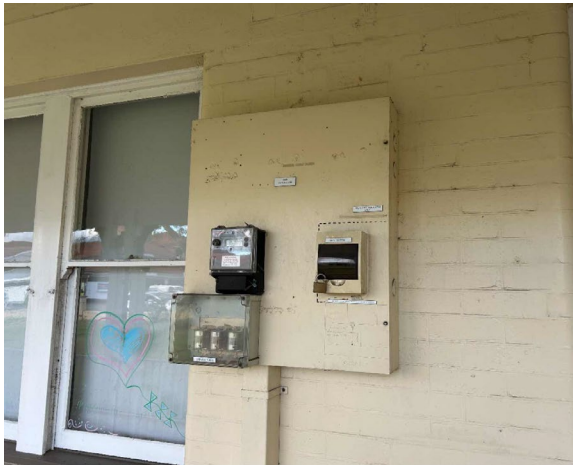
Line ID 3: External, GF, Cessnock House, East Wing, Veranda, Distribution Board, Electrical Components - Suspected Asbestos

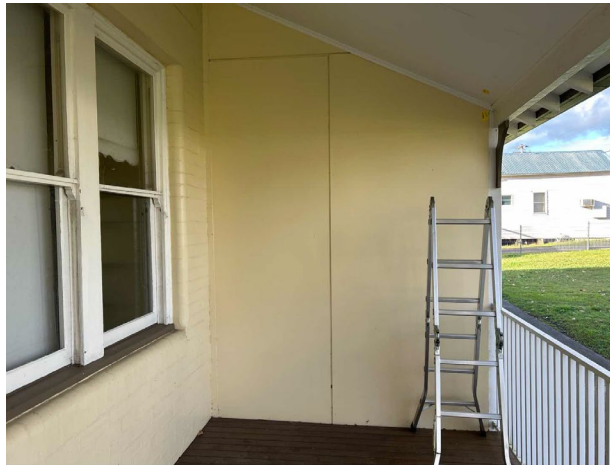
Line ID 4: External, GF, Cessnock House, East Wing, Veranda, East Side, Wall, Fibre Cement Sheeting - No Asbestos Detected

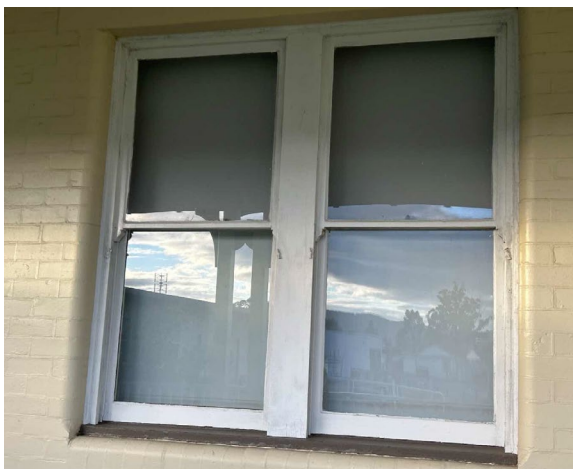
Line ID 5: External, GF, Cessnock House, East Wing, Windows, Window Caulking - No Asbestos Detected

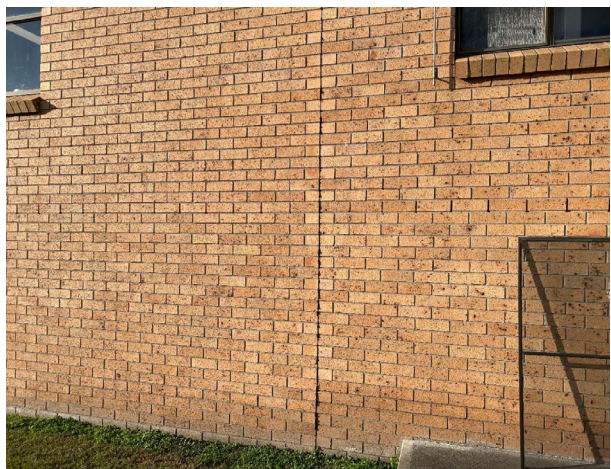
Line ID 6: External, GF, Cessnock House, West Wing, South, Expansion Joint to Wall, Bituminous Material - No Asbestos Detected

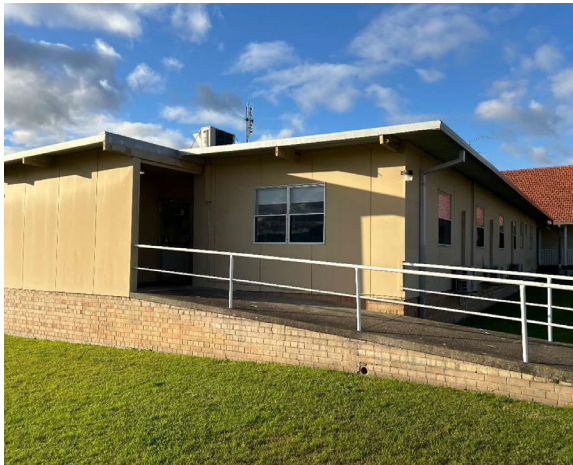
Line ID 7: External, GF, Pathology, South and East Walls, Fibre Cement Sheeting - No Asbestos Detected

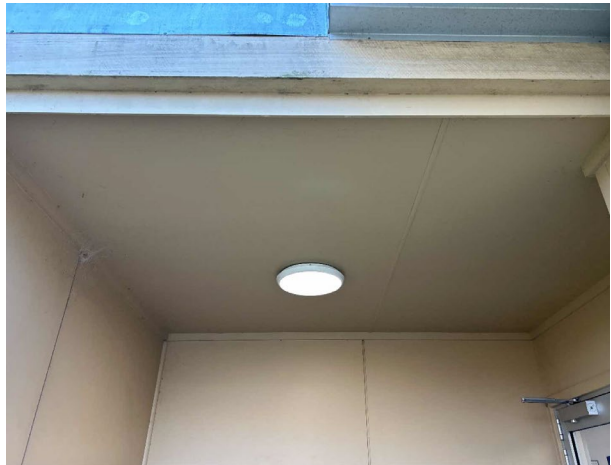
Line ID 8: External, GF, Pathology, Southern Entrance, Ceiling, Fibre Cement Sheeting - No Asbestos Detected

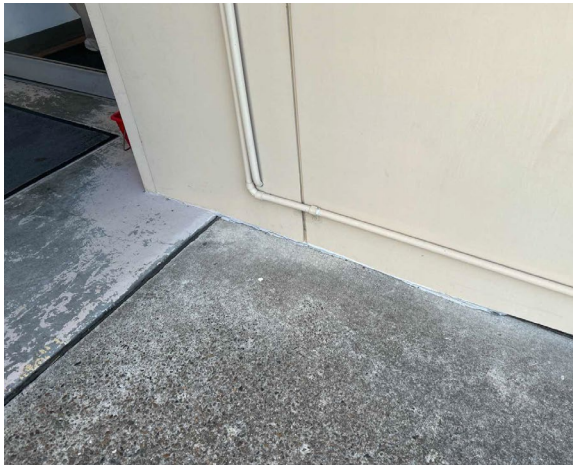
Line ID 9: External, GF, Pathology, Southern Entrance, Expansion Joints to Floor, Mastic Sealant - No Asbestos Detected

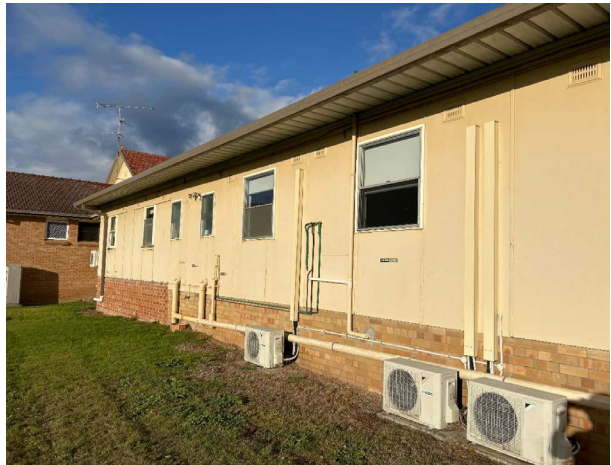
Line ID 10: External, GF, Pathology, West Wall, Fibre Cement Sheeting - Chrysotile Asbestos Detected

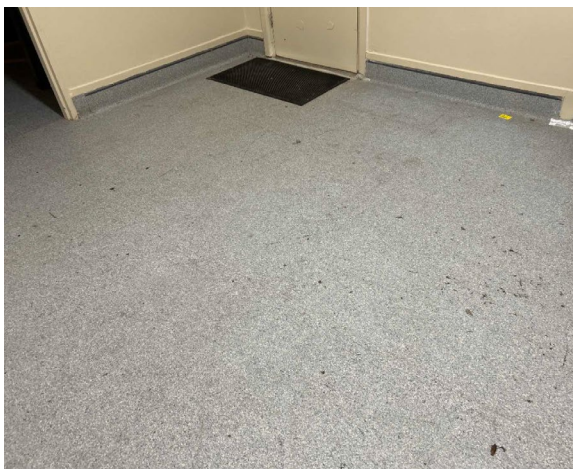
Line ID 11: Internal, GF, Cessnock House, East Wing, All Areas, Floor Below Vinyl Sheeting, Compressed Cement Sheeting - No Asbestos Detected

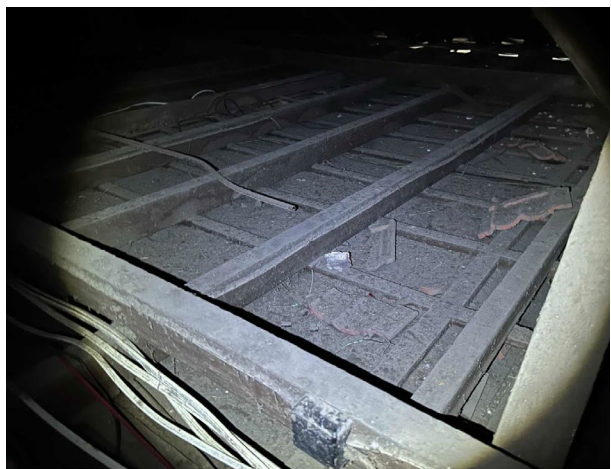
Line ID 12: Internal, GF, Cessnock House, East Wing, Ceiling Space, Dust - No Asbestos Detected

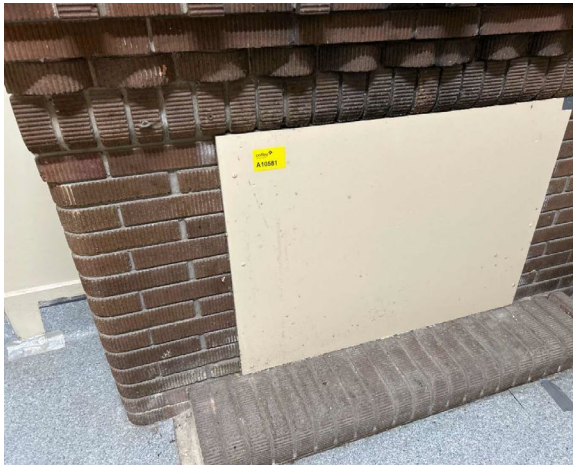
Line ID 13: Internal, GF, Cessnock House, East Wing, Fireplace, Infill Panel, Compressed Cement Sheet - Chrysotile Asbestos Detected

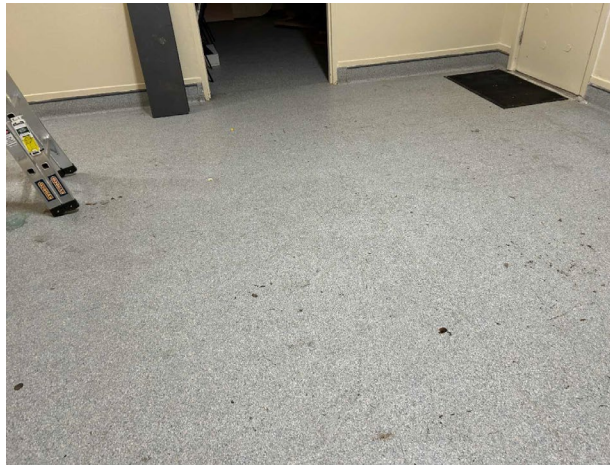
Line ID 14: Internal, GF, Cessnock House, East Wing, Floor Covering, Vinyl Sheet - No Asbestos Suspected

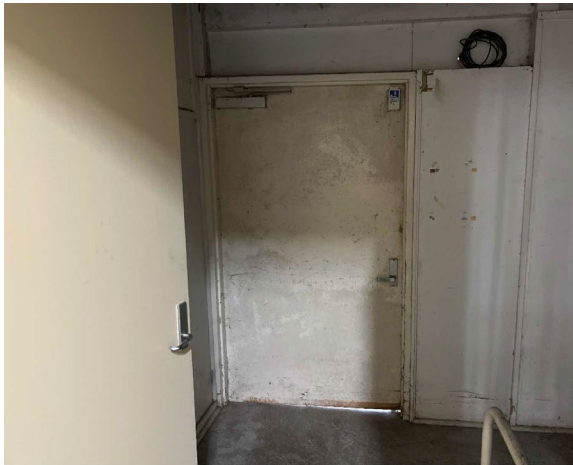
Line ID 15: Internal, GF, Cessnock House, East Wing, Packer, Between Door 8 & Slab, Fibre Cement sheet - No Asbestos Detected

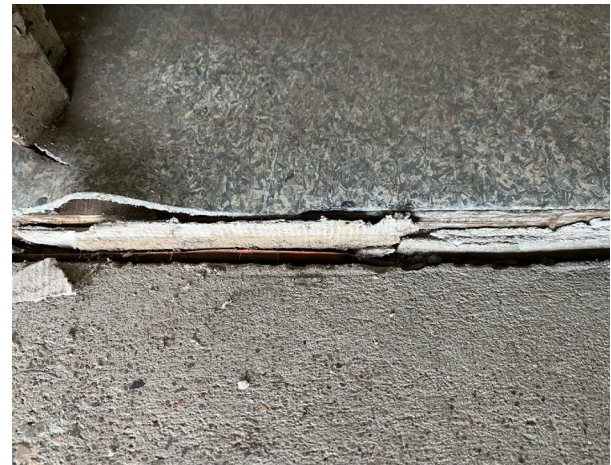
Line ID 15.1: Internal, GF, Cessnock House, East Wing, Packer, Between Door 8 & Slab, Fibre Cement sheet - No Asbestos Detected

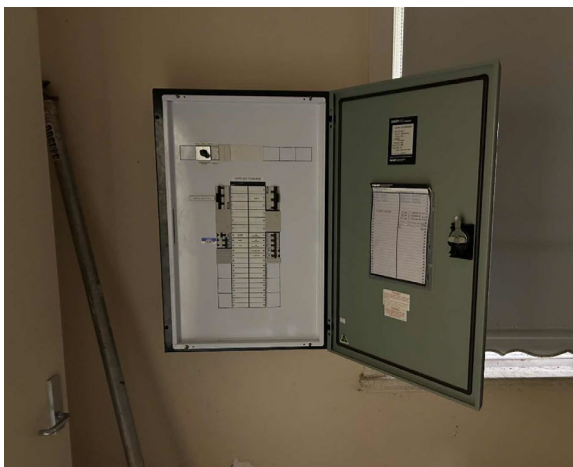
Line ID 16: Internal, GF, Cessnock House, East Wing, Southeast Room, Distribution Board, Electrical Components - Suspected Asbestos

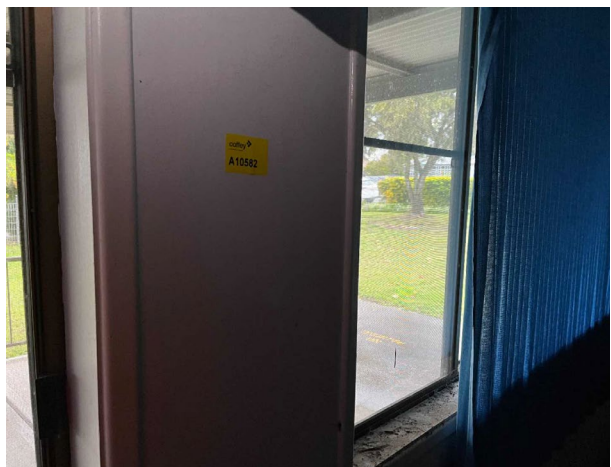
Line ID 17: Internal, GF, Cessnock House, East Wing, Sunroom Infill Panels, Between Windows, Fibre Cement Sheeting - No Asbestos Detected

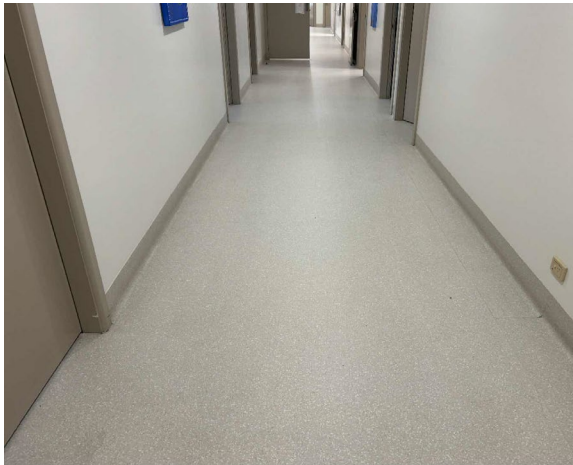
Line ID 18: Internal, GF, Cessnock House, West Wing, All Areas, Floor Covering, Vinyl Sheet - No Asbestos Suspected

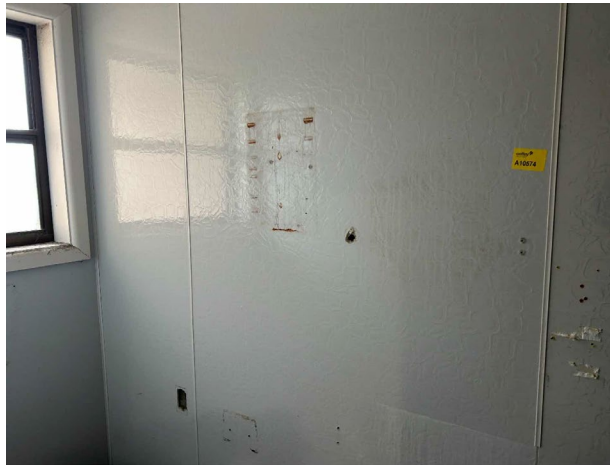
Line ID 19: Internal, GF, Cessnock House, West Wing, Comms Cupboard 0017, Walls, Fibre Cement Sheeting - No Asbestos Detected

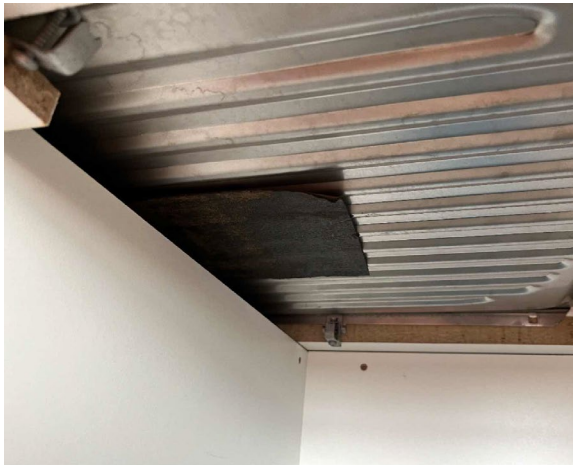
Line ID 20: Internal, GF, Pathology, Staff Room, Sink Pad, Bituminous Material - Chrysotile Asbestos Detected

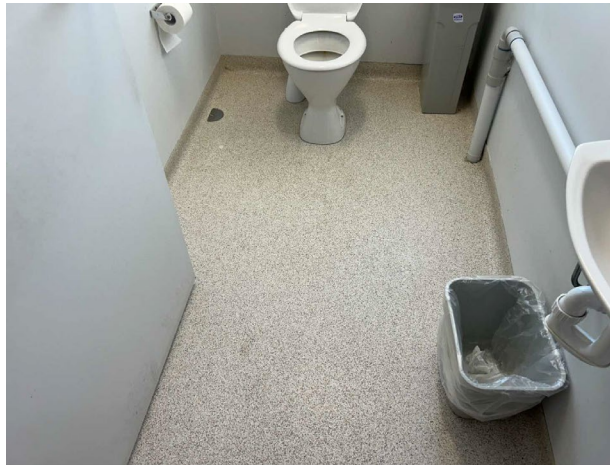
Line ID 21: Internal, GF, Pathology, Toilets, Floor Covering, Vinyl Sheet (Cream) - No Asbestos Suspected

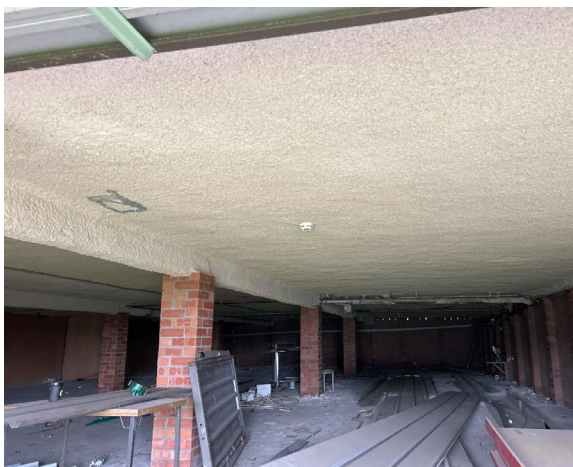
Line ID 22: Internal, Basement, Storage Area, Ceiling and Beams, Sprayed Vermiculite - No Asbestos Detected

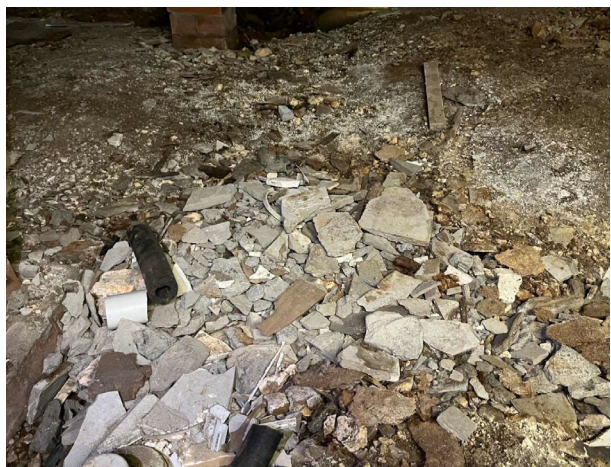
Line ID 23: Internal, Basement, Storage Area, Subfloor, Fibre Cement Debris - No Asbestos Detected

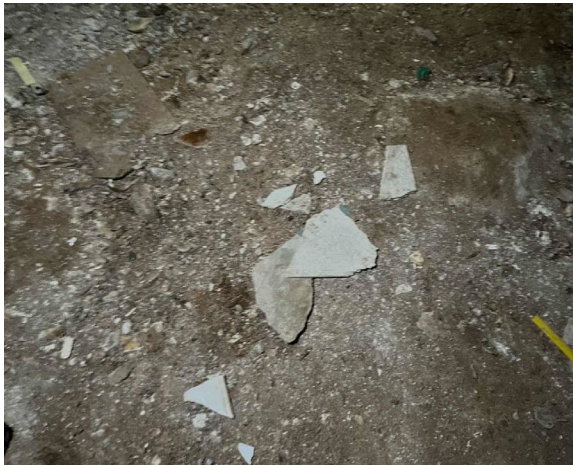
Line ID 24: Internal, Basement, Storage Area, Subfloor, Fibre Cement Debris - No Asbestos Detected

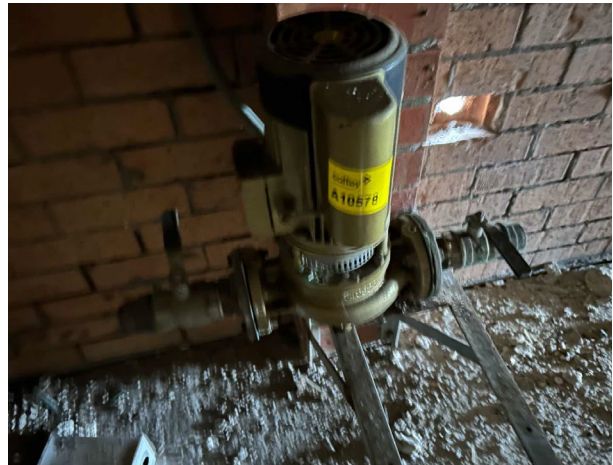
Line ID 25: Internal, Basement, Storage Area, West, Pump, Gasket Material - No Asbestos Detected

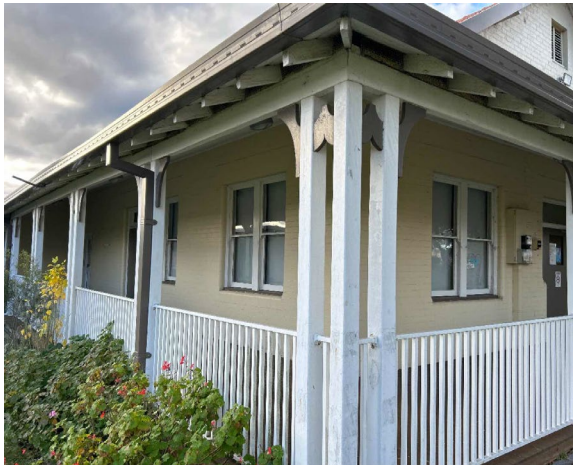
Line ID 26: External, GF, Cessnock House, East Wing, Veranda, Timberwork, White Paint - Lead Detected (2.6 % w/w)

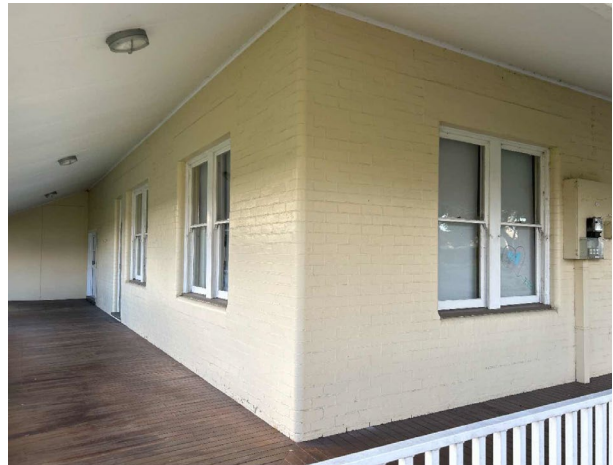
Line ID 27: External, GF, Cessnock House, East Wing, Walls, Cream Paint - Lead Detected (0.02% w/w)

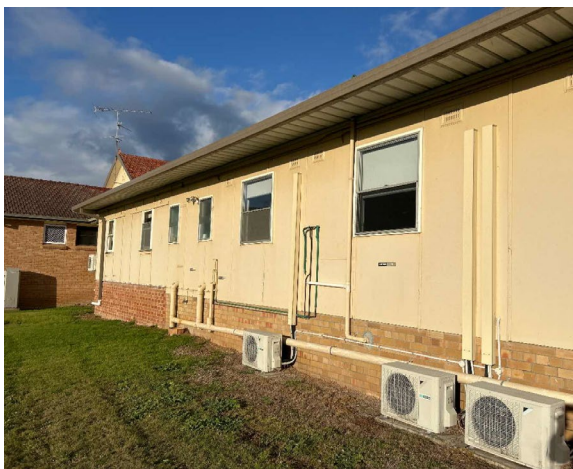
Line ID 28: External, GF, Pathology, South Wall, Cream Paint - Lead Detected (0.19% w/w)

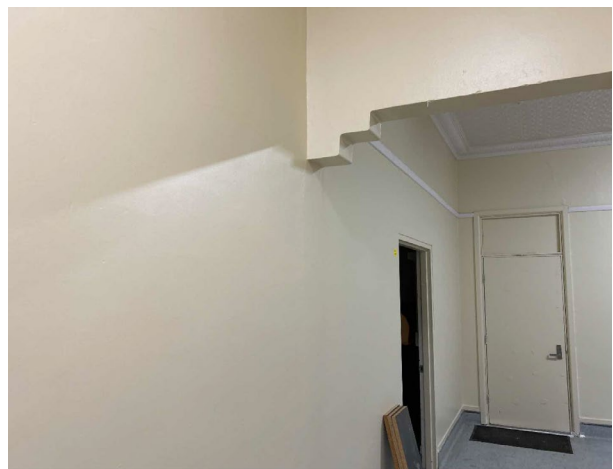
Line ID 29: Internal, GF, Cessnock House, East Wing, Walls, Cream Paint - Lead Detected (0.02% w/w)

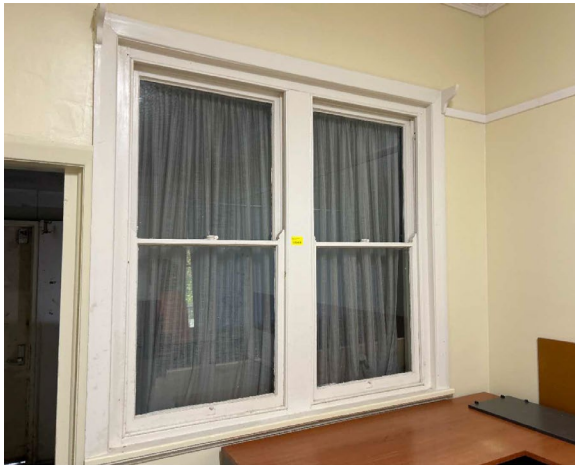
Line ID 30: Internal, GF, Cessnock House, East Wing, Window Frames, White Paint - Lead Detected (2.0% w/w)

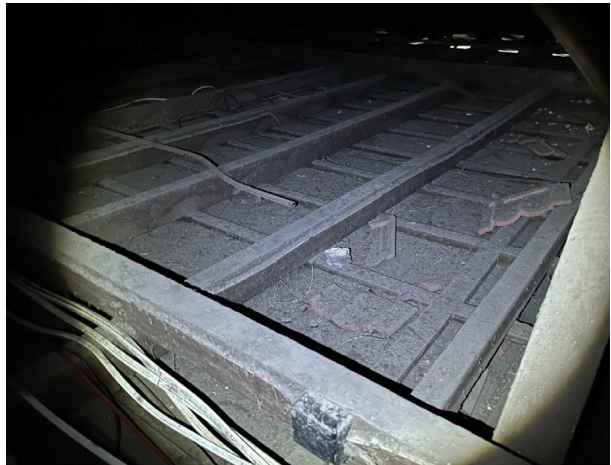
Line ID 31: Internal, GF, Cessnock House, East Wing, Ceiling Space, Dust - Lead Detected (990 mg/kg)

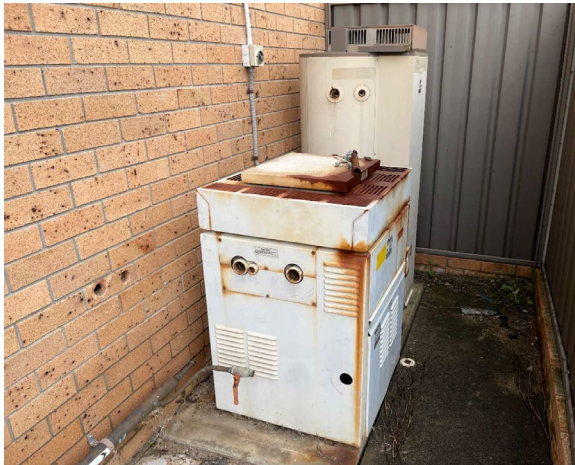
Line ID 32: External, GF, Cessnock House, West Wing, Hot Water Heater, Insulation Material - Suspected SMF

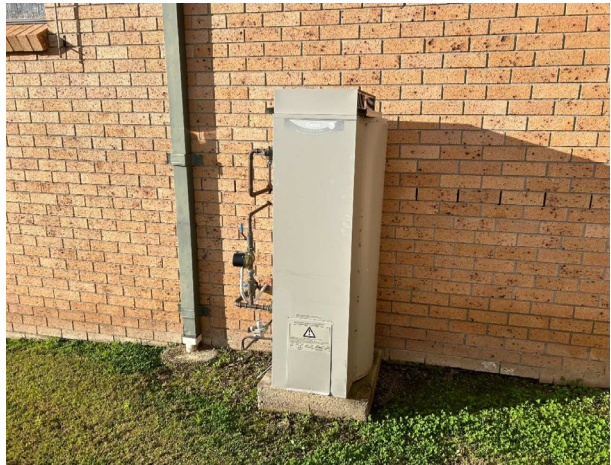
Line ID 33: External, GF, Cessnock House, West Wing, South, Water Heater, Insulation Material - Suspected SMF

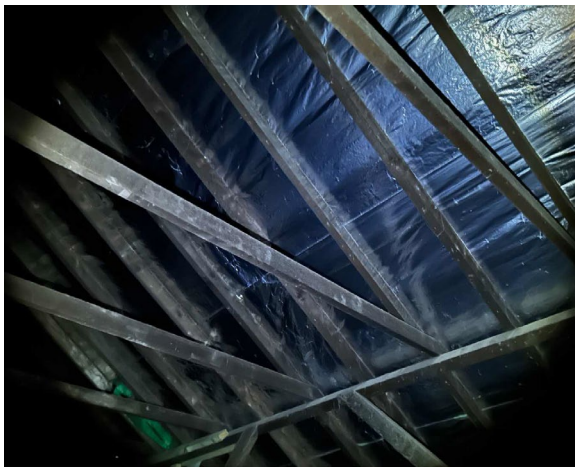
Line ID 34: Internal, GF, Cessnock House, East Wing, Ceiling Space, Sarking Insulation - Suspected SMF

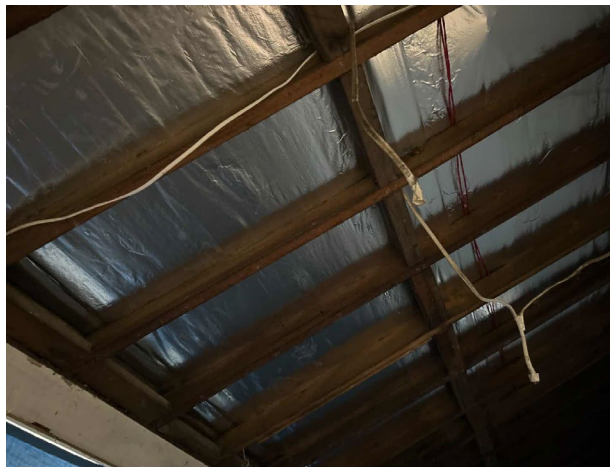
Line ID 35: Internal, GF, Cessnock House, East Wing, Northeast Covered Veranda Room, Ceiling, Sarking Insulation - Suspected SMF

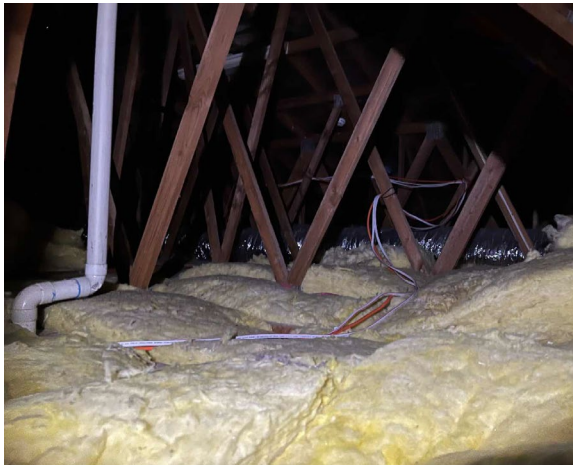
Line ID 36: Internal, GF, Cessnock House, West Wing
- Ceiling Space, Flexible Ductwork, Insulation Material
- Suspected SMF

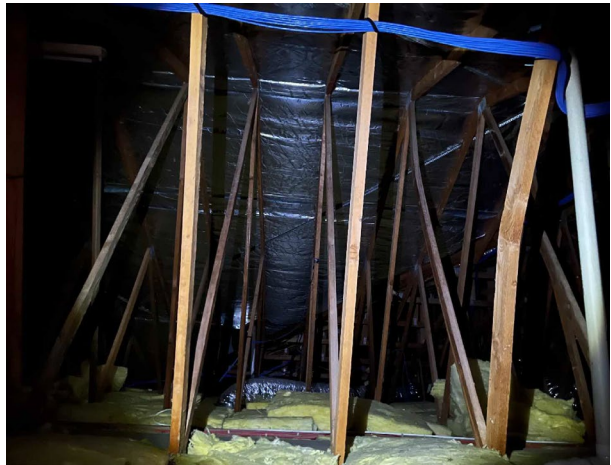
Line ID 37: Internal, GF, Cessnock House, West Wing -
Ceiling Space, Roof Lining, Sarking Insulation - Suspected
SMF

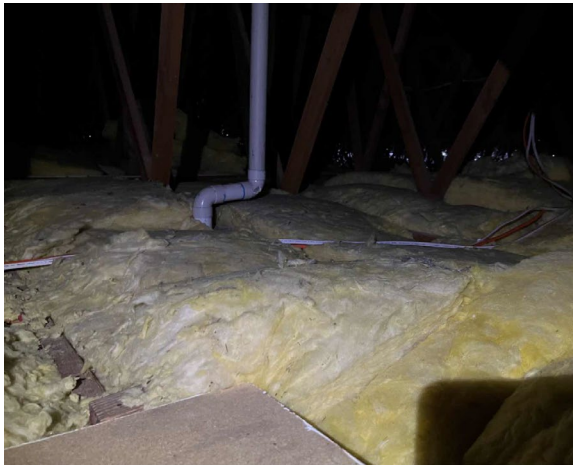
Line ID 38: Internal, GF, Cessnock House, West Wing
- Ceiling Space, Throughout, Insulation Batt's -
Suspected SMF

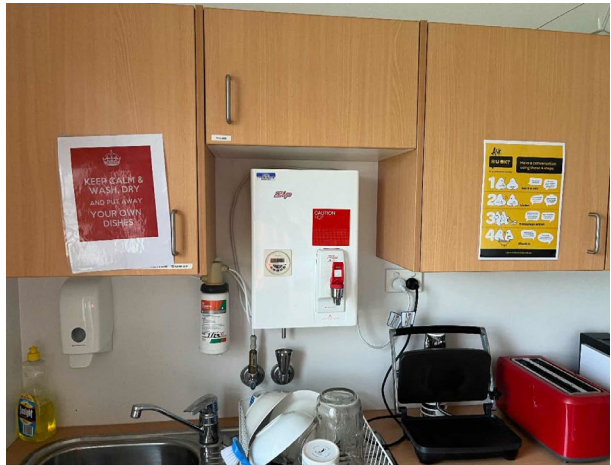
Line ID 39: Internal, GF, Cessnock House, West Wing - Staff
Kitchen, Hot Water Heater, Above Sink, Insulation Material -
Suspected SMF

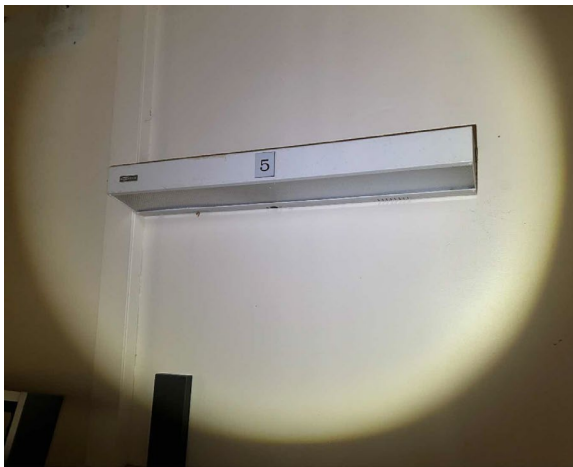
Line ID 40: Internal, GF, Cessnock House, East Wing,
Original Wall Light Fittings, Capacitor(s) - Suspected
PCB

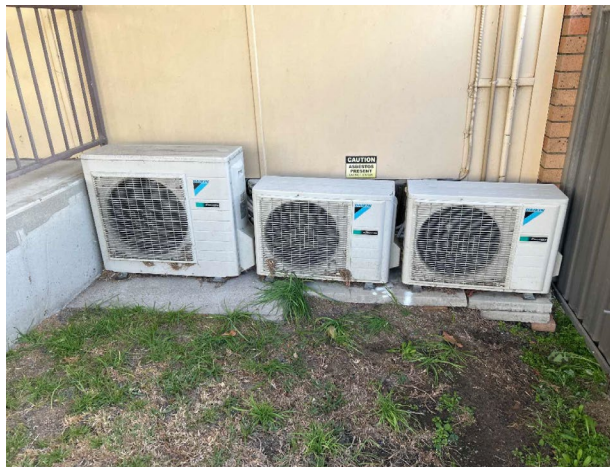
Line ID 41: External, GF, Cessnock House, East Wing, North,
AC Units, R410A Hydrofluorocarbon (HFC) - Non ODS
Refrigerant

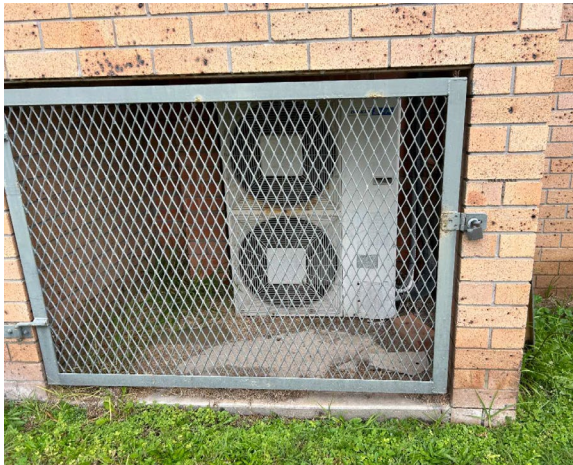
Line ID 42: External, GF, Cessnock House, West Wing, North Side, Below Stairs, AC Units, R22 Hydrochlorofluorocarbon (HCFC) - ODS Refrigerant

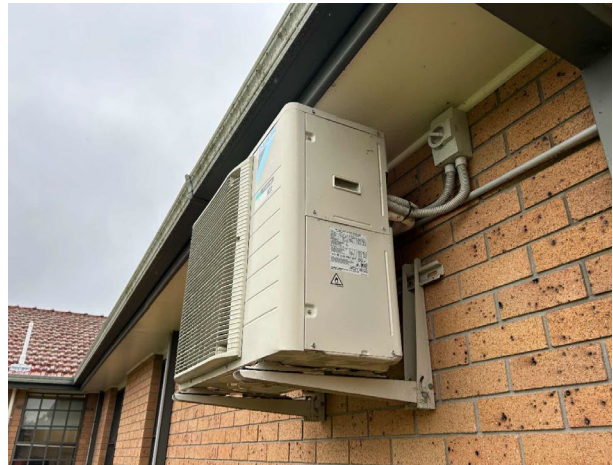
Line ID 43: External, GF, Cessnock House, West Wing, North, AC Units, R32 Refrigerant - Non ODS Refrigerant

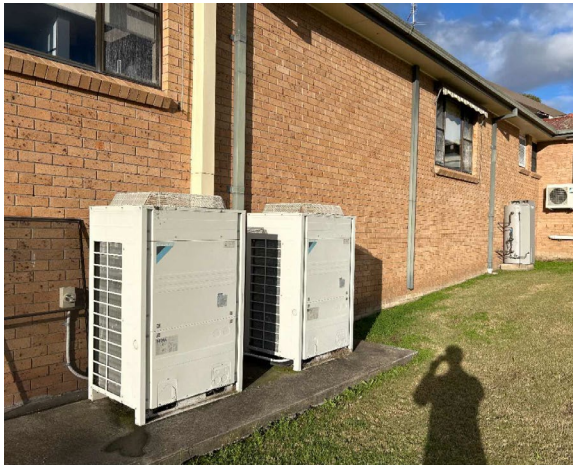
Line ID 44: External, GF, Cessnock House, West Wing, South, AC Units, R410A Hydrofluorocarbon (HFC) - Non ODS Refrigerant

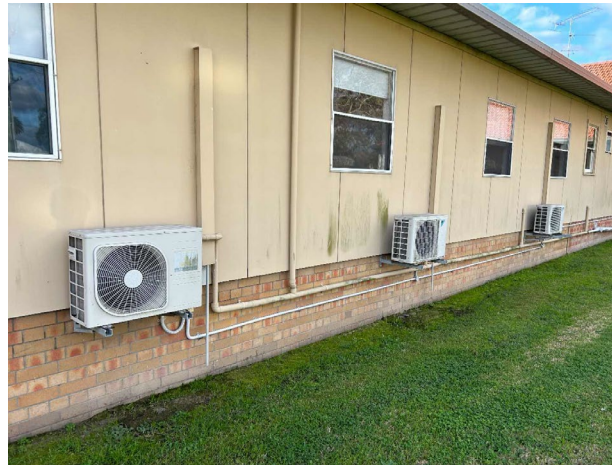
Line ID 45: External, GF, Pathology, East and West, AC Units, R410A Hydrofluorocarbon (HFC) - Non ODS Refrigerant

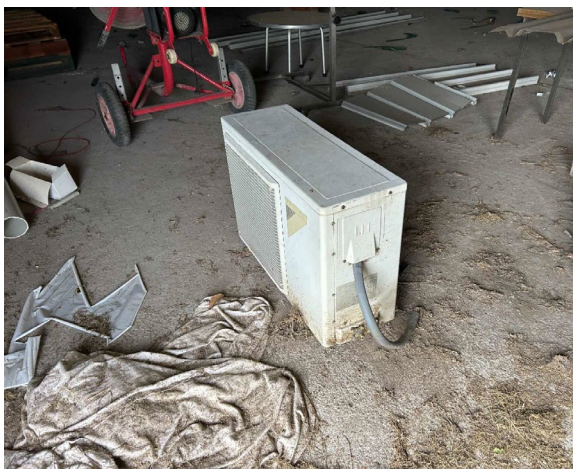
Line ID 46: Internal, Basement, Storage Area, Adjacent Entrance, Redundant AC Unit, R22 Hydrochlorofluorocarbon (HCFC) - ODS Refrigerant

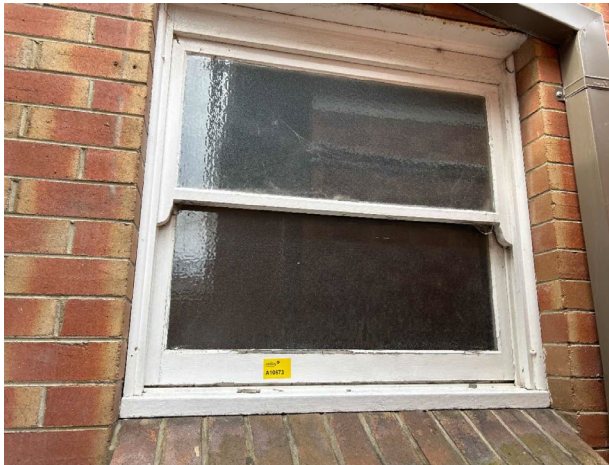
Line ID 1: External, GF, Central Wing, Central Courtyard, Timber Window Frames, Window Caulking - No Asbestos Detected

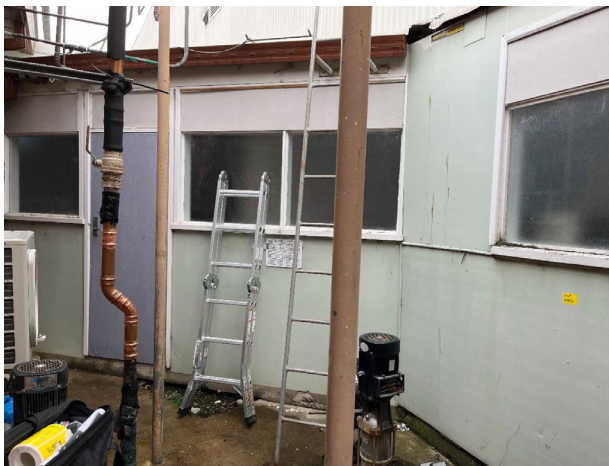
Line ID 2.1: External, GF, Central Wing, Central Courtyard, Wall Lining, Entry, Fibre Cement Sheeting - Chrysotile, Amosite and Crocidolite Asbestos Detected

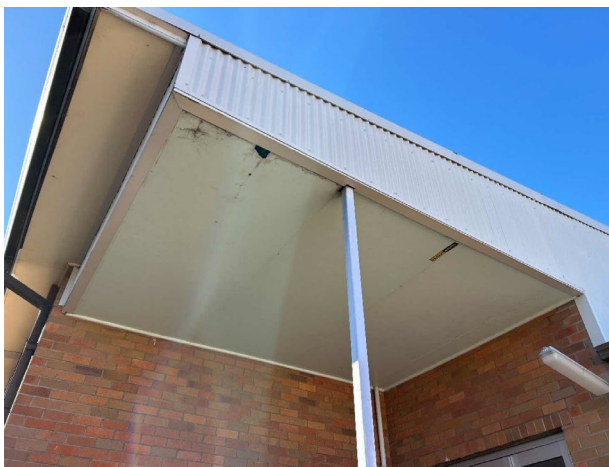
Line ID 4: External, GF, Central Wing, North Side, Entrance Awning Adjacent Room 1048, Fibre Cement Sheeting - No Asbestos Detected

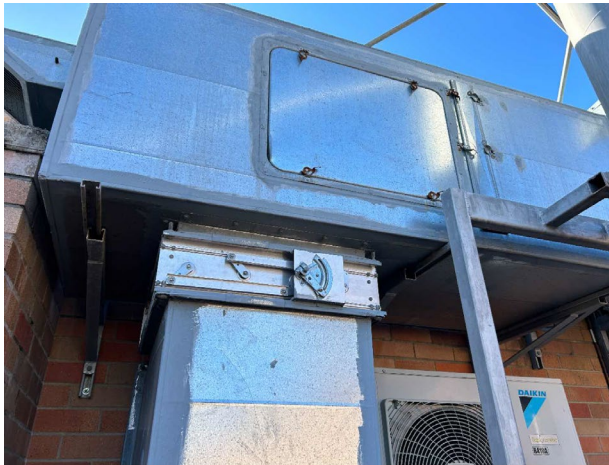
Line ID 6: External, GF, Central Wing, Northern Boiler Area, Ductwork Flange Joints, Mastic Sealant - No Asbestos Detected

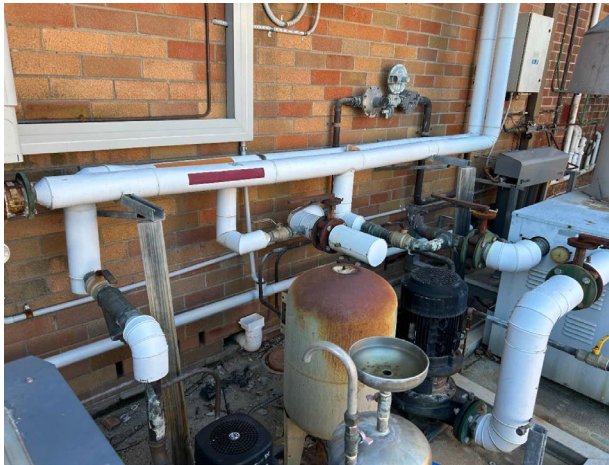
Line ID 8: External, GF, Central Wing, Northern Boiler Area, Metal Encased Pipework, Lagging - Suspected Asbestos

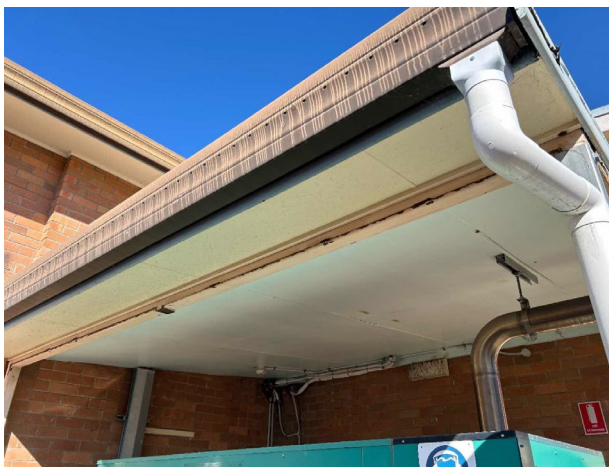
Line ID 10: External, GF, Central Wing, Northern Generator Awning, Fibre Cement Sheetting - No Asbestos Detected

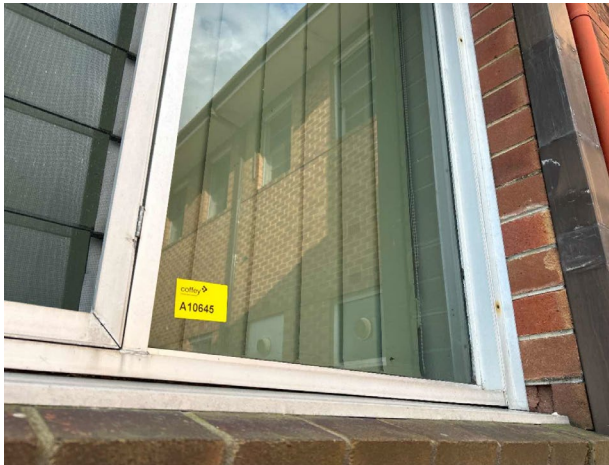
Line ID 12: External, GF, Central Wing, South Side, Metal Window Frames, Window Caulking - Chrysotile Asbestos Detected

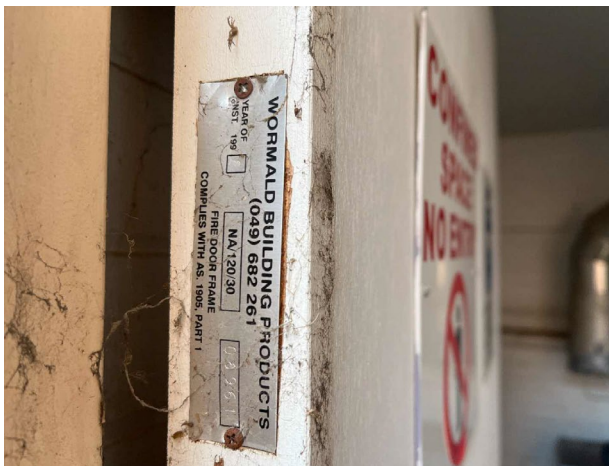
Line ID 13.1: External, GF, Central Wing, Southeast Side, Plant Room, Entrance Door, Fire Door Core - Suspected Asbestos

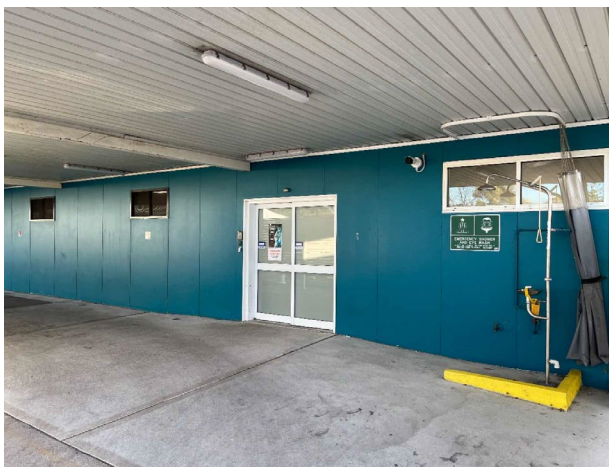
Line ID 15: External, GF, ED Wing, Emergency Entrance, Wall lining, Southwest, Compressed Cement Sheeting - No Asbestos Detected

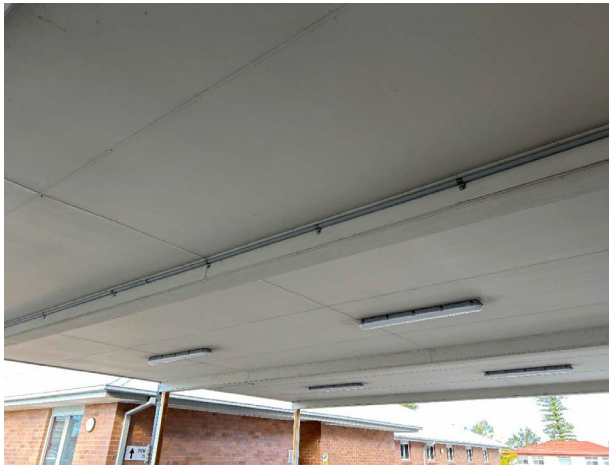
Line ID 17: External, GF, ED Wing, Main Entrance, Awning, Fibre Cement Sheeting - No Asbestos Detected

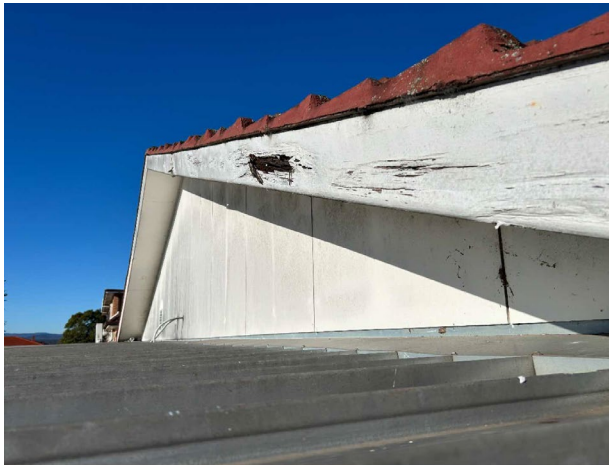
Line ID 19: External, GF, ED Wing, Roof, East and West Sides, Infill Panels Below Roof Gable, Fibre Cement Sheeting - Chrysotile Asbestos Detected

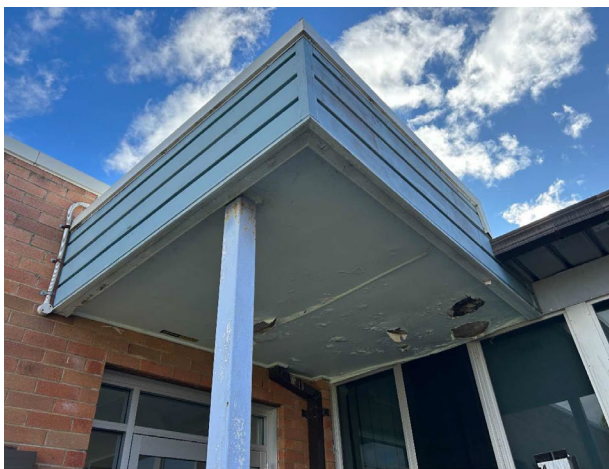
Line ID 21: External, GF, West Wing, Eastern Entrance Awning, Adjacent Room 1171, Fibre Cement Sheeting - Chrysotile & Amosite Asbestos Detected

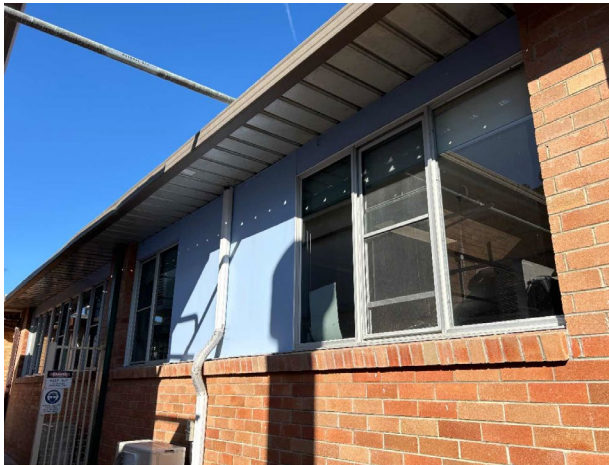
Line ID 23: External, GF, West Wing, North Section, Infill Panels Above Windows, Fibre Cement Sheetting - No Asbestos Detected

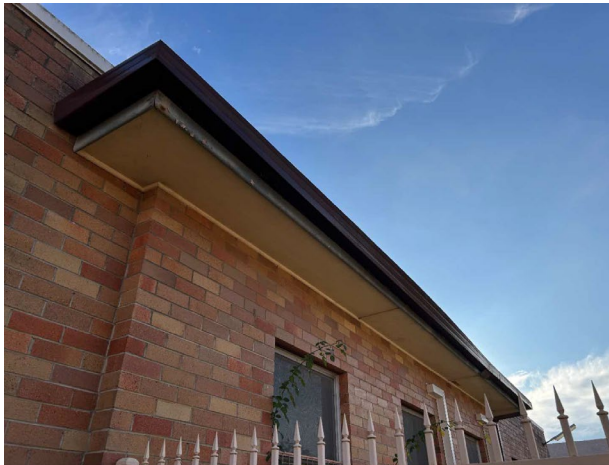
Line ID 24: External, GF, West Wing, South Side, Eaves, Fibre Cement Sheetting - Chrysotile Asbestos Detected

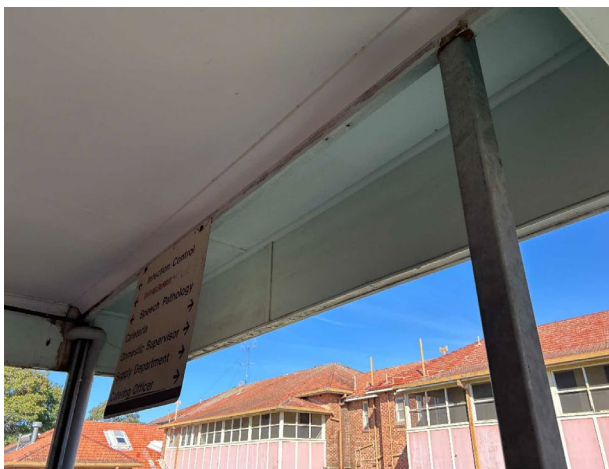
Line ID 25.1: External, GF, West Wing, Western Covered Area Adjacent Kitchen, Awning and Infill Panels, Fibre Cement Sheetting - Chrysotile Asbestos Detected

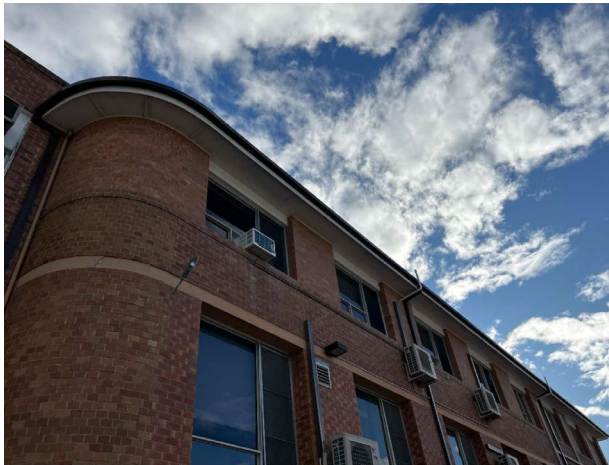
Line ID 27: External, L1, Southeast Wing, Throughout, Eaves, Fibre Cement Sheeting - Chrysotile Asbestos Detected

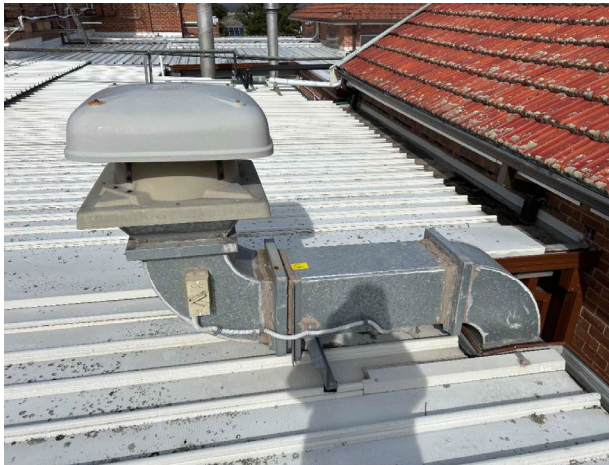
Line ID 28: External, Roof, Central Wing, North Section, Central Area, Ductwork Flange Joints, Mastic Sealant - No Asbestos Detected

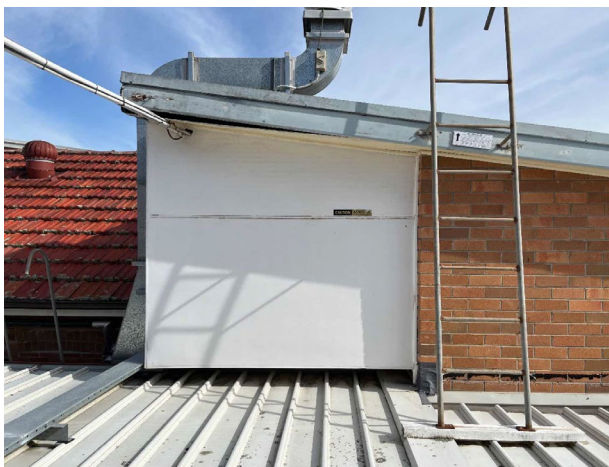
Line ID 30: External, Roof, Central Wing, North Section, Infill Panel, Adjacent Ladder Access, Fibre Cement Sheeting - No Asbestos Detected

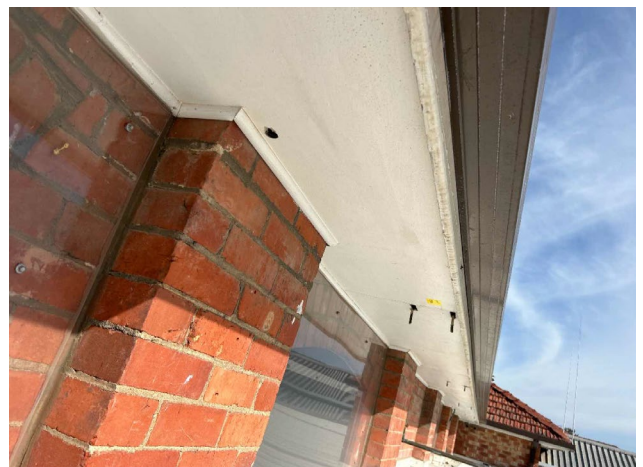
Line ID 31: External, Roof, Central Wing, South Section, Eaves, Fibre Cement Sheeting - No Asbestos Detected

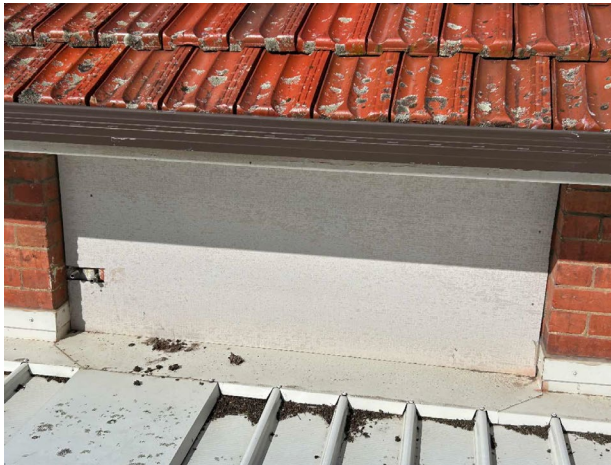
Line ID 32: External, Roof, Central Wing, South Section, North Side, Infill Panel, Fibre Cement Sheeting - None Suspected

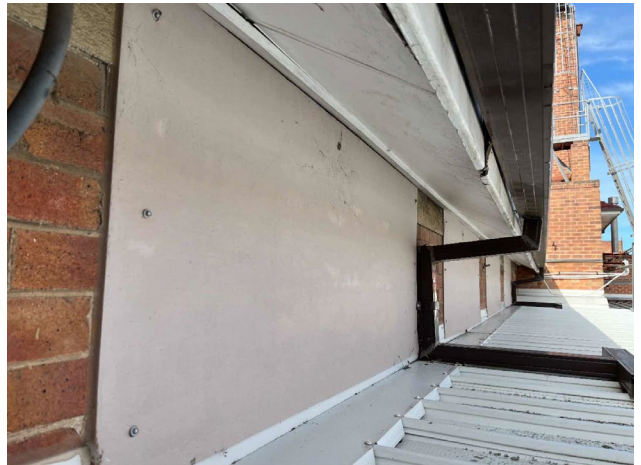
Line ID 33: External, Roof, ED Wing, Eaves, Throughout, Fibre Cement Sheeting - No Asbestos Detected

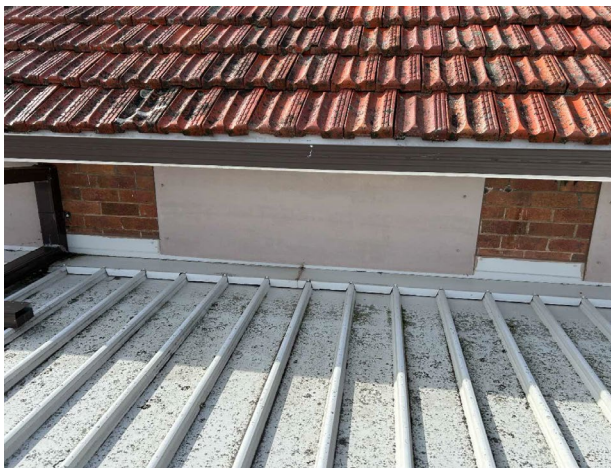
Line ID 34: External, Roof, ED Wing, West Side, Infill Panels, Fibre Cement Sheeting - None Suspected

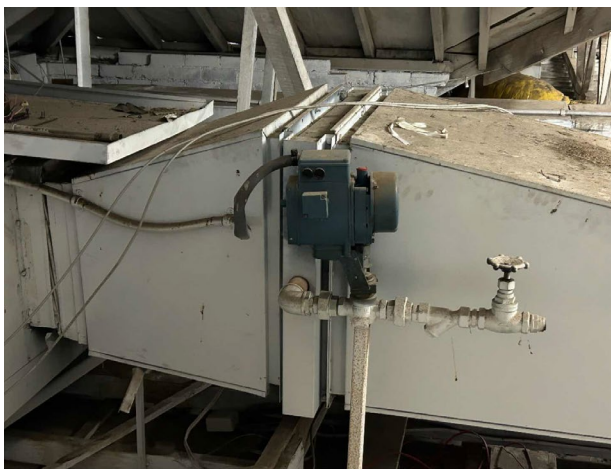
Line ID 36: Internal, GF, All Areas, Ceiling Space, Various Throughout, Heater Banks to AC Ducting, Internal Lining, Millboard Insulation - Suspected Asbestos

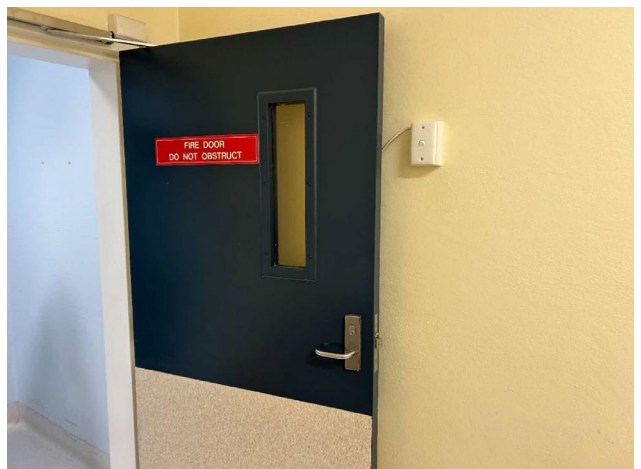
Line ID 37: Internal, GF, All Areas, Various Throughout, Doors, Fire Door Core - None Suspected

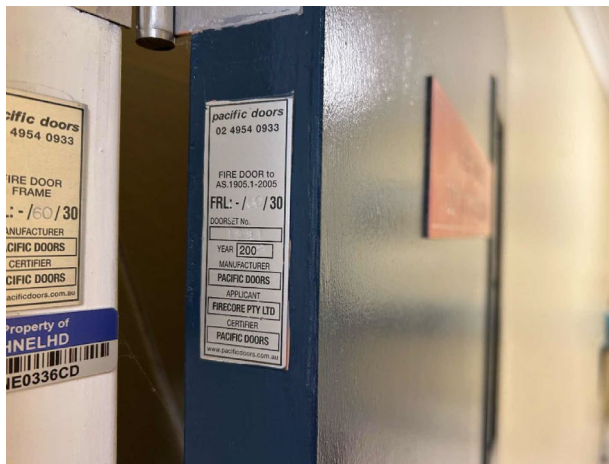
Line ID 37.1: Internal, GF, All Areas, Various Throughout, Doors, Fire Door Core - None Suspected
