Cessnock Hospital - Pre-Demolition Hazardous Materials Survey Report Summary

Asbestos and Hazardous Materials Pre-Demolition Assessment

Kitchen

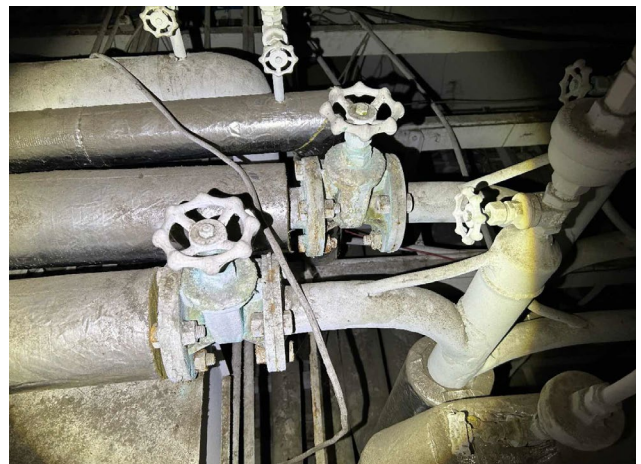
Line ID 38: Internal, GF, Central Wing, Day Surgery/Recovery, Ceiling Space Above Reception Area, Pipework, Gasket Material - Chrysotile Asbestos Detected

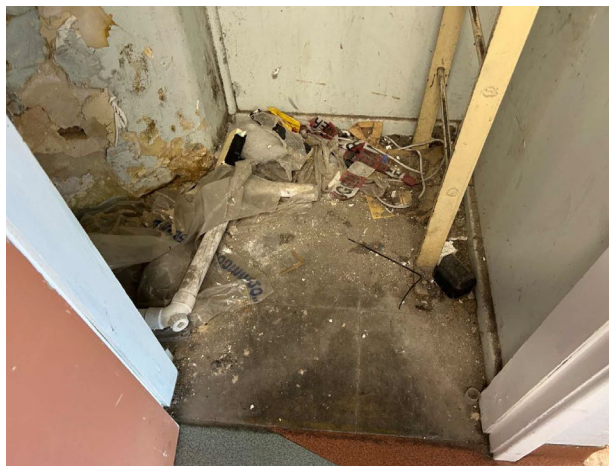
Line ID 39: Internal, GF, Central Wing, Day Surgery/Recovery, Ceiling Space Ladder Access Point Adjacent Reception, Floor Covering, Vinyl Floor Tiles - Chrysotile Asbestos Detected

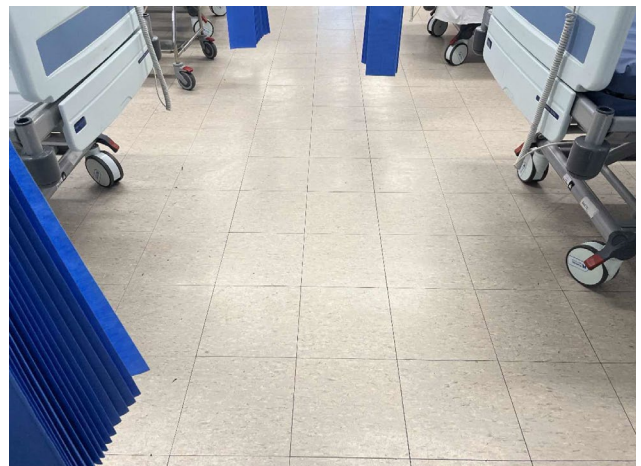
Line ID 40: Internal, GF, Central Wing, Day Surgery/Recovery, Floor covering, Throughout, Vinyl Floor Tiles (white with grey specks) - Chrysotile Asbestos Detected

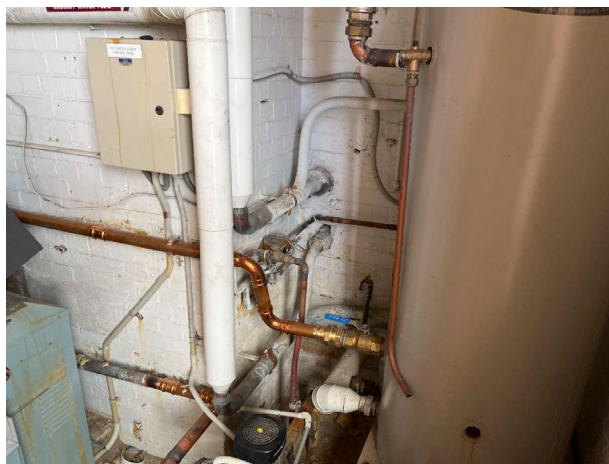
Line ID 41: Internal, GF, Central Wing, Day Surgery/Recovery, Plant Room, Penetration, Pipework, Lagging - Amosite Asbestos Detected

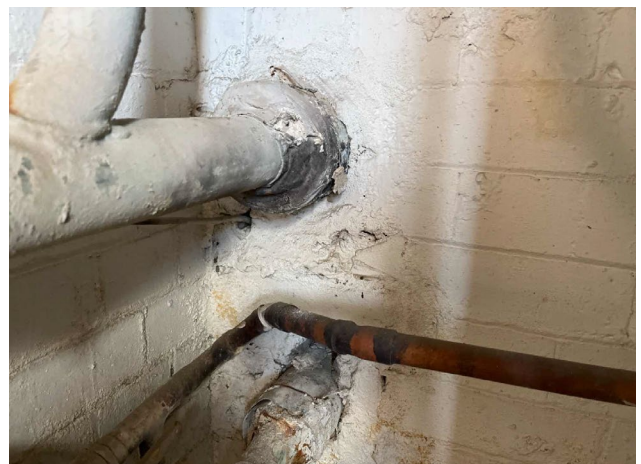
Line ID 41.1: Internal, GF, Central Wing, Day Surgery/Recovery, Plant Room, Penetration, Pipework, Lagging - Amosite Asbestos Detected

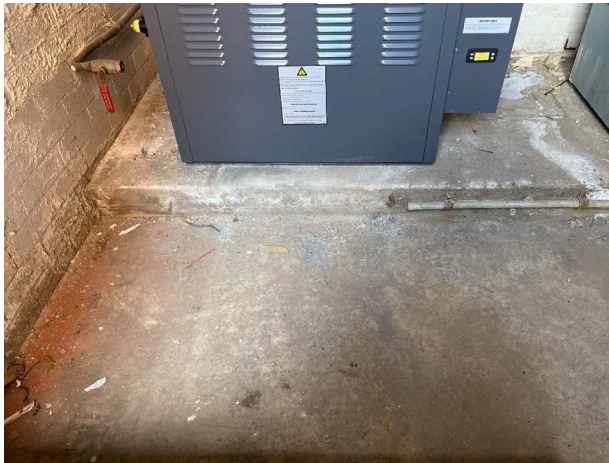
Line ID 42: Internal, GF, Central Wing, Day Surgery/Recovery, Plant Room, Throughout, Dust - No Asbestos Detected

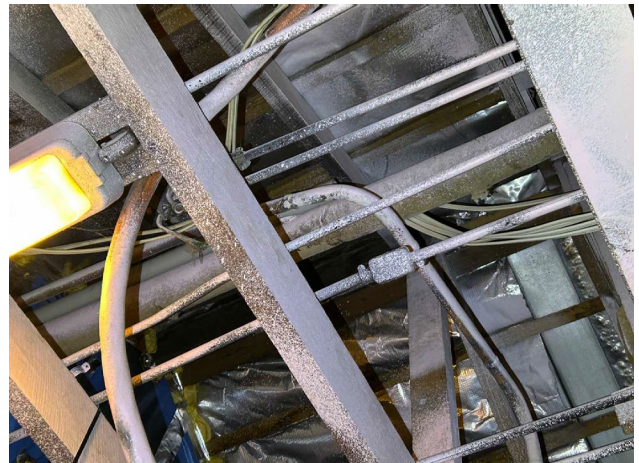
Line ID 43: Internal, GF, Central Wing, North Section, Ceiling Space Above Plant Room 1073, Pipework, Lagging - Amosite Asbestos Detected

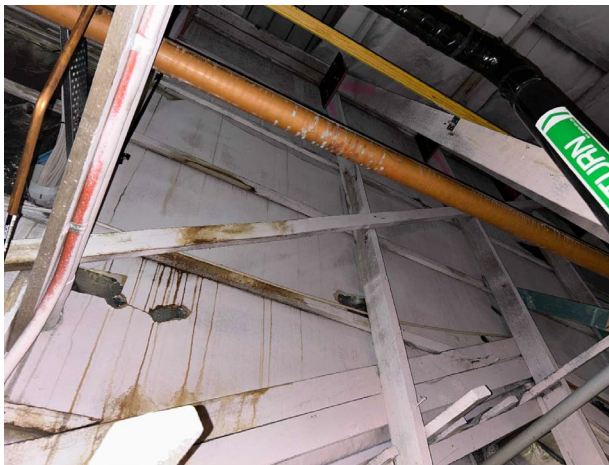
Line ID 44: Internal, GF, Central Wing, North Section, Ceiling Space, South and East Sides, Walls, Fibre Cement Sheeting – Suspected Asbestos

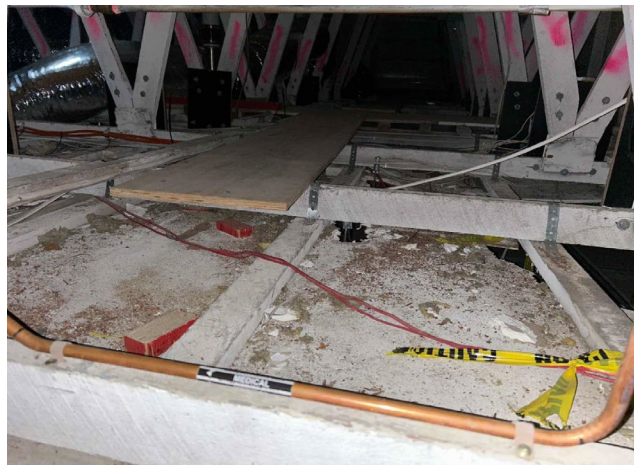
Line ID 45: Internal, GF, Central Wing, North Section, Ceiling Space, Throughout, Dust - No Asbestos Detected

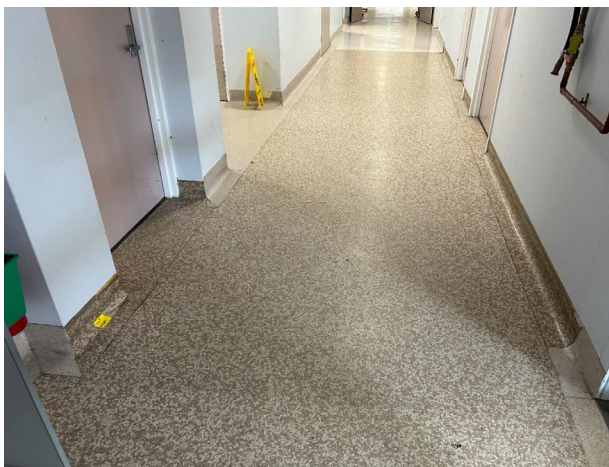
Line ID 47: Internal, GF, Central Wing, North Section, Corridor 1031, Floor Covering, Fibrous Backed Vinyl Sheet - No Asbestos Detected

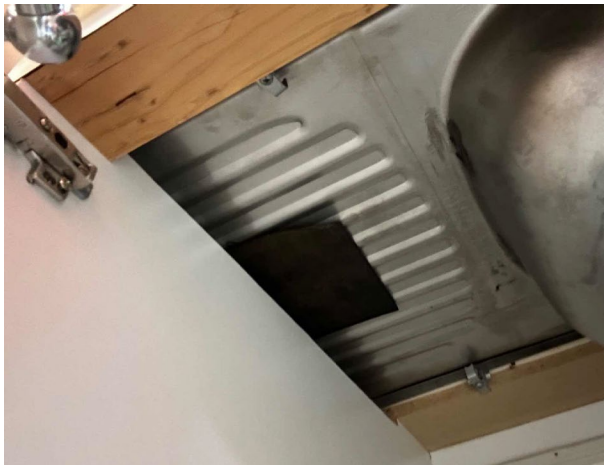
Line ID 49: Internal, GF, Central Wing, North Section, Pharmacy 1075, Sink Pad, Bituminous Material - Chrysotile Asbestos Detected

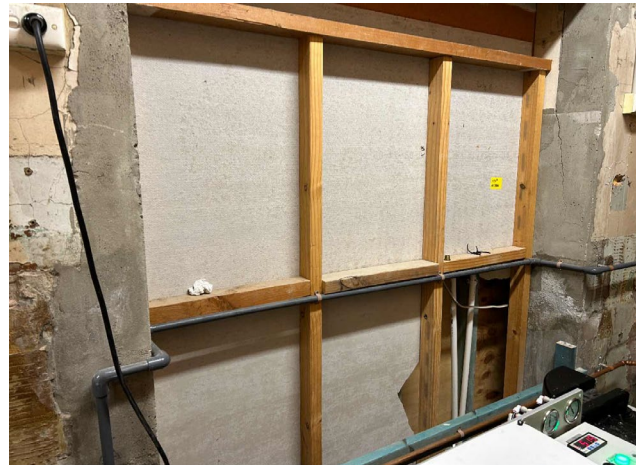
Line ID 50: Internal, GF, Central Wing, North Section, Plant Room 1060, Infill Panels, Fibre Cement Sheetting - No Asbestos Detected

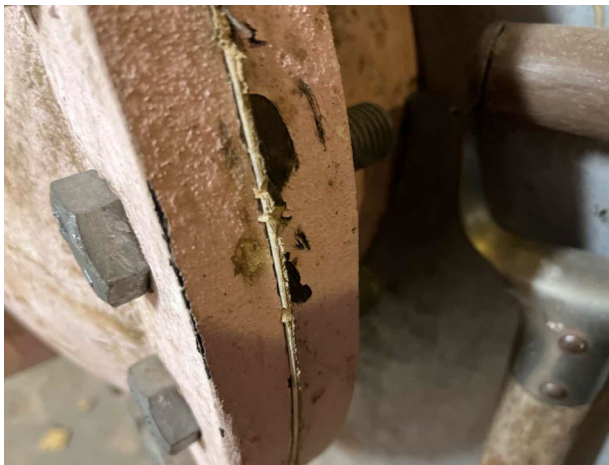
Line ID 51: Internal, GF, Central Wing, North Section, Plant Room 1073, Boiler, Large Gasket, Gasket Material - Chrysotile Asbestos Detected

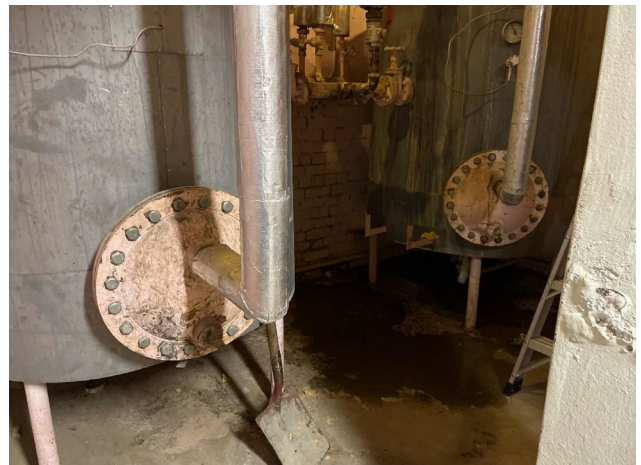
Line ID 51.1: Internal, GF, Central Wing, North Section, Plant Room 1073, Boiler, Large Gasket, Gasket Material - Chrysotile Asbestos Detected

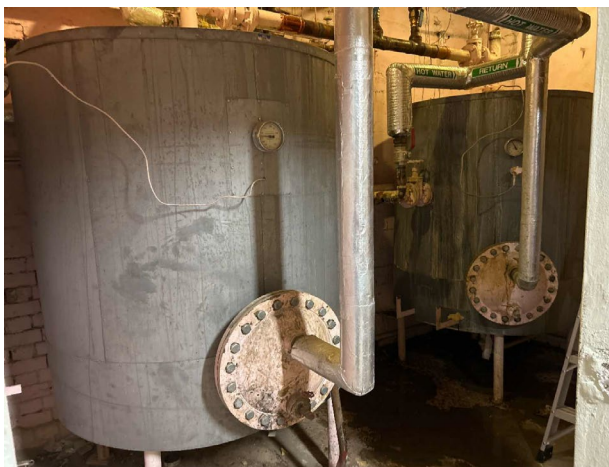
Line ID 52: Internal, GF, Central Wing, North Section, Plant Room 1073, Boilers, Insulation - Suspected Asbestos

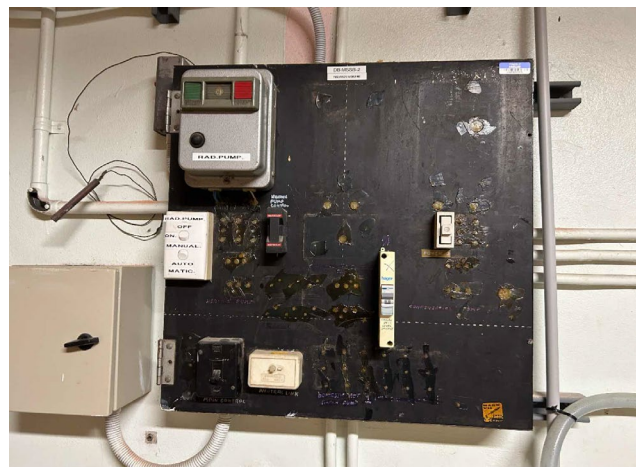
Line ID 53: Internal, GF, Central Wing, North Section, Plant Room 1073, Electrical Switch Board, Bituminous Backing Board - Suspected Asbestos

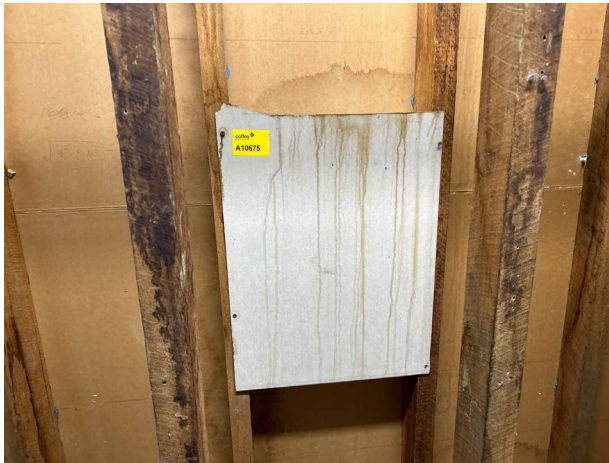
Line ID 54: Internal, GF, Central Wing, North Section, Plant Room 1073, Infill Panels, Fibre Cement Sheeting - No Asbestos Detected

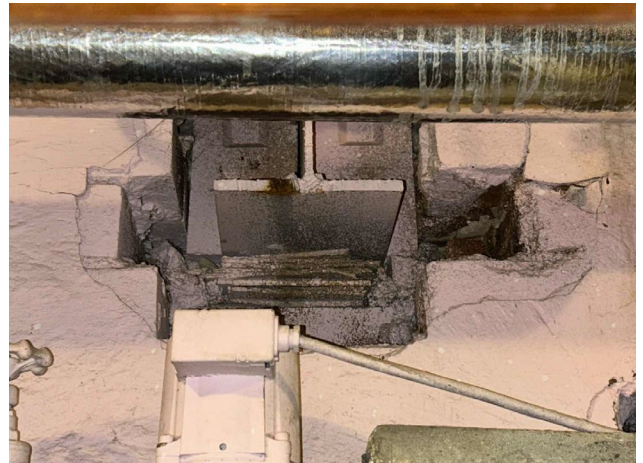
Line ID 55: Internal, GF, Central Wing, North Section, Plant Room 1073, Packing to Penetration Above Boilers, Fibre Cement Sheeting - Chrysotile Asbestos Detected

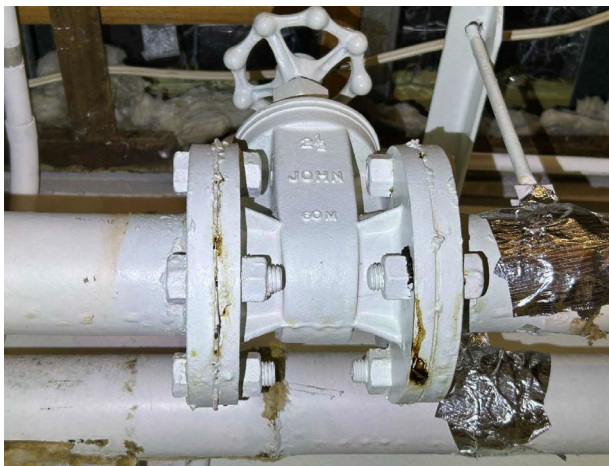
Line ID 56: Internal, GF, Central Wing, North Section, Plant Room 1073, Pipework, Gasket Material - Chrysotile Asbestos Detected

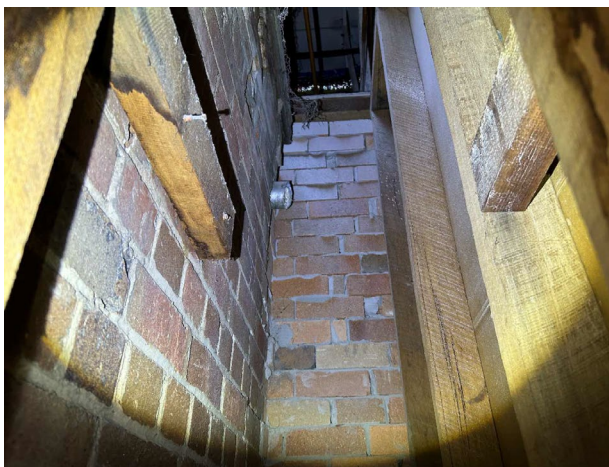
Line ID 57.1: Internal, GF, Central Wing, North Section, Plant Room 1073, Wall Cavity, Penetration, Lagging - Amosite Asbestos Detected

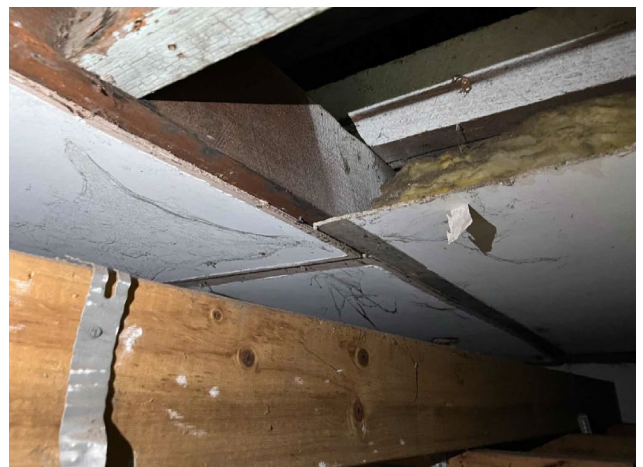
Line ID 58: Internal, GF, Central Wing, North Section, Plant Room 1119, Ceiling Space, Ceiling, Fibre Cement Sheeting - Chrysotile Asbestos Detected

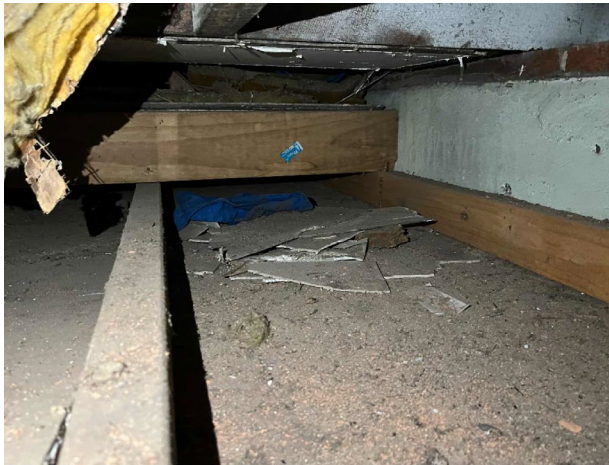
Line ID 59: Internal, GF, Central Wing, North Section, Plant Room 1119, Ceiling Space, Debris, Fibre Cement Debris - Chrysotile Asbestos Detected

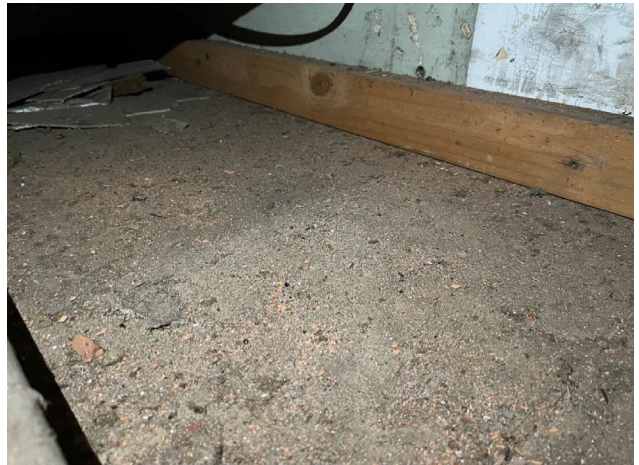
Line ID 60: Internal, GF, Central Wing, North Section, Plant Room 1119, Ceiling Space, on Top of Ceiling, Dust - No Asbestos Detected

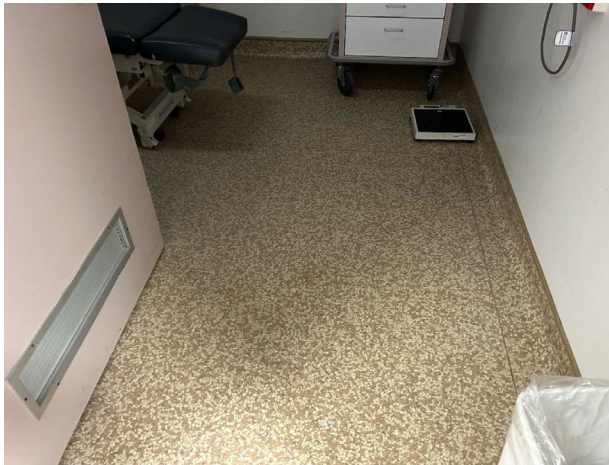
Line ID 61: Internal, GF, Central Wing, North Section, Room 1033, Floor Covering, Fibrous Backed Vinyl Sheet - No Asbestos Detected

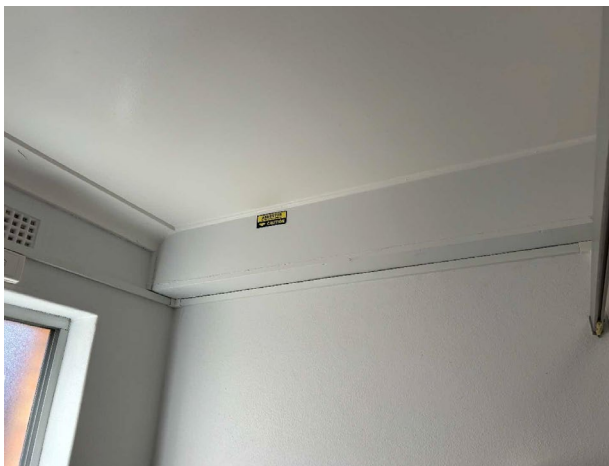
Line ID 66: Internal, GF, Central Wing, Ward A, Room 1096, Wall Cavities, Pipework, Lagging - Amosite Asbestos Detected

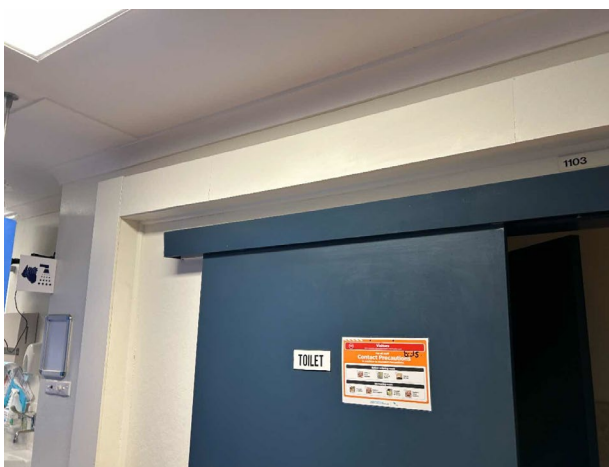
Line ID 67: Internal, GF, Central Wing, Ward A, Room 1097, Within Wall Cavity, Pipework, Lagging - Amosite Asbestos Detected

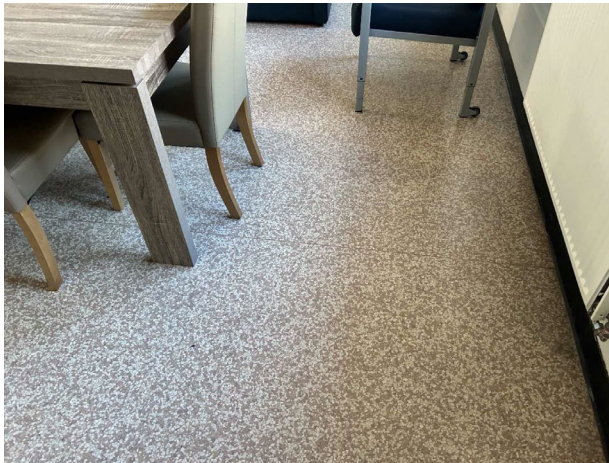
Line ID 69: Internal, GF, Central Wing, Ward A, Rooms 1104, 1105, 1107, 1108 and 1110, Vinyl Floor Tiles (Brown) - Chrysotile Asbestos Detected

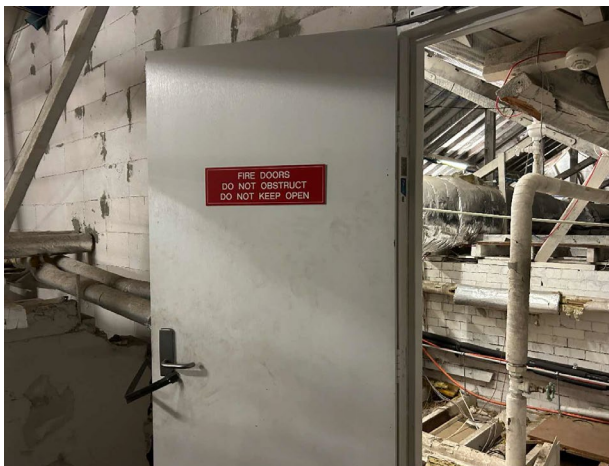
Line ID 71: Internal, GF, Central Wing, Ward A & B, Ceiling Space, All surfaces, Throughout, Dust - No Asbestos Detected

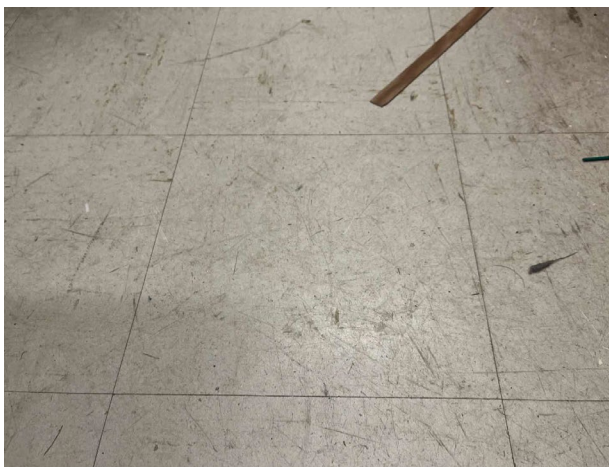
Line ID 73: Internal, GF, Central Wing, Ward B, Floor Covering, Room 1178, Throughout, Vinyl Floor Tiles (white) - Chrysotile Asbestos Detected

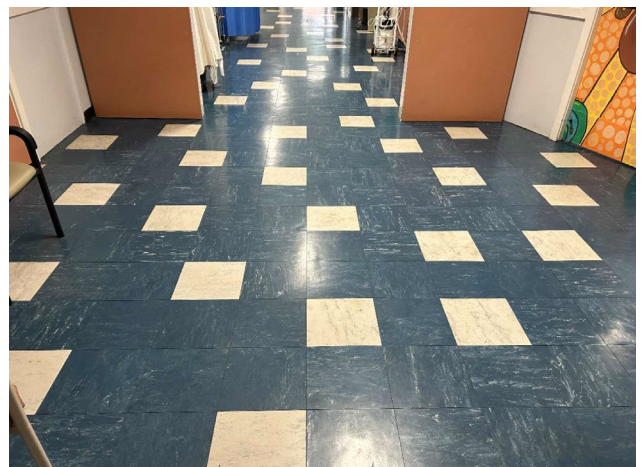
Line ID 73.1: Internal, GF, Central Wing, Ward B, Floor Covering, Room 1178, Throughout, Vinyl Floor Tiles (white) - Chrysotile Asbestos Detected

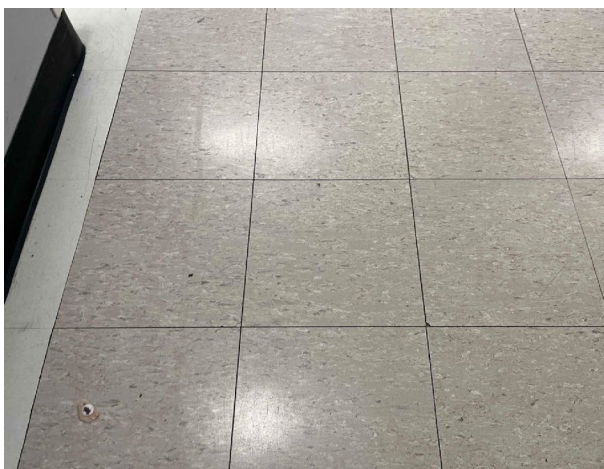
Line ID 78: Internal, GF, Central Wing, Ward B, Rooms 1174, 1176 & 1177, Floor Covering, Vinyl Floor Tiles (white with grey specks) - Chrysotile Asbestos Detected

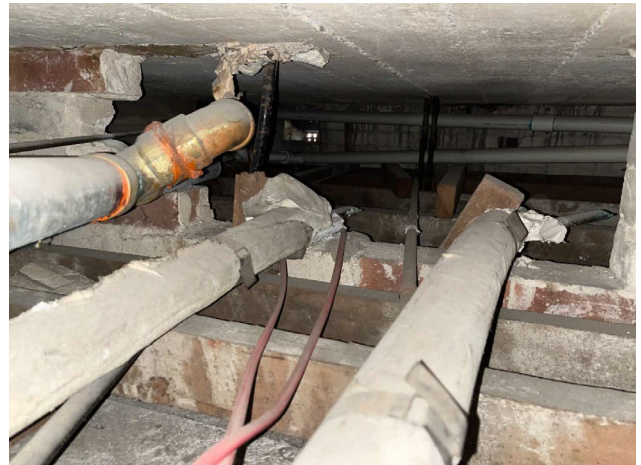
Line ID 80: Internal, GF, Southeast Wing, Ceiling Space, Throughout, Lagging - Amosite Asbestos Detected

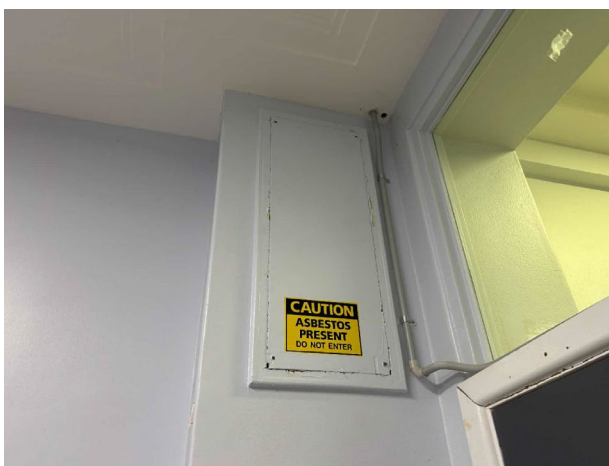
Line ID 82: Internal, GF, Southeast Wing, Reception Room 1237 and Drug Room 1238, Wall Cavities, Pipework, Lagging - Amosite Asbestos Detected

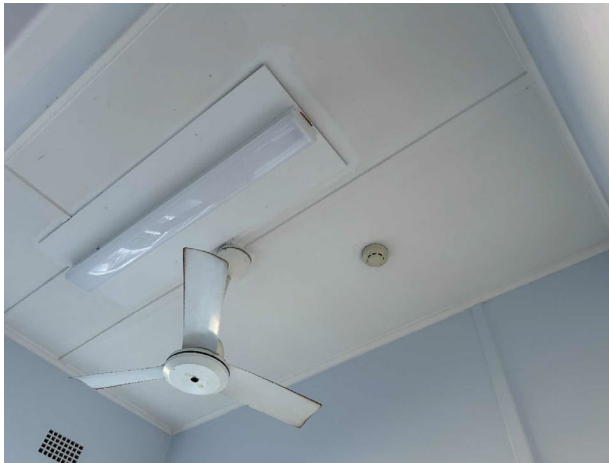
Line ID 85: Internal, GF, Southeast Wing, Room 1202, Ceiling Space, Pipework, Lagging - Amosite Asbestos Detected

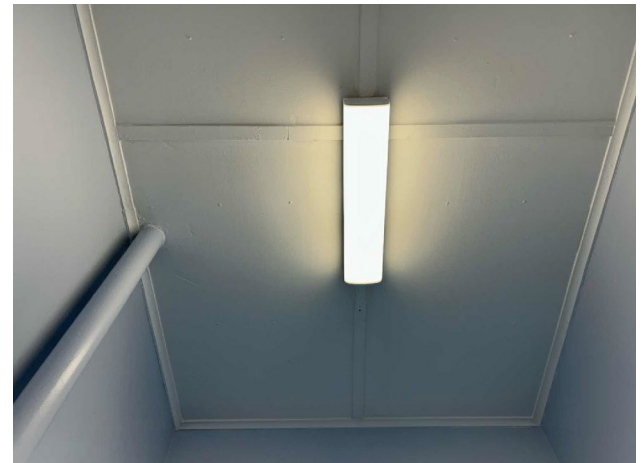
Line ID 86: Internal, GF, Southeast Wing, Rooms 1201, 1202, and 1203, Ceiling, Fibre Cement Sheeting - Chrysotile Asbestos Detected

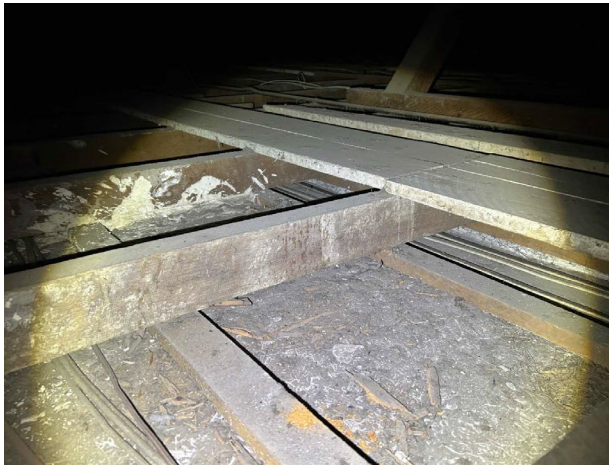
Line ID 90: Internal, GF, Southeast Wing, Southern Sub-Floor Area, Throughout, Dust - No Asbestos Detected

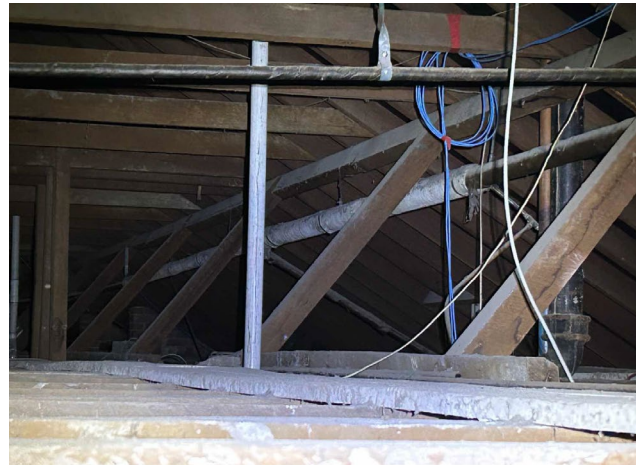
Line ID 91: Internal, L1, Southeast Wing, Ceiling Space, All surfaces, Throughout, Dust - No Asbestos Detected

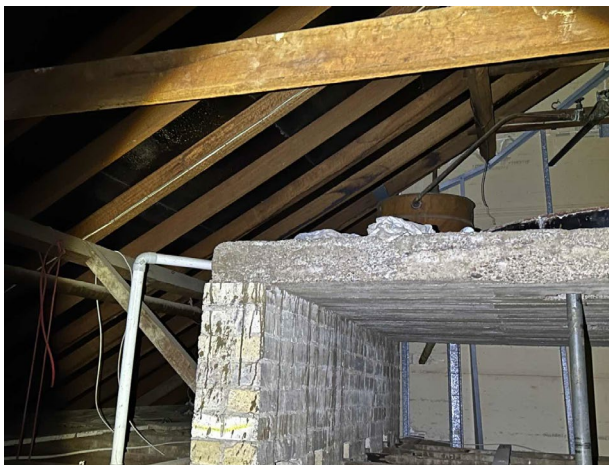
Line ID 92: Internal, L1, Southeast Wing, Ceiling Space, Central, Pipework, Lagging - Amosite Asbestos Detected

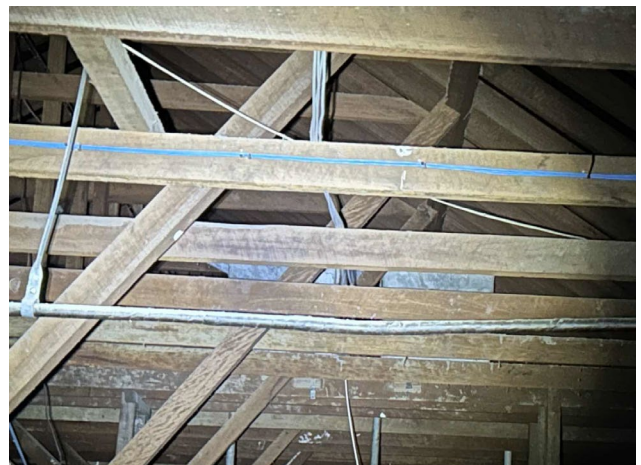
Line ID 93: Internal, L1, Southeast Wing, Ceiling Space, North, Stored On Ledge, Woven Material - Suspected Asbestos

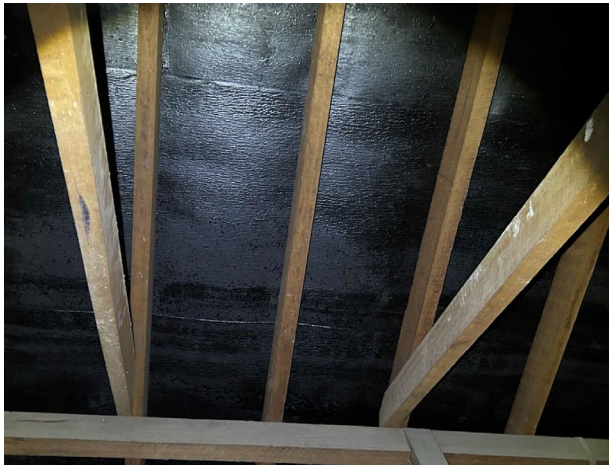
Line ID 94: Internal, L1, Southeast Wing, Ceiling Space, South, Old Water Tanks, Moulded Fibre Cement - Suspected Asbestos

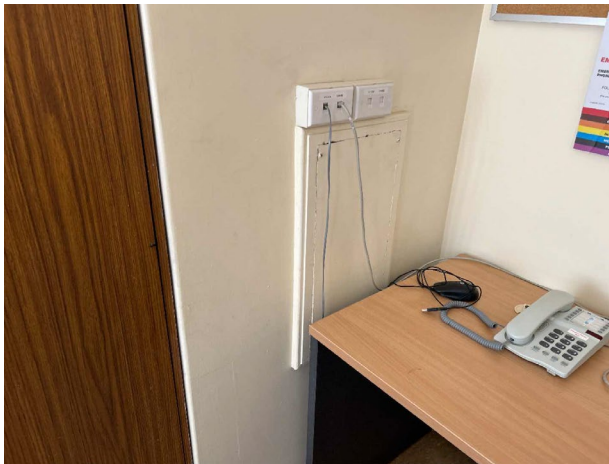
Line ID 96: Internal, L1, Southeast Wing, Central Corridor and Rooms 2002, 2003, 2004, 2005, 2006, 2010, 2011, 2015, 2016, 2017, 2018, 2020, 2023, 2024, 2026 and 2029, Vinyl Floor Tiles (Brown) - Chrysotile Asbestos Detected

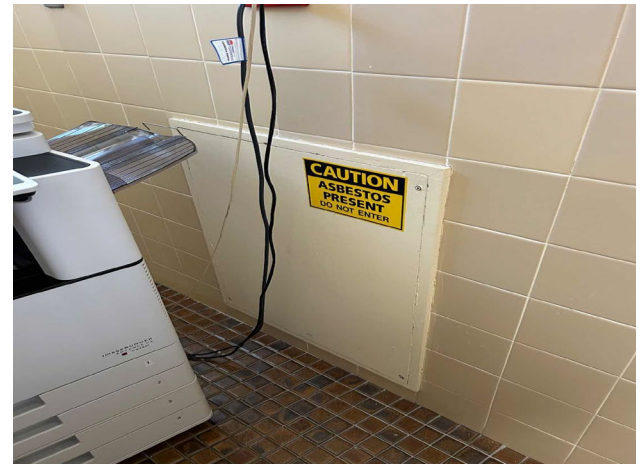
Line ID 97: Internal, L1, Southeast Wing, Room 2006, Wall Cavity, Lagging - Amosite Asbestos Detected

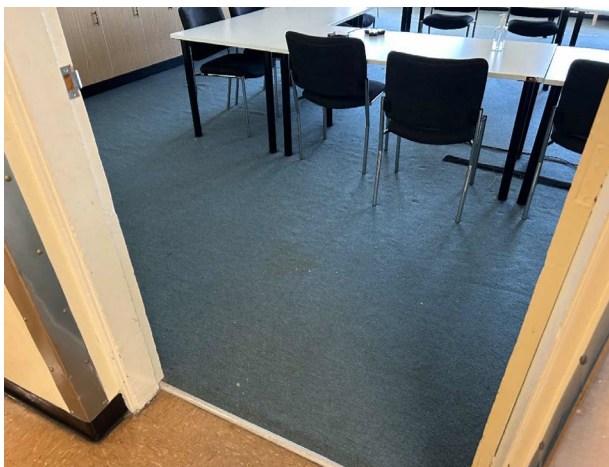
Line ID 98: Internal, L1, Southeast Wing, Room 2014, Wall Cavity, Lagging - Amosite Asbestos Detected

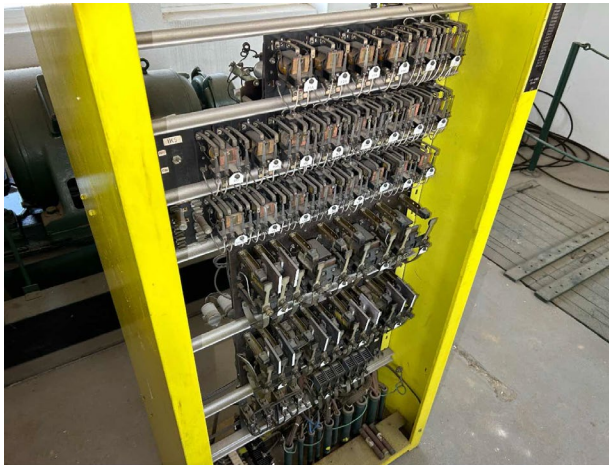
Line ID 100: Internal, L2, Lift Motor Room, Adjacent Motor, Wire Insulation, Woven Material - Suspected Asbestos

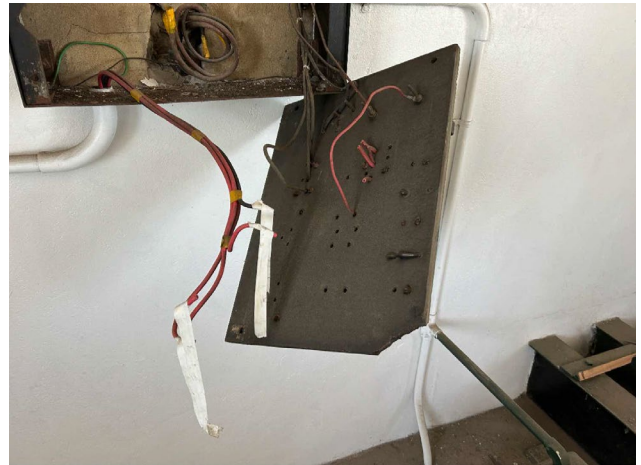
Line ID 101: Internal, L2, Lift Motor Room, Central Electrical Cabinet, Flash Arrestors, Fibre Cement Sheeting - Suspected Asbestos

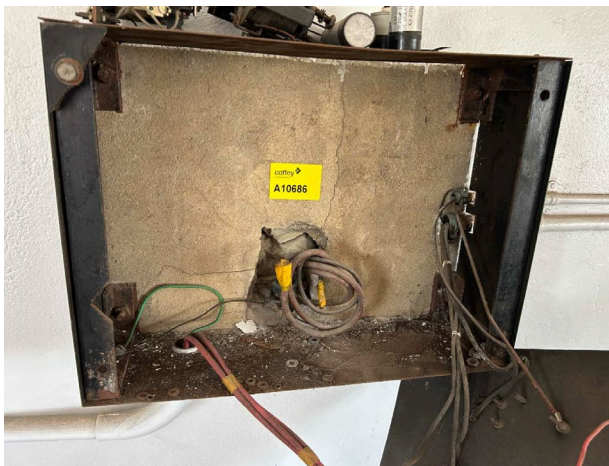
Line ID 102: Internal, L2, Lift Motor Room, Electrical Cabinet, Bituminous Backing Board - Suspected Asbestos

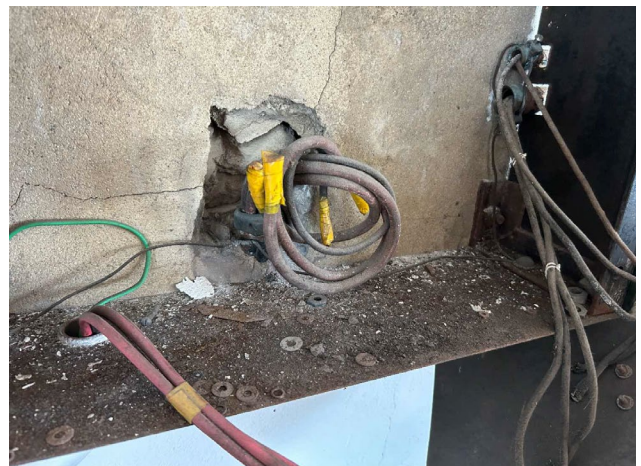
Line ID 103: Internal, L2, Lift Motor Room, Electrical Cabinet, Dust - Chrysotile Asbestos Detected

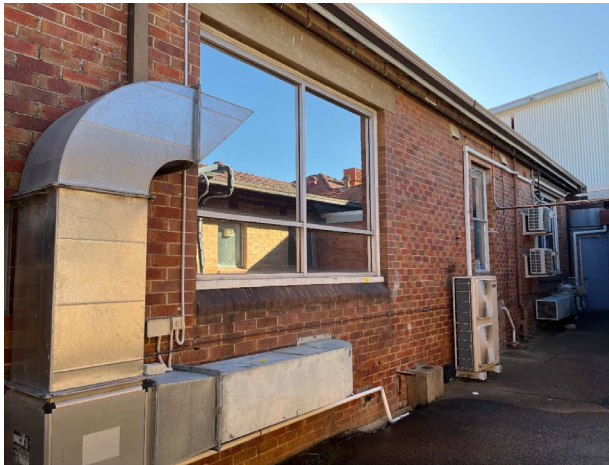
Line ID 108: External, GF, Central Wing, Northern Courtyard, Timber Window Frames, White Paint - Lead Detected (1.8% w/w)

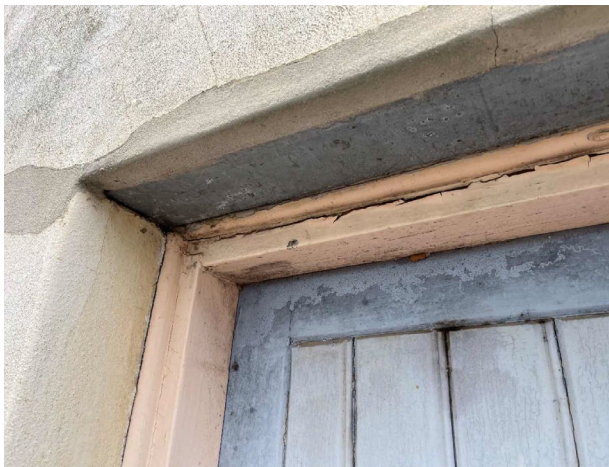
Line ID 109: External, GF, Southeast Wing, Door & Frames, Various Throughout, Pink (Light) Paint - Lead Detected (0.02% w/w)

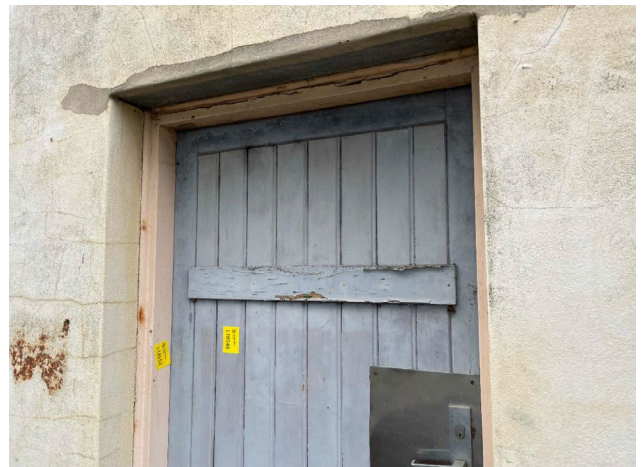
Line ID 109.1: External, GF, Southeast Wing, Door & Frames, Various Throughout, Pink (Light) Paint - Lead Detected (0.02% w/w)

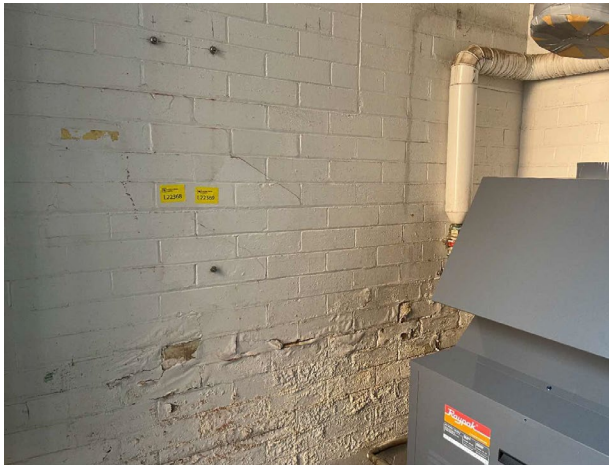
Line ID 112: Internal, GF, All Areas, Various Throughout, Walls, Light Purple Paint - Lead Detected (1.2 % w/w)

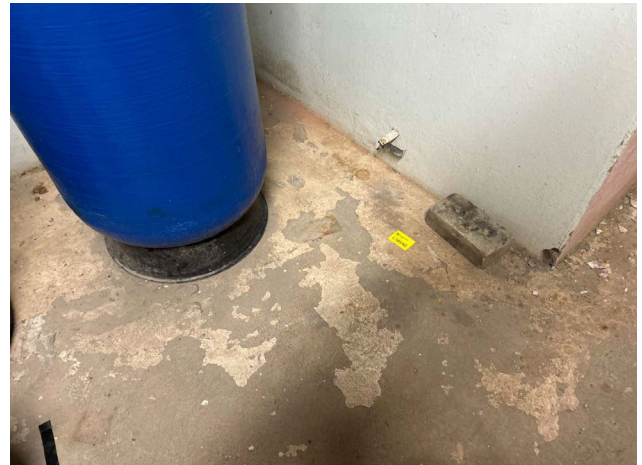
Line ID 113: Internal, GF, Central Wing, Day Surgery/Recovery, Plant Room, Walls, White Paint - Lead Detected (0.099% w/w)

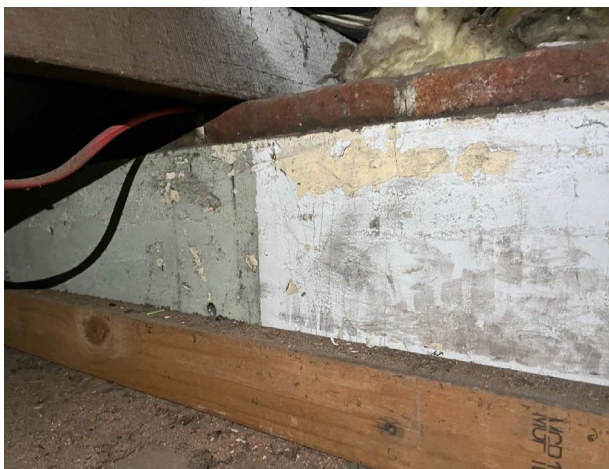
Line ID 114: Internal, GF, Central Wing, North Section, Plant Room 1073, Floor, Cream Paint - Lead Detected (0.03% w/w)

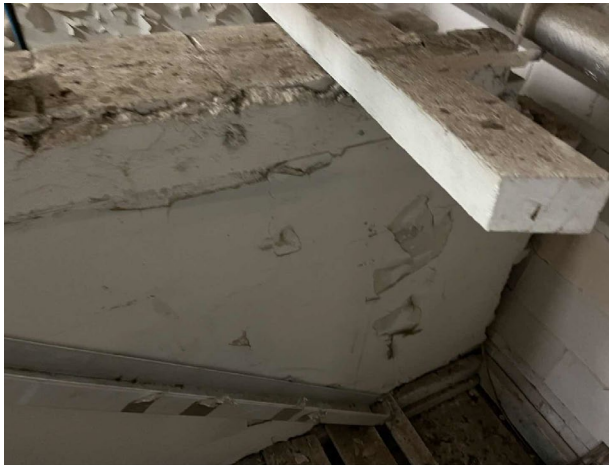
Line ID 116: Internal, GF, Central Wing, North Section, Plant Room 1060, Walls, Cream Paint - Lead Detected (8.7% w/w)

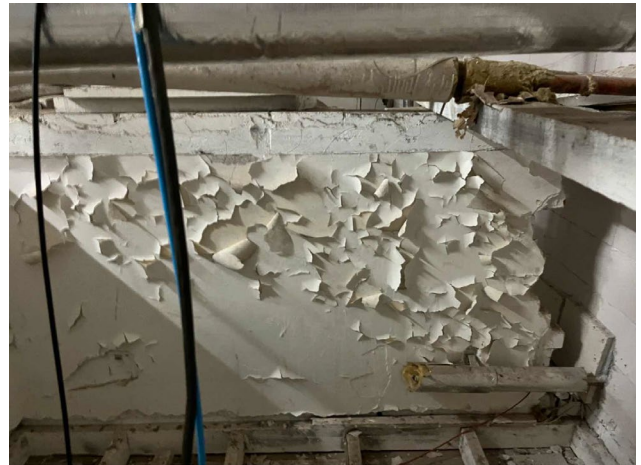
Line ID 117: Internal, GF, Central Wing, Ward A & B, Ceiling Space, Brickwork Lining, White Paint - Lead Detected (4.1% w/w)

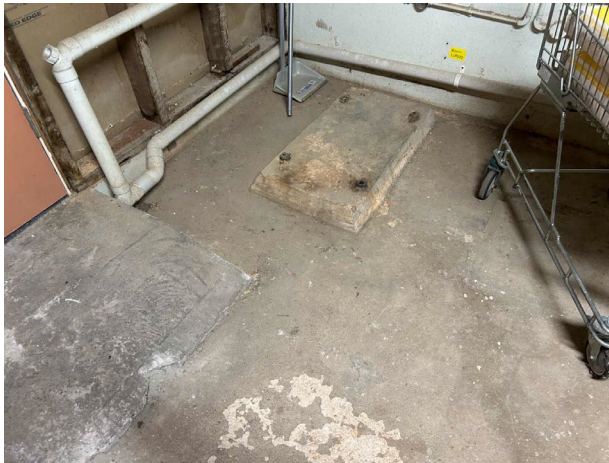
Line ID 123: Internal, GF, Central Wing, North Section, Plant Doom 1060, Throughout, Dust - Lead Detected (52,000mg/kg)

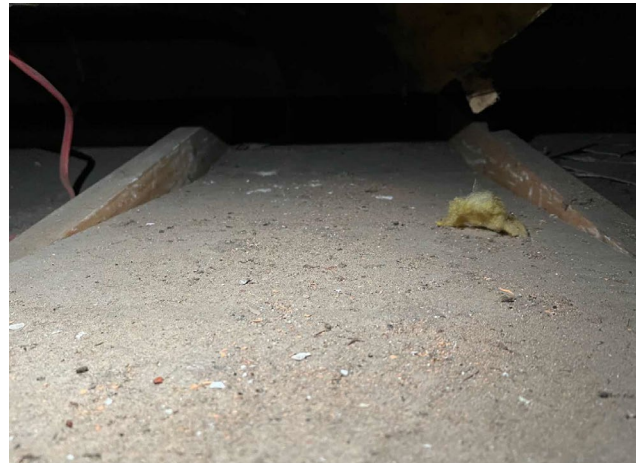
Line ID 124: Internal, GF, Central Wing, North Section, Plant Room 1073, Throughout, Dust - Lead Detected (550 mg/kg)

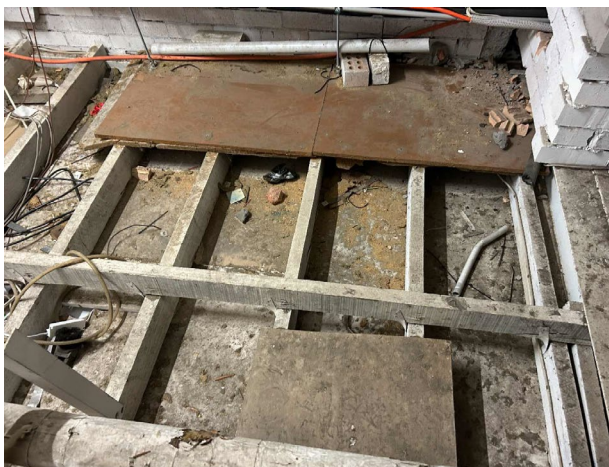
Line ID 125: Internal, GF, Central Wing, North Section, Plant Room 1119, Ceiling Space, Dust - Lead Detected (340mg/kg)

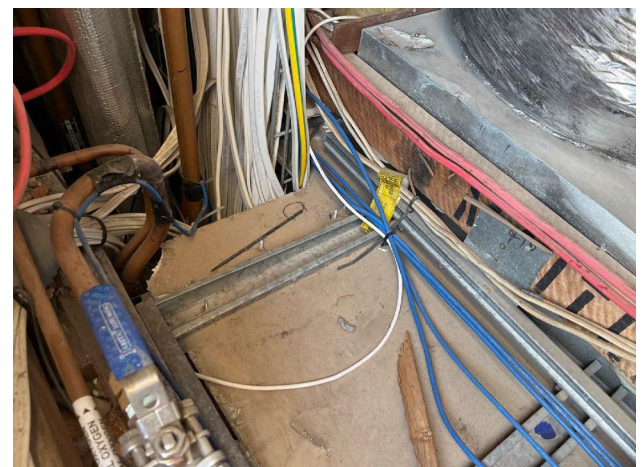
Line ID 126: Internal, GF, Central Wing, Ward A & B, Ceiling Space, All surfaces, Throughout, Dust - Lead Detected (900mg/kg)

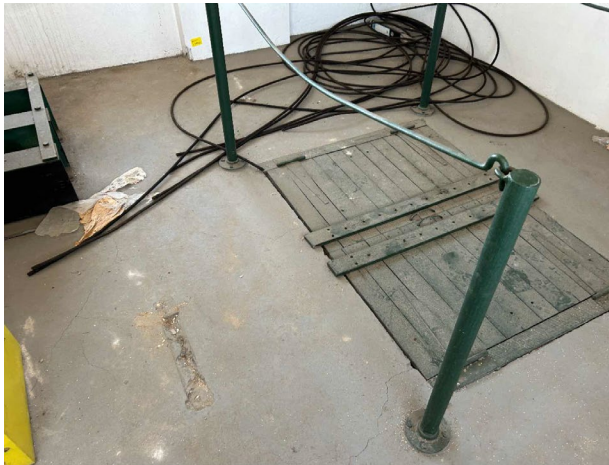
Line ID 129: Internal, GF and L1, Southeast Wing, Ceiling Space, All surfaces, Throughout, Dust - Lead Detected (1,800 mg/kg)

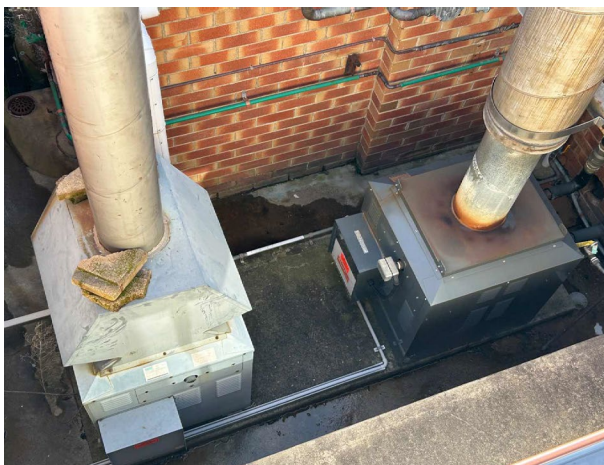
Line ID 131: External, GF, Central Wing, Central Alleyway, Pipework debris, Insulation Material - Suspected SMF

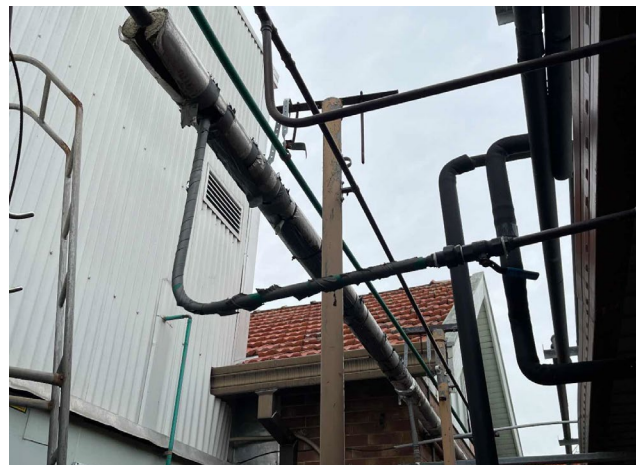
Line ID 132: External, GF, Central Wing, Central Courtyard, Boilers and Associated Pipework, Insulation Material - Suspected SMF

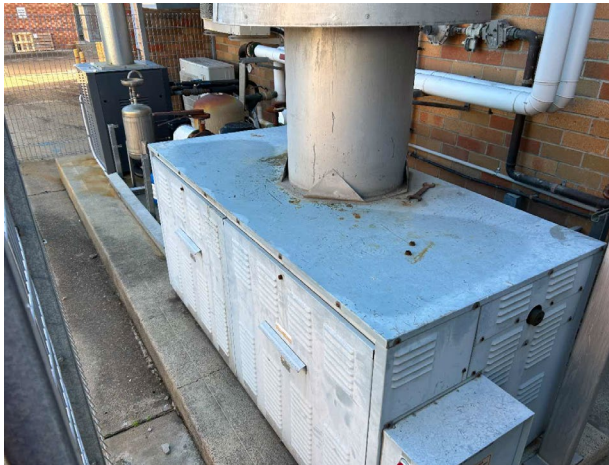
Line ID 133: External, GF, Central Wing, Central Courtyard, Pipework, Central, Insulation Material - Suspected SMF

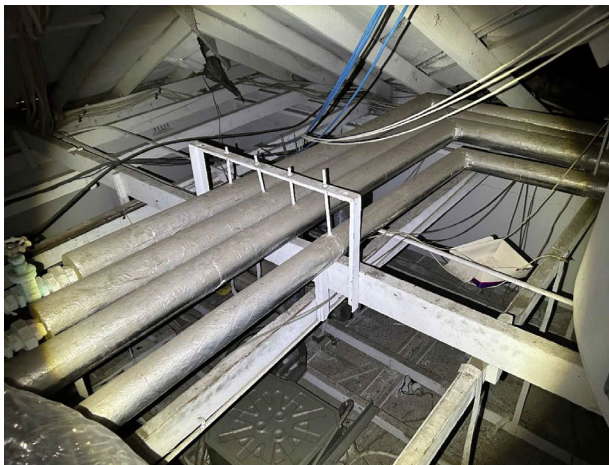
Line ID 136: Internal, GF, All Areas, Ceiling Space, Pipework, Insulation Material - Suspected SMF

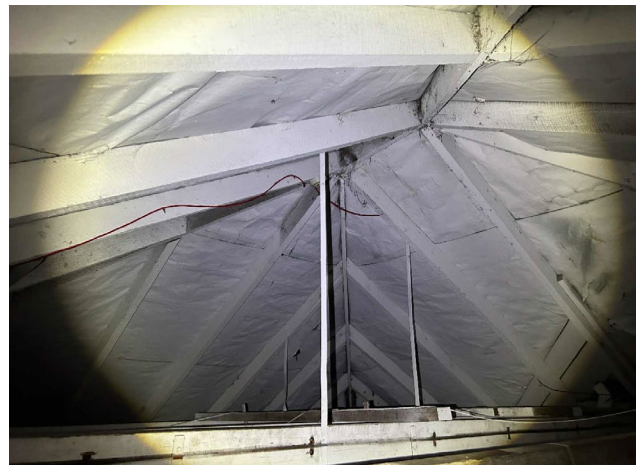
Line ID 137: Internal, GF, All Areas, Ceiling Space, Throughout, Sarking Insulation - Suspected SMF

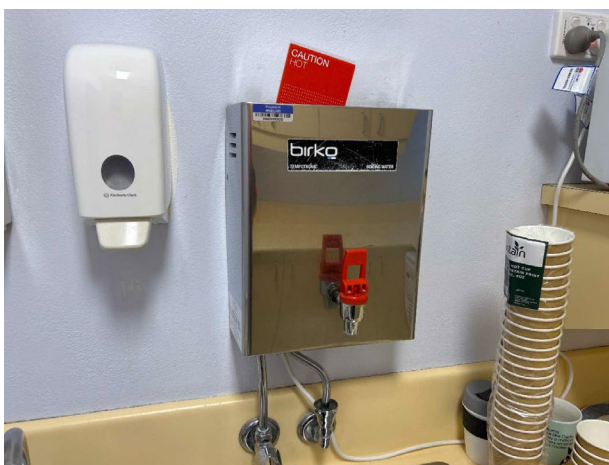
Line ID 138: Internal, GF, All Areas, Staff Rooms and Kitchens, Water Heaters, Insulation Material - Suspected SMF

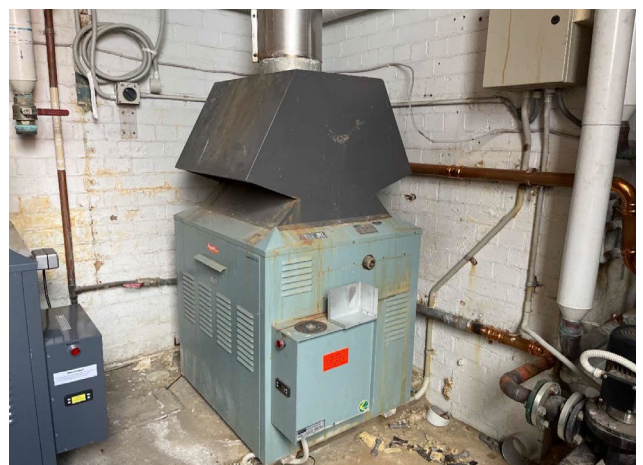
Line ID 139: Internal, GF, Central Wing, Day Surgery/Recovery, Plant Room, Boilers, Insulation Material - Suspected SMF

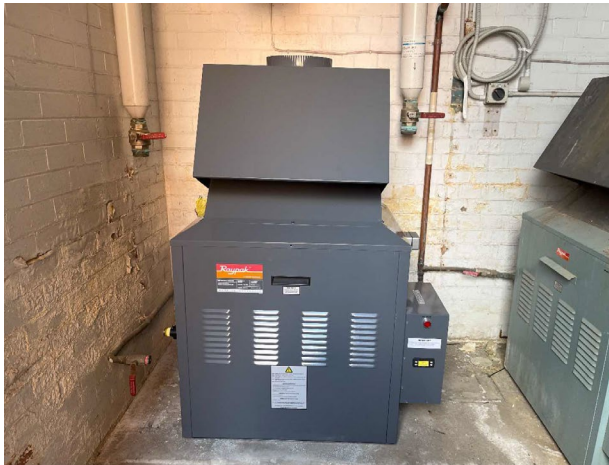
Line ID 139.1: Internal, GF, Central Wing, Day Surgery/Recovery, Plant Room, Boilers, Insulation Material - Suspected SMF

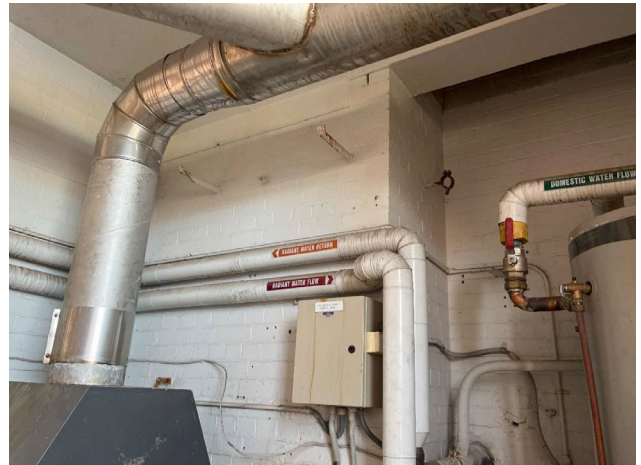
Line ID 140: Internal, GF, Central Wing, Day Surgery/Recovery, Plant Room, Pipework, Insulation Material - Suspected SMF

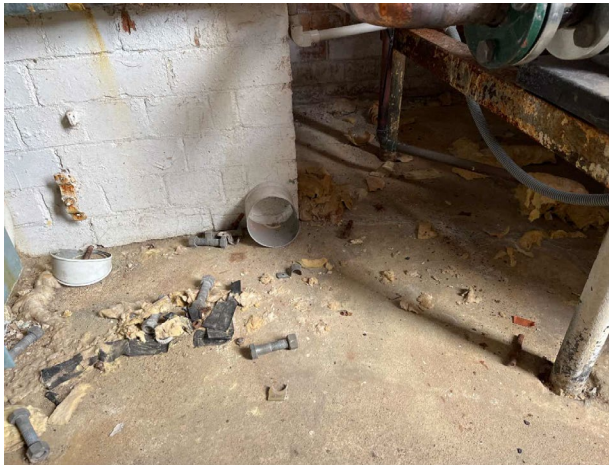
Line ID 141: Internal, GF, Central Wing, Day Surgery/Recovery, Plant Room, Pipework Debris, Insulation Material - Suspected SMF

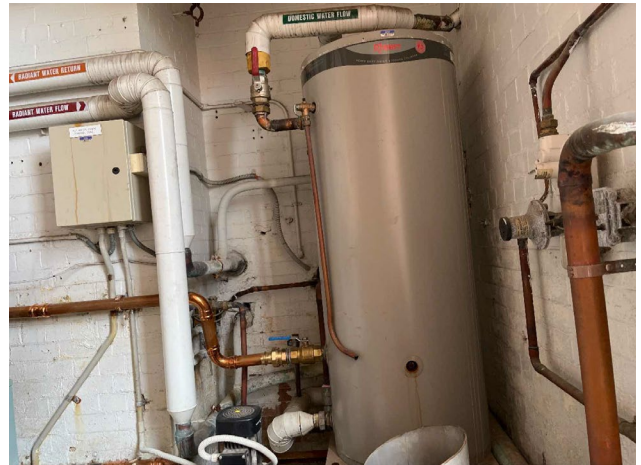
Line ID 142: Internal, GF, Central Wing, Day Surgery/Recovery, Plant Room, Water Heater, Insulation Material - Suspected SMF
