Cessnock Hospital - Pre-Demolition Hazardous Materials Survey Report Summary

Asbestos and Hazardous Materials Pre-Demolition Assessment

Kitchen

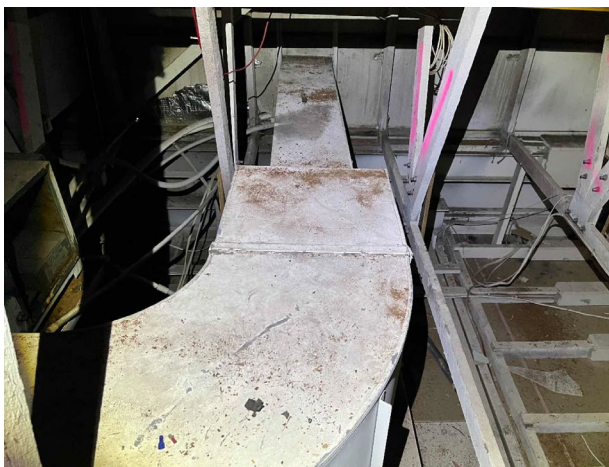
Line ID 143: Internal, GF, Central Wing, North Section, Ceiling Space, Ductwork, Throughout, Insulation Material - Suspected SMF

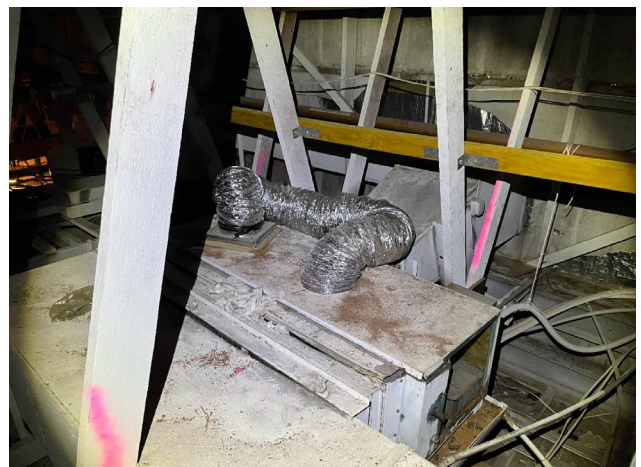
Line ID 144: Internal, GF, Central Wing, North Section, Ceiling Space, Flexible Ductwork, Throughout, Insulation Material - Suspected SMF

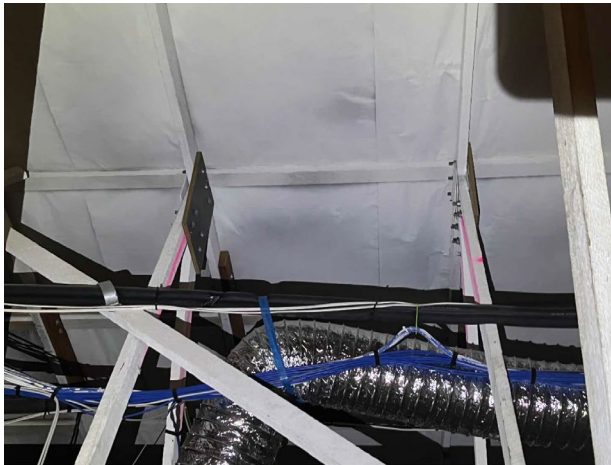
Line ID 145: Internal, GF, Central Wing, North Section, Ceiling Space, Sarking, Roof Lining, Insulation Material - Suspected SMF

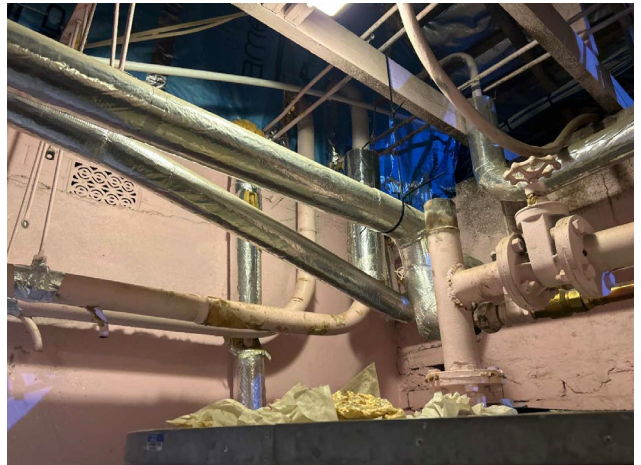
Line ID 146: Internal, GF, Central Wing, North Section, Plant Room 1073, Pipework Above Boilers, Insulation Material - Suspected SMF

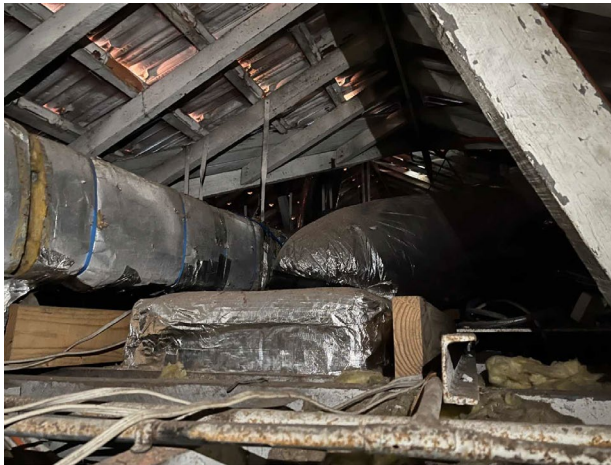
Line ID 147: Internal, GF, Central Wing, North Section, Plant Room 1119, Ceiling Space, Ductwork, Insulation Material - Suspected SMF

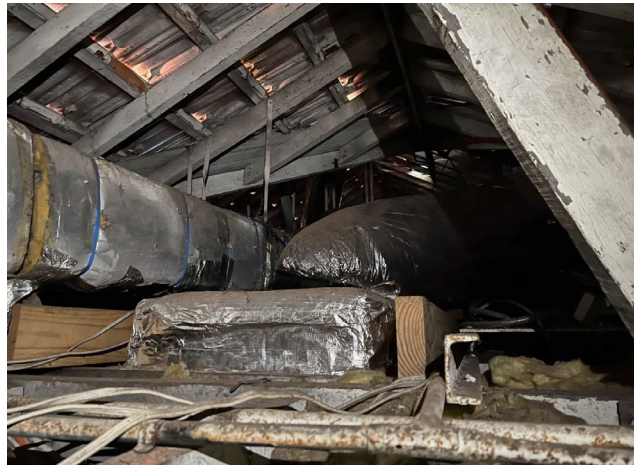
Line ID 148: Internal, GF, Central Wing, North Section, Plant Room 1119, Ceiling Space, Insulation Batts, Insulation Material - Suspected SMF

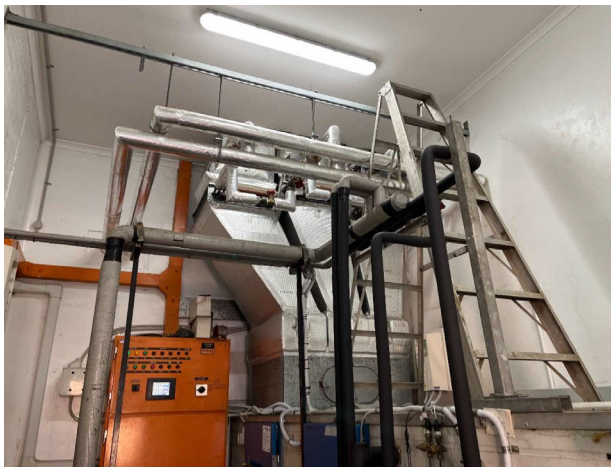
Line ID 149: Internal, GF, Central Wing, North Section, Plant Room 1119, Ductwork, Insulation Material - Suspected SMF

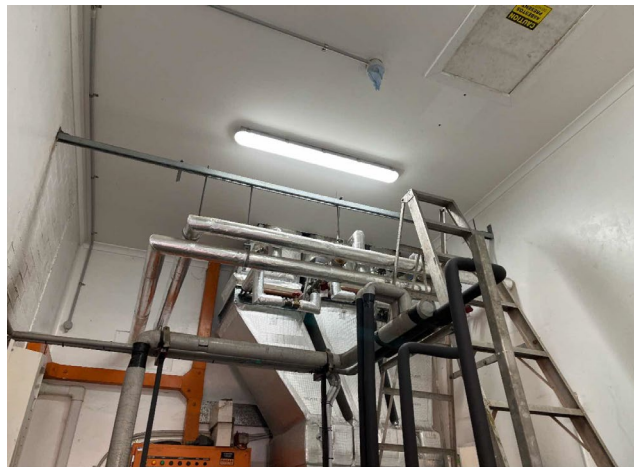
Line ID 150: Internal, GF, Central Wing, North Section, Plant Room 1119, Pipework, Insulation Material - Suspected SMF

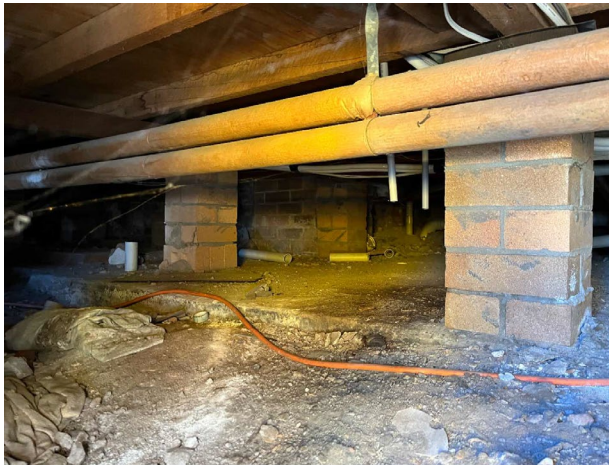
Line ID 151: Internal, GF, Central Wing, North Section, Sub-Floor Area, Pipework, Insulation Material - Suspected SMF

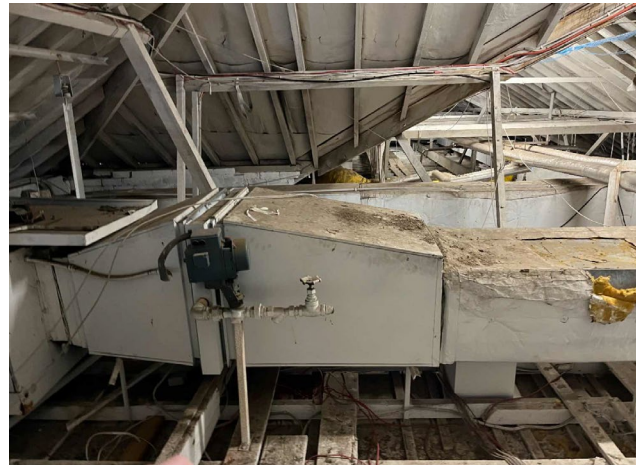
Line ID 152: Internal, GF, Central Wing, Ward A & B, Ceiling Space, Ductwork, Insulation Material - Suspected SMF

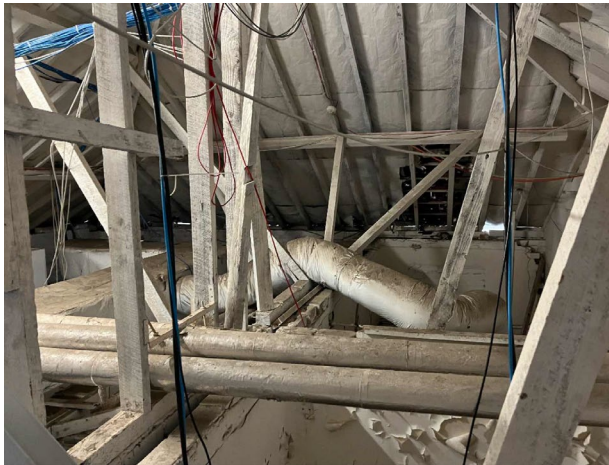
Line ID 153: Internal, GF, Central Wing, Ward A & B, Ceiling Space, Flexible ductwork, Insulation Material - Suspected SMF

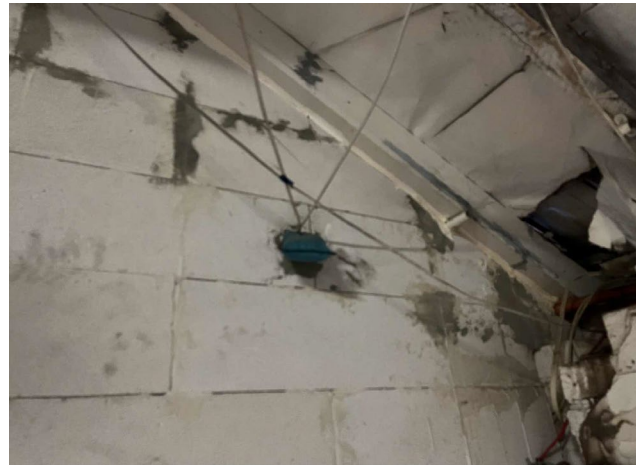
Line ID 154: Internal, GF, Central Wing, Ward A & B, Ceiling Space, Pillow insulation, Penetrations adjacent ladder, Insulation Material - Suspected SMF

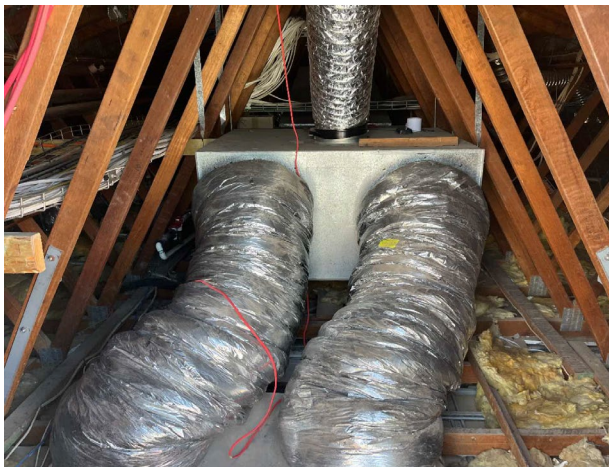
Line ID 155: Internal, GF, ED Wing, Ceiling Space, Ductwork, Various Throughout, Insulation Batts - Suspected SMF

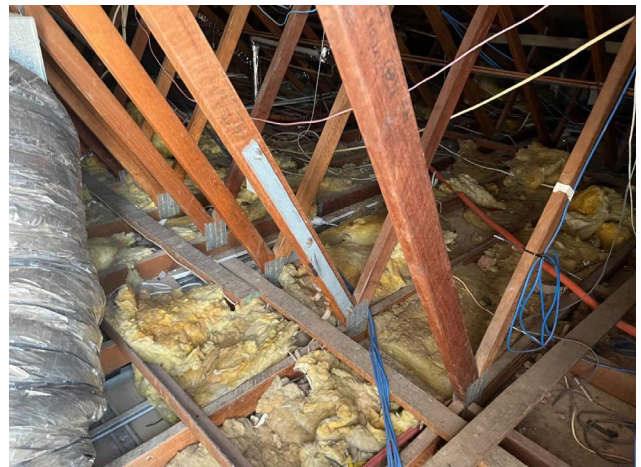
Line ID 156: Internal, GF, ED Wing, Ceiling Space, Insulation Batts, Throughout, Insulation Material - Suspected SMF

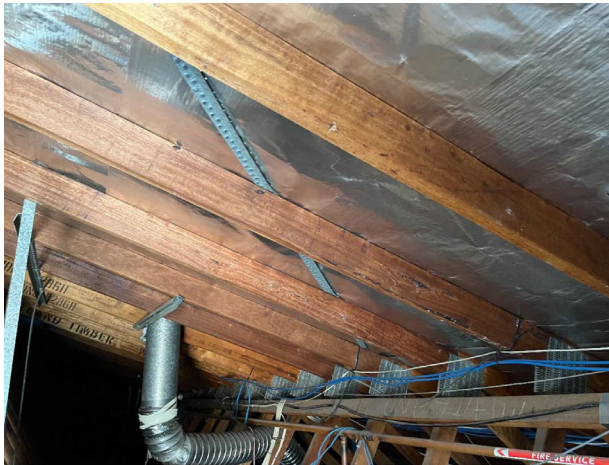
Line ID 157: Internal, GF, ED Wing, Ceiling Space, Sarking, Roof Lining, Insulation Material - Suspected SMF

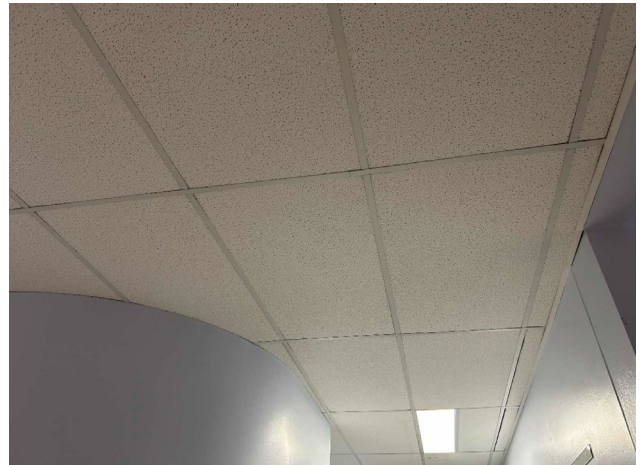
Line ID 158: Internal, GF, Southeast Wing, Central Corridor, Central, Compressed Ceiling Tiles - Suspected SMF

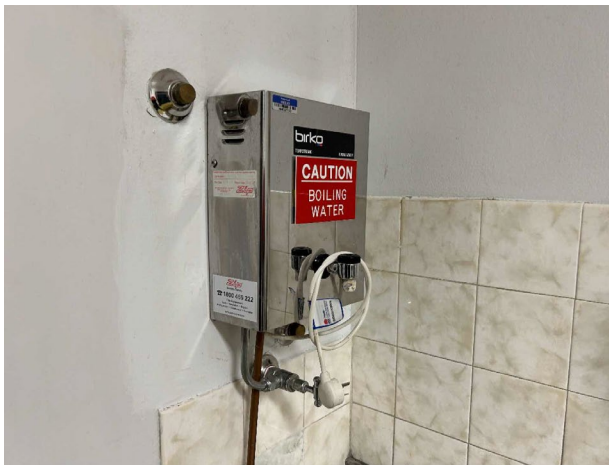
Line ID 159: Internal, GF, Southeast Wing, Room 1191, Water Heater, Insulation Material - Suspected SMF

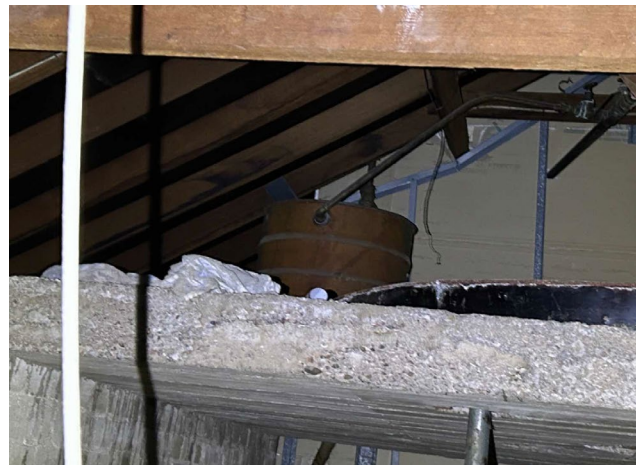
Line ID 160: Internal, L1, Southeast Wing, Ceiling Space, North, Old Metal Water Tank, Insulation Material - Suspected SMF

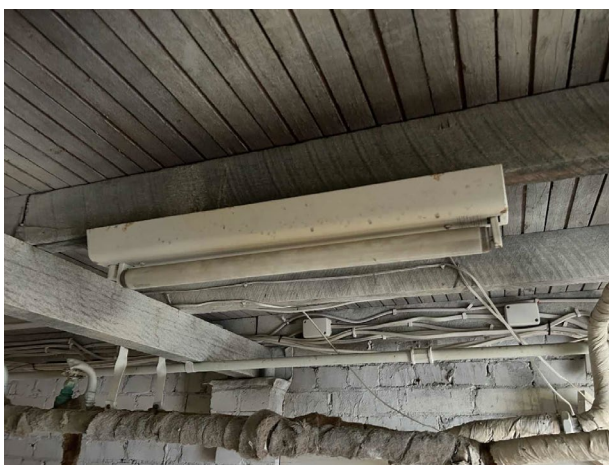
Line ID 161: Internal, GF, Southeast Wing, Southern Sub-Floor Area, Light Fittings, Capacitor(s) - Suspected PCB

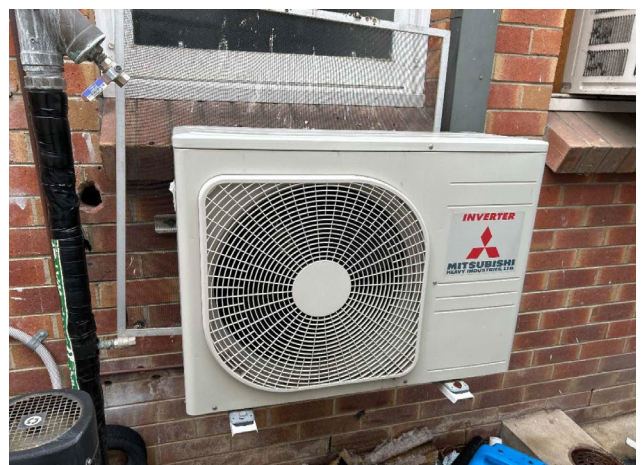
Line ID 162: External, GF, Central Wing, Central Courtyard, AC Unit, R410A Hydrofluorocarbon (HFC) - Non ODS Refrigerant

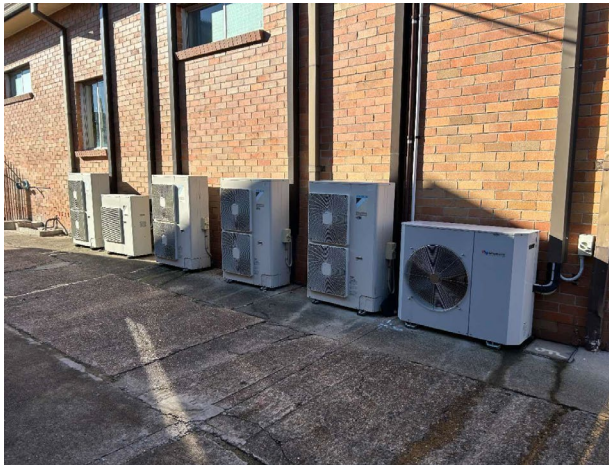
Line ID 163: External, GF, Central Wing, North Side, R410A Hydrofluorocarbon (HFC) - Non ODS Refrigerant

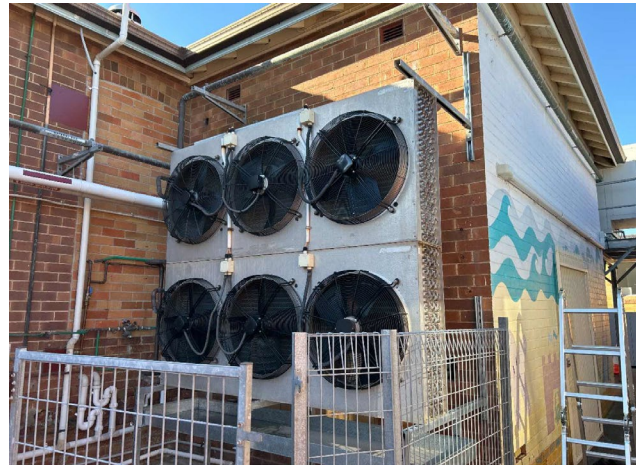
Line ID 164: External, GF, Central Wing, Northern Boiler Area, Chillers, Unknown Refrigerant - Suspected ODS

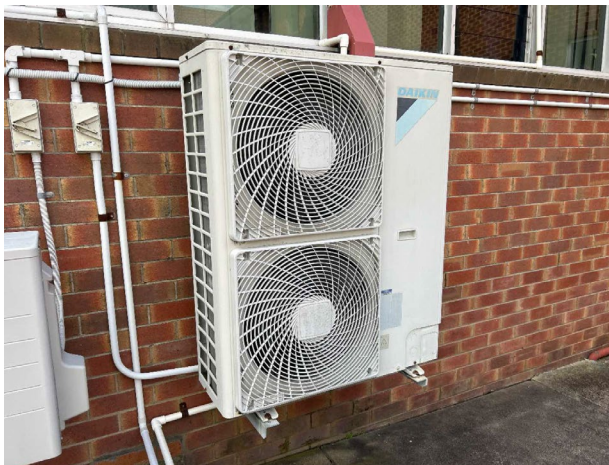
Line ID 165: External, GF, Central Wing, South Side, Unknown Refrigerant - Suspected ODS

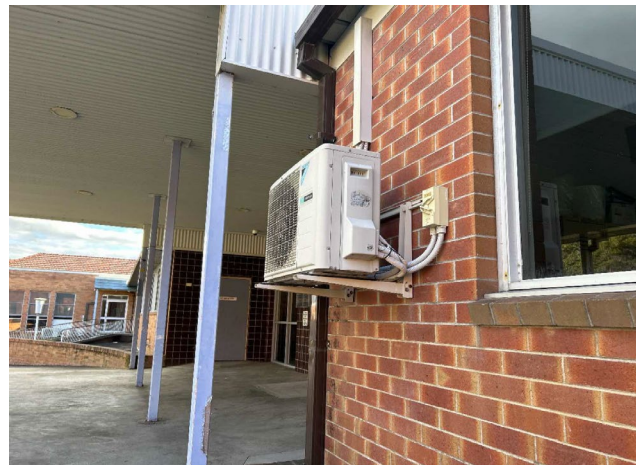
Line ID 165.1: External, GF, Central Wing, South Side, Unknown Refrigerant - Suspected ODS

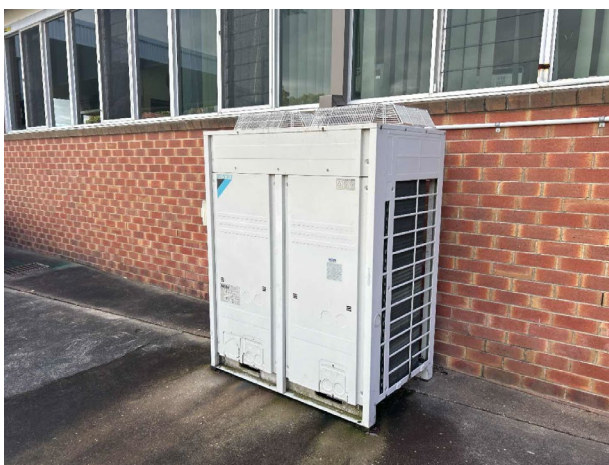
Line ID 166: External, GF, Central Wing, South Side, AC Unit, R410A Hydrofluorocarbon (HFC) - Non ODS Refrigerant

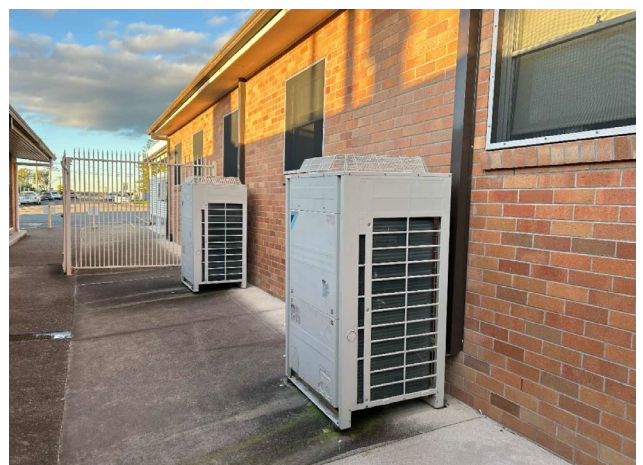
Line ID 167: External, GF, ED Wing, North Side, AC Unit, R410A Hydrofluorocarbon (HFC) - Non ODS Refrigerant

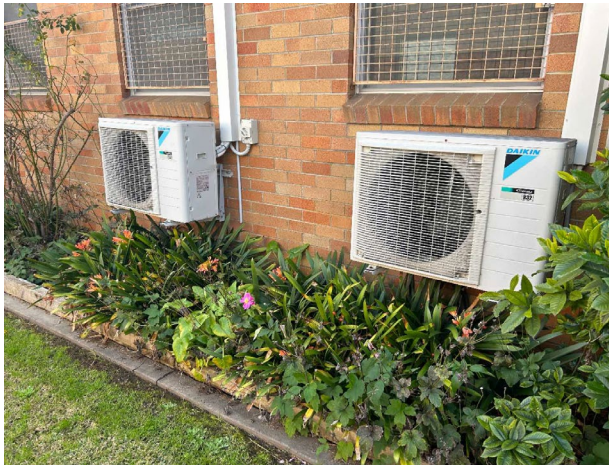
Line ID 168: External, GF, West Wing, South Side, R32 Refrigerant - Non ODS Refrigerant

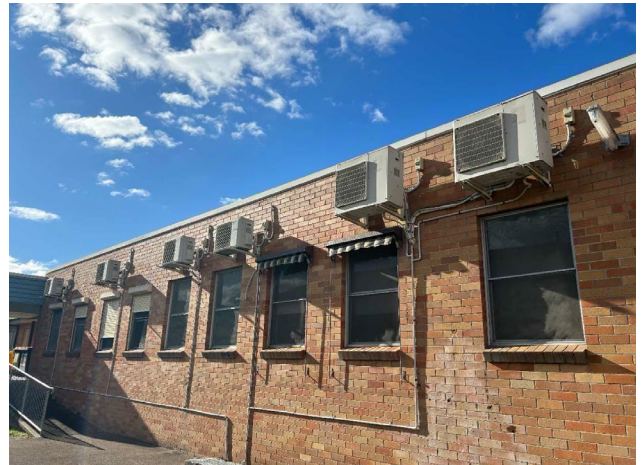
Line ID 169: External, GF, West Wing, South, East and West Sides, R410A Hydrofluorocarbon (HFC) - Non ODS Refrigerant

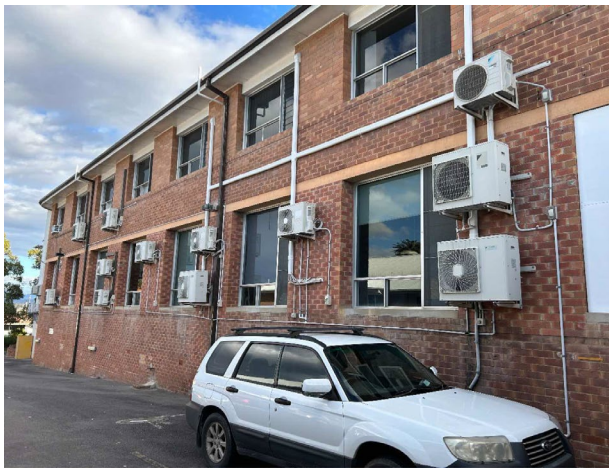
Line ID 170: External, GF and L1, Southeast Wing, East and West Sides, AC Units, R410A and R32 Hydrofluorocarbon (HFC) - Non ODS Refrigerant

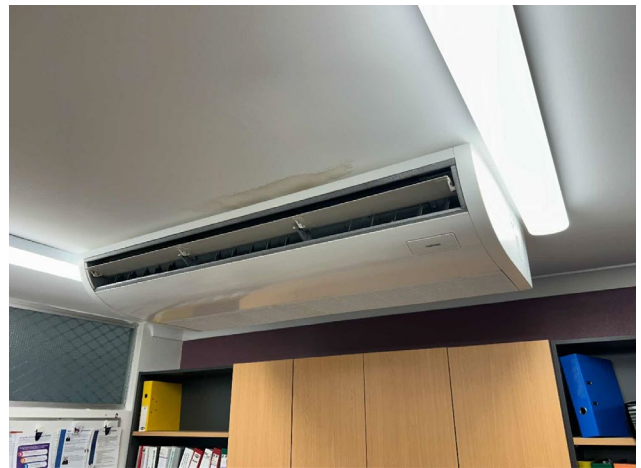
Line ID 171: Internal, GF, Central Wing, North Section, Pharmacy 1075, AC Unit, Unknown Refrigerant - Suspected ODS

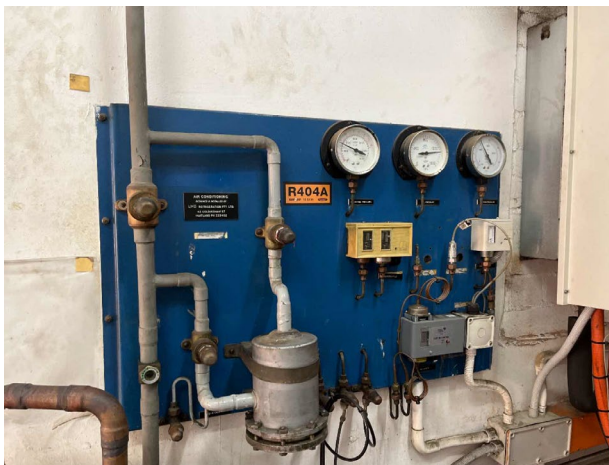
Line ID 172: Internal, GF, Central Wing, North Section, Plant Room 1119, Chiller, R404A Hydrofluorocarbon (HFC) - Non ODS Refrigerant

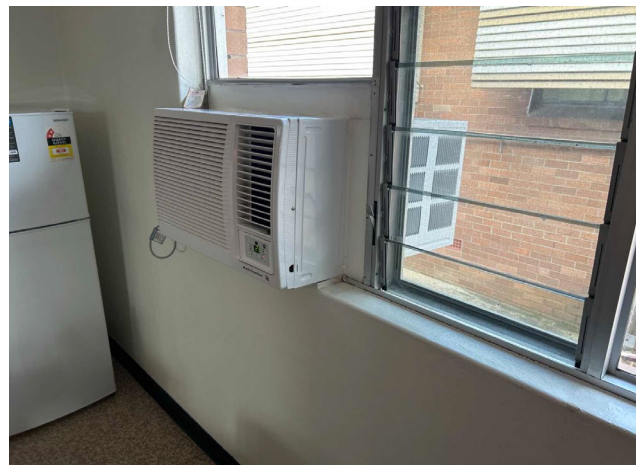
Line ID 173: Internal, GF, Central Wing, Ward A, Staff Room 1118, AC Unit, Unknown Refrigerant - Suspected ODS

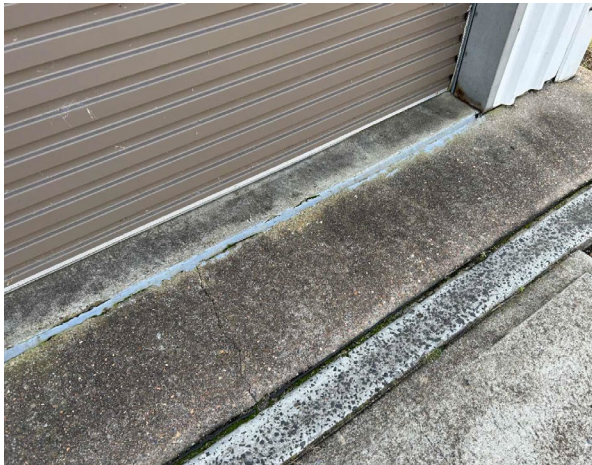
Line ID 1: External, GF, Northern Metal Shed, East, to Floor, Construction Joint Mastic - No Asbestos Detected

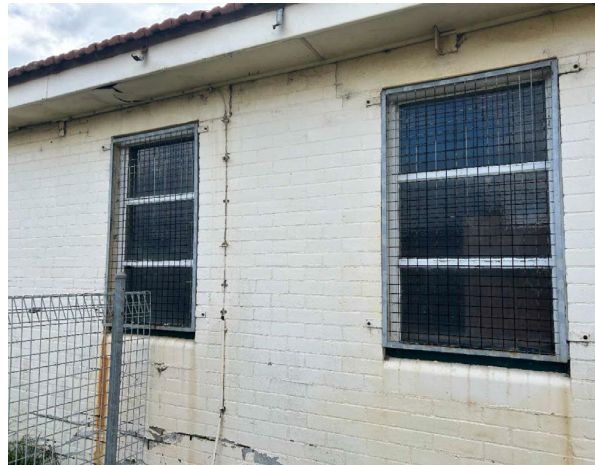
Line ID 2: External, GF, Old Mortuary, South and East Windows, Window Caulking - No Asbestos Detected

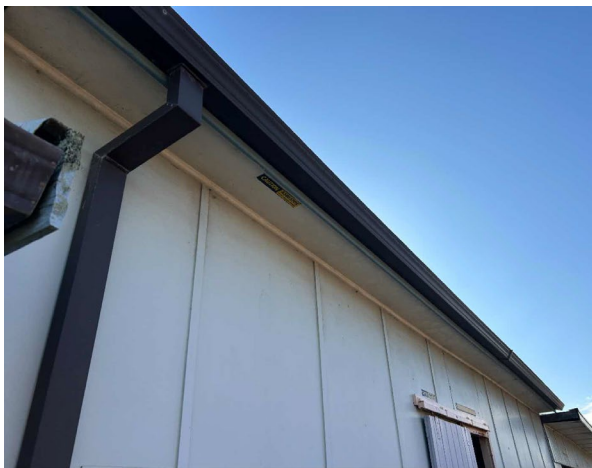
Line ID 3: External, GF, Workshops, All Areas, Central and North Sections, Eaves, Fibre Cement Sheeting - Chrysotile, Amosite and Crocidolite Asbestos Detected

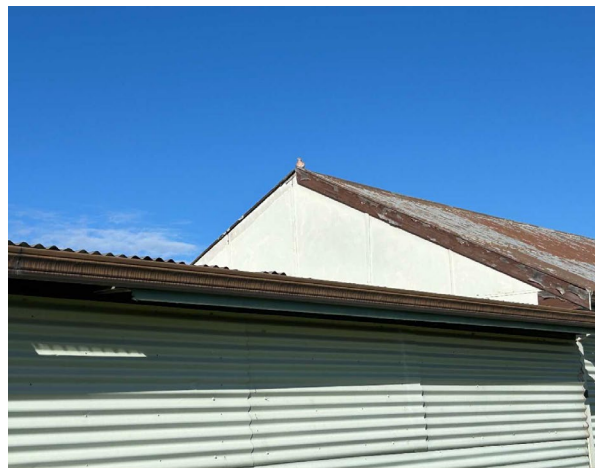
Line ID 4: External, GF, Workshops, All Areas, Central and North Sections, Roof Gable Panels, Fibre Cement Sheeting - Chrysotile, Amosite and Crocidolite Asbestos Detected

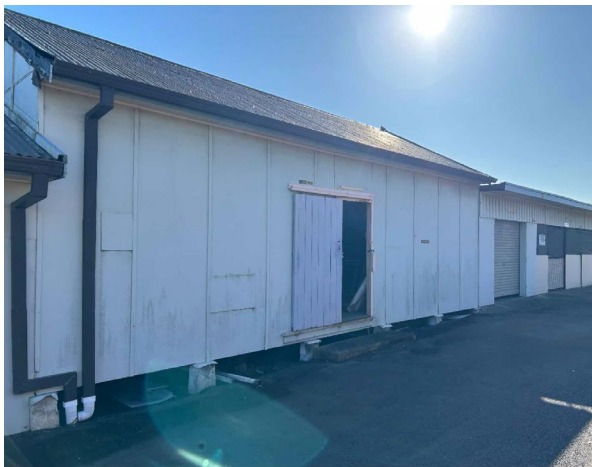
Line ID 5: External, GF, Workshops, All Areas, Central and North Sections, Walls, Fibre Cement Sheeting - Chrysotile, Amosite and Crocidolite Asbestos Detected

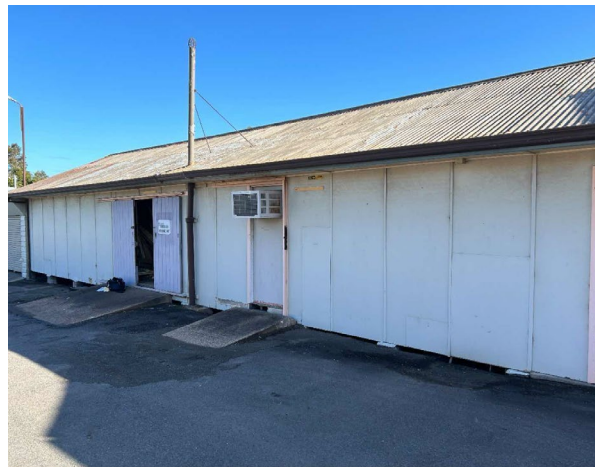
Line ID 5.1: External, GF, Workshops, All Areas, Central and North Sections, Walls, Fibre Cement Sheeting - Chrysotile, Amosite and Crocidolite Asbestos Detected

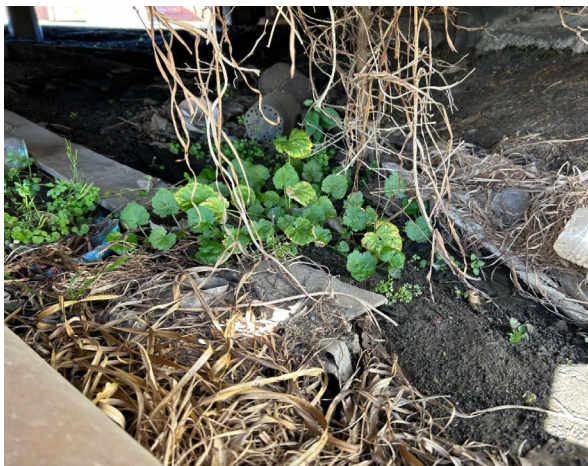
Line ID 6: External, GF, Workshops, All Areas, Central Section, Subfloor, Debris, Fibre Cement Debris - Chrysotile, Amosite and Crocidolite Asbestos Detected

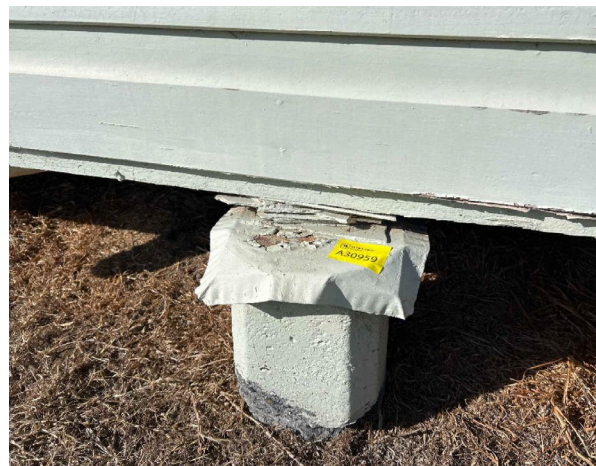
Line ID 7: External, GF, Workshops, All Areas, Central Section, Subfloor, Packing, Fibre Cement Sheetting - Chrysotile Asbestos Detected

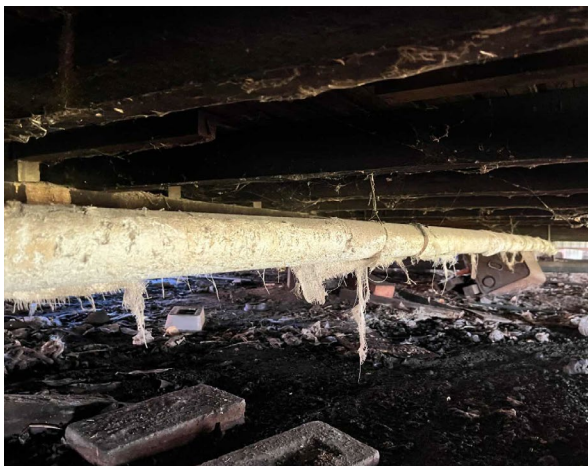
Line ID 8: External, GF, Workshops, All Areas, Central Section, Subfloor, Pipework, Lagging - Amosite Asbestos Detected

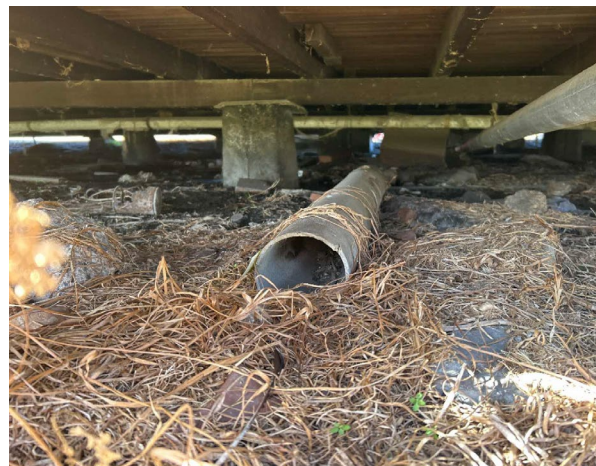
Line ID 9: External, GF, Workshops, All Areas, Central Section, Subfloor, Pipework, Moulded Fibre Cement - Chrysotile and Amosite Asbestos Detected

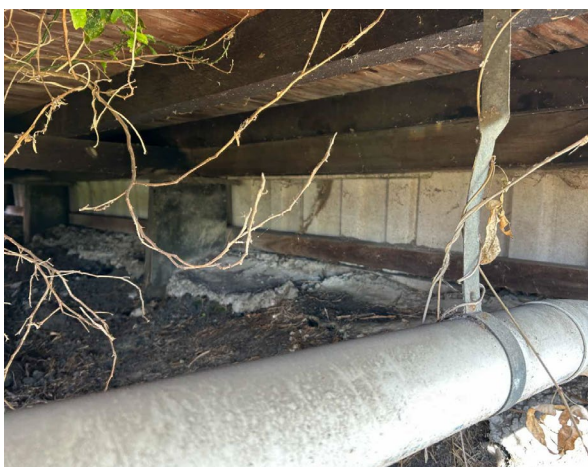
Line ID 10: External, GF, Workshops, All Areas, Central Section, Subfloor, South Wall, Profiled Cement Sheetting - Chrysotile Asbestos Detected

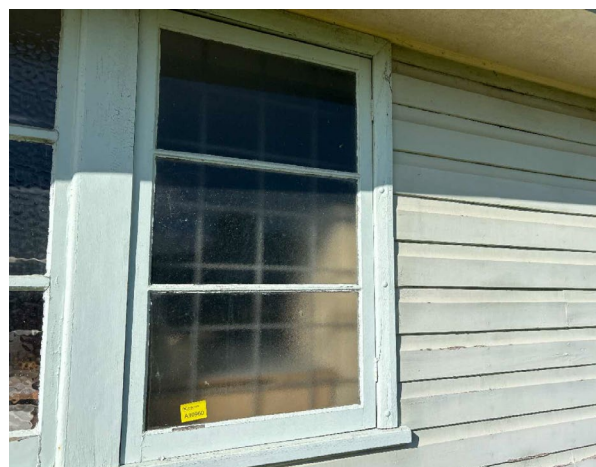
Line ID 11: External, GF, Workshops, All Areas, Central Section, West Windows, Thin Window Caulking - No Asbestos Detected

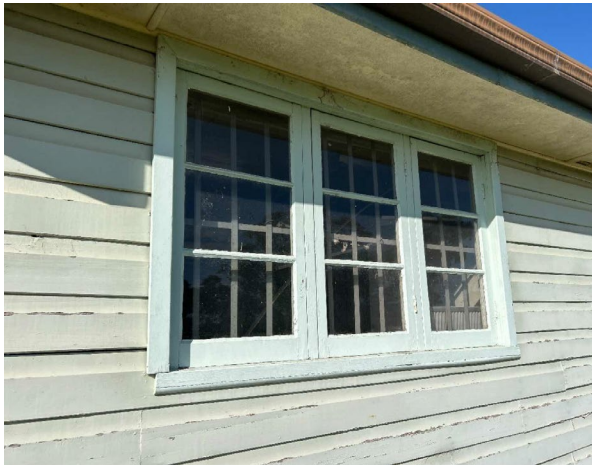
Line ID 12: External, GF, Workshops, All Areas, Central Section, West Windows, Thick Window Caulking - No Asbestos Detected

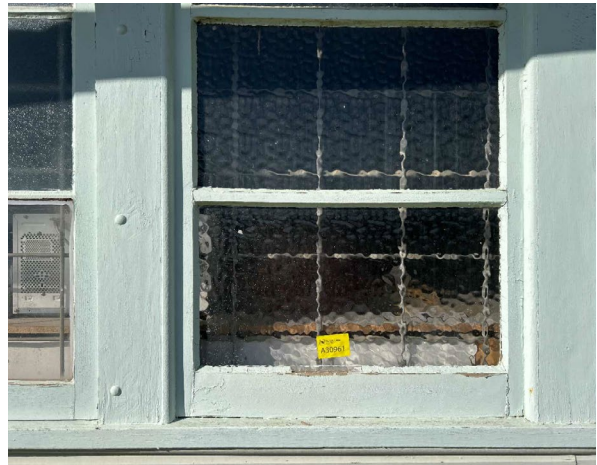
Line ID 12.1: External, GF, Workshops, All Areas, Central Section, West Windows, Thick Window Caulking - No Asbestos Detected

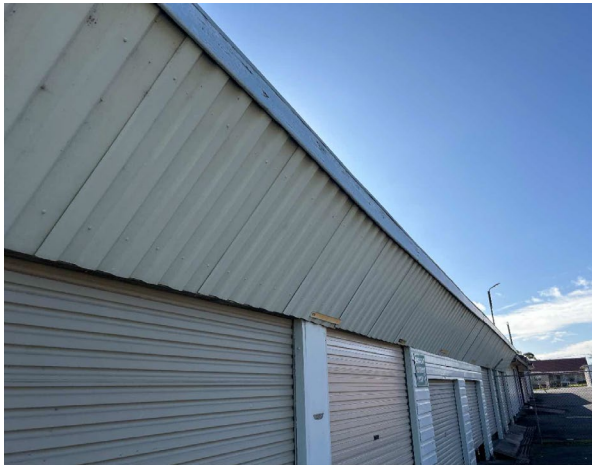
Line ID 13: External, GF, Workshops, All Areas, North and South Sections, Upper Walls, Profiled Cement Sheetting - Chrysotile Asbestos Detected

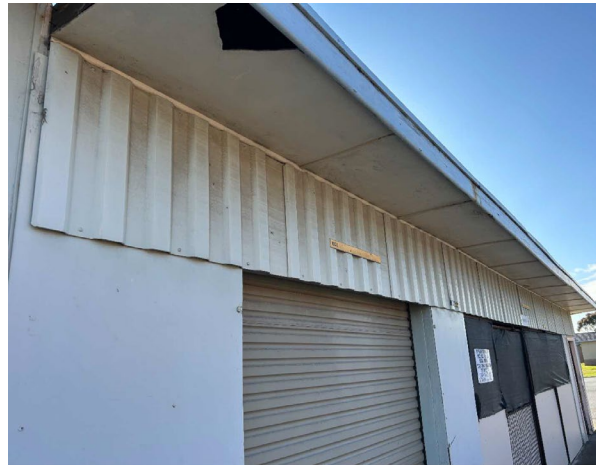
Line ID 13.1: External, GF, Workshops, All Areas, North and South Sections, Upper Walls, Profiled Cement Sheetting - Chrysotile Asbestos Detected

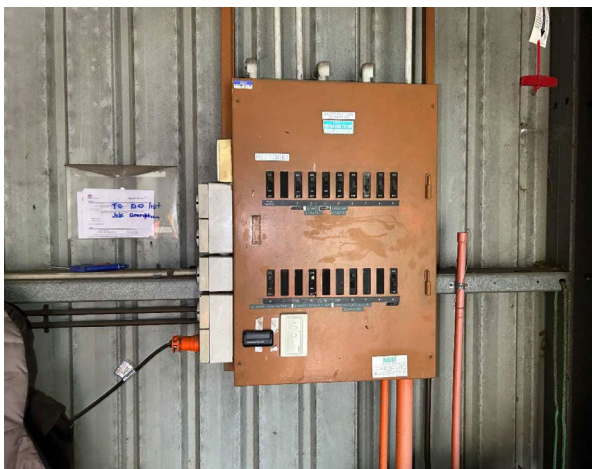
Line ID 14: Internal, GF, Northern Metal Shed, North, Distribution Board, Electrical Components - Suspected Asbestos

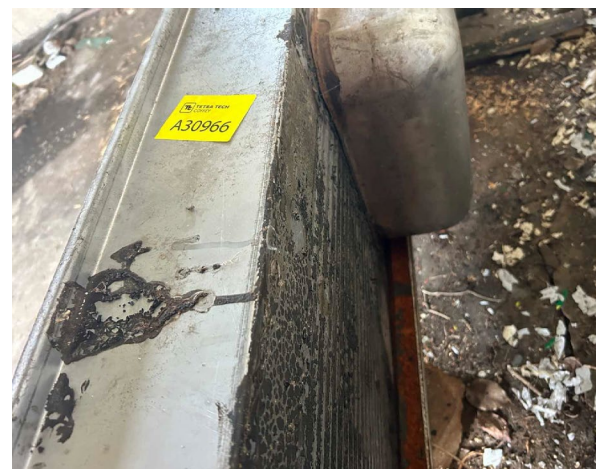
Line ID 15: Internal, GF, Old Mortuary, North Room, to Redundant Sink, Bituminous Material - No Asbestos Detected

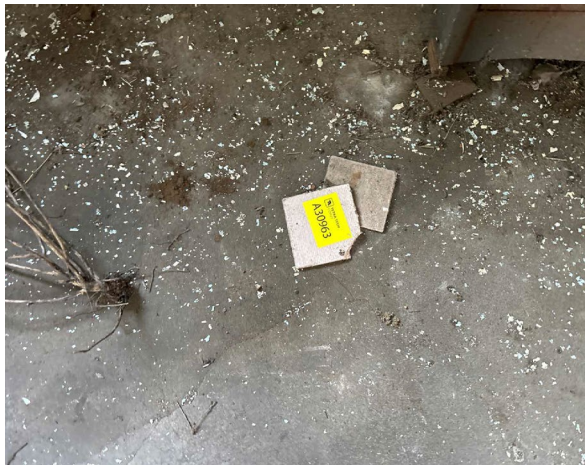
Line ID 16: Internal, GF, Old Mortuary, South Room, on Floor, Fibre Cement Sheetting - No Asbestos Detected

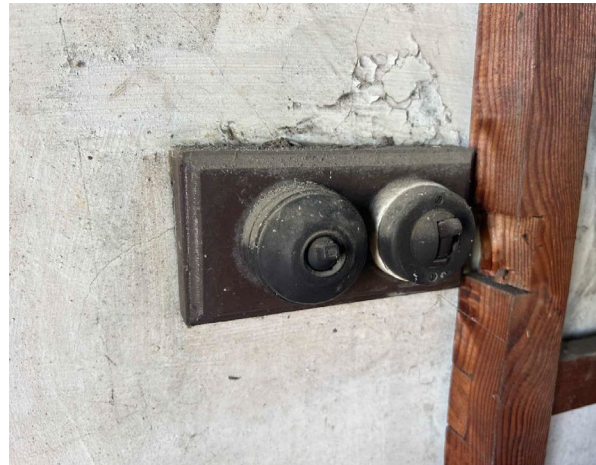
Line ID 17: Internal, GF, Old Mortuary, Various Throughout, Light Switches, Bakelite - Suspected Asbestos

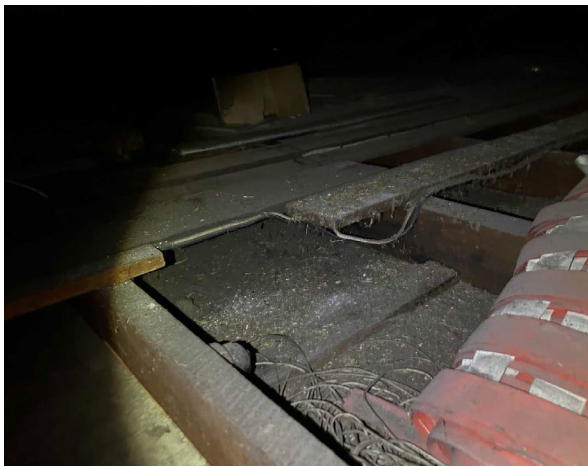
Line ID 18: Internal, GF, Workshops, Central Section, Ceiling Space, Dust - Chrysotile Asbestos Detected

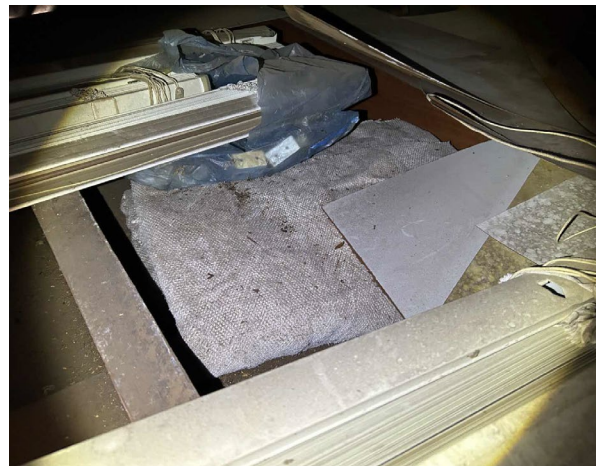
Line ID 19: Internal, GF, Workshops, Central Section, Ceiling Space, Adjacent Access Hatch, Woven Blanket Material - Chrysotile Asbestos Detected

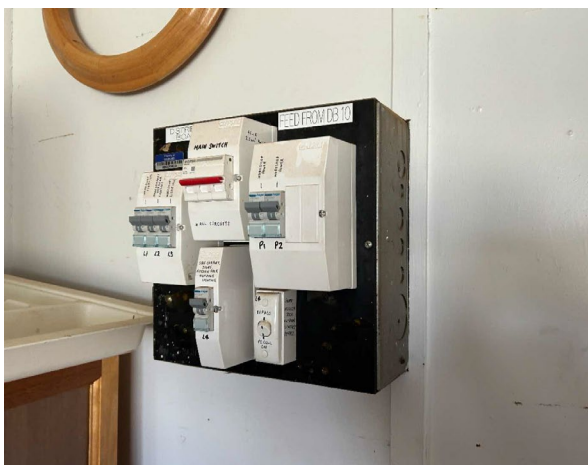
Line ID 20: Internal, GF, Workshops, Central Section, Central Office, Northeast, Bituminous Backing Board - Suspected Asbestos

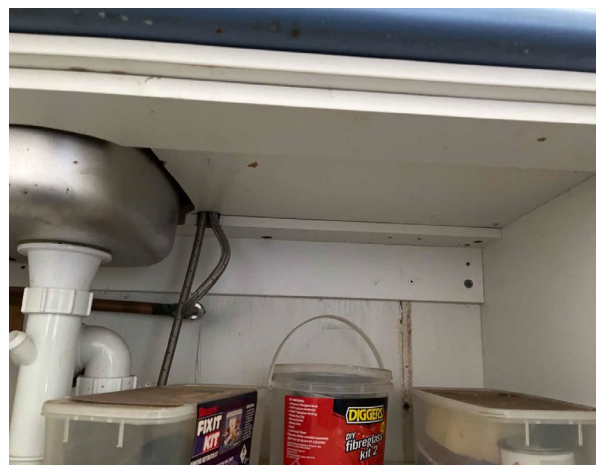
Line ID 21: Internal, GF, Workshops, Central Section, Kitchenette, Under Sink, Sink Pad (no access), Bituminous Material - Chrysotile Asbestos Detected

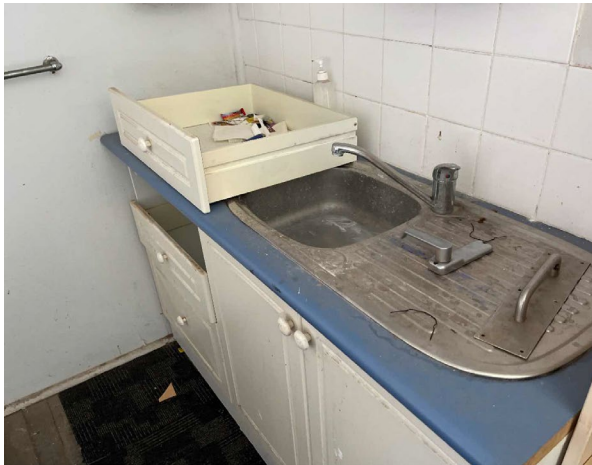
Line ID 21.1: Internal, GF, Workshops, Central Section, Kitchenette, Under Sink, Sink Pad (no access), Bituminous Material - Chrysotile Asbestos Detected

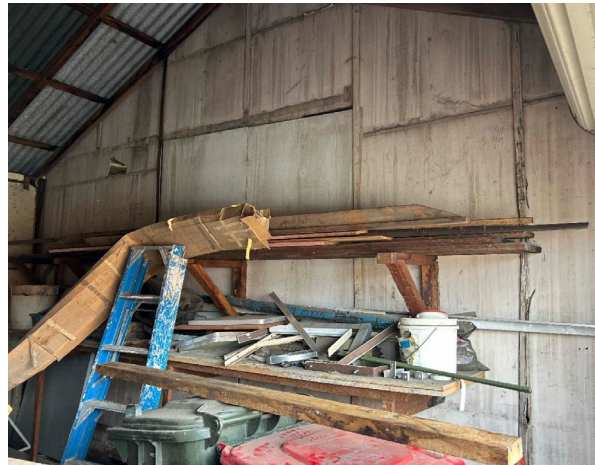
Line ID 22: Internal, GF, Workshops, Central Section, North Store Room, North and South, Walls, Fibre Cement Sheetting - Chrysotile, Amosite and Crocidolite Asbestos Detected

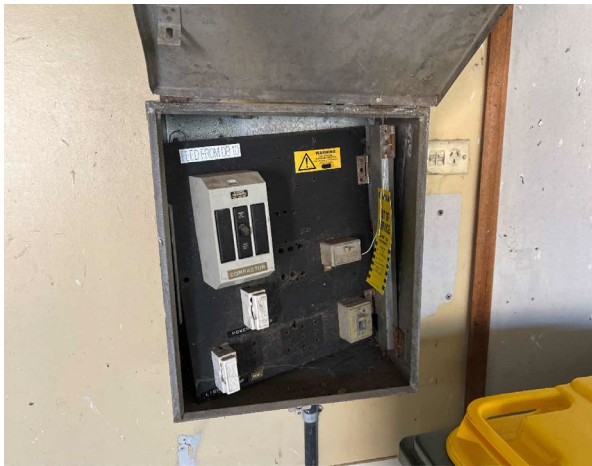
Line ID 23: Internal, GF, Workshops, Northern Section, Electrical Distribution Board 19 - Incinerator, Compressed Bituminous Panel - Suspected Asbestos

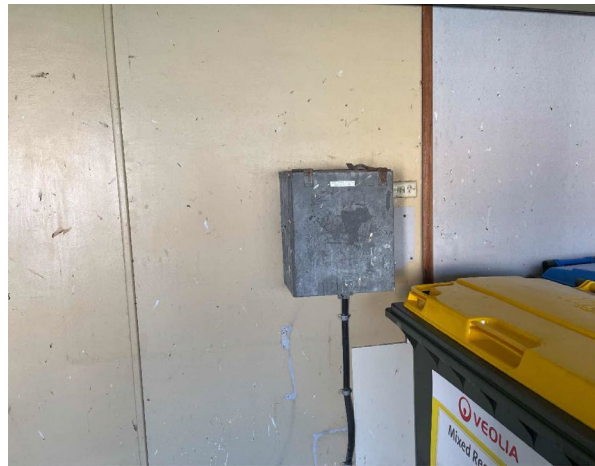
Line ID 23.1: Internal, GF, Workshops, Northern Section, Electrical Distribution Board 19 - Incinerator, Compressed Bituminous Panel - Suspected Asbestos

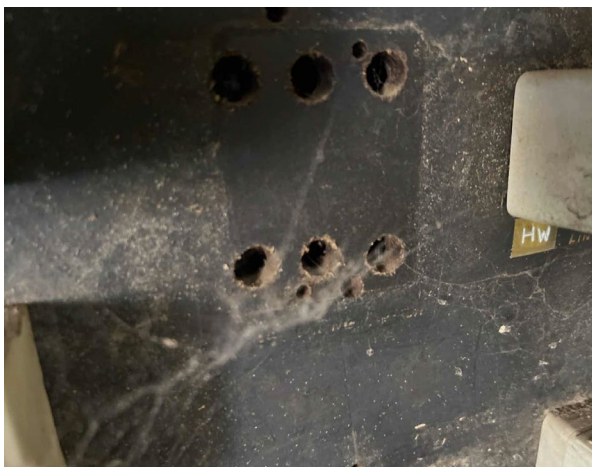
Line ID 23.2: Internal, GF, Workshops, Northern Section, Electrical Distribution Board 19 - Incinerator, Compressed Bituminous Panel - Suspected Asbestos

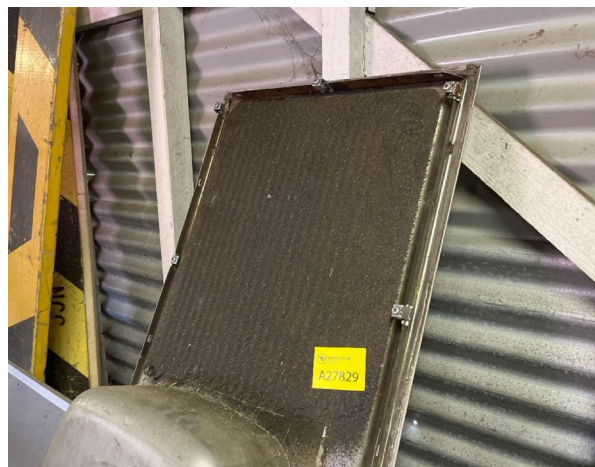
Line ID 24: Internal, GF, Workshops, Northern Section, Room 1004, Sink Pad, Bituminous Material - Chrysotile Asbestos Detected

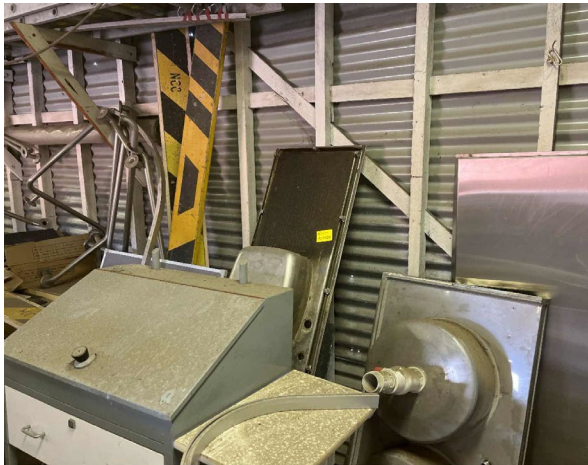
Line ID 24.1: Internal, GF, Workshops, Northern Section, Room 1004, Sink Pad, Bituminous Material - Chrysotile Asbestos Detected

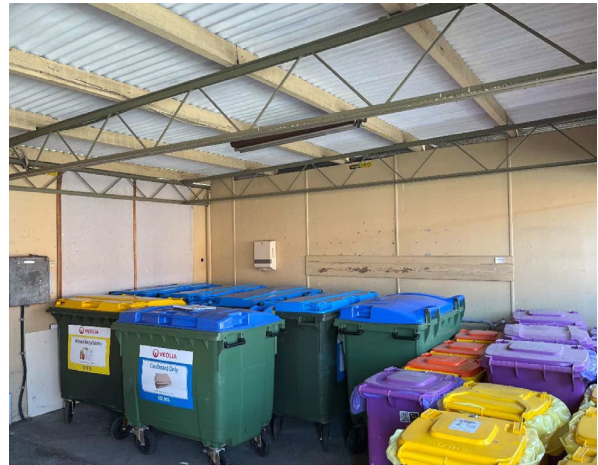
Line ID 25: Internal, GF, Workshops, Northern Section, Wall Lining, Fibre Cement Sheeting - Chrysotile, Amosite and Crocidolite Asbestos Detected

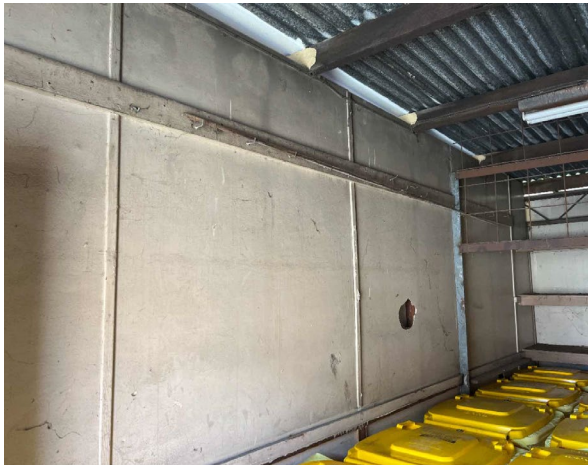
Line ID 25.1: Internal, GF, Workshops, Northern Section, Wall Lining, Fibre Cement Sheeting - Chrysotile, Amosite and Crocidolite Asbestos Detected

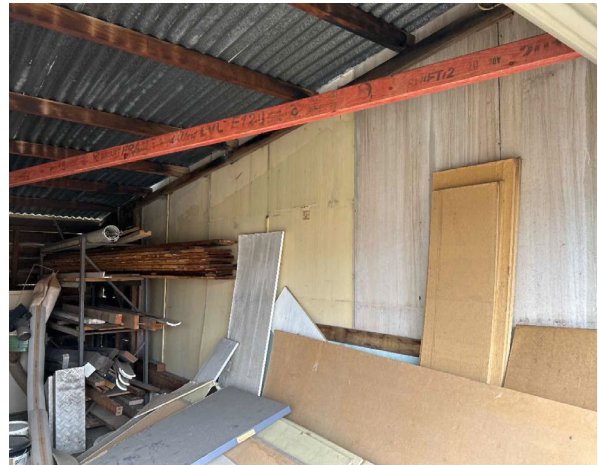
Line ID 26: Internal, GF, Workshops, Southern Section, Northern Unit, North, Wall, Fibre Cement Sheeting - Chrysotile, Amosite and Crocidolite Asbestos Detected

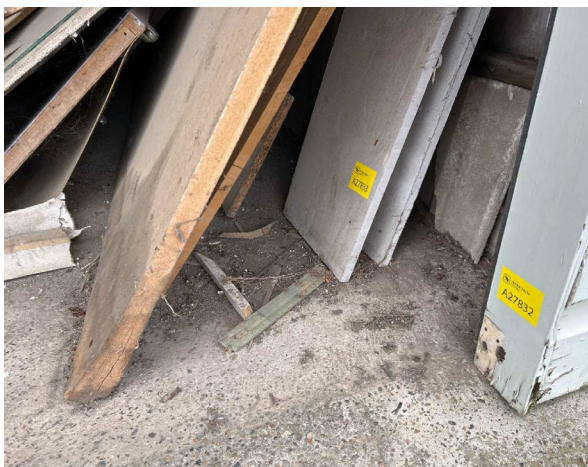
Line ID 27: Internal, GF, Workshops, Southern Section, Unit 1008, Floor, Dust - Chrysotile Asbestos Detected

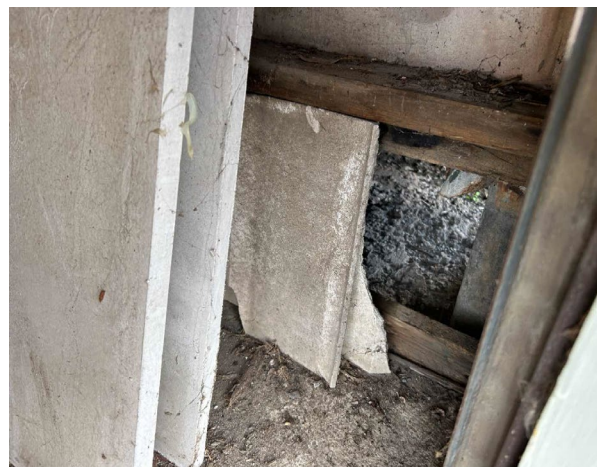
Line ID 28: Internal, GF, Workshops, Southern Section, Unit 1008, North, Lower Infill Panels, Profiled Cement Sheeting - Chrysotile Asbestos Detected

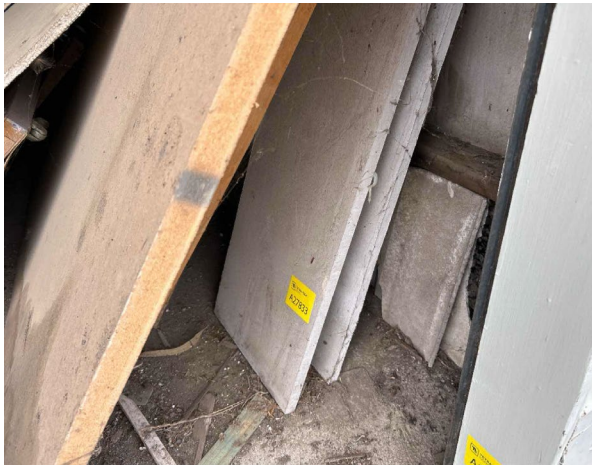
Line ID 29: Internal, GF, Workshops, Southern Section, Unit 1008, Northeast, Stored Sheets, Compressed Cement Sheeting - No Asbestos Detected

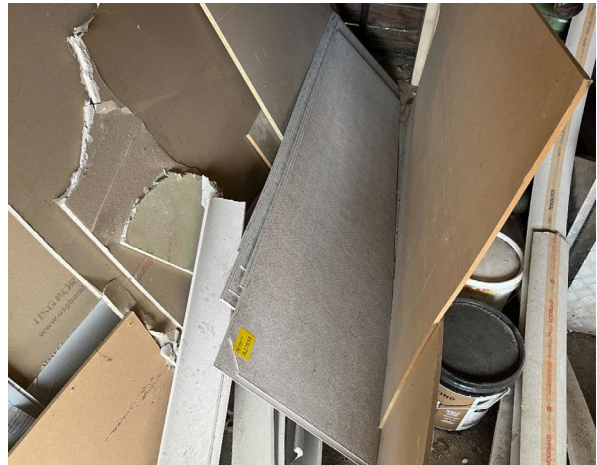
Line ID 30: Internal, GF, Workshops, Southern Section, Unit 1008, Stored Item on Floor, Fibre Cement Sheet - No Asbestos Detected

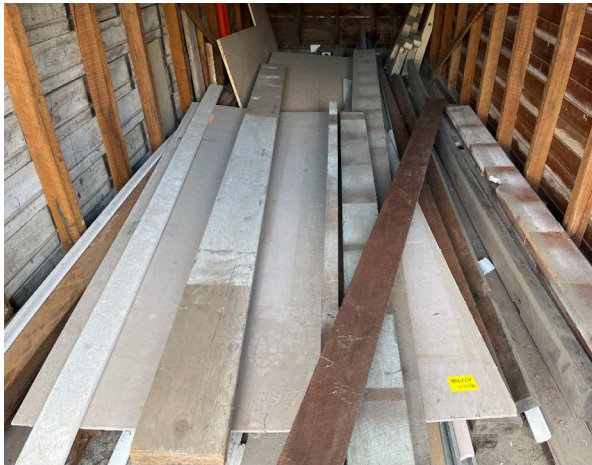
Line ID 31: Internal, GF, Workshops, Southern Section, Unit 1009, Stored Item on Floor, Fibre Cement Sheeting - No Asbestos Detected

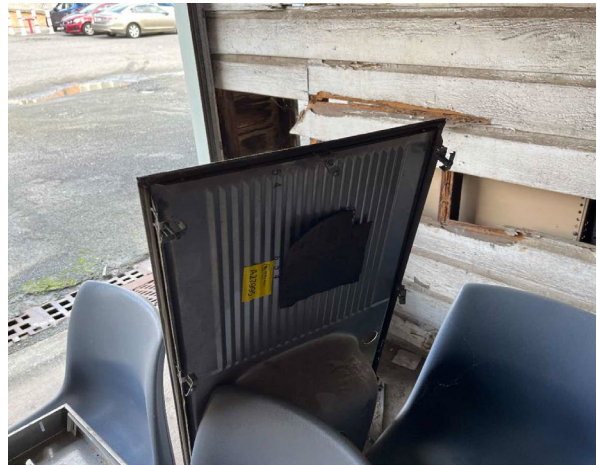
Line ID 32: Internal, GF, Workshops, Southern Section, Unit 1010, Stored Item, Underside of Sink, Bituminous Material - Chrysotile Asbestos Detected
