Cessnock Hospital - Pre-Demolition Hazardous Materials Survey Report Summary

Asbestos and Hazardous Materials Pre-Demolition Assessment

Kitchen

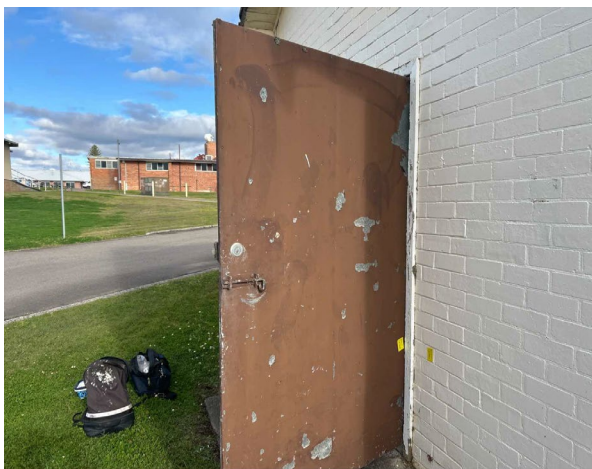
Line ID 33: External, GF, Old Mortuary, Entrance Door, Brown Paint - Lead Detected (0.096% w/w)

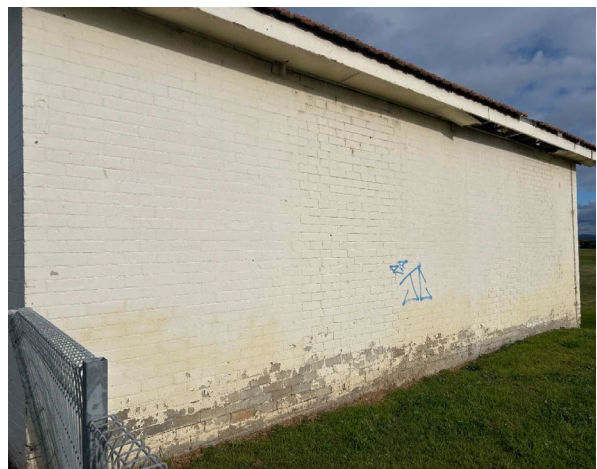
Line ID 34: External, GF, Old Mortuary, Walls, White Paint - Lead Detected (0.30% w/w)

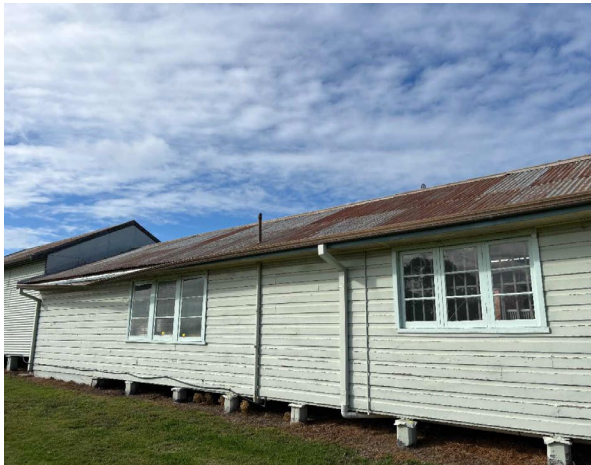
Line ID 35: External, GF, Workshops, All Areas, All Sections, Roof and Metal Work, Brown Paint - Lead Detected (0.26% w/w)

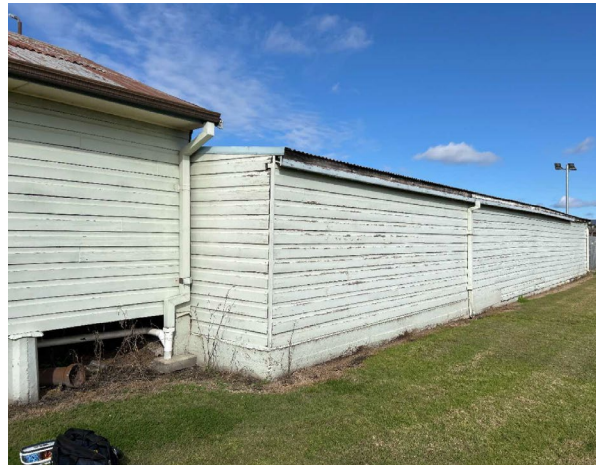
Line ID 36: External, GF, Workshops, All Areas, Central and South Sections, Timber Walls, White Paint - Lead Detected (0.18% w/w)

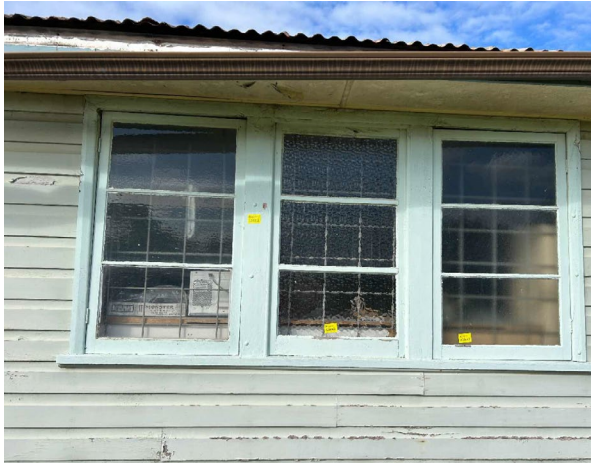
Line ID 37: External, GF, Workshops, All Areas, Central Section, West, Window Frames, White Paint - Lead Detected (0.24% w/w)

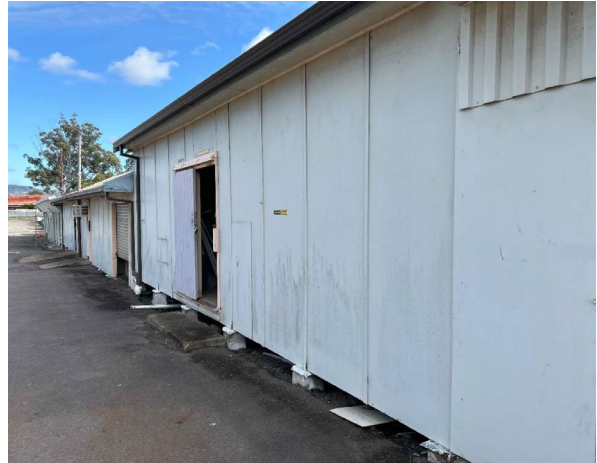
Line ID 38: External, GF, Workshops, All Areas, North and Central Sections, Walls, White Paint - Lead Detected (0.18% w/w)

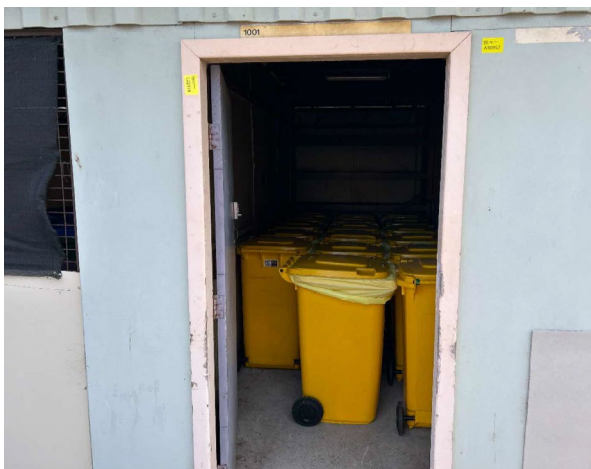
Line ID 39: External, GF, Workshops, All Areas, North Sections, Northeast, Door Frame, Cream Paint - Lead Detected (0.12% w/w)

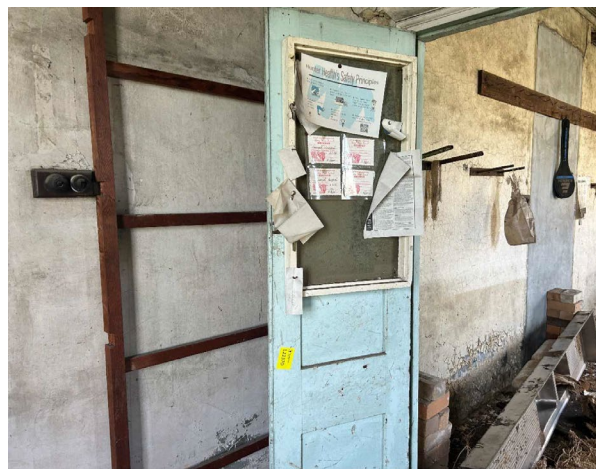
Line ID 40: Internal, GF, Old Mortuary, Central Door and Frame, Blue Paint - Lead Detected (12% w/w)

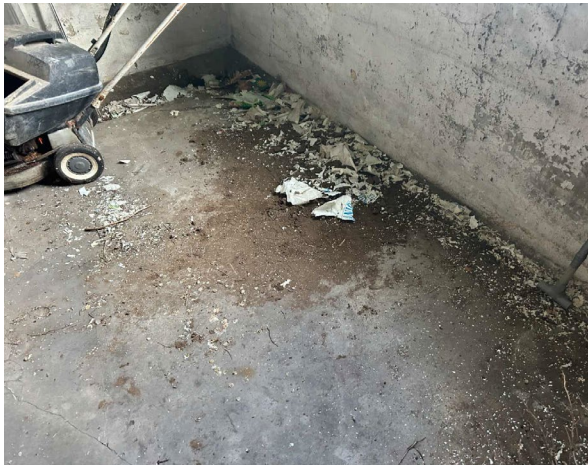
Line ID 41: Internal, GF, Old Mortuary, Debris on Floor, Cream Paint - Lead Detected (0.86% w/w)

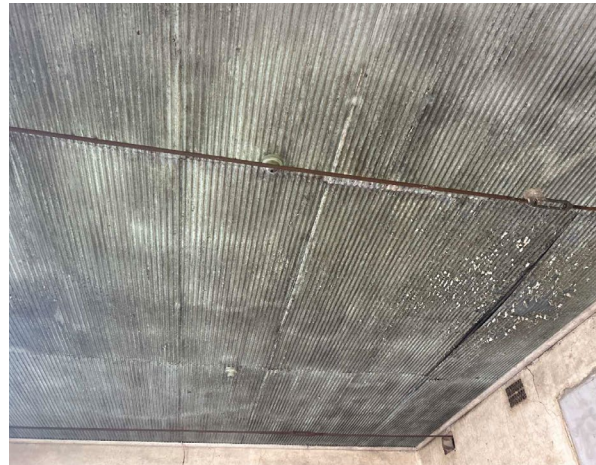
Line ID 42: Internal, GF, Old Mortuary, Throughout, Ceiling, Blue Paint - Lead Detected (12% w/w)

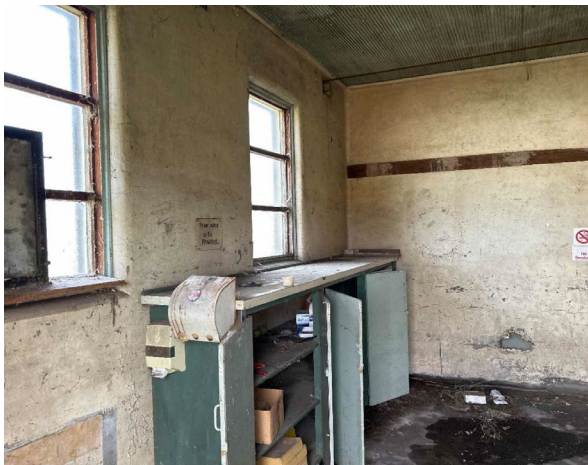
Line ID 43: Internal, GF, Old Mortuary, Walls, Cream Paint - Lead Detected (0.86% w/w)

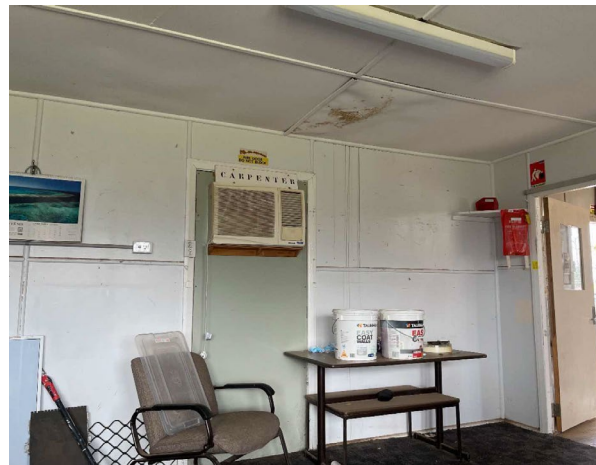
Line ID 44: Internal, GF, Workshops, Central Section, Wall & Ceiling Lining, Blue (Light) Paint - Lead Detected (0.25% w/w)

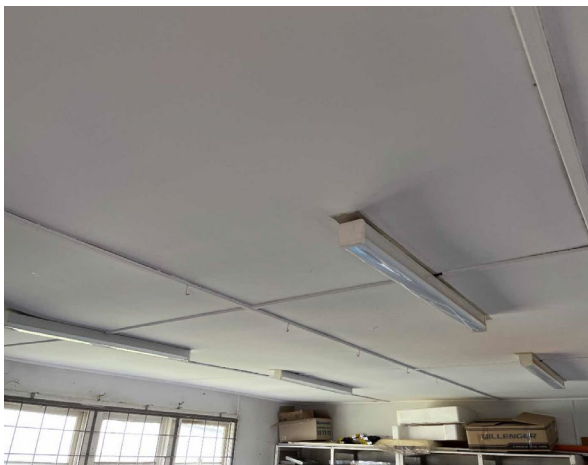
Line ID 44.1: Internal, GF, Workshops, Central Section, Wall & Ceiling Lining, Blue (Light) Paint - Lead Detected (0.25% w/w)

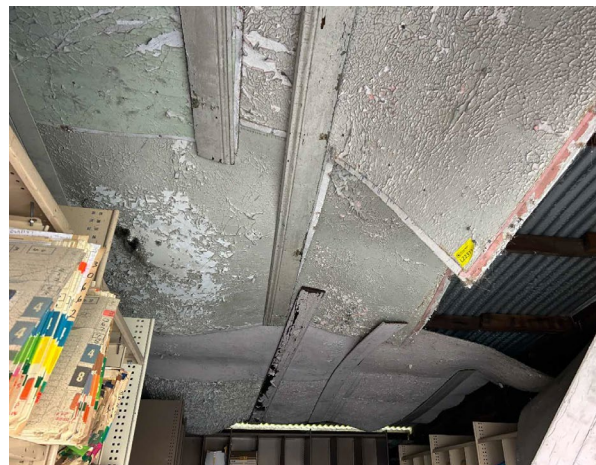
Line ID 45: Internal, GF, Workshops, Southern Section, Unit 1011, Ceiling, White Paint - Lead Detected (3.1% w/w)

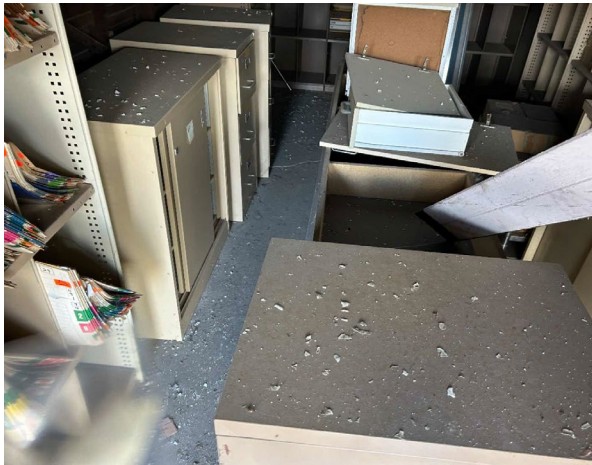
Line ID 46: Internal, GF, Workshops, Southern Section, Unit 1011, Debris on Surfaces, White Paint - Lead Detected (3.1% w/w)

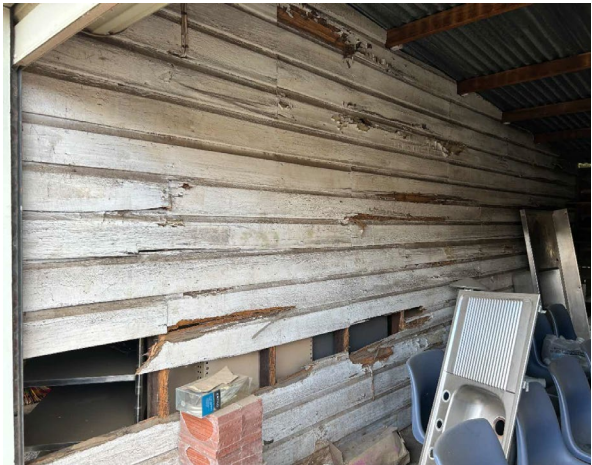
Line ID 47: Internal, GF, Workshops, Southern Section, Various Timber Walls, White Paint - Lead Detected (0.18% w/w)

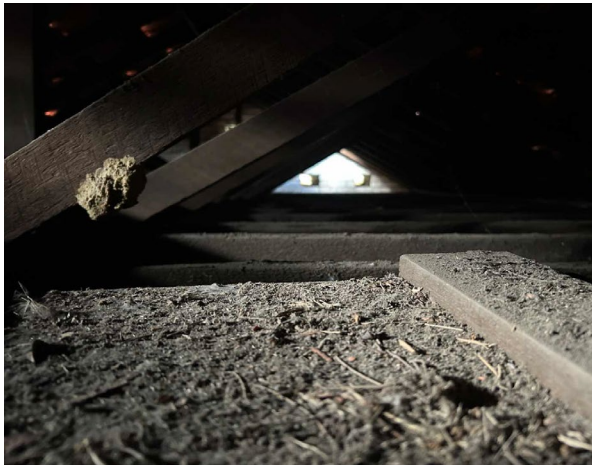
Line ID 48: Internal, GF, Old Mortuary, Ceiling Space, Dust - Lead Detected (290 mg/kg)

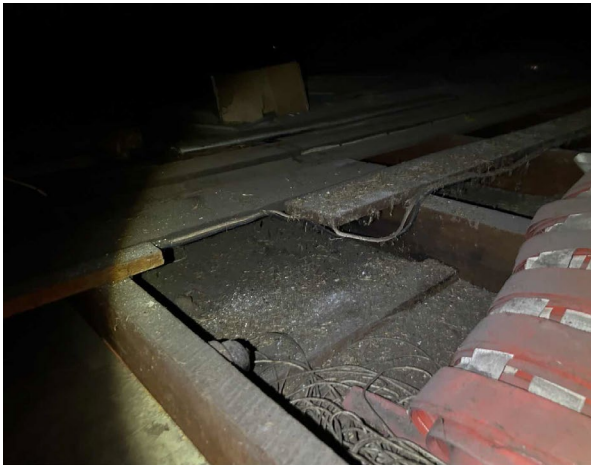
Line ID 49: Internal, GF, Workshops, Central Section, Throughout Ceiling Space, Dust - Lead Detected (5,400 mg/kg)

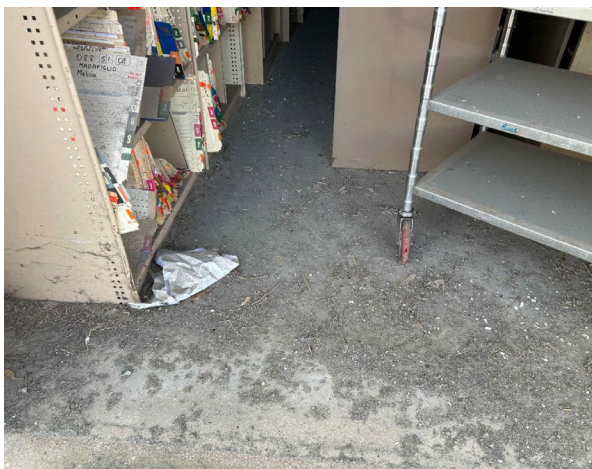
Line ID 50: Internal, GF, Workshops, Southern Section, Floor, Dust - Lead Detected (1,500 mg/kg)

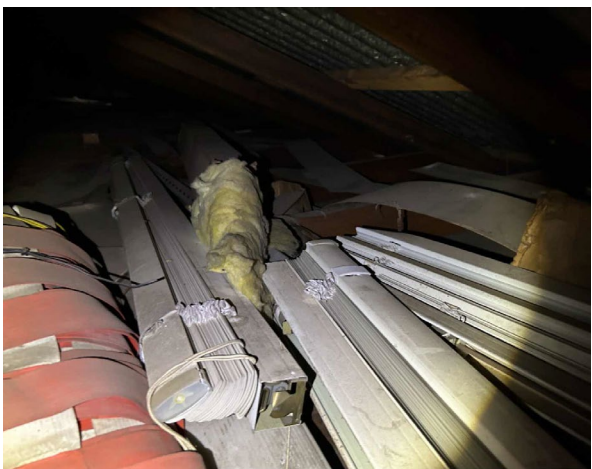
Line ID 51: Internal, GF, Workshops, Central Section, Ceiling Space, Insulation Batts - Suspected SMF

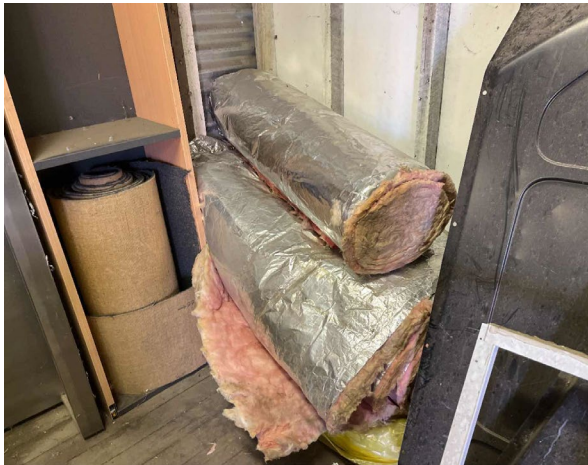
Line ID 52: Internal, GF, Workshops, Northern Section, Room 1004, Sarking Insulation, Stored Item - Suspected SMF

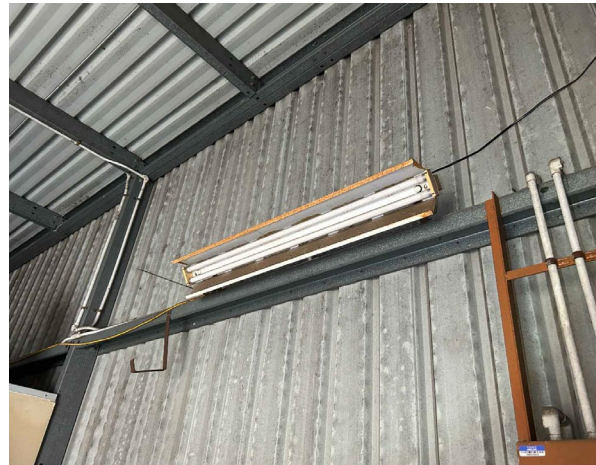
Line ID 53: Internal, GF, Northern Metal Shed, Throughout, Light Fittings, Capacitor(s) - Suspected PCB

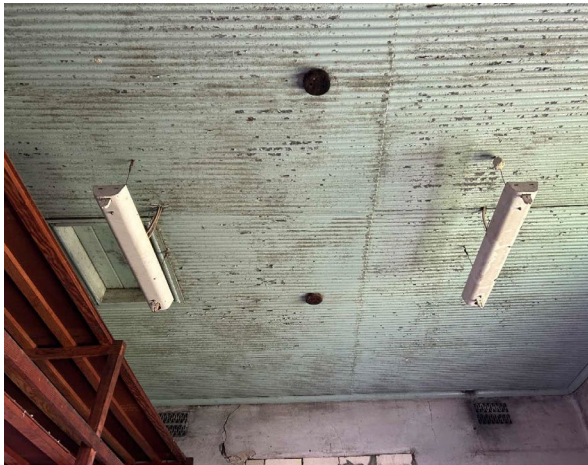
Line ID 54: Internal, GF, Old Mortuary, South Room, Light Fittings, Capacitor(s) - Suspected PCB

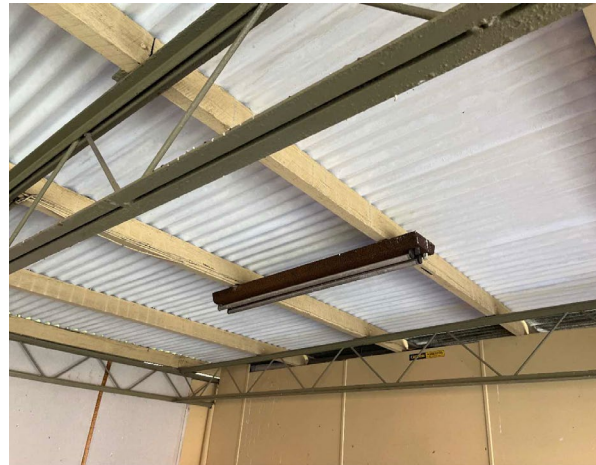
Line ID 55: Internal, GF, Workshops, Northern Section, Double Tube Fluorescent Light Fitting, Capacitor(s) - Suspected PCB

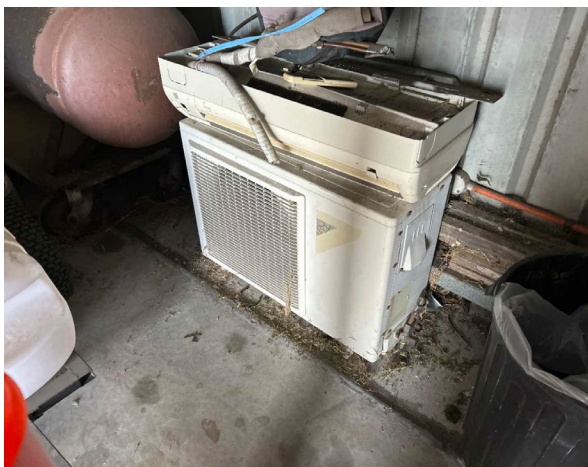
Line ID 56: Internal, GF, Northern Metal Shed, North, AC Unit, Unknown Refrigerant - Suspected ODS

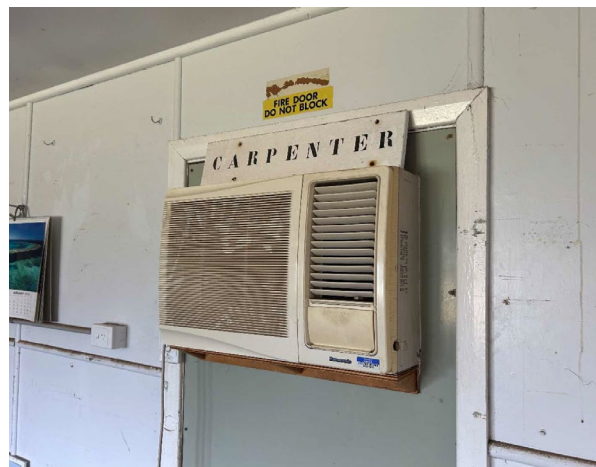
Line ID 57: Internal, GF, Workshops, Central Section, Central Office, AC Unit, R22 Hydrochlorofluorocarbon (HCFC) - ODS Refrigerant
