ARBORICULTURAL IMPACT ASSESSMENT

TREE PROTECTION SPECIFICATION

REF: L&Co24003 | 04 March 2025 | v2.2 SITE ADDRESS | Upgrade to Dundas Public School PREPARED FOR | School Infrastructure NSW PREPARED BY |

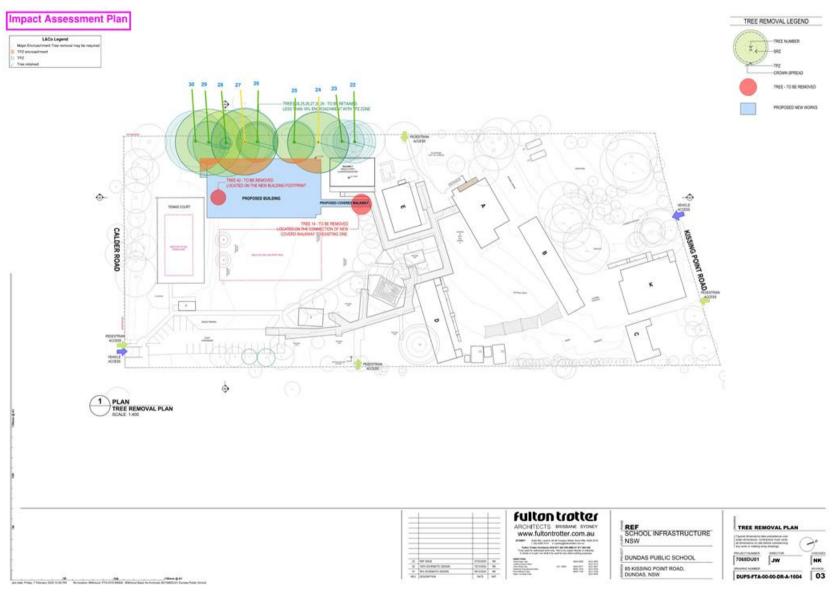
10.0 APPENDIX 5 | ARBORICULTURAL IMPACT ASSESSMENT PLANS

- 4.3.4 Refer to Appendix 5 for further detail
- 4.3.5 Removal and replacement with a healthy advanced size specimen would replace the loss of amenity within a medium timeframe.

- 4.4.3 Refer to Appendix 5 for further detail
- 4.4.4 Removal and replacement with a healthy advanced size specimen would replace the loss of amenity within a medium timeframe.

- 4.7.3 Refer to Appendix 5 for further detail.
- 4.7.4 Removal and replacement with a healthy advanced size specimen would replace the loss of amenity within a long timeframe.

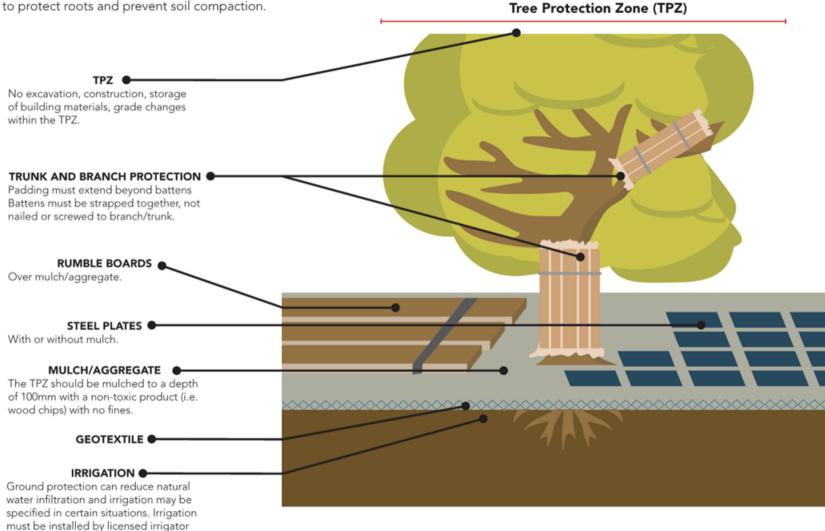
Tree Protection Detail - Ground Protection

Required if temporary access for machinery is required within the TPZ to protect roots and prevent soil compaction.
