## COMPLIANCE HAZARDOUS MATERIAL RE-INSPECTION AND RISK ASSESSMENT

AUGUST 2022

J049948

Milton Ulladulla Hospital -106 Princes Hwy  
Milton NSW  
2538

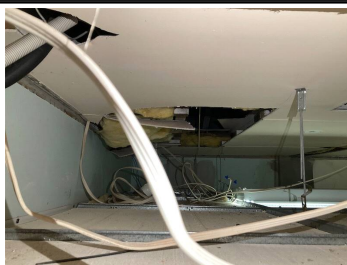
Location		MUH-A - Ground Level - Operating Suite Toilet MUHA00G33 - Throughout - Ceiling Lining - Fibre Cement Sheetting				
Hazard Type		Asbestos	Material Assessment		Disturbance Assessment	
Friability		Non-friable	Product Type	1	Occupancy	1
Sample No.		J149255-02-Block A-009 {CR000162}	Extent of damage	0	Disturbance	1
Result		Positive Amosite + Chrysotile + Crocidolite	Surface Treatment	0	Exposure	1
			Asbestos Type	3	Maintenance	0
Item Number	25	Material Score	4	Disturbance Score 3		
		Priority Score	7	Very Low

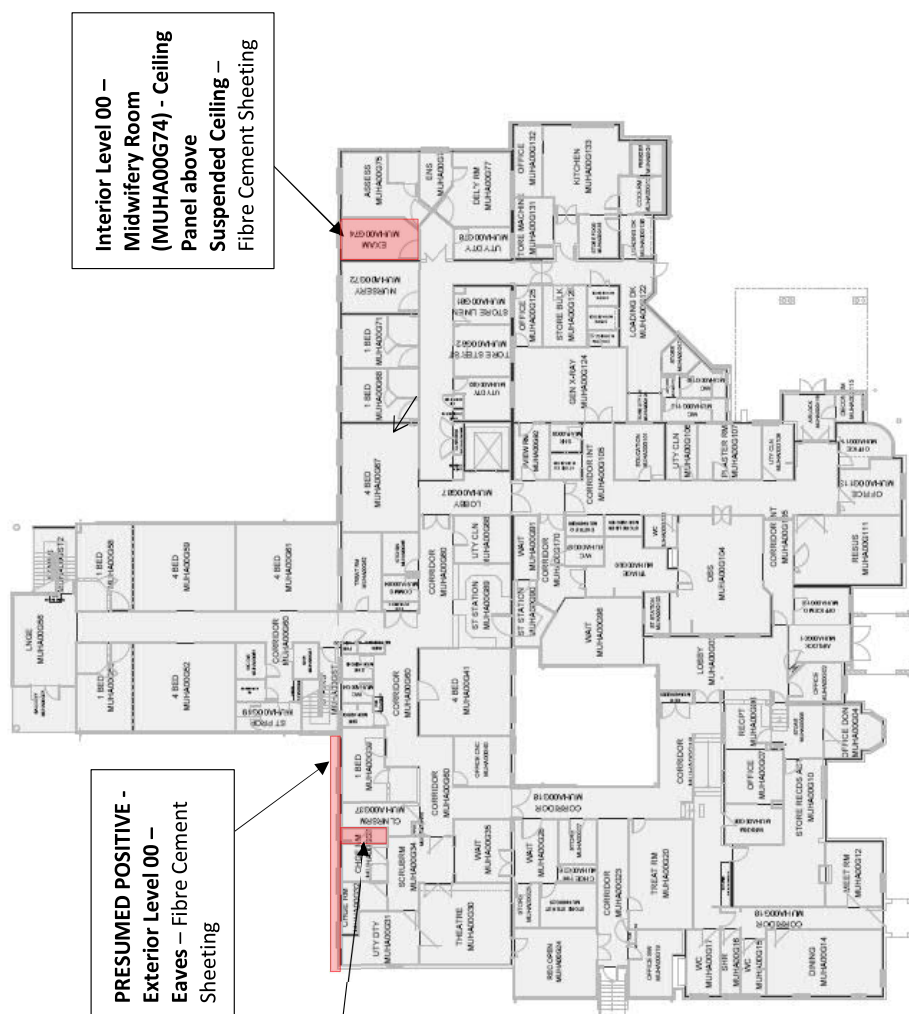
Location of ACM	
		Illawarra Shoalhaven Local Health District (ISLHD)	
		J049948	
		1.0

Interior Level 00 –  
Midwifery Room  
(MUHA00G74) - Ceiling  
Panel above  
Suspended Ceiling –  
Fibre Cement Sheetting

PRESUMED POSITIVE -  
Exterior Level 00 –  
Eaves – Fibre Cement  
Sheetting
