Northern Rivers Flood Recovery – Richmond River High Campus Redevelopment

Hazardous Building Materials Assessment

NSW Department of Education

27 June 2025

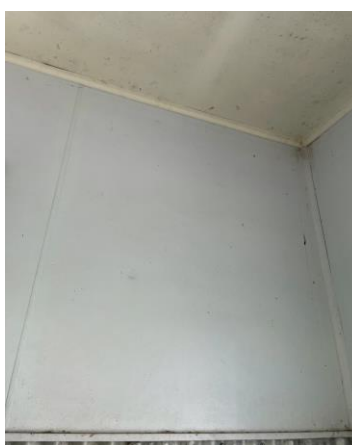
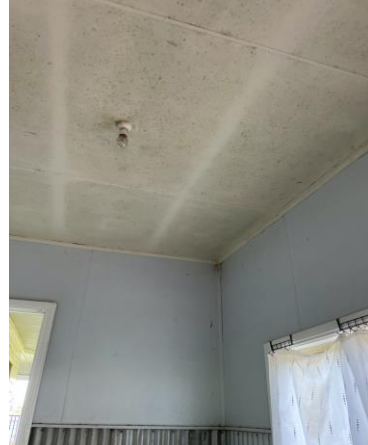
No asbestos detected																							
27-Aug-24		GHD	FH1	GF	Internal	Flat cement product	Bathroom	Rear porch bathroom	Wall and ceiling linings	Sealed	FH1-A01	No Asbestos Fibres Detected	N/A	N/A	N/A	N/A	Not required	N/A	-	-

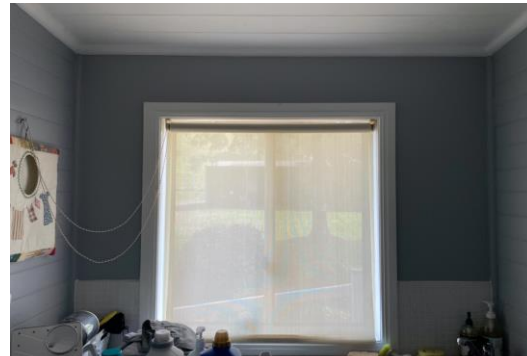
27-Aug-24		GHD	FH1	GF	Internal	Flat cement product	Laundry	Behind taps	Lining	Sealed	Refer FH1-A01	No Asbestos Fibres Detected	N/A	N/A	N/A	N/A	Not required	N/A	-	-

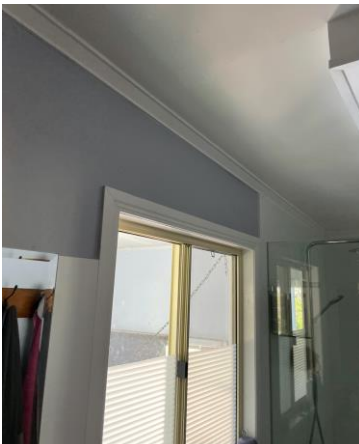
27-Aug-24		GHD	FH1	GF	Internal	Flat cement product	Bathroom	Ceiling and wall linings	Lining	Sealed	Refer FH1-A01	No Asbestos Fibres Detected	N/A	N/A	N/A	N/A	Not required	N/A	-	-

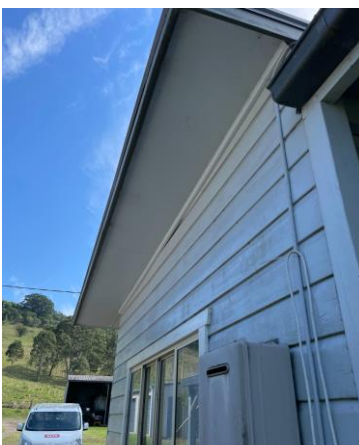
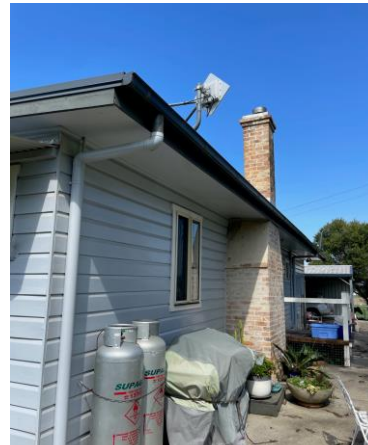
27-Aug-24		GHD	FH1	GF	External	Flat cement product	Eaves linings	External eaves to rear	Lining	Sealed	Refer FH1-A01	No Asbestos Fibres Detected	N/A	N/A	N/A	N/A	Not required	N/A	-	-

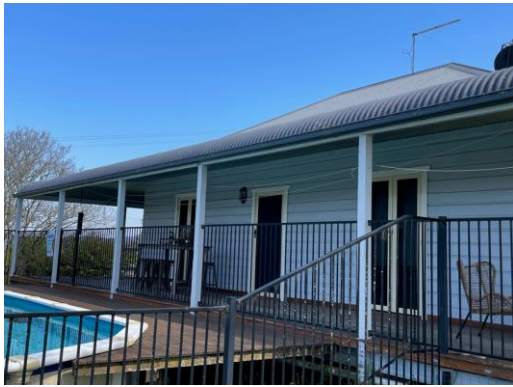
27-Aug-24		GHD	FH1	GF	Internal	Paint	Bannister	White paint	Paint	Sealed	FH1-P02	No lead paint detected <0.1% w/w (<0.01% w/w)	N/A	N/A	N/A	N/A	Not required	-	-	-	-

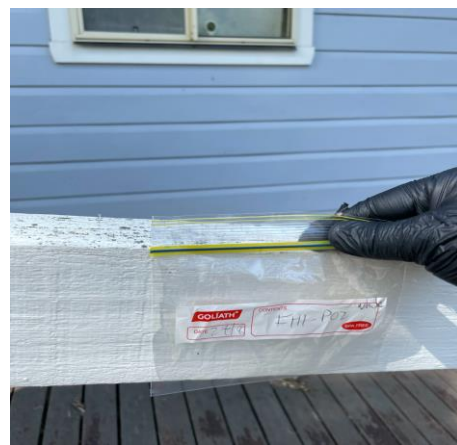
27-Aug-24		GHD	FH1	GF	Internal	Paint	Internal wall paint	White paint	Paint	Sealed	Refer FH1-P02	No lead paint detected <0.1% w/w (<0.01% w/w detected)	N/A	N/A	N/A	N/A	Not required	-	-	-	-

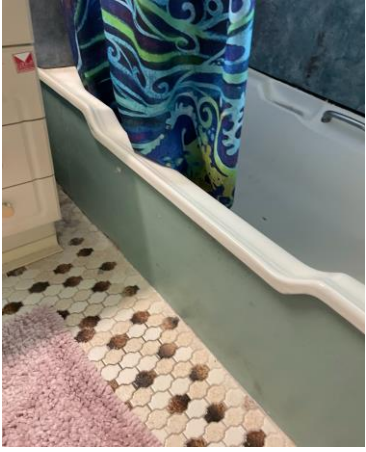
27-Aug-24		GHD	FH2	01	Internal	Flat cement product	Bathroom	"Tilux" sheet around shower	Linings	Sealed	FH2-A09	No Asbestos Fibres Detected	N/A	N/A	N/A	N/A	Not required	N/A	-	-	-

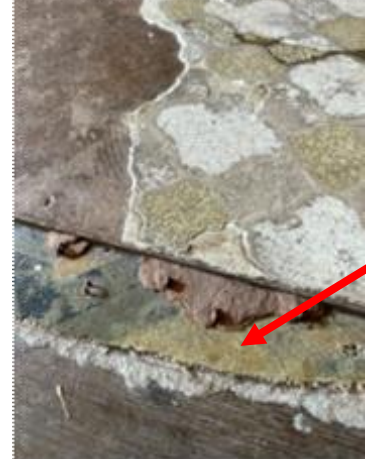
27-Aug-24		GHD	FH2	01	Internal	Textiles - ropes, yarns, cloth	Front rooms	Flooring	Carpet underlay and backing	Unsealed	FH2-A17	No Asbestos Fibres Detected	N/A	N/A	N/A	N/A	Not required	N/A	-	-	-

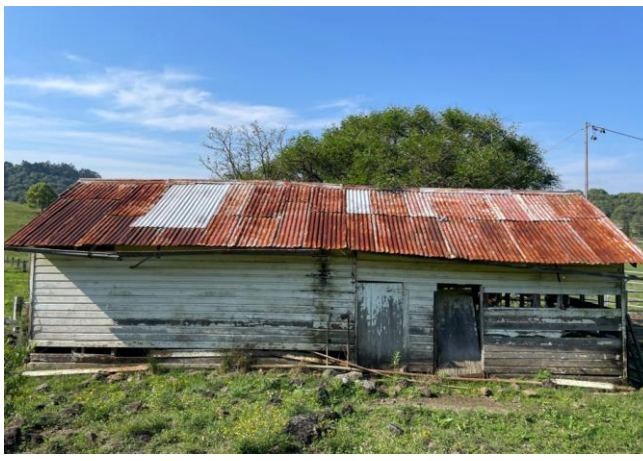
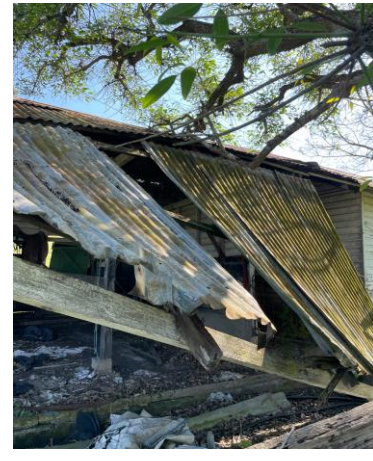
Building Description			Dairy - Timber structure on concrete slab. One portion fallen in. No access to damaged area.

No potential asbestos materials detected or assumed																									
Lead paint																									
27-Aug-24		GHD	Dairy	GF	External	Paint	Wall paint	Cream paint	Paint	Sealed	FH2-P04	Lead paint detected >0.1% w/w (8.6% w/w)	N/A	Poor	Low	Low	Removal	N/A	25	m2

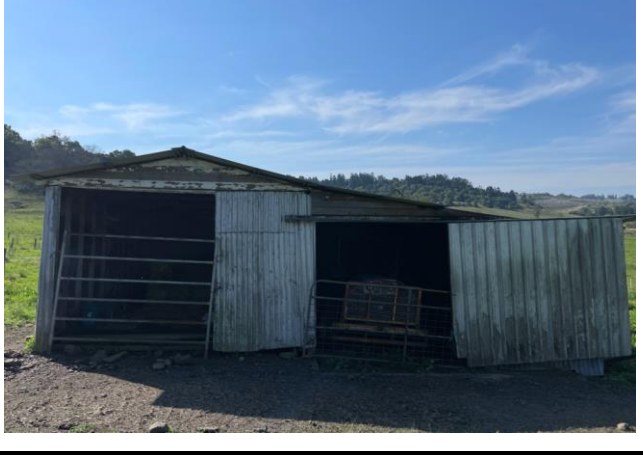
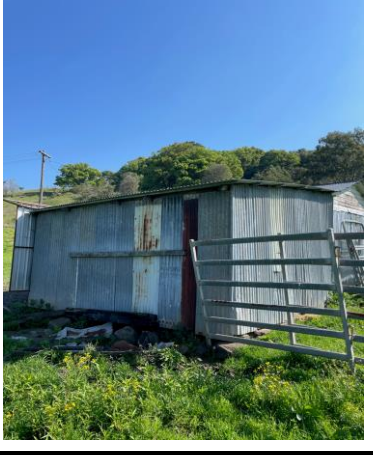
No PCB capacitors observed																									
No synthetic mineral fibre observed or assumed																									
Building Description			Shed - Timber structure on concrete slab

No potential asbestos materials detected or assumed																									
Lead paint																									
27-Aug-24		GHD	Shed	GF	External	Paint	Door and external weatherboards	Cream paint	Paint	Sealed	FH2-P05	Lead paint detected >0.1% w/w (20% w/w)	N/A	Poor	Medium	Medium	Removal	N/A	35	m2

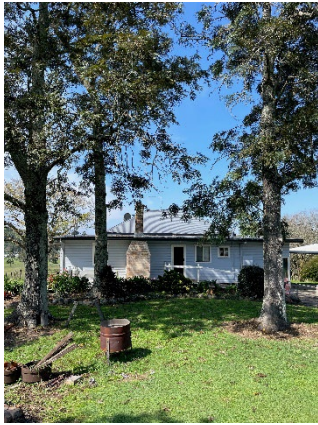
Photograph 1: Farmhouse 1 looking east

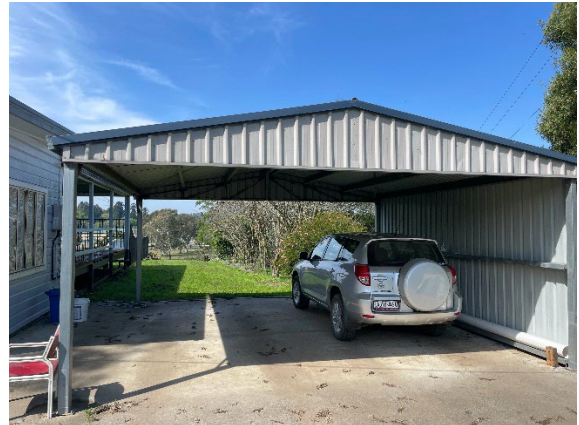
Photograph 2: Farmhouse 1 carport

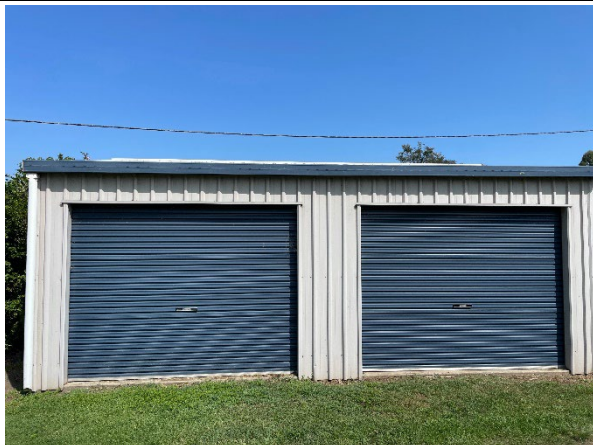
Photograph 3: Farmhouse 1 southern shed

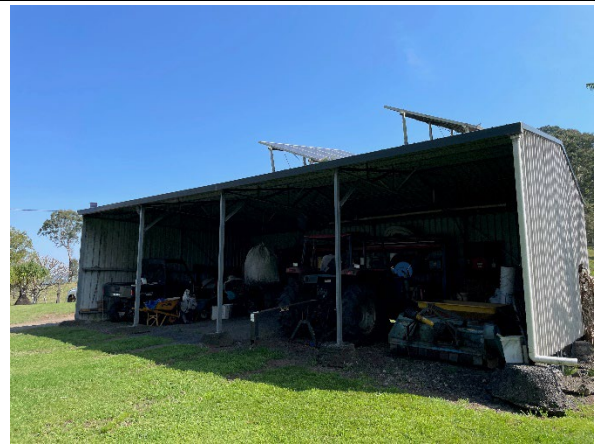
Photograph 4: Farmhouse 1 western shed

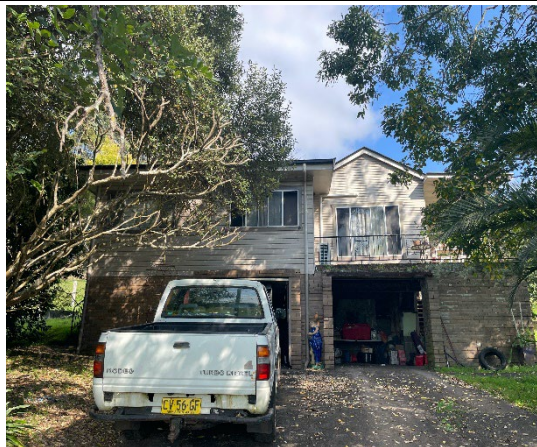
Photograph 5: Farmhouse 2 looking west

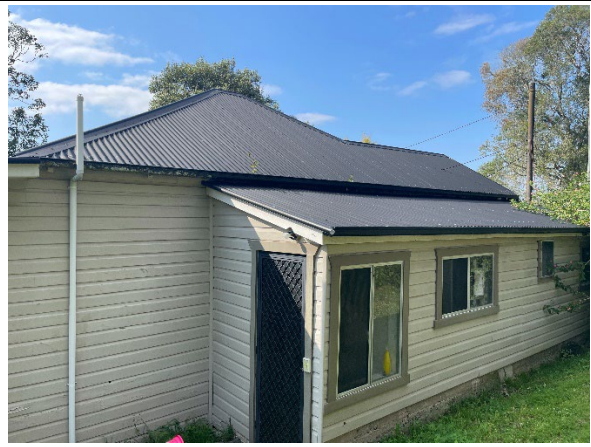
Photograph 6: rear of Farmhouse 2 looking south east

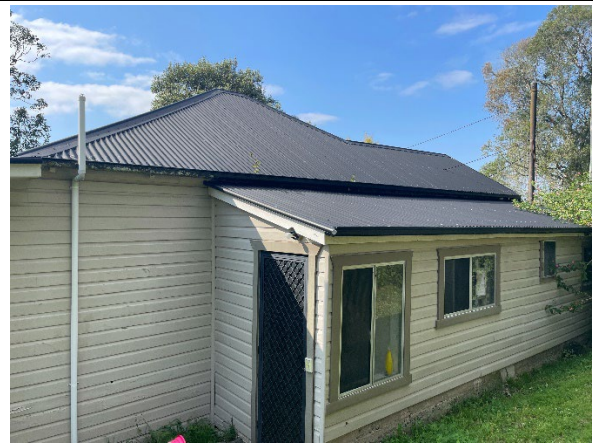
Photograph 6: rear of Farmhouse 2 looking south east

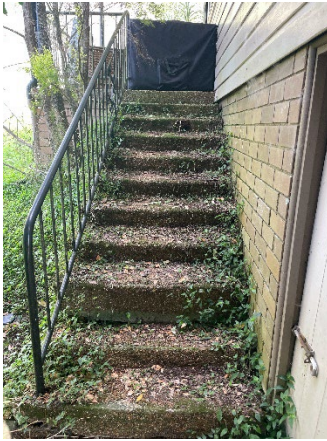
Photograph 7: Farmhouse 2 southern stairway and porch

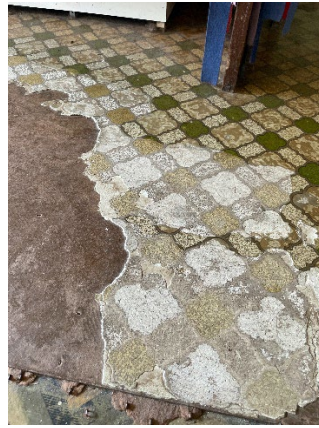
Photograph 8: Farmhouse2 internal kitchen/dining area flooring (Friable asbestos detected)

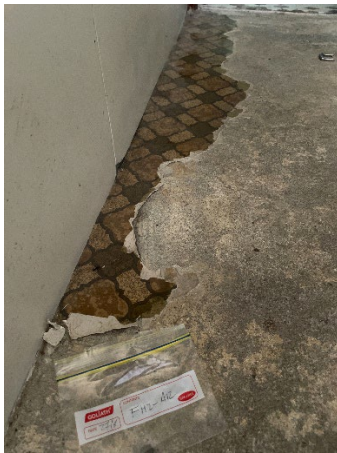
Photograph 9: Farmhouse 2 hallway floor to bathroom (friable asbestos detected)

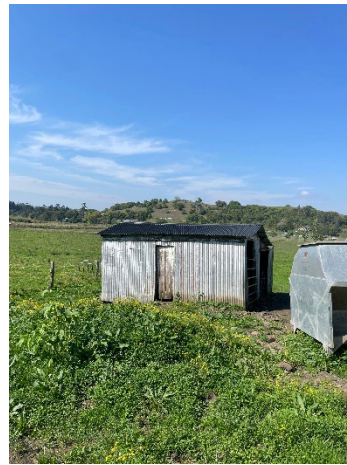
Photograph 10: Farmhouse 2 Shed

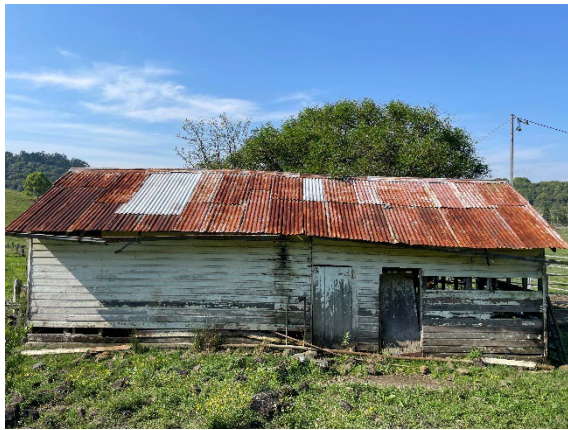
Photograph 11: Farmhouse 2 Dairy

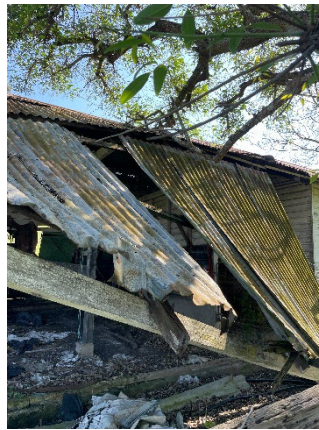
Photograph 12: Farmhouse 2 Dairy – collapsed roof area
