# New High School for Leppington and Denham Court – Hazardous Building Materials Survey

NSW Department of Education

JBS&G 67606 | 163,954 Rev 1

13 January 2025

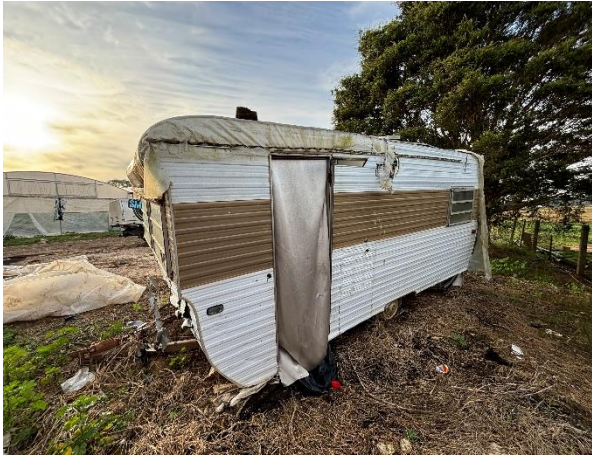
Photo 1: Caravan – Overview

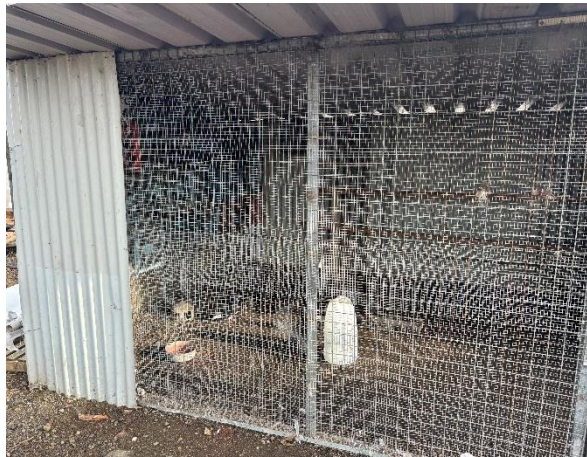
Photo 5: Overview – chicken coop (central)

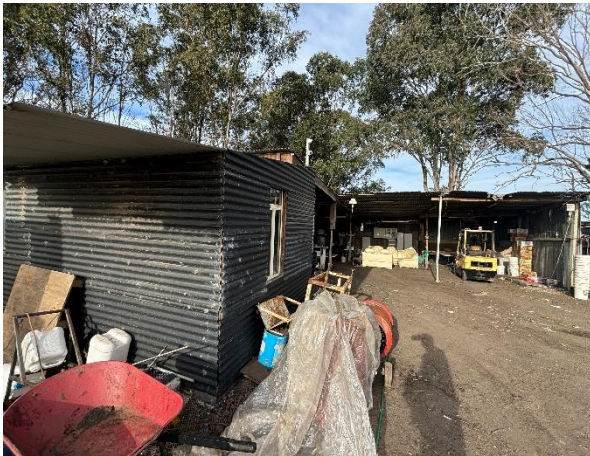
Photo 10: Large Shed Area - Overview
