# Hazardous Building Materials Assessment

**Lismore South Public School – Flood  
Recovery Rebuild**

NSW Department of Education

04 June 2025

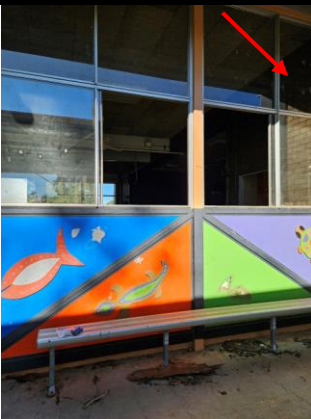
| Consultant | | | Location / Description | | | | | | | | | | Risk Assessment | | | | | | | | | | | |
|---|---|---|---|---|---|---|---|---|---|---|---|---|---|---|---|---|---|---|---|---|---|---|---|--|
| 18-Jul-24 | | GHD | B00A - Library | GF | External | Sealant / Adhesives | All windows to ground floor south wall | South wall | Putty | Unsealed | Refer to B00A-A06 | Chrysotile Detected | Non-friable | Poor | High | Very high | Removal | Labels required (not affixed or not sufficient) | 6 | Item | Quantity estimate based on number of individual windows. | | | |

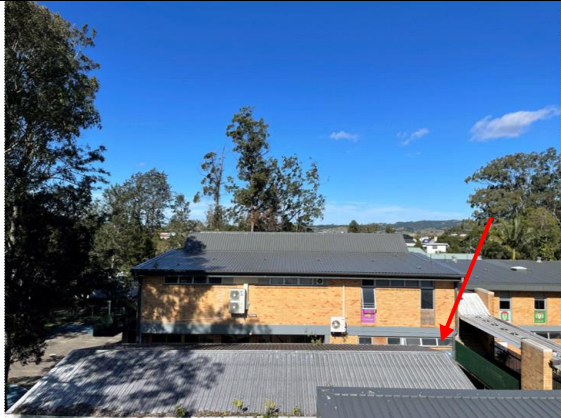
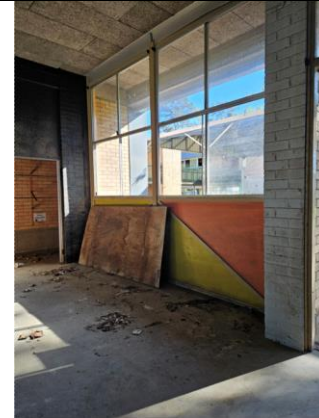
| Consultant | | | Location / Description | | | | | | | | | | Risk Assessment | | | | | | | | | | | |
|---|---|---|---|---|---|---|---|---|---|---|---|---|---|---|---|---|---|---|---|---|---|---|---|--|
| 18-Jul-24 | | GHD | B00A - Library | GF | External | Sealant / Adhesives | All windows to ground floor north wall | North wall | Putty | Unsealed | Refer to B00A-A06 | Chrysotile Detected | Non-friable | Poor | High | Very high | Removal | Labels required (not affixed or not sufficient) | <1 | m2 | Quantity estimate based on number of individual windows. | | | |

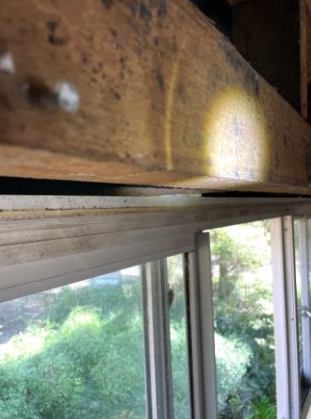
| Consultant | | | Location / Description | | | | | | | | | | Risk Assessment | | | | | | | | | | | |
|---|---|---|---|---|---|---|---|---|---|---|---|---|---|---|---|---|---|---|---|---|---|---|---|--|
| 18-Jul-24 | | GHD | B00A - Library | GF | External | Flat cement product | Window surrounds | Flat cement sheet packers present above and below external window frames throughout ground and first floors of building B00A | Packers | Unsealed | refer to B00F-A04 | Chrysotile & Amosite Detected | Non-friable | Fair | High | Very high | Removal | Not required | 55 | Item | Quantity estimate based on presence of packers per window. ACM sheet fragment packers present to all window surrounds present in B00A. | | | |

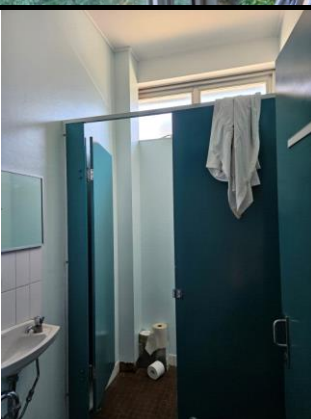
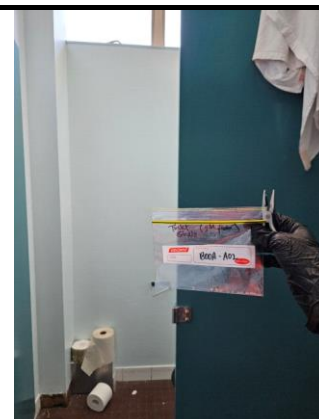
| Consultant | | | Location / Description | | | | | | | | | | Risk Assessment | | | | | | | | | | | |
|---|---|---|---|---|---|---|---|---|---|---|---|---|---|---|---|---|---|---|---|---|---|---|---|--|
| 18-Jul-24 | | GHD | B00A - Library | 01 | Internal | Flat cement product | Toilets | Toilet stalls | Cubicle panels | Sealed | B00A-A02 | Chrysotile & Amosite Detected | Non-friable | Good | Very high | Very high | Removal | Labels required (not affixed or not sufficient) | 8 | m2 | | | | |

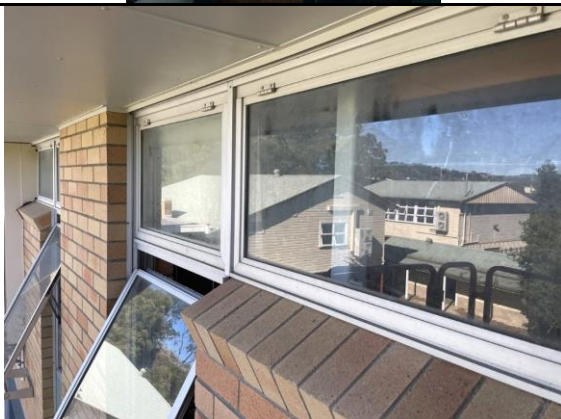
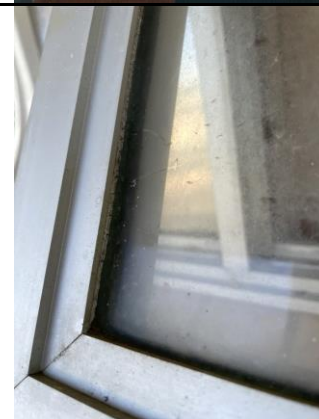
| Consultant | | | Location / Description | | | | | | | | | | Risk Assessment | | | | | | | | | | | |
|---|---|---|---|---|---|---|---|---|---|---|---|---|---|---|---|---|---|---|---|---|---|---|---|--|
| 18-Jul-24 | | GHD | B00A - Library | 01 | External | Sealant / Adhesives | Window putty between glass and window frame within upper rectangular windows | South wall - first floor | Putty | Unsealed | B00A-A06 | Chrysotile Detected | Non-friable | Poor | High | Very high | Removal | Labels required (not affixed or not sufficient) | 13 | Item | Quantity estimate based on number of individual windows. | | | |

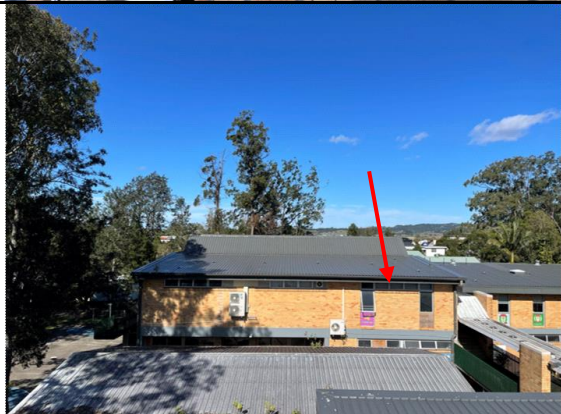
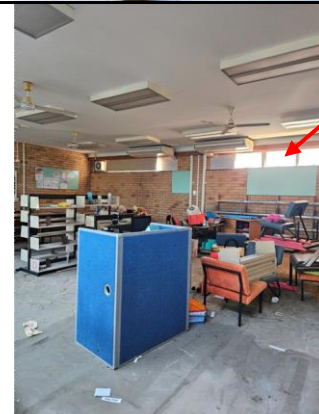
| Consultant | | | Location / Description | | | | | | | | | | Risk Assessment | | | | | | | | | | | |
|---|---|---|---|---|---|---|---|---|---|---|---|---|---|---|---|---|---|---|---|---|---|---|---|--|
| 18-Jul-24 | | GHD | B00A - Library | 01 | External | Sealant / Adhesives | Window putty between glass and window frame within upper rectangular windows | North wall - first floor | Putty | Unsealed | Refer to B00A-A06 | Chrysotile Detected | Non-friable | Poor | High | Very high | Removal | Labels required (not affixed or not sufficient) | 16 | Item | Quantity estimate based on number of individual windows. | | | |

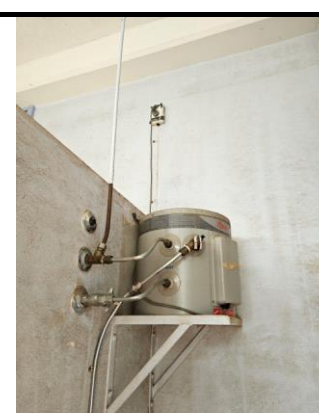
| Inspection date | Reinspection Date | Consultant and Surveyor Reference | Building Ref | Floor | Room or Space | Material description | Primary location | Secondary location | Application | Surface treatment | Sample identification | Laboratory results | Friability | Material condition | Likelihood of disturbance | Risk | Control method | Labelling | Estimated quantity | Units | Comments | Photograph reference | | Photograph reference | |
|---|---|---|---|---|---|---|---|---|---|---|---|---|---|---|---|---|---|---|---|---|---|---|--|---|--|
| 18-Jul-24 | | GHD | B00A - Hall | GF | Internal | Thermal insulation | Male toilets | Hot water heater | Insulation | Sealed | Assumed | Presumed to contain SMF until proven otherwise | N/A | Good | High | Very high | Removal | N/A | 1 | Item | Hot water system | | | | |

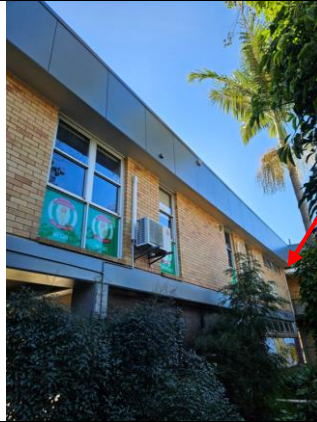
| Consultant | | | Location / Description | | | | | | | | | | Risk Assessment | | | | | | | | | | | |
|---|---|---|---|---|---|---|---|---|---|---|---|---|---|---|---|---|---|---|---|---|---|---|---|--|
| 18-Jul-24 | | GHD | B00B - Administration | 01 | External | Sealant / Adhesives | Window putty between glass and window frame within rectangular windows | Staff toilets - south wall | Putty | Unsealed | Refer to B00A-A06 | Chrysotile Detected | Non-friable | Fair | High | Very high | Removal | Labels required (not affixed or not sufficient) | 4 | Item | Quantity estimate based on number of individual windows. | | | |

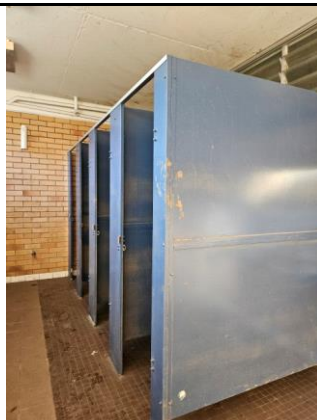
| Consultant | | | Location / Description | | | | | | | | | | Risk Assessment | | | | | | | | | | | |
|---|---|---|---|---|---|---|---|---|---|---|---|---|---|---|---|---|---|---|---|---|---|---|---|--|
| 18-Jul-24 | | GHD | B00B - Toilet Block | GF | Internal | Flat cement product | Female toilet stalls | Cubicle lining | Panels | Sealed | B00B-A01 | Chrysotile & Amosite Detected | Non-friable | Good | High | Very high | Removal | Labels required (not affixed or not sufficient) | 20 | m2 | | | | |

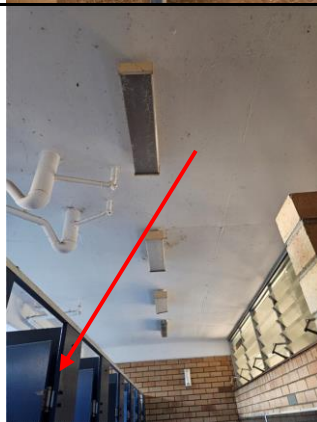
| Consultant | | | Location / Description | | | | | | | | | | Risk Assessment | | | | | | | | | | | |
|---|---|---|---|---|---|---|---|---|---|---|---|---|---|---|---|---|---|---|---|---|---|---|---|--|
| 18-Jul-24 | | GHD | B00B - Toilet Block | GF | Internal | Flat cement product | Male toilet stalls | Cubicle lining | Panels | Sealed | Refer to B00B-A01 | Chrysotile & Amosite Detected | Non-friable | Good | High | Very high | Removal | Labels required (not affixed or not sufficient) | 20 | m2 | | | | |

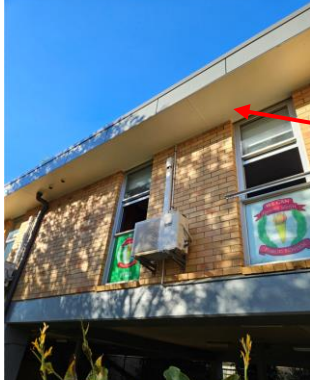
| Inspection date | Reinspection Date | Consultant and Surveyor Reference | Building Ref | Floor | Room or Space | Material description | Primary location | Secondary location | Application | Surface treatment | Sample identification | Laboratory results | Friability | Material condition | Likelihood of disturbance | Risk | Control method | Labelling | Estimated quantity | Units | Comments | Photograph reference | Photograph reference |
|---|---|---|---|---|---|---|---|---|---|---|---|---|---|---|---|---|---|---|---|---|---|---|---|
| 18-Jul-24 | | GHD | B00B - Administration | Roof | External | Flat cement product | Eaves | Eaves to north and south aspects | Lining | Sealed | Refer to B00A-A04 | No Asbestos Fibres Detected | N/A | N/A | N/A | N/A | Not required | N/A | 65 | m2 | | | |

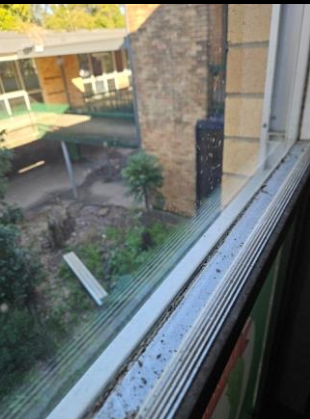
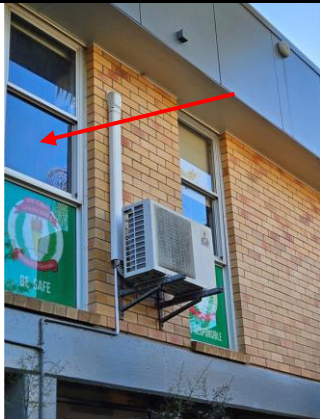
| Inspection date | Reinspection Date | Consultant and Surveyor Reference | Building Ref | Floor | Room or Space | Material description | Primary location | Secondary location | Application | Surface treatment | Sample identification | Laboratory results | Friability | Material condition | Likelihood of disturbance | Risk | Control method | Labelling | Estimated quantity | Units | Comments | Photograph reference | Photograph reference |
|---|---|---|---|---|---|---|---|---|---|---|---|---|---|---|---|---|---|---|---|---|---|---|---|
| 18-Jul-24 | | GHD | B00B - Administration | 01 | Internal | Sealant / Adhesives | Windows | Northern and southern walls | Putty | Unsealed | B00B-A03 | No Asbestos Fibres Detected | N/A | N/A | N/A | N/A | Not required | N/A | - | - | | | |

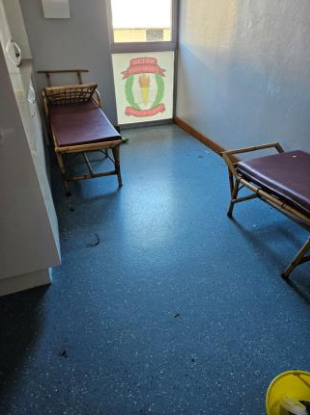
| Inspection date | Reinspection Date | Consultant and Surveyor Reference | Building Ref | Floor | Room or Space | Material description | Primary location | Secondary location | Application | Surface treatment | Sample identification | Laboratory results | Friability | Material condition | Likelihood of disturbance | Risk | Control method | Labelling | Estimated quantity | Units | Comments | Photograph reference | Photograph reference |
|---|---|---|---|---|---|---|---|---|---|---|---|---|---|---|---|---|---|---|---|---|---|---|---|
| 18-Jul-24 | | GHD | B00B - Administration | 01 | Internal | Floor sheeting | Blue speckled vinyl flooring sick bay | Floor | Floor covering | Sealed | B00B-A04 | No Asbestos Fibres Detected | N/A | N/A | N/A | N/A | Not required | N/A | - | - | | | |

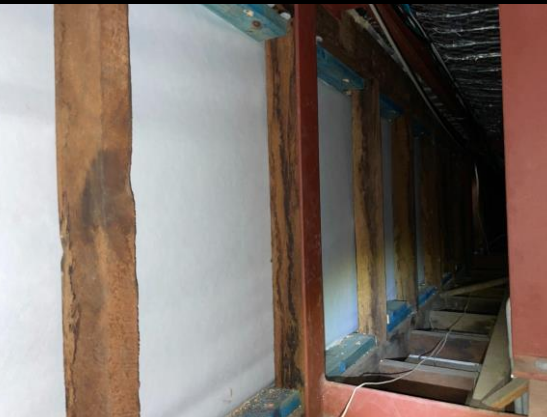
| Inspection date | Reinspection Date | Consultant and Surveyor Reference | Building Ref | Floor | Room or Space | Material description | Primary location | Secondary location | Application | Surface treatment | Sample identification | Laboratory results | Friability | Material condition | Likelihood of disturbance | Risk | Control method | Labelling | Estimated quantity | Units | Comments | Photograph reference | Photograph reference |
|---|---|---|---|---|---|---|---|---|---|---|---|---|---|---|---|---|---|---|---|---|---|---|---|
| 18-Jul-24 | | GHD | B00B | Roof | Internal | Debris | Roof space | Throughout ceiling space | Lead paint dust | - | B00B-LD01 | Calculated 2.34mg/m2 (210 µg lead) | N/A | Poor | High | - | Removal | N/A | <1 | m2 | Dust in B00B ceiling space sampled | | |

Given the absence of current Australian guidance for lead in surface dust, prior to any proposed demolition works that may disturb lead containing dusts, it is recommended further risk assessment is undertaken, taking into account potential exposure routes and duration, to adequately identify hazards, associated risks and controls. This additional risk assessment should be included as a Demolition Management Plan (or similar) requirement.

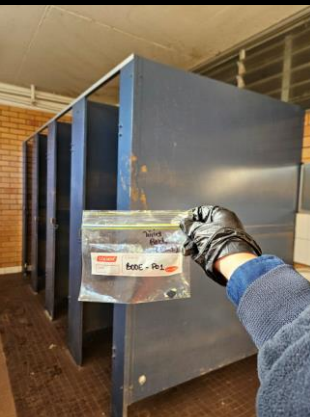
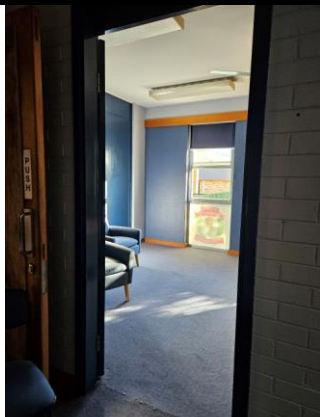
| Inspection date | Reinspection Date | Consultant and Surveyor Reference | Building Ref | Floor | Room or Space | Material description | Primary location | Secondary location | Application | Surface treatment | Sample identification | Laboratory results | Friability | Material condition | Likelihood of disturbance | Risk | Control method | Labelling | Estimated quantity | Units | Comments | Photograph reference | Photograph reference |
|---|---|---|---|---|---|---|---|---|---|---|---|---|---|---|---|---|---|---|---|---|---|---|---|
| 18-Jul-24 | | GHD | B00B - Toilets | GF | Internal | - | Toilet stalls | 1st floor walls, doors and door frames | Paint | - | B00B-P01 | <0.01% w/w | N/A | N/A | N/A | N/A | Not required | N/A | 20 | m2 | | | |

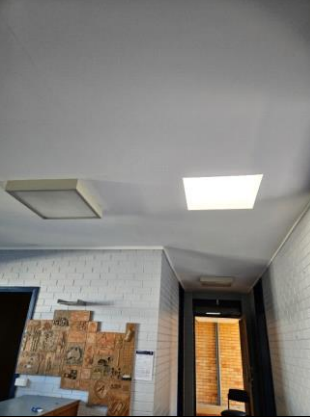
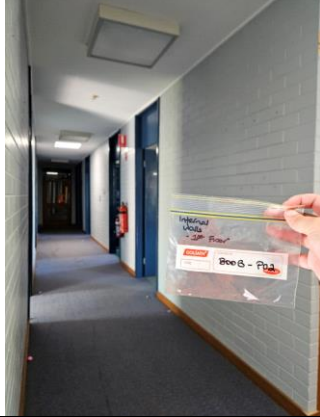
| Inspection date | Reinspection Date | Consultant and Surveyor Reference | Building Ref | Floor | Room or Space | Material description | Primary location | Secondary location | Application | Surface treatment | Sample identification | Laboratory results | Friability | Material condition | Likelihood of disturbance | Risk | Control method | Labelling | Estimated quantity | Units | Comments | Photograph reference | Photograph reference |
|---|---|---|---|---|---|---|---|---|---|---|---|---|---|---|---|---|---|---|---|---|---|---|---|
| 18-Jul-24 | | GHD | B00B - General areas | 01 | Internal | - | Walls | All aspects | Paint | - | B00B-P02 | <0.01% w/w | N/A | N/A | N/A | N/A | Not required | N/A | 250 | m2 | | | |

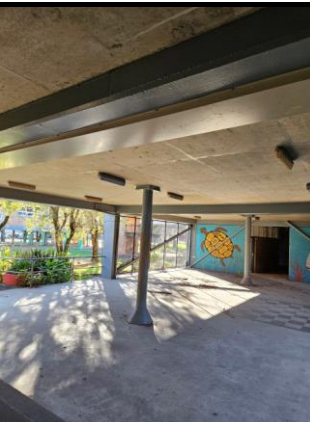
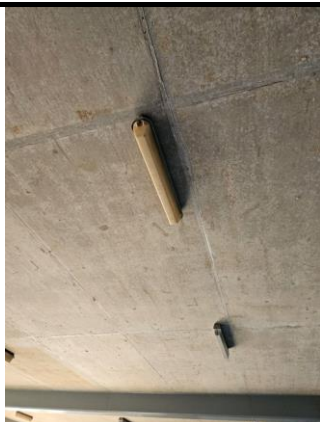
| Inspection date | Reinspection Date | Consultant and Surveyor Reference | Building Ref | Floor | Room or Space | Material description | Primary location | Secondary location | Application | Surface treatment | Sample identification | Laboratory results | Friability | Material condition | Likelihood of disturbance | Risk | Control method | Labelling | Estimated quantity | Units | Comments | Photograph reference | Photograph reference |
|---|---|---|---|---|---|---|---|---|---|---|---|---|---|---|---|---|---|---|---|---|---|---|---|
| 18-Jul-24 | | GHD | B00B - Administration | GF | External | Capacitors | Walkway cover (underside of slabs) | Throughout | Fluorescent lights | - | Assumed | Presumed to contain PCB until proven otherwise | - | Good | High | Very high | Removal | N/A | 14 | Item | | | |

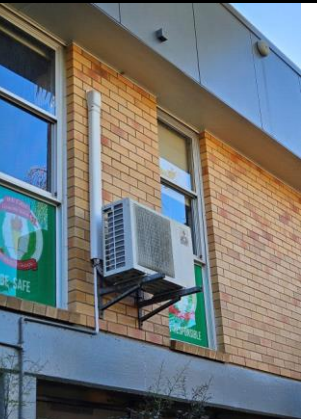
| Inspection date | Reinspection Date | Consultant and Surveyor Reference | Building Ref | Floor | Room or Space | Material description | Primary location | Secondary location | Application | Surface treatment | Sample identification | Laboratory results | Friability | Material condition | Likelihood of disturbance | Risk | Control method | Labelling | Estimated quantity | Units | Comments | Photograph reference | Photograph reference |
|---|---|---|---|---|---|---|---|---|---|---|---|---|---|---|---|---|---|---|---|---|---|---|---|
| 18-Jul-24 | | GHD | B00B - Administration | 01 | External | Thermal insulation | Southern wall | Air conditioners | Insulation | Sealed | Assumed | Presumed to contain SMF until proven otherwise | Non-friable | Good | High | Very high | Removal | Not required | 8 | Item | | | |

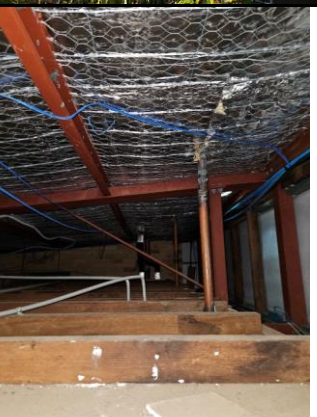
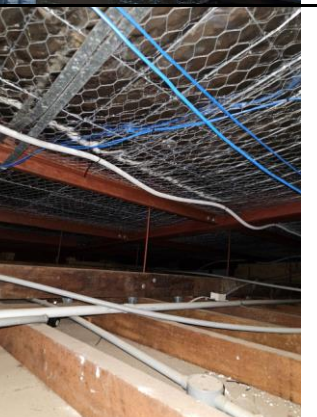
| Inspection date | Reinspection Date | Consultant and Surveyor Reference | Building Ref | Floor | Room or Space | Material description | Primary location | Secondary location | Application | Surface treatment | Sample identification | Laboratory results | Friability | Material condition | Likelihood of disturbance | Risk | Control method | Labelling | Estimated quantity | Units | Comments | Photograph reference | Photograph reference |
|---|---|---|---|---|---|---|---|---|---|---|---|---|---|---|---|---|---|---|---|---|---|---|---|
| 18-Jul-24 | | GHD | B00B - Administration | Roof | Internal | Thermal insulation | Roof cavity | Throughout | Foil covered insulation | Sealed | Assumed | Presumed to contain SMF until proven otherwise | Non-friable | Good | High | Very high | Removal | Not required | 65 | m2 | | | |

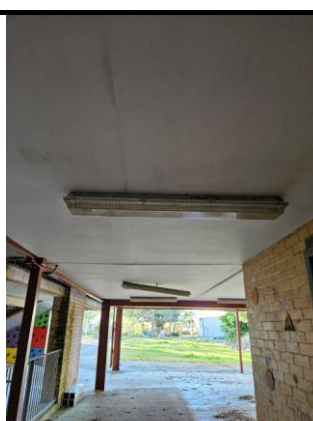
| Consultant | | | Location / Description | | | | | | | | | | Risk Assessment | | | | | | | | | | | |
|---|---|---|---|---|---|---|---|---|---|---|---|---|---|---|---|---|---|---|---|---|---|---|---|--|
| 17-Jul-24 | | GHD | B00C | GF | Internal | Flat cement product | Ceiling | Throughout ground floor | Ceiling lining | Sealed | B00C-A01 | No Asbestos Fibres Detected | N/A | N/A | N/A | N/A | Not required | N/A | 125 | - | | | | |

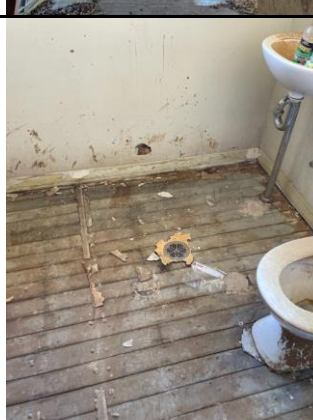
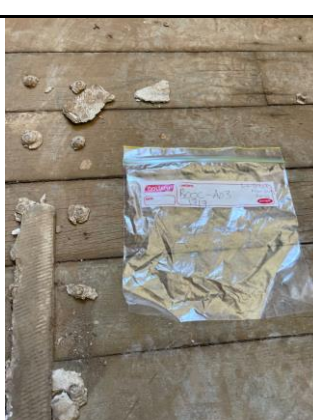
| Consultant | | | Location / Description | | | | | | | | | | Risk Assessment | | | | | | | | | | | |
|---|---|---|---|---|---|---|---|---|---|---|---|---|---|---|---|---|---|---|---|---|---|---|---|--|
| 17-Jul-24 | | GHD | B00C - Toilet | 01 | Internal | Flat cement product | Fragments to floor | Toilet | Debris | Unsealed | B00C-A03 | No Asbestos Fibres Detected | N/A | N/A | N/A | N/A | Not required | N/A | <1 | m2 | | | | |

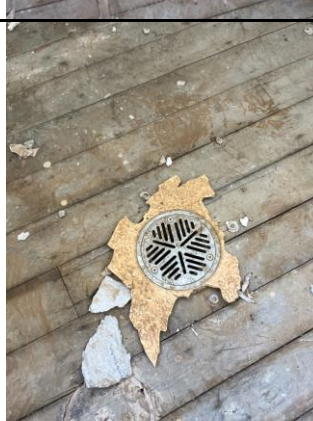
| Consultant | | | Location / Description | | | | | | | | | | Risk Assessment | | | | | | | | | | | |
|---|---|---|---|---|---|---|---|---|---|---|---|---|---|---|---|---|---|---|---|---|---|---|---|--|
| 17-Jul-24 | | GHD | B00C - Toilet | 01 | Internal | Floor tiles | Residual vinyl flooring to floor | Toilet | Floor covering | Sealed | B00C-A04 | No Asbestos Fibres Detected | N/A | N/A | N/A | N/A | Not required | N/A | <1 | m2 | | | | |

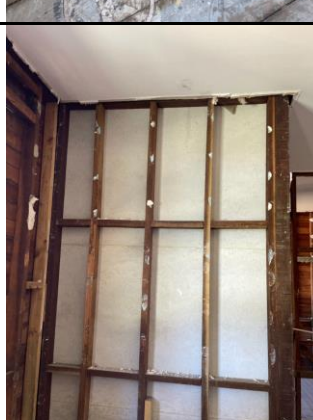
| Consultant | | | Location / Description | | | | | | | | | | Risk Assessment | | | | | | | | | | | |
|---|---|---|---|---|---|---|---|---|---|---|---|---|---|---|---|---|---|---|---|---|---|---|---|--|
| 17-Jul-24 | | GHD | B00C - Toilet | 01 | Internal | Flat cement product | Walls | Western bathroom wall | Lining | Unsealed | B00C-A05 | No Asbestos Fibres Detected | N/A | N/A | N/A | N/A | Not required | N/A | - | - | | | | |

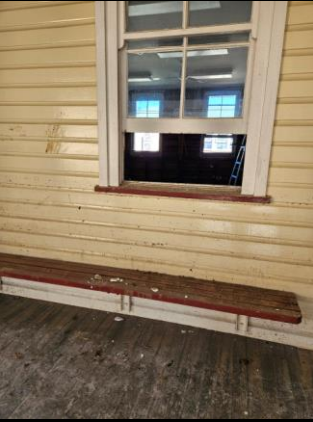
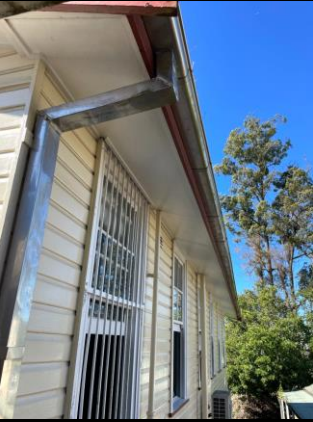
| Inspection date | Reinspection Date | Consultant and Surveyor Reference | Building Ref | Floor | Room or Space | Material description | Primary location | Secondary location | Application | Surface treatment | Sample identification | Laboratory results | Friability | Material condition | Likelihood of disturbance | Risk | Control method | Labelling | Estimated quantity | Units | Comments | Photograph reference | Photograph reference |
|---|---|---|---|---|---|---|---|---|---|---|---|---|---|---|---|---|---|---|---|---|---|---|---|
| 17-Jul-24 | | GHD | B00C | GF | External | Paint | Window frames - white paint | All aspects | Coating | - | B00C-P03 | 0.11% w/w Lead paint detected | N/A | Good | High | Very high | Removal | N/A | 20 | m2 | | | |

| Mitigation Number/Name | Aspect/Section | Mitigation Measure | Reason for Mitigation Measure |
|---|---|---|---|
| Lead containing materials | Prior to demolition | Lead based paints may be disposed of attached to the substrates as long as they are in good condition. If chalking or delaminating, the paint residues will be removed from the substrates in accordance with AS/NZS 4361.2:2017; Guide to Hazardous Paint Management. Part 2: Lead and other Hazardous Metallic Pigments in Industrial Applications. The waste generated will be disposed of as a lead containing material in accordance with NSW EPA requirements.<br><br>Detailed methodology for the safe removal of lead based paint should be included in a Demolition Management Plan (or similar) for the Site | Presence of lead based paints |

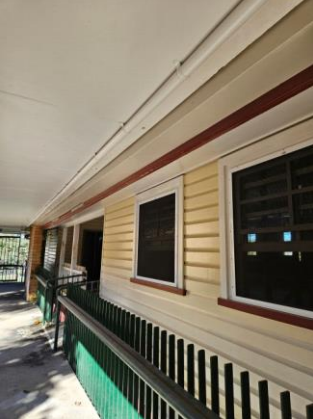
| Inspection date | Reinspection Date | Consultant and Surveyor Reference | Building Ref | Floor | Room or Space | Material description | Primary location | Secondary location | Application | Surface treatment | Sample identification | Laboratory results | Friability | Material condition | Likelihood of disturbance | Risk | Control method | Labelling | Estimated quantity | Units | Comments | Photograph reference | Photograph reference |
|---|---|---|---|---|---|---|---|---|---|---|---|---|---|---|---|---|---|---|---|---|---|---|---|
| 17-Jul-24 | | GHD | B00C | GF | External | Paint | Balcony bench = brown paint | Window frame - lower portion | Coating | - | B00C-P04 | 0.03% w/w Lead paint detected | N/A | N/A | N/A | N/A | Not required | N/A | 5 | m2 | | | |

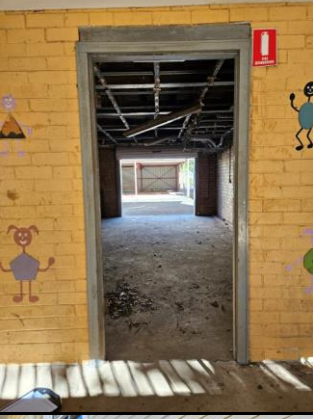
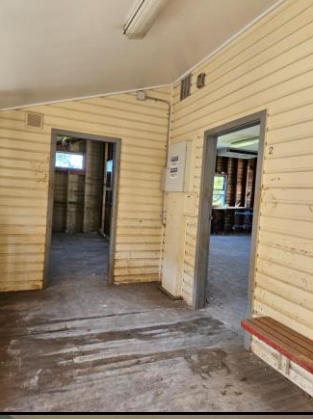
| Inspection date | Reinspection Date | Consultant and Surveyor Reference | Building Ref | Floor | Room or Space | Material description | Primary location | Secondary location | Application | Surface treatment | Sample identification | Laboratory results | Friability | Material condition | Likelihood of disturbance | Risk | Control method | Labelling | Estimated quantity | Units | Comments | Photograph reference | Photograph reference |
|---|---|---|---|---|---|---|---|---|---|---|---|---|---|---|---|---|---|---|---|---|---|---|---|
| 17-Jul-24 | | GHD | B00C | GF | External | Paint | Door frames - grey paint | All doorways in B00C | Coating | - | B00C-P02 | 0.09% w/w Lead paint detected | N/A | N/A | N/A | N/A | Not required | N/A | 10 | m2 | | | |

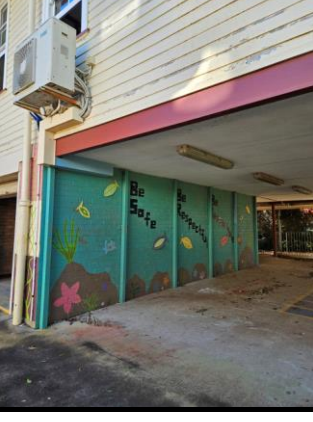
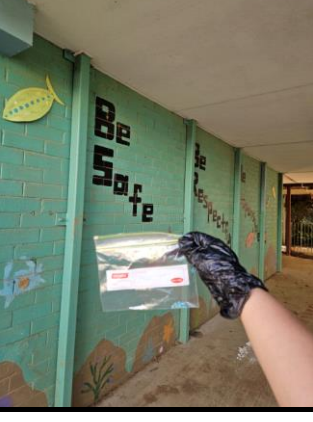
| Inspection date | Reinspection Date | Consultant and Surveyor Reference | Building Ref | Floor | Room or Space | Material description | Primary location | Secondary location | Application | Surface treatment | Sample identification | Laboratory results | Friability | Material condition | Likelihood of disturbance | Risk | Control method | Labelling | Estimated quantity | Units | Comments | Photograph reference | Photograph reference |
|---|---|---|---|---|---|---|---|---|---|---|---|---|---|---|---|---|---|---|---|---|---|---|---|
| 17-Jul-24 | | GHD | B00C | GF | External | Paint | Walls | All aspects | Coating | - | B00C-P01 | <0.01% w/w | N/A | N/A | N/A | N/A | Not required | N/A | 45 | m2 | | | |

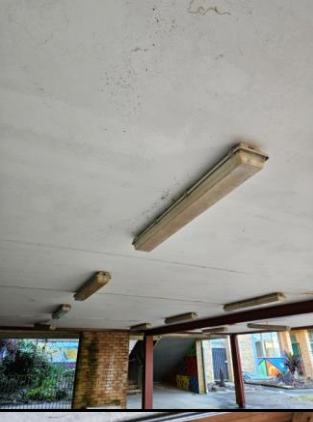
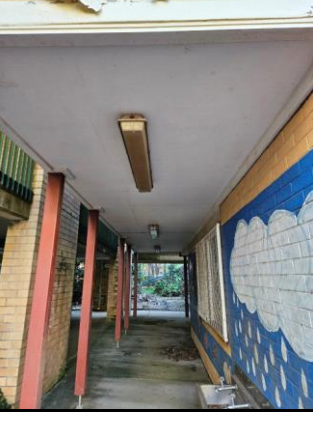
| Inspection date | Reinspection Date | Consultant and Surveyor Reference | Building Ref | Floor | Room or Space | Material description | Primary location | Secondary location | Application | Surface treatment | Sample identification | Laboratory results | Friability | Material condition | Likelihood of disturbance | Risk | Control method | Labelling | Estimated quantity | Units | Comments | Photograph reference | Photograph reference |
|---|---|---|---|---|---|---|---|---|---|---|---|---|---|---|---|---|---|---|---|---|---|---|---|
| 17-Jul-24 | | GHD | B00C - Undercroft | GF | External | Capacitors | Ceiling | All aspect | Fluorescent light | - | Assumed | Presumed to contain PCB until proven otherwise | - | - | High | Very high | Removal | Not required | 16 | Item | | | |

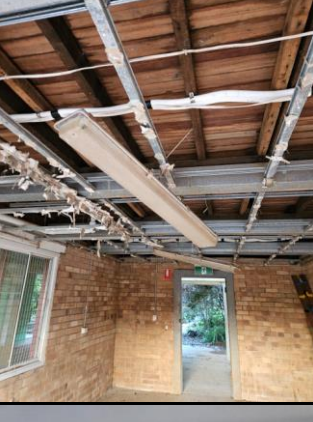
| Inspection date | Reinspection Date | Consultant and Surveyor Reference | Building Ref | Floor | Room or Space | Material description | Primary location | Secondary location | Application | Surface treatment | Sample identification | Laboratory results | Friability | Material condition | Likelihood of disturbance | Risk | Control method | Labelling | Estimated quantity | Units | Comments | Photograph reference | Photograph reference |
|---|---|---|---|---|---|---|---|---|---|---|---|---|---|---|---|---|---|---|---|---|---|---|---|
| 17-Jul-24 | | GHD | B00C - Storage | GF | Internal | Capacitors | Storage room | All aspect | Fluorescent light | - | Assumed | Presumed to contain PCB until proven otherwise | - | - | High | Very high | Removal | Not required | 2 | Item | | | |

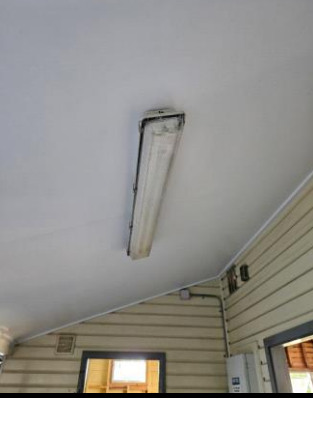
| Inspection date | Reinspection Date | Consultant and Surveyor Reference | Building Ref | Floor | Room or Space | Material description | Primary location | Secondary location | Application | Surface treatment | Sample identification | Laboratory results | Friability | Material condition | Likelihood of disturbance | Risk | Control method | Labelling | Estimated quantity | Units | Comments | Photograph reference | Photograph reference |
|---|---|---|---|---|---|---|---|---|---|---|---|---|---|---|---|---|---|---|---|---|---|---|---|
| 17-Jul-24 | | GHD | B00C - Balcony | 01 | External | Capacitors | Balcony | All aspect | Fluorescent light | - | Assumed | Presumed to contain PCB until proven otherwise | - | - | High | Very high | Removal | Not required | 1 | Item | | | |

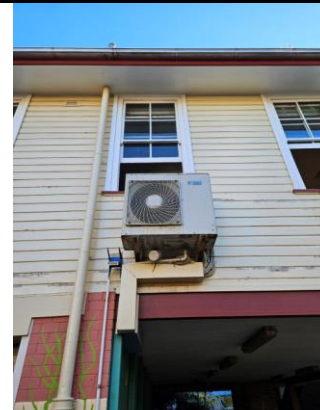
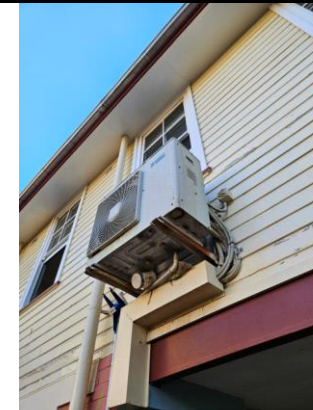
| Inspection date | Reinspection Date | Consultant and Surveyor Reference | Building Ref | Floor | Room or Space | Material description | Primary location | Secondary location | Application | Surface treatment | Sample identification | Laboratory results | Friability | Material condition | Likelihood of disturbance | Risk | Control method | Labelling | Estimated quantity | Units | Comments | Photograph reference | Photograph reference | |
|---|---|---|---|---|---|---|---|---|---|---|---|---|---|---|---|---|---|---|---|---|---|---|---|---|
| 17-Jul-24 | | GHD | B00C | 01 | External | Thermal insulation | Southern wall | Air conditioning units | Insulation | Unsealed | Assumed | Presumed to contain SMF until proven otherwise | N/A | Good | High | Very high | Removal | Not required | 1 | Item | | | | |

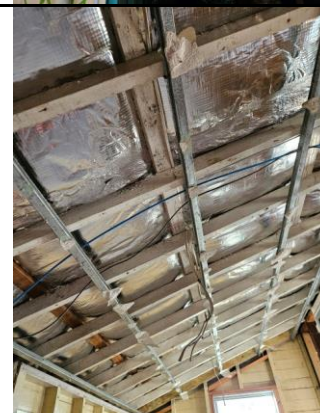
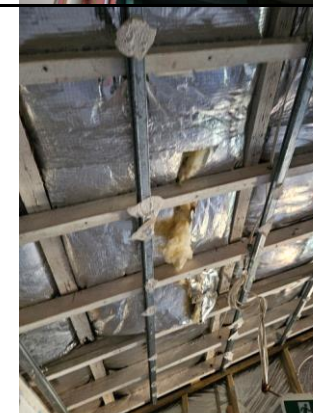
| Inspection date | Reinspection Date | Consultant and Surveyor Reference | Building Ref | Floor | Room or Space | Material description | Primary location | Secondary location | Application | Surface treatment | Sample identification | Laboratory results | Friability | Material condition | Likelihood of disturbance | Risk | Control method | Labelling | Estimated quantity | Units | Comments | Photograph reference | Photograph reference | |
|---|---|---|---|---|---|---|---|---|---|---|---|---|---|---|---|---|---|---|---|---|---|---|---|---|
| 17-Jul-24 | | GHD | B00C | 01 | Internal | Thermal insulation | Underside of roof/ceiling | Foil backed insulation | Insulation | Unsealed | Assumed | Presumed to contain SMF until proven otherwise | N/A | Poor | High | Very high | Removal | Not required | 190 | m2 | | | | |

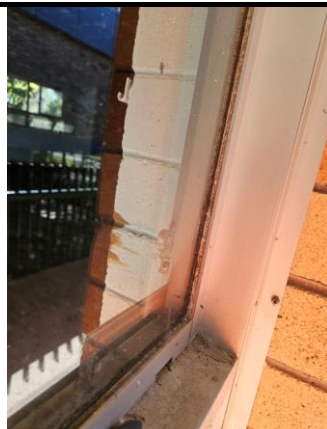
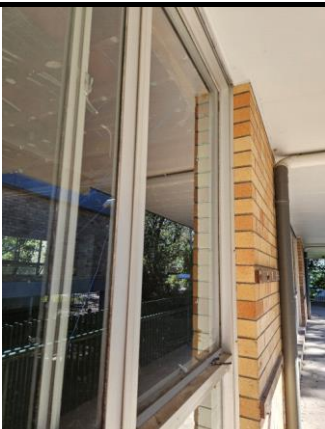
| Consultant | | | Location / Description | | | | | | | | | | Risk Assessment | | | | | | | | | | | |
|---|---|---|---|---|---|---|---|---|---|---|---|---|---|---|---|---|---|---|---|---|---|---|---|--|
| 17-Jul-24 | | GHD | B00D - Classrooms (room reference R1003, R1006, R1007) | 01 | External | Sealant / Adhesives | Window putty between glass and frame within windows to classrooms | Window to northern and southern aspects of B00D | Window putty | Unsealed | B00D-A01 | Chrysotile Detected | Non-friable | Poor | Very high | Very high | Removal | Labels required (not affixed or not sufficient) | 6 | Item | Quantity estimate based on per window.<br><br>Positive asbestos indentification applicable to all windows present in B00D | | | |

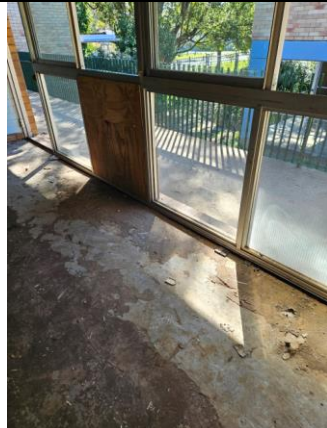
| Consultant | | | Location / Description | | | | | | | | | | Risk Assessment | | | | | | | | | | | |
|---|---|---|---|---|---|---|---|---|---|---|---|---|---|---|---|---|---|---|---|---|---|---|---|--|
| 17-Jul-24 | | GHD | B00D - Classrooms (room reference R1003, R1006, R1007) | 01 | External | Flat cement product | Window to northern and southern aspects of B00D | All aspect | Lining | Unsealed | B00D-A04 | Chrysotile Detected | Non-friable | Fair | High | Very high | Removal | Not required | 6 | Item | Quantity estimate based on presence of packers per window.<br><br>ACM sheet frgment packers present to all window surrounds present in B00D. | | | |

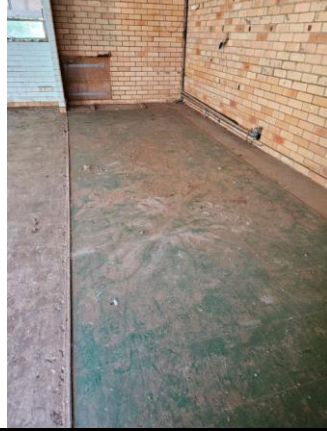
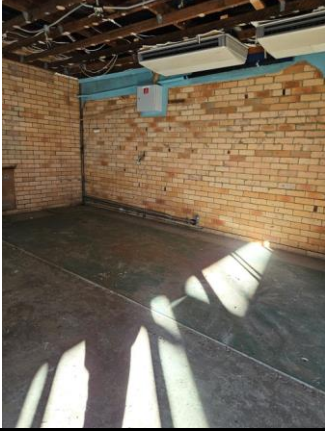
| Consultant | | | Location / Description | | | | | | | | | | Risk Assessment | | | | | | | | | | | |
|---|---|---|---|---|---|---|---|---|---|---|---|---|---|---|---|---|---|---|---|---|---|---|---|--|
| 17-Jul-24 | | GHD | B00D - Classrooms (room reference R1003, R1006, R1007) | 01 | Internal | Floor tiles | Green vinyl floor tile to classroom floors | Throughout | Lining | Sealed | B00D-A02 | Chrysotile Detected | Non-friable | Fair | High | Very high | Removal | Labels required (not affixed or not sufficient) | 18 | m2 | Green vinyl floor tiles to all classrooms within B00D | | | |

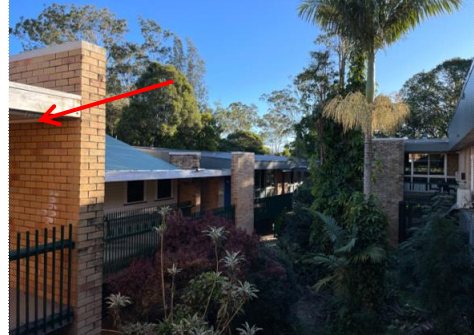
| Consultant | | | Location / Description | | | | | | | | | | Risk Assessment | | | | | | | | | | | |
|---|---|---|---|---|---|---|---|---|---|---|---|---|---|---|---|---|---|---|---|---|---|---|---|--|
| 17-Jul-24 | | GHD | B00D - R0002 - Stairs | GF | Internal | Flat cement product | Ceiling linings to stairway north east | All aspect | Lining | Sealed | Refer to B00H-A06 | Chrysotile & Amosite Detected | Non-friable | Good | High | Very high | Removal | Labels required (not affixed or not sufficient) | 10 | m2 | | | | |

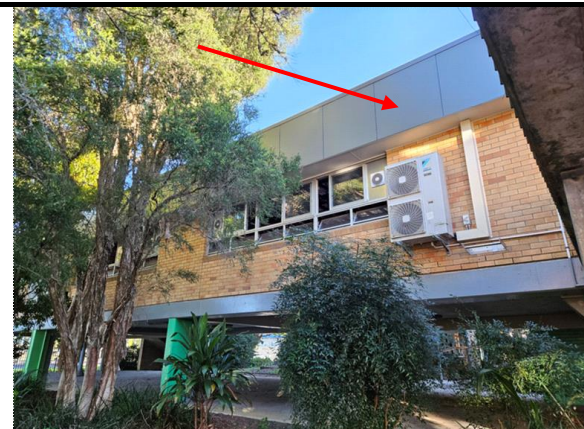
| Consultant | | | Location / Description | | | | | | | | | | Risk Assessment | | | | | | | | | | | |
|---|---|---|---|---|---|---|---|---|---|---|---|---|---|---|---|---|---|---|---|---|---|---|---|--|
| 17-Jul-24 | | GHD | B00D - - Classrooms | Roof | External | Flat cement product | Roof gable panels | All aspects | Lining | Sealed | Refer to B00F-A02 | No Asbestos Fibres Detected | N/A | N/A | N/A | N/A | Not required | N/A | - | - | | | | |

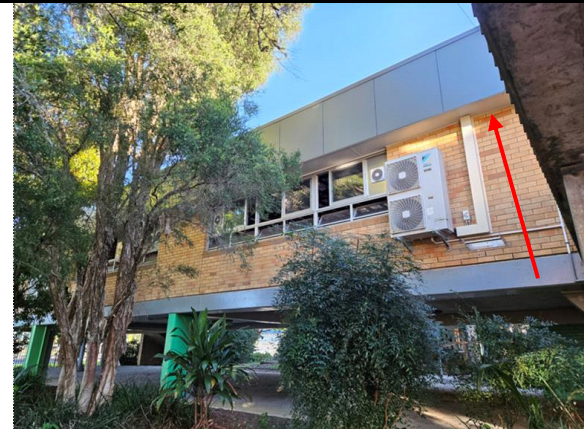
| Consultant | | | Location / Description | | | | | | | | | | Risk Assessment | | | | | | | | | | | |
|---|---|---|---|---|---|---|---|---|---|---|---|---|---|---|---|---|---|---|---|---|---|---|---|--|
| 17-Jul-24 | | GHD | B00D - Classrooms | Roof | External | Flat cement product | Eaves | All aspects | Lining | Sealed | Refer to B00F-A03 | No Asbestos Fibres Detected | N/A | N/A | N/A | N/A | Not required | N/A | - | - | | | | |

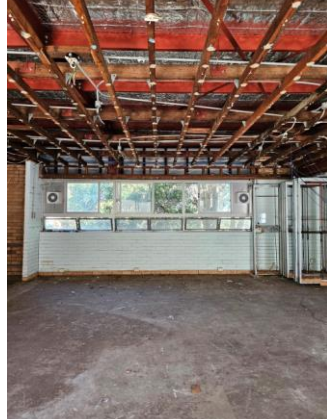
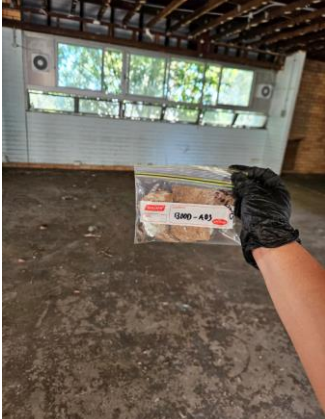
| Consultant | | | Location / Description | | | | | | | | | | Risk Assessment | | | | | | | | | | | |
|---|---|---|---|---|---|---|---|---|---|---|---|---|---|---|---|---|---|---|---|---|---|---|---|--|
| 17-Jul-24 | | GHD | B00D - Classrooms | 01 | Internal | Debris | Residual carpet underlay and mastic to floors | All B00D classrooms | Lining | Unsealed | B00D-A03 | No Asbestos Fibres Detected | N/A | N/A | N/A | N/A | Not required | N/A | - | - | | | | |

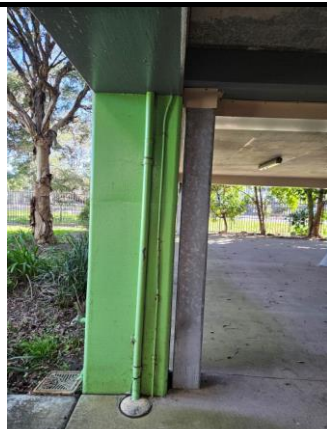
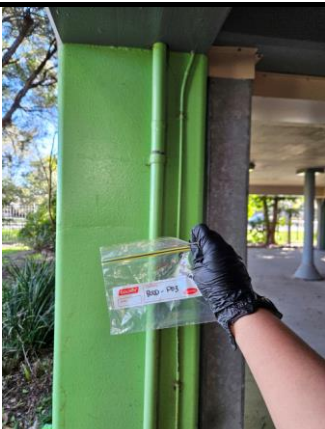
| Inspection date | Reinspection Date | Consultant and Surveyor Reference | Building Ref | Floor | Room or Space | Material description | Primary location | Secondary location | Application | Surface treatment | Sample identification | Laboratory results | Friability | Material condition | Likelihood of disturbance | Risk | Control method | Labelling | Estimated quantity | Units | Comments | Photograph reference | Photograph reference |
|---|---|---|---|---|---|---|---|---|---|---|---|---|---|---|---|---|---|---|---|---|---|---|---|
| 17/724 | | GHD | B00D - Undercroft | GF | External | Paint | Columns | All aspects | Coating | - | B00D-P03 | 0.03% w/w<br>Lead paint detected | N/A | Fair | High | Very high | Removal | Not required | | m2 | | | |

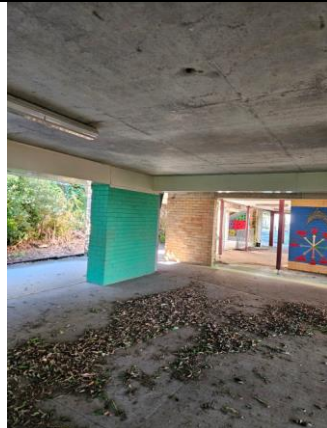
| Inspection date | Reinspection Date | Consultant and Surveyor Reference | Building Ref | Floor | Room or Space | Material description | Primary location | Secondary location | Application | Surface treatment | Sample identification | Laboratory results | Friability | Material condition | Likelihood of disturbance | Risk | Control method | Labelling | Estimated quantity | Units | Comments | Photograph reference | Photograph reference |
|---|---|---|---|---|---|---|---|---|---|---|---|---|---|---|---|---|---|---|---|---|---|---|---|
| 17/724 | | GHD | B00D - Undercroft | GF | External | Paint | Columns | All aspects | Coating | - | B00D-P01 | <0.01% w/w<br>No lead paint detected | N/A | Fair | High | Very high | Removal | Not required | | m2 | | | |

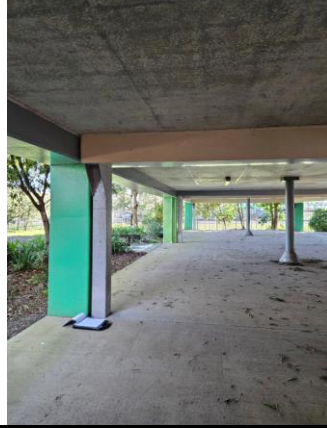
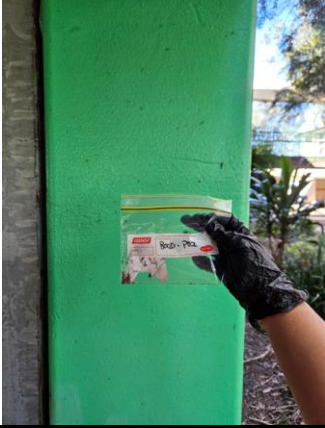
| Inspection date | Reinspection Date | Consultant and Surveyor Reference | Building Ref | Floor | Room or Space | Material description | Primary location | Secondary location | Application | Surface treatment | Sample identification | Laboratory results | Friability | Material condition | Likelihood of disturbance | Risk | Control method | Labelling | Estimated quantity | Units | Comments | Photograph reference | Photograph reference |
|---|---|---|---|---|---|---|---|---|---|---|---|---|---|---|---|---|---|---|---|---|---|---|---|
| 17/724 | | GHD | B00D - Undercroft | GF | External | Paint | Columns | All aspects | Coating | - | B00D-P02 | <0.01% w/w<br>No lead paint detected | N/A | Fair | High | Very high | Removal | Not required | | m2 | | | |

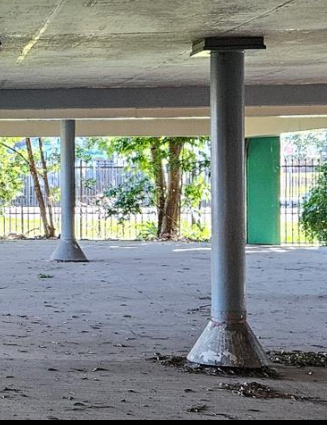
| Inspection date | Reinspection Date | Consultant and Surveyor Reference | Building Ref | Floor | Room or Space | Material description | Primary location | Secondary location | Application | Surface treatment | Sample identification | Laboratory results | Friability | Material condition | Likelihood of disturbance | Risk | Control method | Labelling | Estimated quantity | Units | Comments | Photograph reference | Photograph reference |
|---|---|---|---|---|---|---|---|---|---|---|---|---|---|---|---|---|---|---|---|---|---|---|---|
| 17/724 | | GHD | B00D - Undercroft | GF | External | Paint | Steel columns | All aspects | Coating | - | B00D-P04 | <0.01% w/w<br>No lead paint detected | N/A | Fair | High | Very high | Removal | Not required | | m2 | | | |

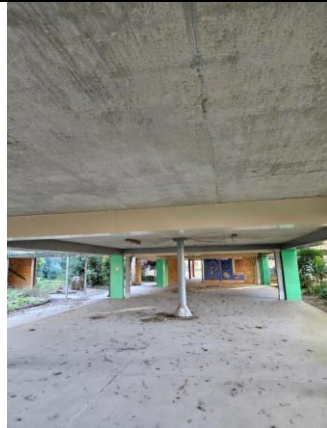
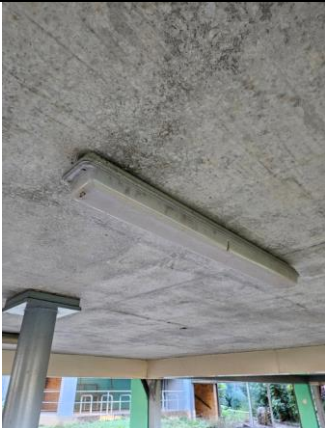
| Inspection date | Reinspection Date | Consultant and Surveyor Reference | Building Ref | Floor | Room or Space | Material description | Primary location | Secondary location | Application | Surface treatment | Sample identification | Laboratory results | Friability | Material condition | Likelihood of disturbance | Risk | Control method | Labelling | Estimated quantity | Units | Comments | Photograph reference | Photograph reference |
|---|---|---|---|---|---|---|---|---|---|---|---|---|---|---|---|---|---|---|---|---|---|---|---|
| 17/724 | | GHD | B00D - General Learning | GF | External | Capacitors | Walkways | Fixed to ceiling | Fluorescent lights | Sealed | Assumed | Presumed to contain SMF until proven otherwise | N/A | Good | High | Very high | Removal | Not required | 4 | Item | | | |

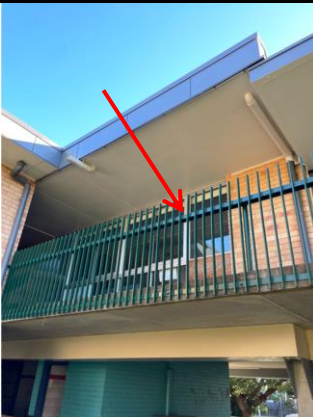
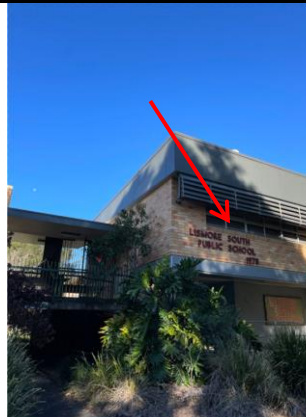
| Consultant | | | Location / Description | | | | | | | | | | Risk Assessment | | | | | | | | | | | | |
|---|---|---|---|---|---|---|---|---|---|---|---|---|---|---|---|---|---|---|---|---|---|---|---|--|--|
| 17-Jul-24 | | GHD | B00D - Classrooms (room reference R1003, R1004) | 01 | External | Sealant / Adhesives | Window putty between glass and frame within windows to classrooms | Window to eastern and western aspects of B00E | Window putty | Unsealed | Refer to B00D-A01 | Chrysotile Detected | Non-friable | Poor | Very high | Very high | Removal | Labels required (not affixed or not sufficient) | 4 | Item | Quantity estimate based on per window.<br><br>Positive asbestos indentification applicable to all windows present in B00D | | | | |

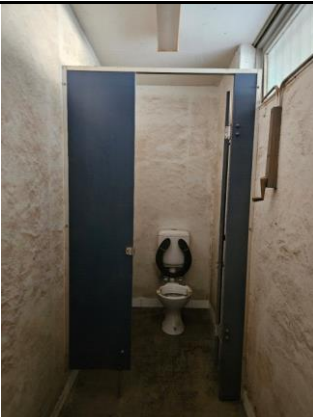
| Consultant | | | Location / Description | | | | | | | | | | Risk Assessment | | | | | | | | | | | | |
|---|---|---|---|---|---|---|---|---|---|---|---|---|---|---|---|---|---|---|---|---|---|---|---|--|--|
| 17-Jul-24 | | GHD | B00E - Canteen | GF | Internal | Flat cement product | Toilet stalls | Cubicle partitions | Partitions | Sealed | Refer to B00B-A01 | Chrysotile & Amosite Detected | Non-friable | Good | High | Very high | Removal | Not required | 5 | m2 | | | | | |

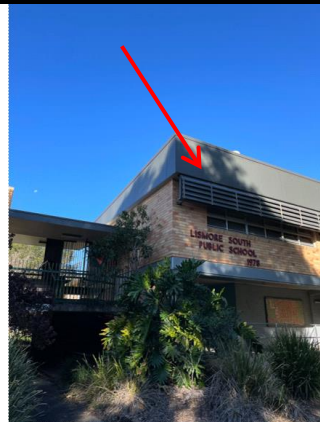
| Inspection date | Reinspection Date | Consultant and Surveyor Reference | Building Ref | Floor | Room or Space | Material description | Primary location | Secondary location | Application | Surface treatment | Sample identification | Laboratory results | Friability | Material condition | Likelihood of disturbance | Risk | Control method | Labelling | Estimated quantity | Units | Comments | Photograph reference | Photograph reference | |
|---|---|---|---|---|---|---|---|---|---|---|---|---|---|---|---|---|---|---|---|---|---|---|---|--|
| 18-Jul-24 | | GHD | B00F - Classrooms | Roof | External | Flat cement product | Roof gable panels | All aspects | Lining | Sealed | Refer to B00F-A02 | No Asbestos Fibres Detected | N/A | N/A | N/A | N/A | Not required | N/A | - | - | | | | |

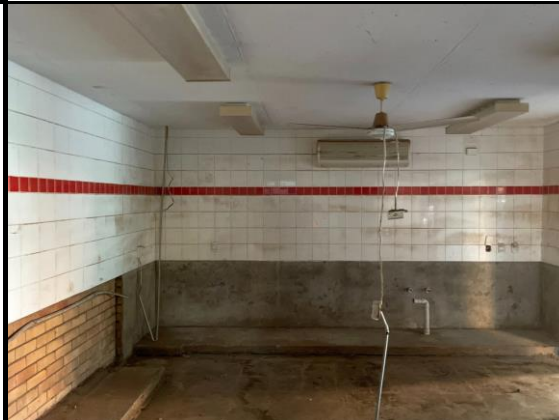
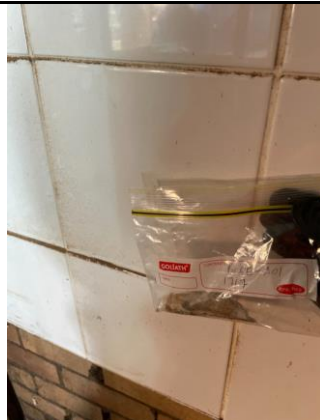
| Inspection date | Reinspection Date | Consultant and Surveyor Reference | Building Ref | Floor | Room or Space | Material description | Primary location | Secondary location | Application | Surface treatment | Sample identification | Laboratory results | Friability | Material condition | Likelihood of disturbance | Risk | Control method | Labelling | Estimated quantity | Units | Comments | Photograph reference | Photograph reference | |
|---|---|---|---|---|---|---|---|---|---|---|---|---|---|---|---|---|---|---|---|---|---|---|---|--|
| 17-Jul-24 | | GHD | B00E - Canteen | GF | Internal | Flat cement product | Walls | Behind tiles | Lining | Unsealed | B00E - A01 | No Asbestos Fibres Detected | N/A | N/A | N/A | N/A | Not required | N/A | - | - | | | | |

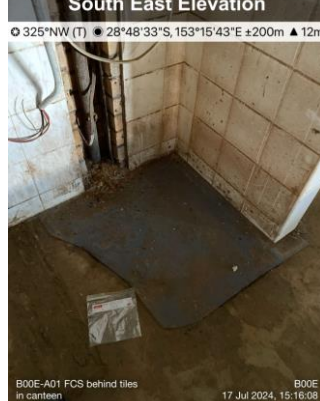
| Inspection date | Reinspection Date | Consultant and Surveyor Reference | Building Ref | Floor | Room or Space | Material description | Primary location | Secondary location | Application | Surface treatment | Sample identification | Laboratory results | Friability | Material condition | Likelihood of disturbance | Risk | Control method | Labelling | Estimated quantity | Units | Comments | Photograph reference | Photograph reference | |
|---|---|---|---|---|---|---|---|---|---|---|---|---|---|---|---|---|---|---|---|---|---|---|---|--|
| 17-Jul-24 | | GHD | B00E - Canteen | GF | Internal | Floor tiles | Floor Coverings Res/Textile | All aspect | Lining | Sealed | B00E - A02 | No Asbestos Fibres Detected | N/A | N/A | N/A | N/A | Not required | N/A | - | - | | | | |

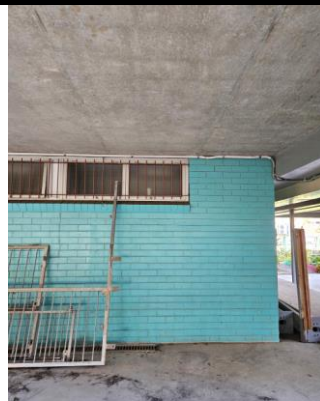
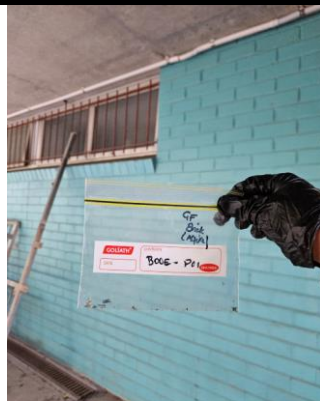
| Inspection date | Reinspection Date | Consultant and Surveyor Reference | Building Ref | Floor | Room or Space | Material description | Primary location | Secondary location | Application | Surface treatment | Sample identification | Laboratory results | Friability | Material condition | Likelihood of disturbance | Risk | Control method | Labelling | Estimated quantity | Units | Comments | Photograph reference | Photograph reference | |
|---|---|---|---|---|---|---|---|---|---|---|---|---|---|---|---|---|---|---|---|---|---|---|---|--|
| 17-Jul-24 | | GHD | B00E - Canteen | GF | External | Paint | Southern wall | Eastern wall | Coating | - | B00E - P01 | <0.01% w/w | N/A | N/A | N/A | N/A | Not required | Not required | - | - | | | | |

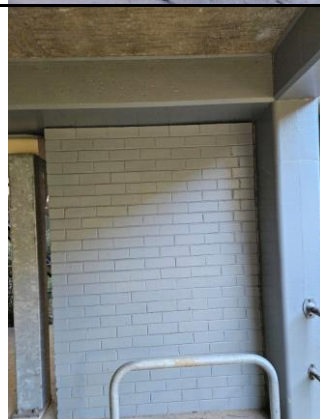
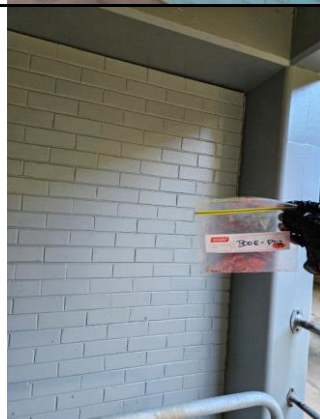
| Inspection date | Reinspection Date | Consultant and Surveyor Reference | Building Ref | Floor | Room or Space | Material description | Primary location | Secondary location | Application | Surface treatment | Sample identification | Laboratory results | Friability | Material condition | Likelihood of disturbance | Risk | Control method | Labelling | Estimated quantity | Units | Comments | Photograph reference | Photograph reference | |
|---|---|---|---|---|---|---|---|---|---|---|---|---|---|---|---|---|---|---|---|---|---|---|---|--|
| 17-Jul-24 | | GHD | B00E - Canteen | GF | External | Paint | Walls | Columns | Coating | - | B00E - P02 | 0.05% w/w Lead paint detected | N/A | N/A | N/A | N/A | Not required | N/A | - | - | | | | |

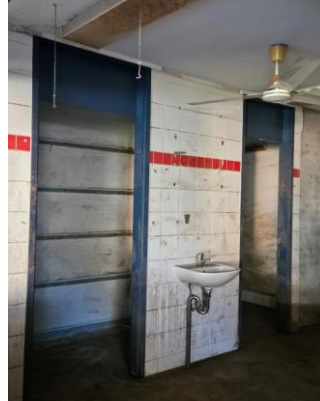
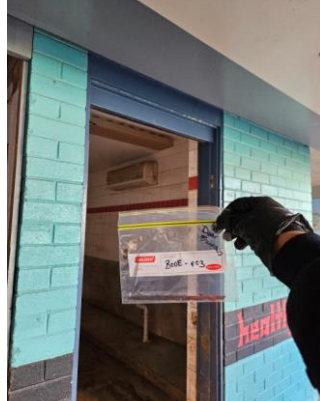
| Inspection date | Reinspection Date | Consultant and Surveyor Reference | Building Ref | Floor | Room or Space | Material description | Primary location | Secondary location | Application | Surface treatment | Sample identification | Laboratory results | Friability | Material condition | Likelihood of disturbance | Risk | Control method | Labelling | Estimated quantity | Units | Comments | Photograph reference | Photograph reference | |
|---|---|---|---|---|---|---|---|---|---|---|---|---|---|---|---|---|---|---|---|---|---|---|---|--|
| 17-Jul-24 | | GHD | B00E - Canteen | GF | External | Paint | Canteen door frames | All aspect | Coating | - | B00E - P03 | 0.02% w/w Lead paint detected | N/A | N/A | N/A | N/A | Not required | N/A | - | - | | | | |

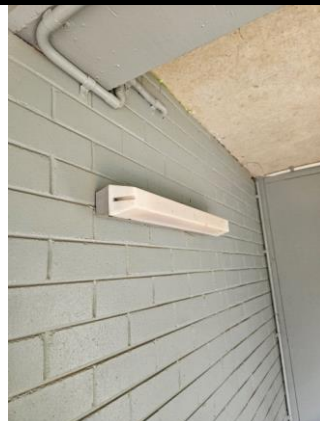
| Inspection date | Reinspection Date | Consultant and Surveyor Reference | Building Ref | Floor | Room or Space | Material description | Primary location | Secondary location | Application | Surface treatment | Sample identification | Laboratory results | Friability | Material condition | Likelihood of disturbance | Risk | Control method | Labelling | Estimated quantity | Units | Comments | Photograph reference | Photograph reference | |
|---|---|---|---|---|---|---|---|---|---|---|---|---|---|---|---|---|---|---|---|---|---|---|---|--|
| 17-Jul-24 | | GHD | B00H - Canteen | GF | External | Capacitors | Western wall | Fluorescent light fitting | Insulation | - | Assumed | Presumed to contain PCB until proven otherwise | - | Good | High | Very high | Removal | | 1 | Item | | | | |
