# Hazardous Building Materials Assessment

**Lismore South Public School – Flood  
Recovery Rebuild**

NSW Department of Education

04 June 2025

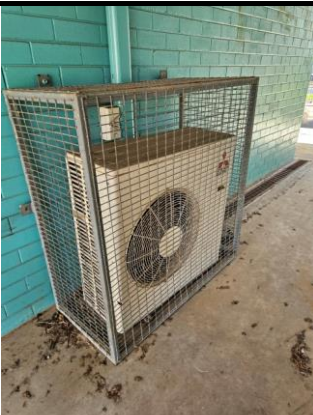
| Inspection date | Reinspection Date | Consultant and Surveyor Reference | Building Ref | Floor | Room or Space | Material description | Primary location | Secondary location | Application | Surface treatment | Sample identification | Laboratory results | Friability | Material condition | Likelihood of disturbance | Risk | Control method | Labelling | Estimated quantity | Units | Comments | Photograph reference | Photograph reference | |
|---|---|---|---|---|---|---|---|---|---|---|---|---|---|---|---|---|---|---|---|---|---|---|---|--|
| 17-Jul-24 | | GHD | B00H - Canteen | GF | External | Thermal insulation | Southern wall | Air conditioning unit | Insulation | Sealed | Assumed | Presumed to contain SMF until proven otherwise | N/A | Good | High | Very high | Removal | Not required | 1 | Item | | | | |

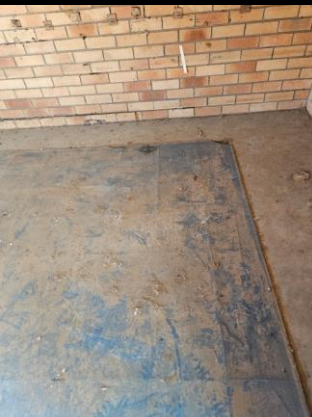
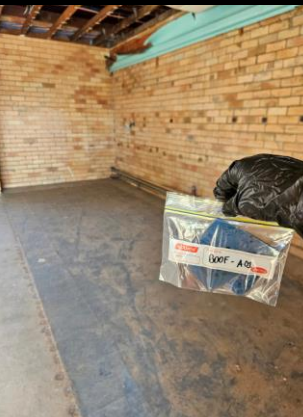
| Consultant | | | Location / Description | | | | | | | | | | Risk Assessment | | | | | | | | | | | |
|---|---|---|---|---|---|---|---|---|---|---|---|---|---|---|---|---|---|---|---|---|---|---|---|--|
| 18-Jul-24 | | GHD | B00F - Classrooms (R1003, R1005, R1006, R1009, R1010 and R1013) | 01 | Internal | Floor tiles | Classrooms | Blue vinyl tiles to floor | Floor covering | Sealed | B00F-A01 | Chrysotile Detected | Non-friable | Poor | High | Very high | Removal | Labels required (not affixed or not sufficient) | 19 | m2 | Blue vinyl floor tiles to 4 classrooms within B00F | | | |

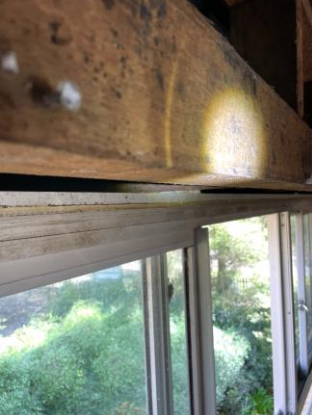
| Consultant | | | Location / Description | | | | | | | | | | Risk Assessment | | | | | | | | | | | |
|---|---|---|---|---|---|---|---|---|---|---|---|---|---|---|---|---|---|---|---|---|---|---|---|--|
| 18-Jul-24 | | GHD | B00F - Classrooms | 01 | External | Flat cement product | Window surrounds | Flat cement sheet packers present above and below window frames throughout building B00F | Packers | Unsealed | B00F-A04 | Chrysotile & Amosite Detected | Non-friable | Poor | High | Very high | Removal | Not required | 11 | Item | Quantity estimate based on presence of packers per window.<br><br>ACM sheet frgment packers present to all window surrounds present in B00D. | | | |

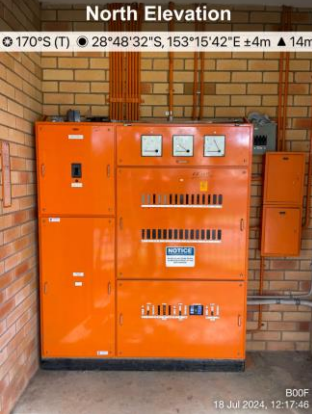
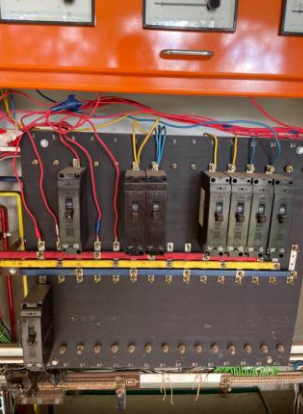
| Consultant | | | Location / Description | | | | | | | | | | Risk Assessment | | | | | | | | | | | |
|---|---|---|---|---|---|---|---|---|---|---|---|---|---|---|---|---|---|---|---|---|---|---|---|--|
| 18-Jul-24 | | GHD | B00F - Classrooms | 01 | Internal | Asbestos boards – insulating board in cores & linings | Distribution boards | Level 1 distribution board cupboard | Backing board | Unsealed | B00F-A05 | Chrysotile Detected | Non-friable | Fair | High | Very high | Removal | Labels required (not affixed or not sufficient) | 2 | m2 | | | | |

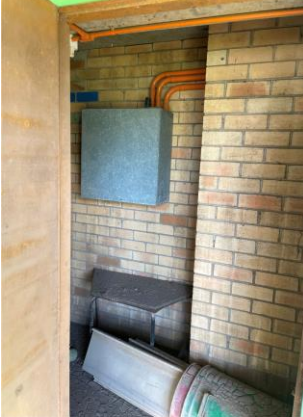
| Consultant | | | Location / Description | | | | | | | | | | Risk Assessment | | | | | | | | | | | |
|---|---|---|---|---|---|---|---|---|---|---|---|---|---|---|---|---|---|---|---|---|---|---|---|--|
| 18-Jul-24 | | GHD | B00F - Classrooms | GF | Internal | Asbestos boards – insulating board in cores & linings | Distribution boards | Ground floor electrical room | Backing board within cabinet | Unsealed | refer to B00F-A05 | Chrysotile Detected | Non-friable | Fair | High | Very high | Removal | Labels required (not affixed or not sufficient) | 2 | m2 | | | | |

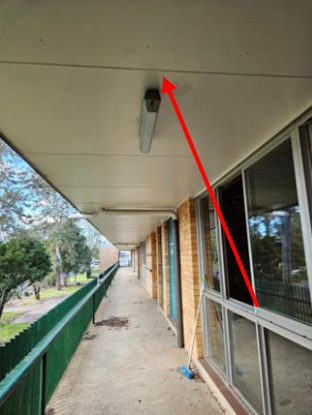
| Consultant | | | Location / Description | | | | | | | | | | Risk Assessment | | | | | | | | | | | |
|---|---|---|---|---|---|---|---|---|---|---|---|---|---|---|---|---|---|---|---|---|---|---|---|--|
| 18-Jul-24 | | GHD | B00F - Movement | 01 | External | Flat cement product | Walkway ceiling lining | Sheet to ceiling | Lining | Sealed | Refer to Movement 6-A01 | Chrysotile & Amosite Detected | Non-friable | Good | High | Very high | Removal | Labels required (not affixed or not sufficient) | 120 | m2 | | | | |

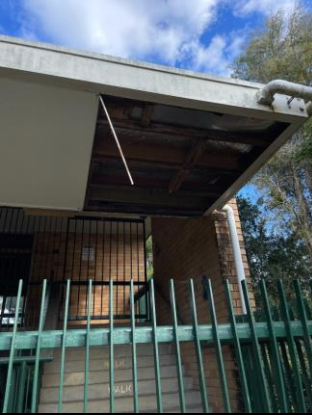
| Consultant | | | Location / Description | | | | | | | | | | Risk Assessment | | | | | | | | | | | |
|---|---|---|---|---|---|---|---|---|---|---|---|---|---|---|---|---|---|---|---|---|---|---|---|--|
| 18-Jul-24 | | GHD | B00F - Movement | 01 | External | Flat cement product | Awning lining | Sheet to B00F western stairway | Lining | Sealed | Movement 6-A01 | Chrysotile & Amosite Detected | Non-friable | Poor | High | Very high | Removal | Labels required (not affixed or not sufficient) | 15 | m2 | | | | |

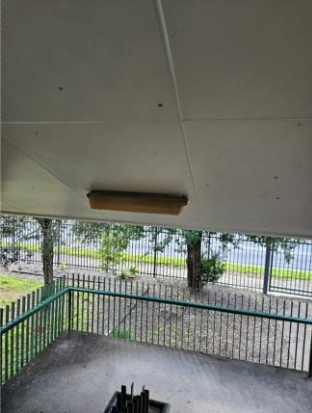
| Consultant | | | Location / Description | | | | | | | | | | Risk Assessment | | | | | | | | | | | |
|---|---|---|---|---|---|---|---|---|---|---|---|---|---|---|---|---|---|---|---|---|---|---|---|--|
| 18-Jul-24 | | GHD | B00F - Movement | 01 | External | Flat cement product | Awning lining | Sheet to B00F eastern stairway | Lining | Sealed | Refer to Movement 6-A01 | Chrysotile & Amosite Detected | Non-friable | Fair | High | Very high | Removal | Labels required (not affixed or not sufficient) | 15 | m2 | | | | |

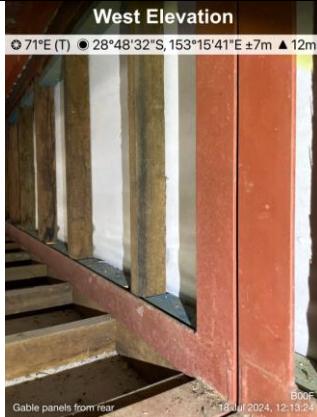
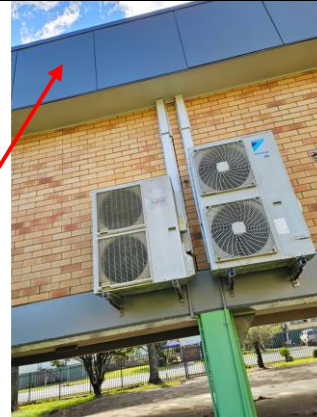
| Inspection date | Reinspection Date | Consultant and Surveyor Reference | Building Ref | Floor | Room or Space | Material description | Primary location | Secondary location | Application | Surface treatment | Sample identification | Laboratory results | Friability | Material condition | Likelihood of disturbance | Risk | Control method | Labelling | Estimated quantity | Units | Comments | Photograph reference | Photograph reference |
|---|---|---|---|---|---|---|---|---|---|---|---|---|---|---|---|---|---|---|---|---|---|---|---|
| 18-Jul-24 | | GHD | B00F - Classrooms | Roof | External | Flat cement product | Gable panels, east side | All aspect | Lining | Sealed | B00F-A02 | No Asbestos Fibres Detected | N/A | N/A | N/A | N/A | Not required | N/A | - | - | | | |

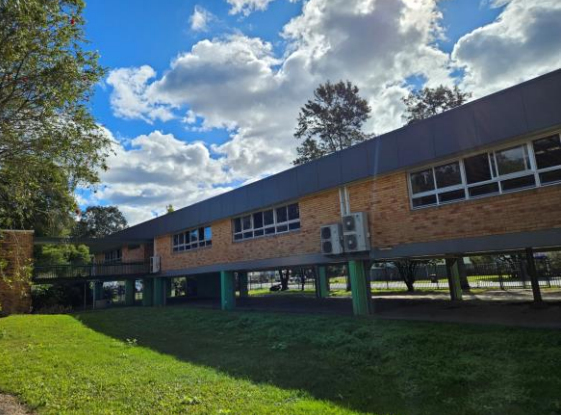
| Inspection date | Reinspection Date | Consultant and Surveyor Reference | Building Ref | Floor | Room or Space | Material description | Primary location | Secondary location | Application | Surface treatment | Sample identification | Laboratory results | Friability | Material condition | Likelihood of disturbance | Risk | Control method | Labelling | Estimated quantity | Units | Comments | Photograph reference | Photograph reference |
|---|---|---|---|---|---|---|---|---|---|---|---|---|---|---|---|---|---|---|---|---|---|---|---|
| 18-Jul-24 | | GHD | B00F - Classrooms | Roof | External | Flat cement product | Eaves | All aspect | Lining | Sealed | B00F-A03 | No Asbestos Fibres Detected | N/A | N/A | N/A | N/A | Not required | N/A | - | - | | | |

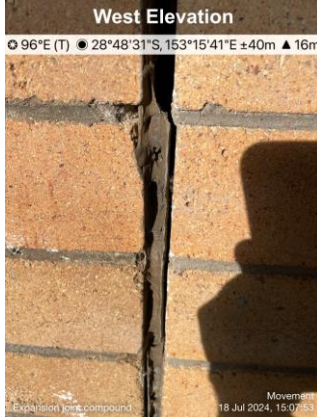
| Inspection date | Reinspection Date | Consultant and Surveyor Reference | Building Ref | Floor | Room or Space | Material description | Primary location | Secondary location | Application | Surface treatment | Sample identification | Laboratory results | Friability | Material condition | Likelihood of disturbance | Risk | Control method | Labelling | Estimated quantity | Units | Comments | Photograph reference | Photograph reference |
|---|---|---|---|---|---|---|---|---|---|---|---|---|---|---|---|---|---|---|---|---|---|---|---|
| 18-Jul-24 | | GHD | B00F - Movement | 01 | External | Sealant / Adhesives | Expansion joint compound | Throughout all movement areas | Putty material / insulation | Sealed | Movement 5-A01 | No Asbestos Fibres Detected | N/A | N/A | N/A | N/A | Not required | N/A | - | - | | | |

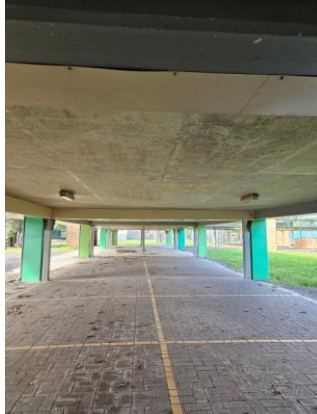
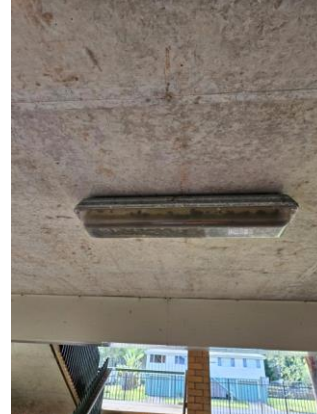
| Inspection date | Reinspection Date | Consultant and Surveyor Reference | Building Ref | Floor | Room or Space | Material description | Primary location | Secondary location | Application | Surface treatment | Sample identification | Laboratory results | Friability | Material condition | Likelihood of disturbance | Risk | Control method | Labelling | Estimated quantity | Units | Comments | Photograph reference | Photograph reference |
|---|---|---|---|---|---|---|---|---|---|---|---|---|---|---|---|---|---|---|---|---|---|---|---|
| 18-Jul-24 | | GHD | B00F - General Learning | GF | External | Capacitors | Fixed to ceiling | Walkways | Fluorescent lights | Sealed | Assumed | Presumed to contain PCB until proven otherwise | N/A | Good | High | Very high | Removal | N/A | 12 | Item | | | |

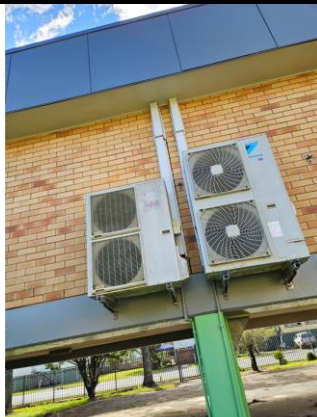
| Inspection date | Reinspection Date | Consultant and Surveyor Reference | Building Ref | Floor | Room or Space | Material description | Primary location | Secondary location | Application | Surface treatment | Sample identification | Laboratory results | Friability | Material condition | Likelihood of disturbance | Risk | Control method | Labelling | Estimated quantity | Units | Comments | Photograph reference | Photograph reference |
|---|---|---|---|---|---|---|---|---|---|---|---|---|---|---|---|---|---|---|---|---|---|---|---|
| 17/724 | | GHD | B00F - General Learning | 01 | External | Thermal insulation | Southern wall | Air conditioning units | Insulation | - | Assumed | Presumed to contain SMF until proven otherwise | N/A | Good | High | Very high | Removal | Not required | 4 | Item | | | |

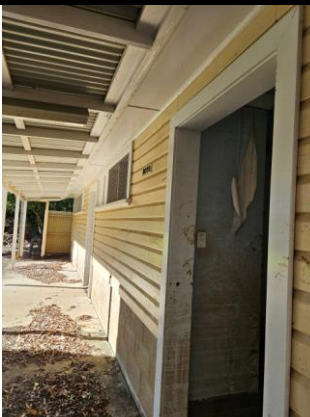
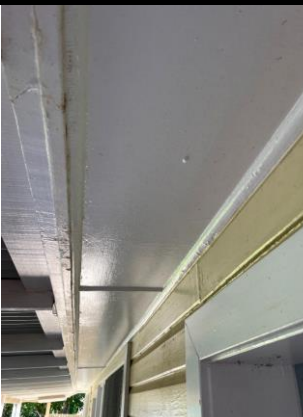
| Consultant | | | Location / Description | | | | | | | | | | Risk Assessment | | | | | | | | | | | |
|---|---|---|---|---|---|---|---|---|---|---|---|---|---|---|---|---|---|---|---|---|---|---|---|--|
| 17-Jul-24 | | GHD | B00G - Toilet Block | GF | External | Flat cement product | Eaves | All aspects | Lining | Sealed | B00G-A02 | Chrysotile & Amosite Detected | Non-friable | Good | High | High | Removal | Not required | 12 | m2 | | | | |

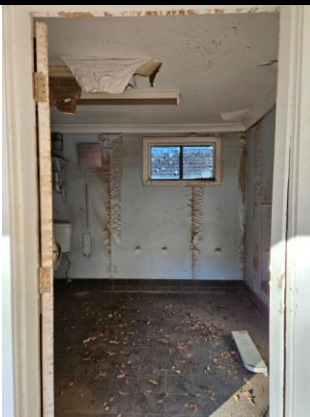
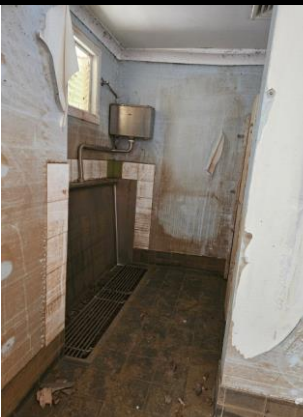
| Consultant | | | Location / Description | | | | | | | | | | Risk Assessment | | | | | | | | | | | |
|---|---|---|---|---|---|---|---|---|---|---|---|---|---|---|---|---|---|---|---|---|---|---|---|--|
| 17-Jul-24 | | GHD | B00G - Toilet Block | GF | Internal | Flat cement product | Toilet walls | Internal wall and ceiling linings | Lining | Sealed | B00G-A01 | No Asbestos Fibres Detected | N/A | N/A | N/A | N/A | Not required | N/A | - | - | | | | |

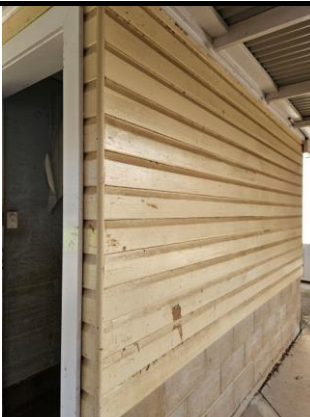
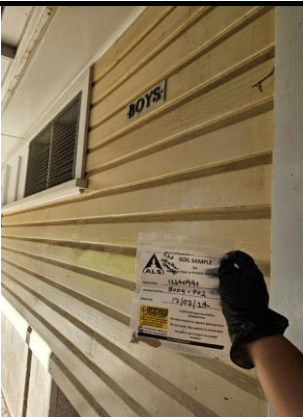
| Consultant | | | Location / Description | | | | | | | | | | Risk Assessment | | | | | | | | | | | |
|---|---|---|---|---|---|---|---|---|---|---|---|---|---|---|---|---|---|---|---|---|---|---|---|--|
| 17-Jul-24 | | GHD | B00G | GF | External | - | Cream paint to external walls | All aspect | Paint | - | B00G-P02 | 0.13% w/w Lead paint detected | N/A | Good | High | High | Removal | N/A | 120 | m2 | | | | |

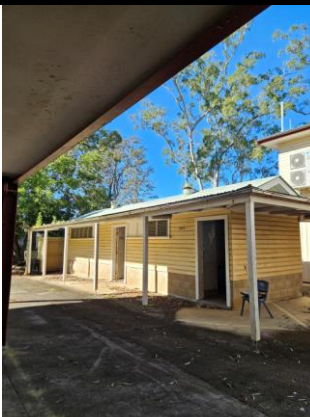
| Consultant | | | Location / Description | | | | | | | | | | Risk Assessment | | | | | | | | | | | |
|---|---|---|---|---|---|---|---|---|---|---|---|---|---|---|---|---|---|---|---|---|---|---|---|--|
| 17-Jul-24 | | GHD | B00G | GF | External | - | Columns | All aspects | Paint | - | B00G-P01 | <0.01% w/w | N/A | N/A | N/A | N/A | Not required | N/A | - | - | | | | |

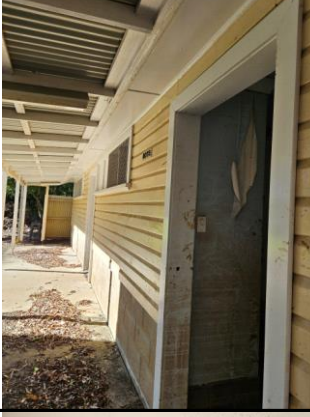
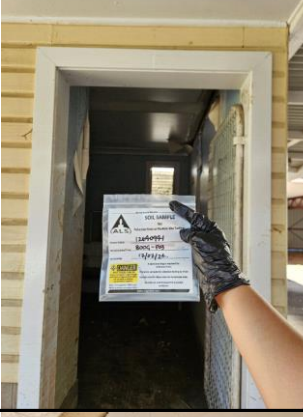
| Consultant | | | Location / Description | | | | | | | | | | Risk Assessment | | | | | | | | | | | |
|---|---|---|---|---|---|---|---|---|---|---|---|---|---|---|---|---|---|---|---|---|---|---|---|--|
| 17-Jul-24 | | GHD | B00G | GF | External | - | Door frames | All aspect | Paint | - | B00G-P03 | <0.01% w/w | N/A | N/A | N/A | N/A | Not required | N/A | - | - | | | | |

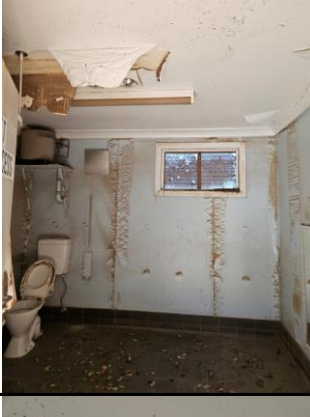
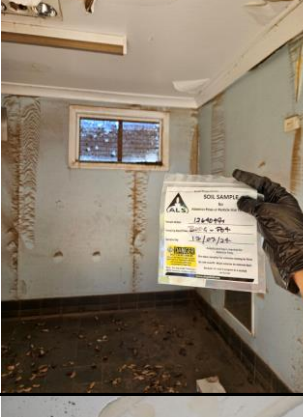
| Consultant | | | Location / Description | | | | | | | | | | Risk Assessment | | | | | | | | | | | |
|---|---|---|---|---|---|---|---|---|---|---|---|---|---|---|---|---|---|---|---|---|---|---|---|--|
| 17-Jul-24 | | GHD | B00G | GF | Internal | - | Walls | All aspects | Paint | - | B00G-P04 | <0.01% w/w | N/A | N/A | N/A | N/A | Not required | N/A | - | - | | | | |

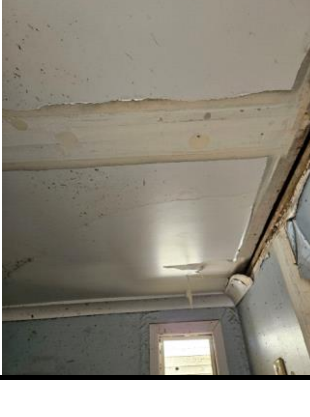
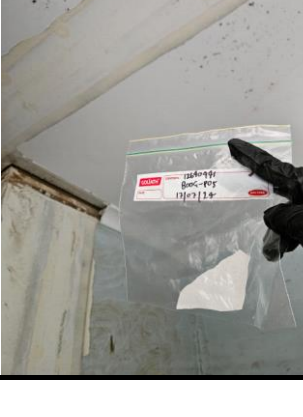
| Consultant | | | Location / Description | | | | | | | | | | Risk Assessment | | | | | | | | | | | |
|---|---|---|---|---|---|---|---|---|---|---|---|---|---|---|---|---|---|---|---|---|---|---|---|--|
| 17-Jul-24 | | GHD | B00G | GF | Internal | - | Ceiling | All aspects | Paint | - | B00G-P05 | <0.01% w/w | N/A | N/A | N/A | N/A | Not required | N/A | - | - | | | | |

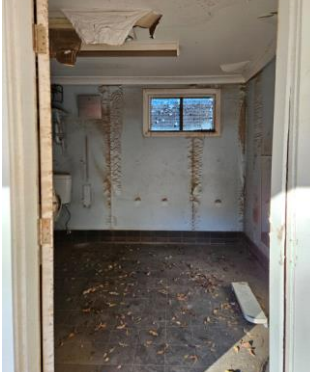
| Consultant | | | Location / Description | | | | | | | | | | Risk Assessment | | | | | | | | | | | |
|---|---|---|---|---|---|---|---|---|---|---|---|---|---|---|---|---|---|---|---|---|---|---|---|--|
| 18-Jul-24 | | GHD | B00G | GF | Internal | Debris | Floor of boys toilet | Throughout | Lead in dust | - | B00G-LD01 | Calculated 0.39mg/m2 (35 µg lead) | N/A | Poor | High | High | Removal | N/A | <1 | m2 | | | | |

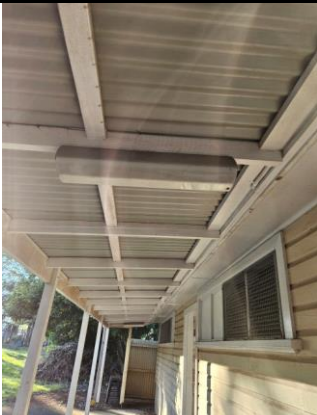
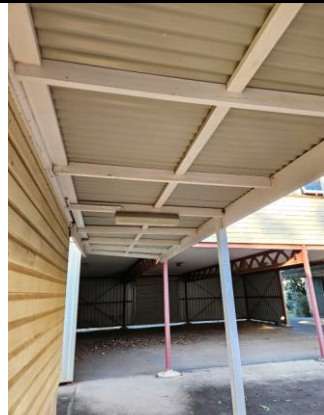
| Inspection date | Reinspection Date | Consultant and Surveyor Reference | Building Ref | Floor | Room or Space | Material description | Primary location | Secondary location | Application | Surface treatment | Sample identification | Laboratory results | Friability | Material condition | Likelihood of disturbance | Risk | Control method | Labelling | Estimated quantity | Units | Comments | Photograph reference | Photograph reference |
|---|---|---|---|---|---|---|---|---|---|---|---|---|---|---|---|---|---|---|---|---|---|---|---|
| 17-Jul-24 | | GHD | B00G-Toilet Block | GF | External | Capacitors | Awning | Fixed to roof timbers | Fluorescent lights | Sealed | Assumed | Presumed to contain PCB until proven otherwise | N/A | Good | High | High | Removal | Not required | 3 | Item | | | |

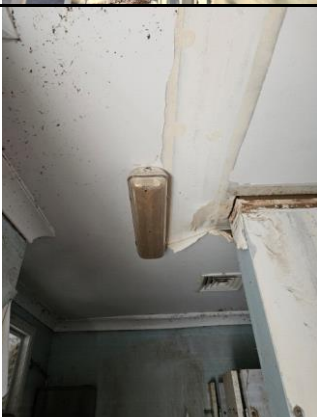
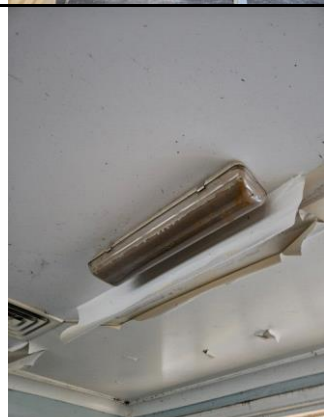
| Inspection date | Reinspection Date | Consultant and Surveyor Reference | Building Ref | Floor | Room or Space | Material description | Primary location | Secondary location | Application | Surface treatment | Sample identification | Laboratory results | Friability | Material condition | Likelihood of disturbance | Risk | Control method | Labelling | Estimated quantity | Units | Comments | Photograph reference | Photograph reference |
|---|---|---|---|---|---|---|---|---|---|---|---|---|---|---|---|---|---|---|---|---|---|---|---|
| 17-Jul-24 | | GHD | B00G-Toilet Block | GF | Internal | Capacitors | Toilets | Fixed to ceiling | Fluorescent lights | Sealed | Assumed | Presumed to contain PCB until proven otherwise | N/A | Good | High | High | Removal | Not required | 3 | Item | 1x for each bathroom | | |

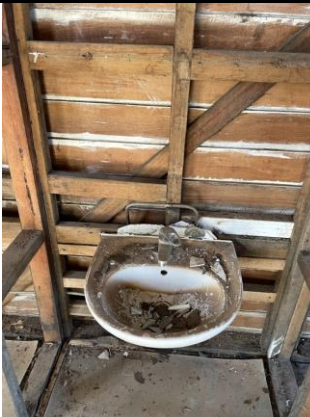
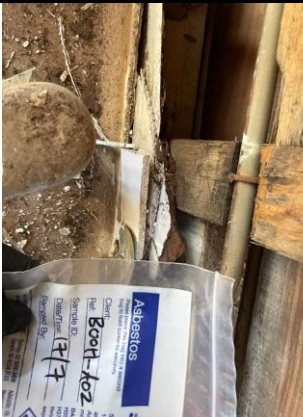
| Consultant | | | Location / Description | | | | | | | | | | Risk Assessment | | | | | | | | | | | |
|---|---|---|---|---|---|---|---|---|---|---|---|---|---|---|---|---|---|---|---|---|---|---|---|--|
| 17-Jul-24 | | GHD | B00H - Toilet | 01 | Internal | Debris | Behind sink | Fragments on floors | Debris | Unsealed | B00H-A02 | Chrysotile Detected | Non-friable | Poor | Very high | Very high | Removal | Not required | 1 | m2 | | | | |

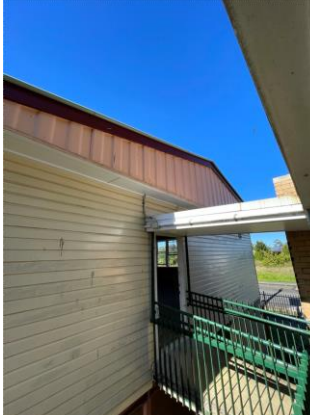
| Consultant | | | Location / Description | | | | | | | | | | Risk Assessment | | | | | | | | | | | |
|---|---|---|---|---|---|---|---|---|---|---|---|---|---|---|---|---|---|---|---|---|---|---|---|--|
| 17-Jul-24 | | GHD | B00H | 01 | External | Flat cement product | Ceiling to entryway | Walkway/movement area ceiling | Lining | Sealed | B00H-A06 | Chrysotile & Amosite Detected | Non-friable | Fair | High | Very high | Removal | Labels required (not affixed or not sufficient) | 12 | m2 | | | | |

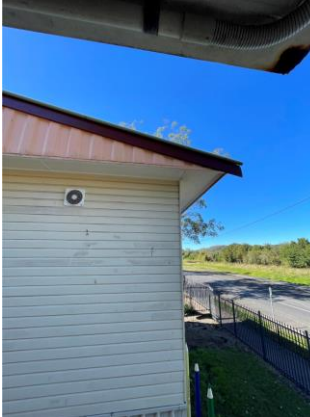
| Consultant | | | Location / Description | | | | | | | | | | Risk Assessment | | | | | | | | | | | |
|---|---|---|---|---|---|---|---|---|---|---|---|---|---|---|---|---|---|---|---|---|---|---|---|--|
| 17-Jul-24 | | GHD | B00H - General Learning | Roof | External | Flat cement product | Gable ends | All aspects | Lining | Sealed | B00H-A07 | Chrysotile & Amosite Detected | Non-friable | Fair | Very high | Very high | Removal | Labels required (not affixed or not sufficient) | 20 | m2 | | | | |

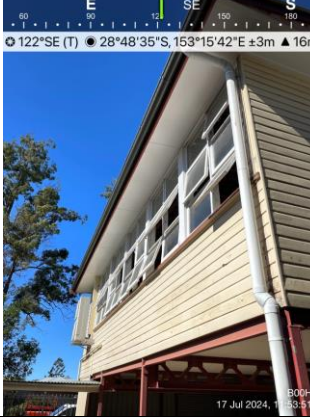
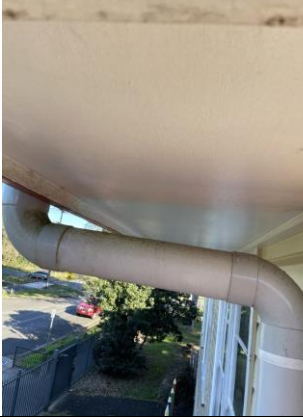
| Consultant | | | Location / Description | | | | | | | | | | Risk Assessment | | | | | | | | | | | |
|---|---|---|---|---|---|---|---|---|---|---|---|---|---|---|---|---|---|---|---|---|---|---|---|--|
| 17-Jul-24 | | GHD | B00H - General Learning | Roof | External | Flat cement product | Eaves | All aspects | Lining | Sealed | B00H-A08 | Chrysotile & Amosite Detected | Non-friable | Fair | Very high | Very high | Removal | Labels required (not affixed or not sufficient) | 40 | m2 | | | | |

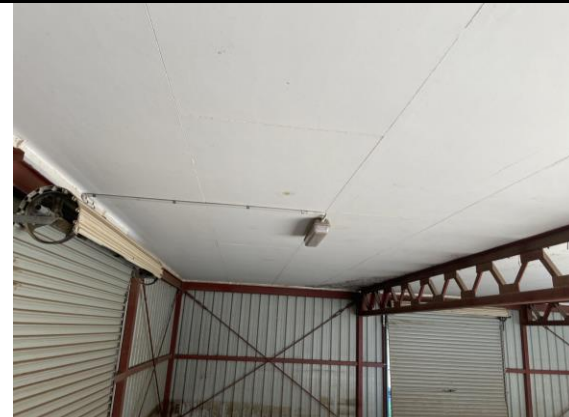
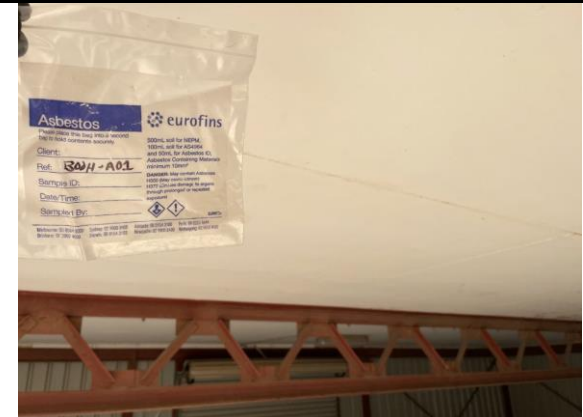
| Consultant | | | Location / Description | | | | | | | | | | Risk Assessment | | | | | | | | | | | |
|---|---|---|---|---|---|---|---|---|---|---|---|---|---|---|---|---|---|---|---|---|---|---|---|--|
| 17-Jul-24 | | GHD | B00H - General Learning | GF | External | Flat cement product | Ceiling to ground floor open area | Throughout ground floor | Lining | Sealed | B00H-A01 | No Asbestos Fibres Detected | N/A | N/A | N/A | N/A | Not required | N/A | - | - | | | | |

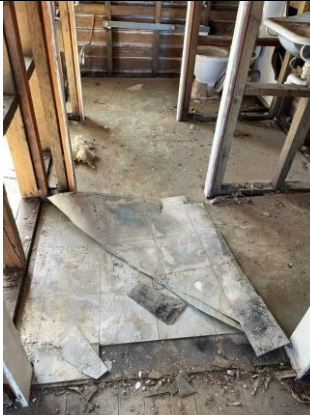
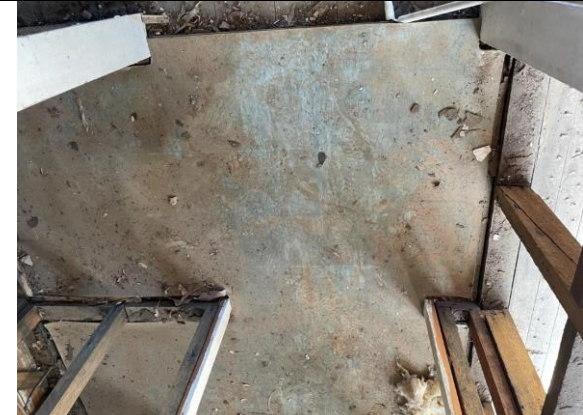
| Consultant | | | Location / Description | | | | | | | | | | Risk Assessment | | | | | | | | | | | |
|---|---|---|---|---|---|---|---|---|---|---|---|---|---|---|---|---|---|---|---|---|---|---|---|--|
| 17-Jul-24 | | GHD | B00H | 01 | Internal | Floor tiles | Vinyl floor tiles to bathroom floor | Bathroom and toilet floor | Floor covering | Sealed | B00H-A03 | No Asbestos Fibres Detected | N/A | N/A | N/A | N/A | Not required | N/A | - | - | | | | |

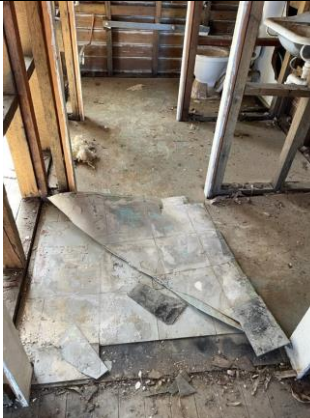
| Consultant | | | Location / Description | | | | | | | | | | Risk Assessment | | | | | | | | | | | |
|---|---|---|---|---|---|---|---|---|---|---|---|---|---|---|---|---|---|---|---|---|---|---|---|--|
| 17-Jul-24 | | GHD | B00H - Toilet | 01 | Internal | Sealant / Adhesives | Beneath vinyl flooring | Bathroom and toilet floor | Floor covering | Sealed | B00H-A04 | No Asbestos Fibres Detected | N/A | N/A | N/A | N/A | Not required | N/A | - | - | | | | |

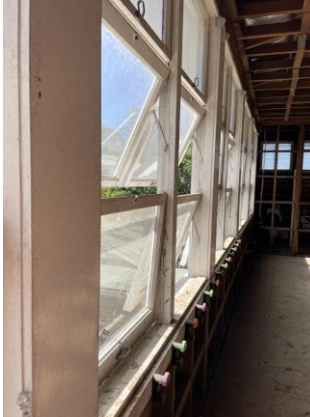
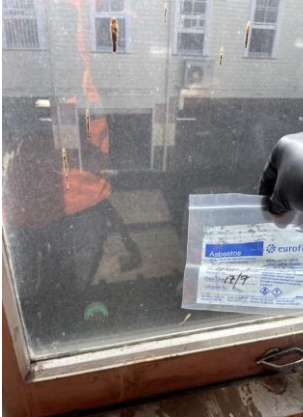
| Consultant | | | Location / Description | | | | | | | | | | Risk Assessment | | | | | | | | | | | |
|---|---|---|---|---|---|---|---|---|---|---|---|---|---|---|---|---|---|---|---|---|---|---|---|--|
| 17-Jul-24 | | GHD | B00H - Classroom | 01 | Internal | Sealant / Adhesives | Windows | Window frames | Putty | Unsealed | B00H-A05 | No Asbestos Fibres Detected | N/A | N/A | N/A | N/A | Not required | N/A | - | - | | | | |

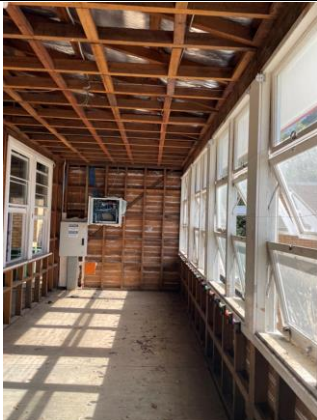
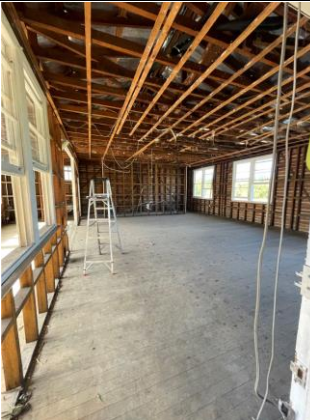
| Inspection date | Reinspection Date | Consultant and Surveyor Reference | Building Ref | Floor | Room or Space | Material description | Primary location | Secondary location | Application | Surface treatment | Sample identification | Laboratory results | Friability | Material condition | Likelihood of disturbance | Risk | Control method | Labelling | Estimated quantity | Units | Comments | Photograph reference | Photograph reference |
|---|---|---|---|---|---|---|---|---|---|---|---|---|---|---|---|---|---|---|---|---|---|---|---|
| 18-Jul-24 | | GHD | B00H - General Learning | 01 | Internal | Debris | Dust to floor of B00H internal areas | Internal floor | Dust | Unsealed | B00H-AD01 | No asbestos detected at the reporting limit of 0.01% w/w. | N/A | N/A | N/A | N/A | Not required | N/A | - | - | | | |

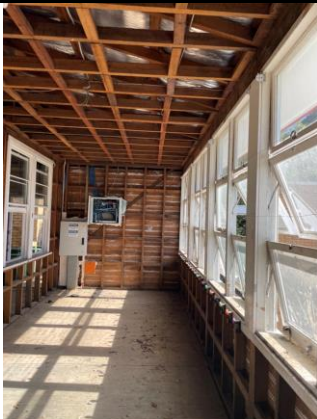
| Inspection date | Reinspection Date | Consultant and Surveyor Reference | Building Ref | Floor | Room or Space | Material description | Primary location | Secondary location | Application | Surface treatment | Sample identification | Laboratory results | Friability | Material condition | Likelihood of disturbance | Risk | Control method | Labelling | Estimated quantity | Units | Comments | Photograph reference | Photograph reference |
|---|---|---|---|---|---|---|---|---|---|---|---|---|---|---|---|---|---|---|---|---|---|---|---|
| 18-Jul-24 | | GHD | B00H | GF | Internal | - | Floor | All aspects | Lead paint dust | | B00H-LD01 | Calculated 5.45mg/m2 (490 µg) | N/A | Poor | High | - | Removal | N/A | <1 | m3 | Dust to floor in south east corner | | |

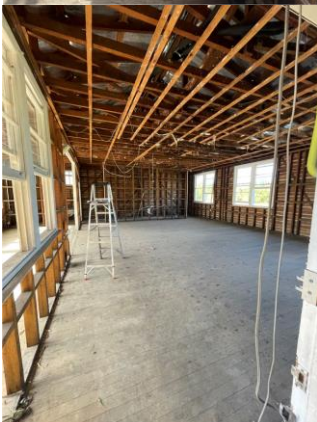
| Inspection date | Reinspection Date | Consultant and Surveyor Reference | Building Ref | Floor | Room or Space | Material description | Primary location | Secondary location | Application | Surface treatment | Sample identification | Laboratory results | Friability | Material condition | Likelihood of disturbance | Risk | Control method | Labelling | Estimated quantity | Units | Comments | Photograph reference | Photograph reference |
|---|---|---|---|---|---|---|---|---|---|---|---|---|---|---|---|---|---|---|---|---|---|---|---|
| 18-Jul-24 | | GHD | B00H | GF | Internal | - | Window sill | All aspects | Lead paint dust | | B00H-LD02 | Calculated 2.89mg/m2 (260 µg) | N/A | Poor | High | - | Removal | N/A | <1 | m3 | Dust to window sills | | |

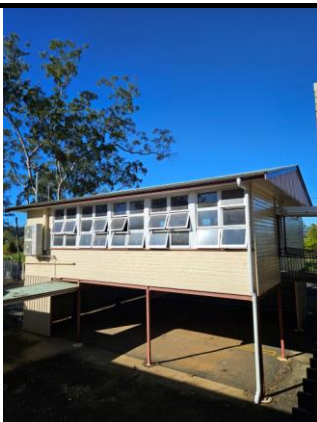
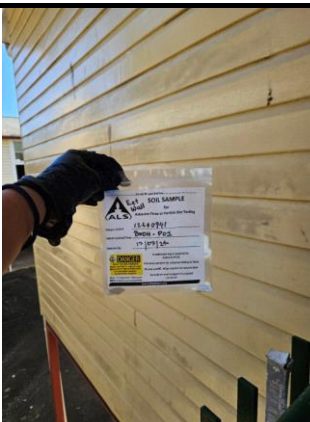
| Inspection date | Reinspection Date | Consultant and Surveyor Reference | Building Ref | Floor | Room or Space | Material description | Primary location | Secondary location | Application | Surface treatment | Sample identification | Laboratory results | Friability | Material condition | Likelihood of disturbance | Risk | Control method | Labelling | Estimated quantity | Units | Comments | Photograph reference | Photograph reference |
|---|---|---|---|---|---|---|---|---|---|---|---|---|---|---|---|---|---|---|---|---|---|---|---|
| 17-Jul-24 | | GHD | B00H | 01 | External | - | Cream paint to external weatherboard | All aspects | Paint | - | B00H-P01 | 0.19% w/w Lead paint detected | N/A | Good | High | Very high | Removal | N/A | 130 | m2 | | | |

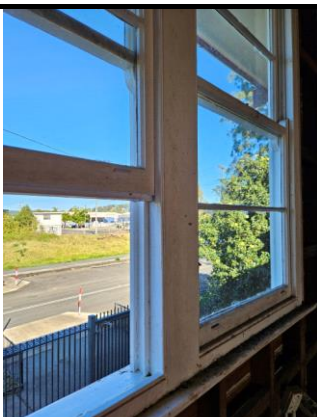
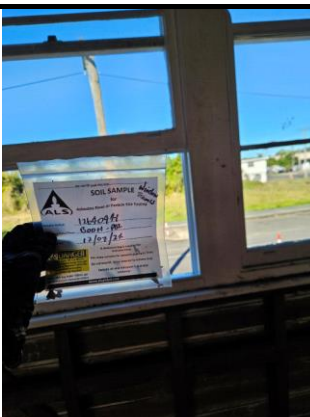
| Inspection date | Reinspection Date | Consultant and Surveyor Reference | Building Ref | Floor | Room or Space | Material description | Primary location | Secondary location | Application | Surface treatment | Sample identification | Laboratory results | Friability | Material condition | Likelihood of disturbance | Risk | Control method | Labelling | Estimated quantity | Units | Comments | Photograph reference | Photograph reference |
|---|---|---|---|---|---|---|---|---|---|---|---|---|---|---|---|---|---|---|---|---|---|---|---|
| 17-Jul-24 | | GHD | B00H | 01 | Internal | - | Window frames | All aspects | Paint | - | B00H-P02 | 0.05% w/w Lead paint detected | N/A | N/A | N/A | N/A | Not required | N/A | - | N/A | | | |

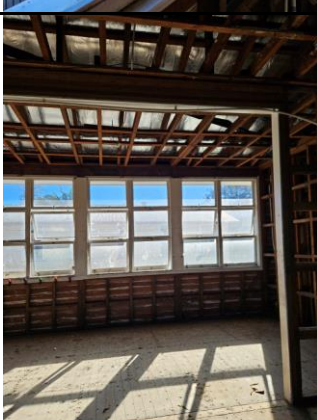
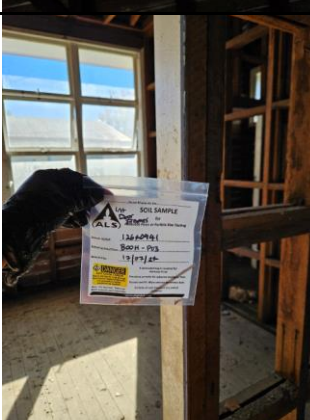
| Inspection date | Reinspection Date | Consultant and Surveyor Reference | Building Ref | Floor | Room or Space | Material description | Primary location | Secondary location | Application | Surface treatment | Sample identification | Laboratory results | Friability | Material condition | Likelihood of disturbance | Risk | Control method | Labelling | Estimated quantity | Units | Comments | Photograph reference | Photograph reference |
|---|---|---|---|---|---|---|---|---|---|---|---|---|---|---|---|---|---|---|---|---|---|---|---|
| 17-Jul-24 | | GHD | B00H | 01 | Internal | - | Door frames | All aspects | Paint | - | B00H-P03 | 0.06% w/w Lead paint detected | N/A | N/A | N/A | N/A | Not required | N/A | - | N/A | | | |

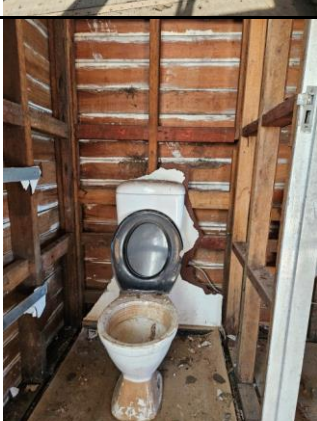
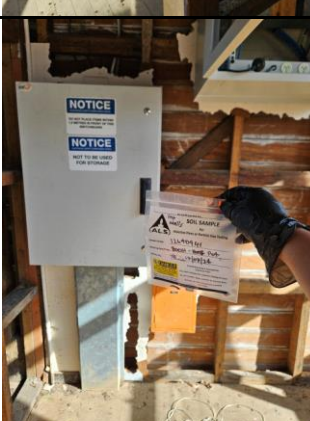
| Inspection date | Reinspection Date | Consultant and Surveyor Reference | Building Ref | Floor | Room or Space | Material description | Primary location | Secondary location | Application | Surface treatment | Sample identification | Laboratory results | Friability | Material condition | Likelihood of disturbance | Risk | Control method | Labelling | Estimated quantity | Units | Comments | Photograph reference | Photograph reference |
|---|---|---|---|---|---|---|---|---|---|---|---|---|---|---|---|---|---|---|---|---|---|---|---|
| 17-Jul-24 | | GHD | B00H | 01 | Internal | - | Walls | All aspects | Paint | - | B00H-P04 | 0.06% w/w Lead paint detected | N/A | N/A | N/A | N/A | Not required | N/A | - | N/A | | | |

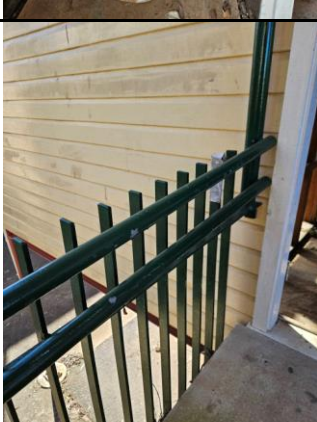
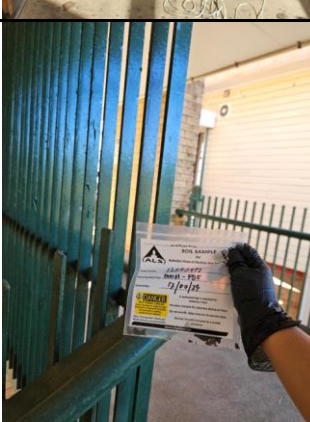
| Inspection date | Reinspection Date | Consultant and Surveyor Reference | Building Ref | Floor | Room or Space | Material description | Primary location | Secondary location | Application | Surface treatment | Sample identification | Laboratory results | Friability | Material condition | Likelihood of disturbance | Risk | Control method | Labelling | Estimated quantity | Units | Comments | Photograph reference | Photograph reference |
|---|---|---|---|---|---|---|---|---|---|---|---|---|---|---|---|---|---|---|---|---|---|---|---|
| 17-Jul-24 | | GHD | B00H | 01 | External | - | Railings | All aspects | Paint | - | B00H-P05 | 0.03% w/w Lead paint detected | N/A | N/A | N/A | N/A | Not required | N/A | - | N/A | | | |

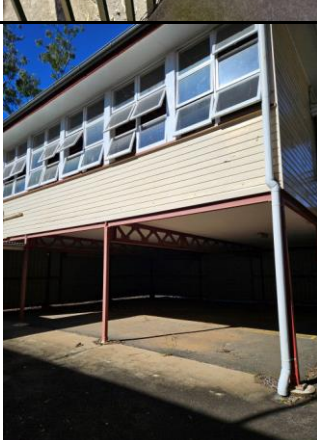
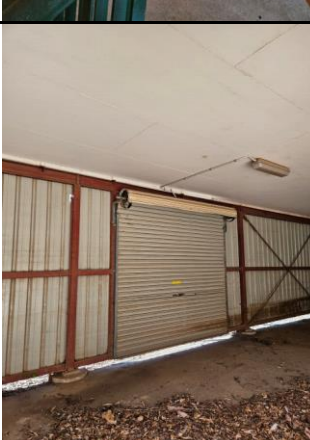
| Inspection date | Reinspection Date | Consultant and Surveyor Reference | Building Ref | Floor | Room or Space | Material description | Primary location | Secondary location | Application | Surface treatment | Sample identification | Laboratory results | Friability | Material condition | Likelihood of disturbance | Risk | Control method | Labelling | Estimated quantity | Units | Comments | Photograph reference | Photograph reference |
|---|---|---|---|---|---|---|---|---|---|---|---|---|---|---|---|---|---|---|---|---|---|---|---|
| 17-Jul-24 | | GHD | B00H | GF | External | - | Columns | Beams | Paint | - | B00H-P06 | 0.02% w/w Lead paint detected | N/A | N/A | N/A | N/A | Not required | N/A | - | N/A | | | |

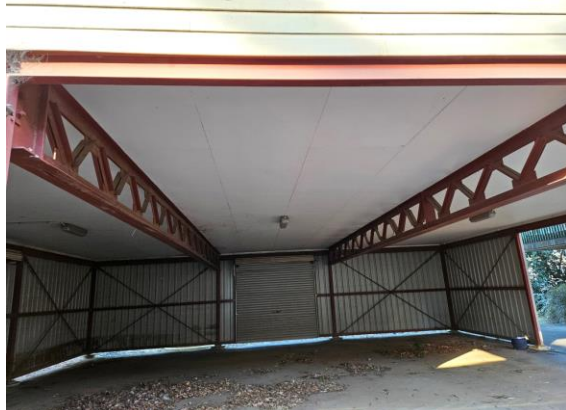
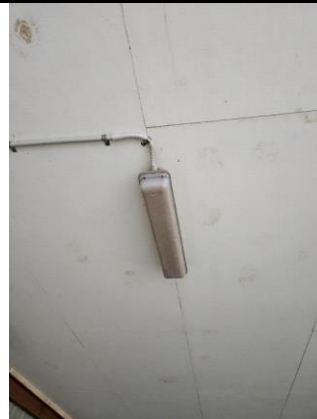
| Inspection date | Reinspection Date | Consultant and Surveyor Reference | Building Ref | Floor | Room or Space | Material description | Primary location | Secondary location | Application | Surface treatment | Sample identification | Laboratory results | Friability | Material condition | Likelihood of disturbance | Risk | Control method | Labelling | Estimated quantity | Units | Comments | Photograph reference | Photograph reference |
|---|---|---|---|---|---|---|---|---|---|---|---|---|---|---|---|---|---|---|---|---|---|---|---|
| 17-Jul-24 | | GHD | B00H - General Learning | GF | External | Capacitors | Ceiling | Fixed to ceiling | Fluorescent lights | Sealed | Assumed | Presumed to contain PCB until proven otherwise | N/A | Good | High | Very high | Removal | N/A | 3 | Item | | | |

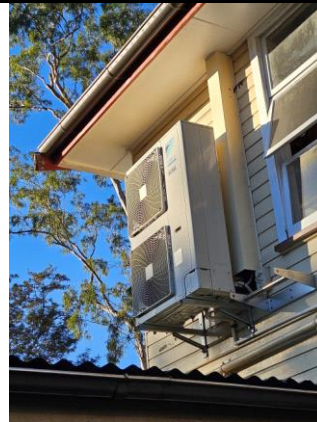
| Inspection date | Reinspection Date | Consultant and Surveyor Reference | Building Ref | Floor | Room or Space | Material description | Primary location | Secondary location | Application | Surface treatment | Sample identification | Laboratory results | Friability | Material condition | Likelihood of disturbance | Risk | Control method | Labelling | Estimated quantity | Units | Comments | Photograph reference | Photograph reference |
|---|---|---|---|---|---|---|---|---|---|---|---|---|---|---|---|---|---|---|---|---|---|---|---|
| 17-Jul-24 | | GHD | B00H - General Learning | GF | External | Thermal insulation | Northern wall | Air conditioning unit | Insulation | Sealed | Assumed | Presumed to contain SMF until proven otherwise | N/A | Good | High | Very high | Removal | N/A | 1 | Item | | | |

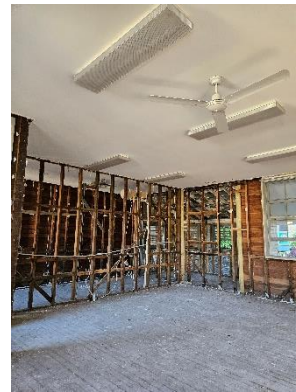
Photograph 10: B00C internal areas (Asbestos fibres detected in dust on floor)

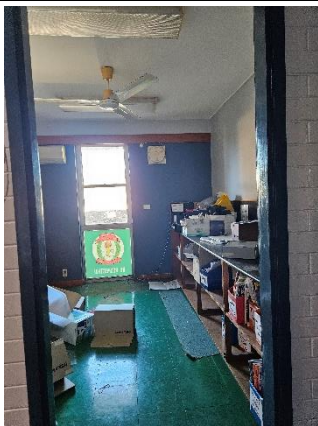
Photograph 11: Building B00B photocopy room (Asbestos detected in green floor tiles)

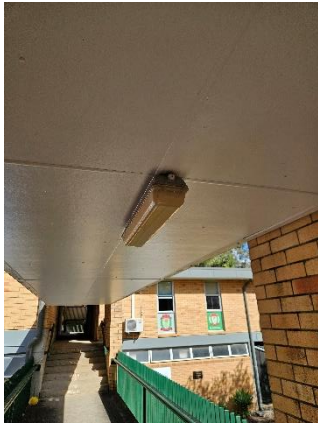
Photograph 13: Movement area between building B00B and B00F (Asbestos detected in flat cement sheet ceiling lining)

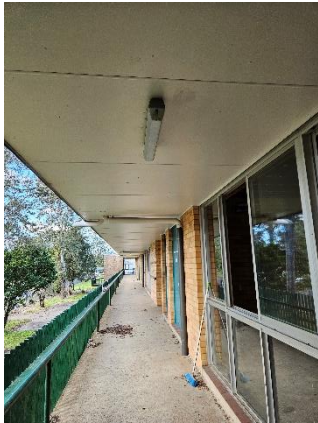
Photograph 15: Building B00F walkway/movement area (Asbestos detected in flat cement sheet ceiling lining)

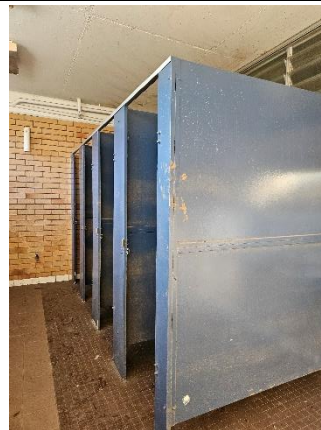
Photograph 18: Toilet cubicles in building B00B ground floor toilets (Asbestos detected in compressed cement sheet cubicle wall linings)

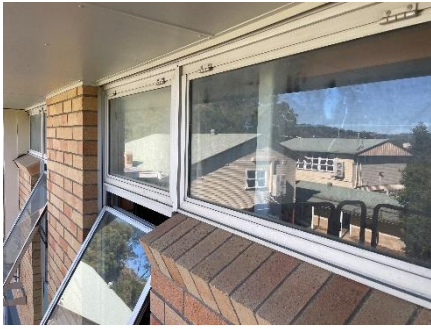
Photograph 19: External windows B00A (Asbestos detected in window putty within the rectangular top windows)

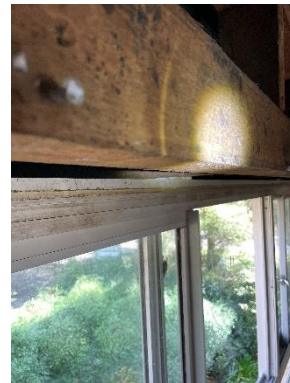
Photograph 22: Flat cement sheet fragments packers used between window frames and timber/brick framework (Asbestos detected in packer fragments)

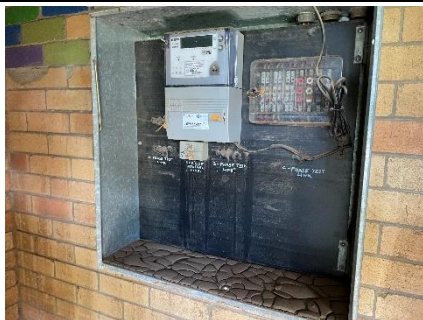
Photograph 23: Electrical distribution board ground floor B00F (Asbestos detected)

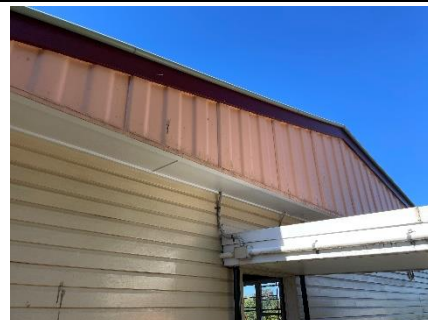
Photograph 24: Roof gable ends and eaves to building B00H (Asbestos detected in roof gable end and eave lining)
