# Scope of Works for Hazmat Remediation and Demolition

Willyama High School, Broken Hill, NSW, 2880

**Report No.:** 31174 - R02

**Site visit and assessment** - 4<sup>th</sup> June 2024

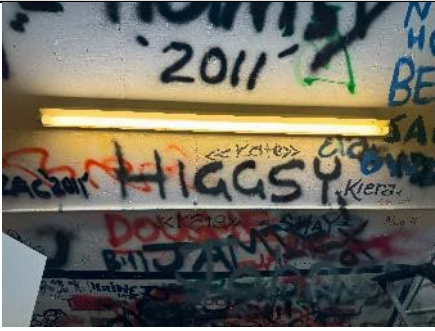
Interior Fluorescent Lights	Visual Inspection	A5	Remove potential PCB containing light fittings under controlled conditions and appropriate disposal.

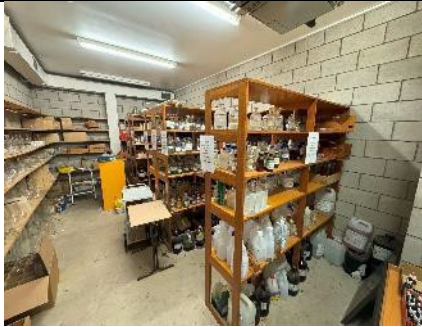
Chemical Store AR2E12 AR2E14	Visual Inspection identified mercury, acids, alkalines	A1	It is recommended to utilise a chemical collection and disposal contractor to identify, remove, transport and dispose of appropriately. Currently in the process of removal early November 2024, any remaining or discovered chemicals to be treated as an unexpected finds

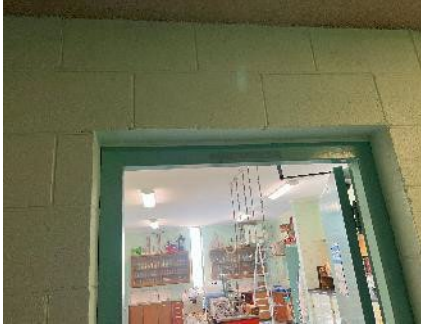
Laboratory and chemical stores AR2E03 AR2E18	Visual Inspection identified Fume hood and laboratory chemicals	A1	it is recommended to utilise a chemical collection and disposal contractor to identify, remove, transport and dispose of appropriately. Currently in the process of removal early November 2024, any remaining or discovered chemicals to be treated as an unexpected finds
5 <sup>th</sup> June 2024

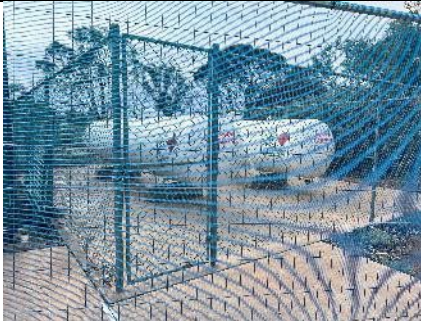
External – North  Gas tanks and service infrastructure	Visual Inspection – identified gas tanks and service lines	A5	Remove enclosed units as per manufacturer guidelines

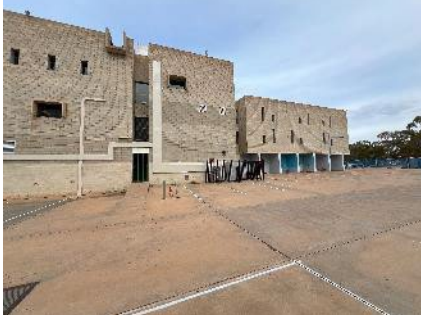
External Potential Underground service lines, tanks, pipework.	Visual evidence, plans and anecdotal historical evidence of potential hazardous materials	A5	Further investigation once access has been obtained. An unexpected finds protocol for demolition and earthworks controlled removal and validation of site will be required.

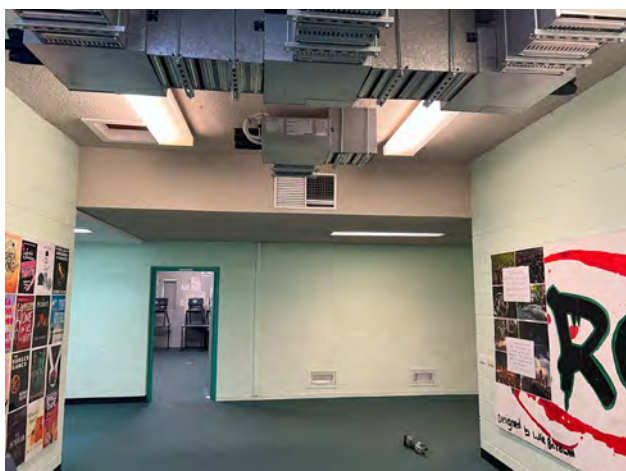
Image 1: Airconditioning ducting bulkhead lining, movement area R2W24.

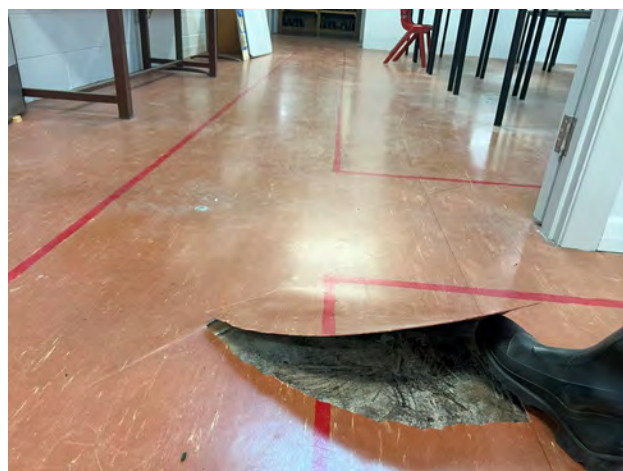
Image 2: Flooring materials – ACM containing adhesive black glue under vinyl flooring

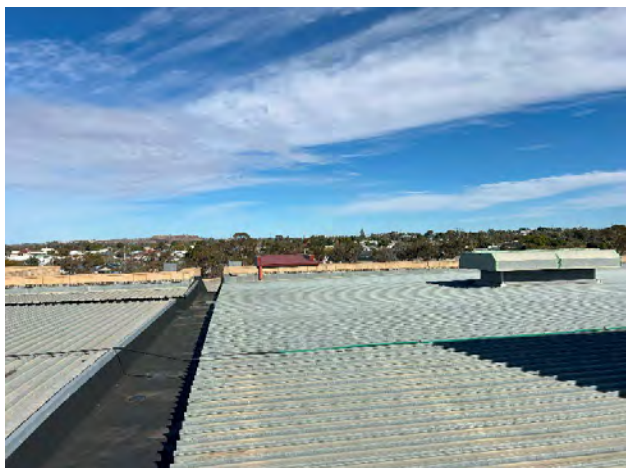
Image 3: Roof Box gutter, only ACM identified is the bituminous lining at the join between the wall and the gutter.

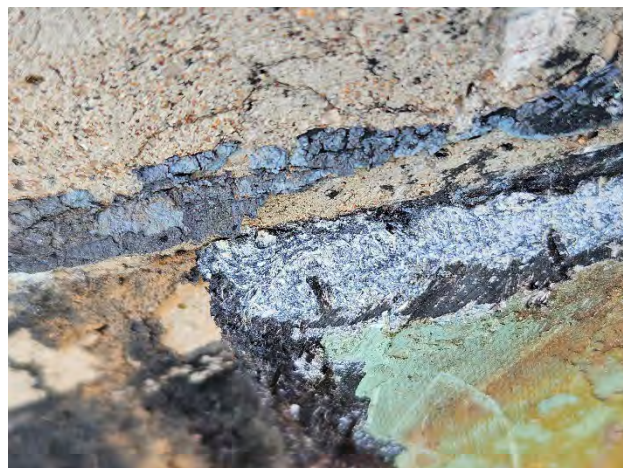
Image 4: ACM identified in bituminous lining between the wall and the gutter.

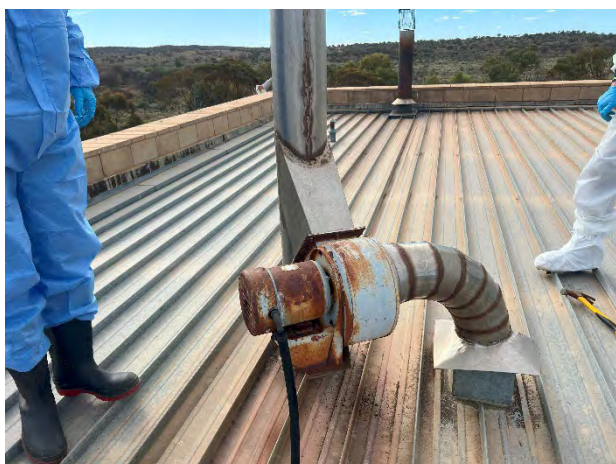
Image 5: Roof exhaust toilet flues. ACM identified in the gaskets.

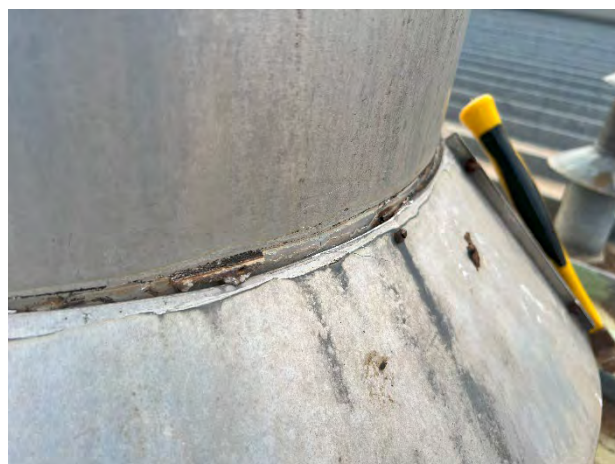
Image 6: Roof exhaust boiler flue. ACM identified in the joint putty.

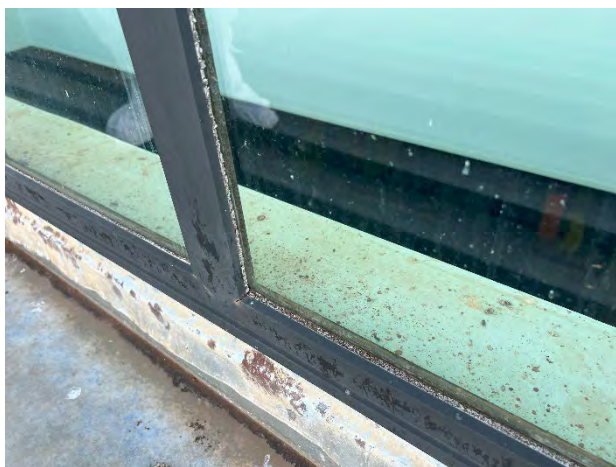
Image 7: Roof Skylight, ACM identified in the internal wall lining, no asbestos materials detected in the window putty or plastic window frame lining.

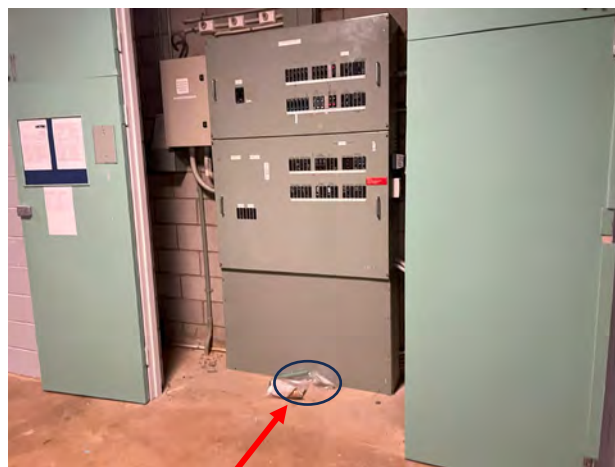
Subfloor pipework

Image 8: Subfloor ACM Fibre Cement conduit pipework.

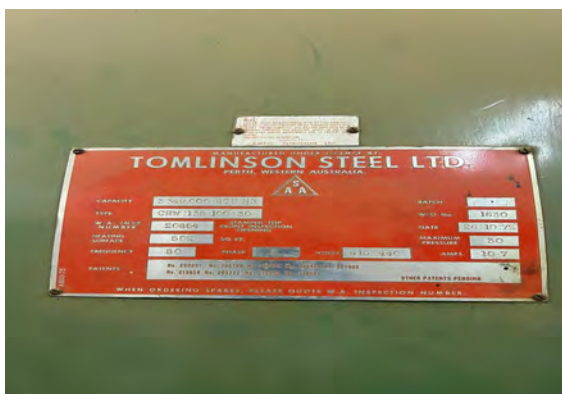
Image 9: Main Gas Boiler ID tag, plant room.  
Encapsulated unit (1975).

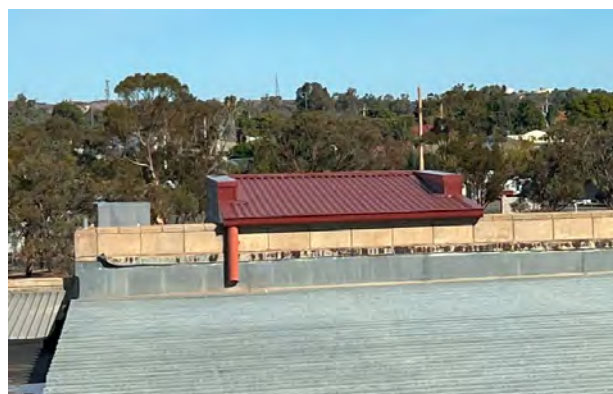
Image 10: Lift extension, no asbestos materials  
identified.

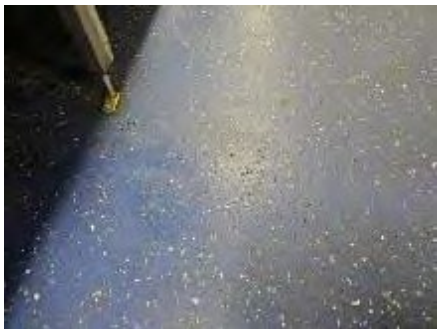
LOCATION of Surface Swabs 16 <sup>th</sup> Jan 2024	ORGANISM grown
<p>R01-30158-S01</p> <p>Room AR-ON-11, floor</p>

<p>Growth of Cladosporium, Alternaria, Rhizopus spp</p>

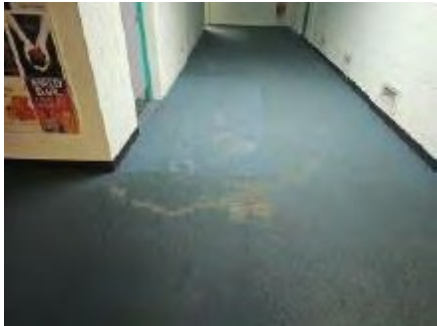
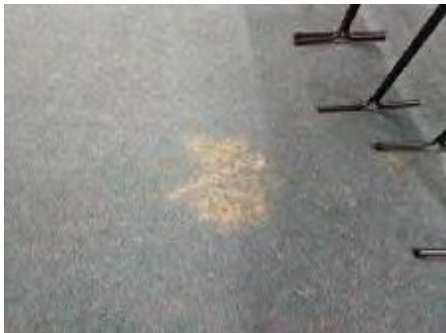
<p>Growth of Alternaria, Bipolaris and Mucor spp, and environmental bacilli</p>

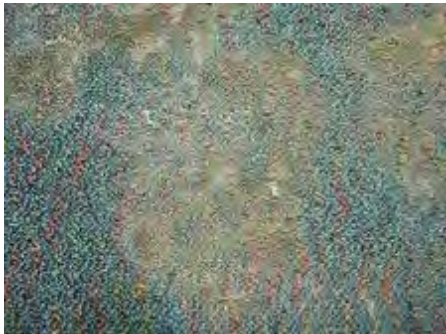
LOCATION of Bio-Tapes – 16 <sup>th</sup> Jan 2024	ORGANISM at 400x
<p>R01-30158-S03 Room AR-OW-18, floor</p>

<p>Spores of Cladosporium and Penicillium spp detected</p>

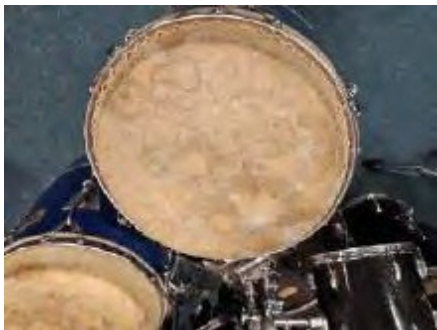
<p>Occasional spores of Cladosporium spp detected.</p>

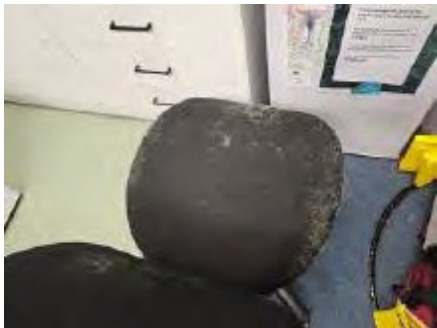
<p>Spores of Aspergillus and Alternaria spp detected.</p>

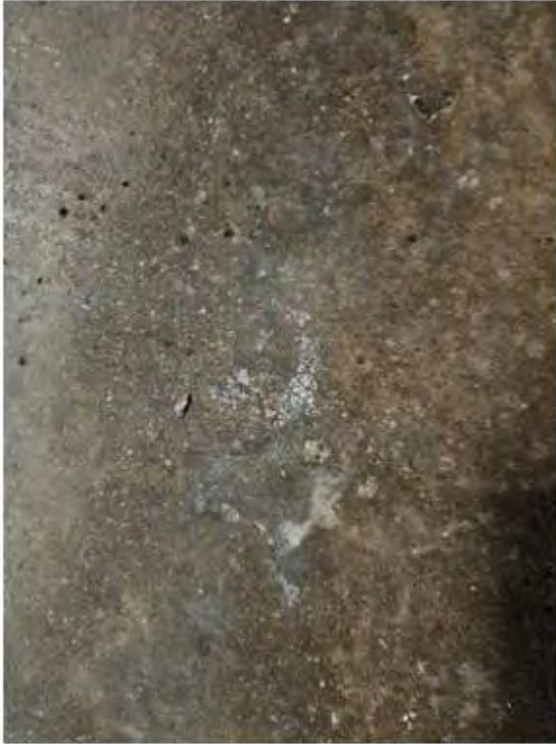
Image 1: Mould

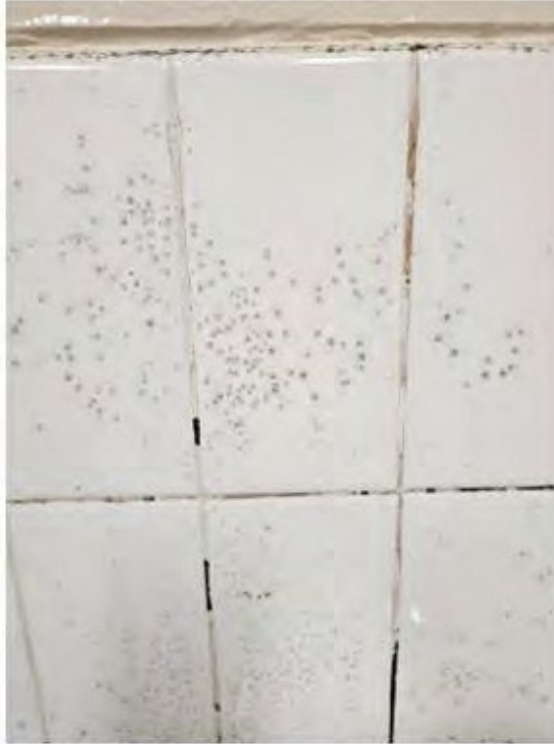
Image 2: Mould on grime on ceramic tiles

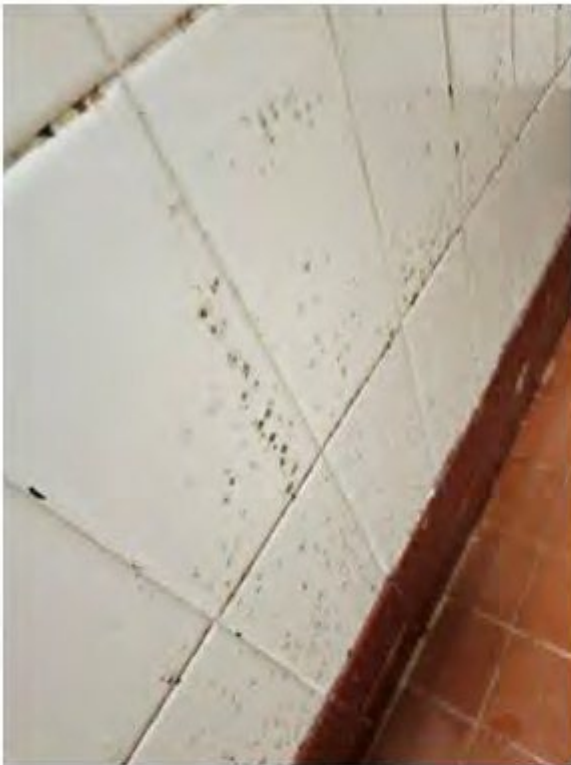
Image 3: Mould

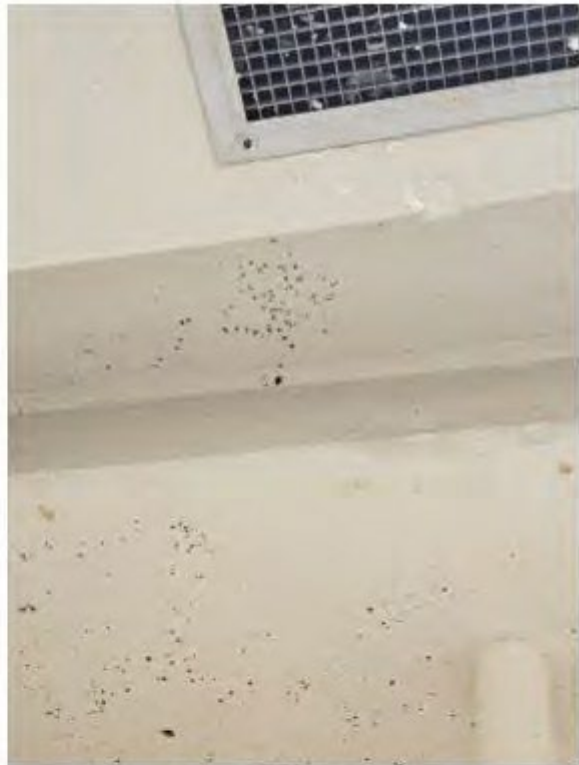
Image 4: Wall/ceiling

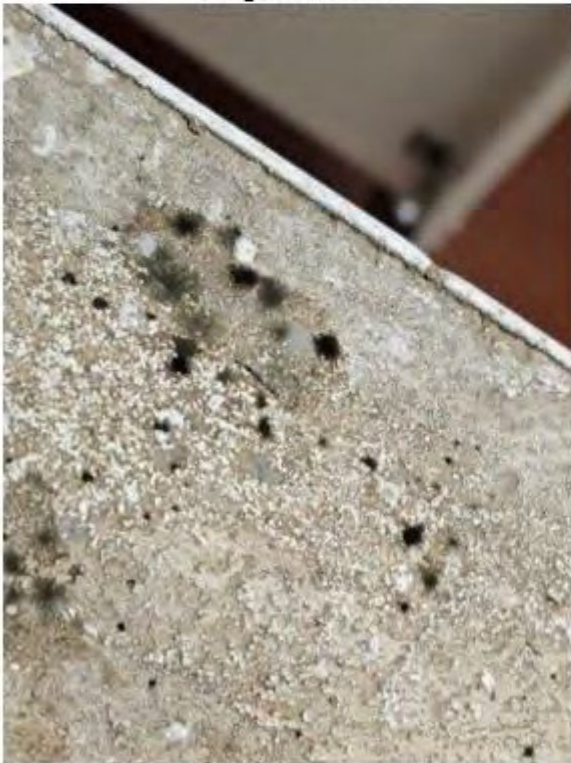
Image 5: Mould on concrete

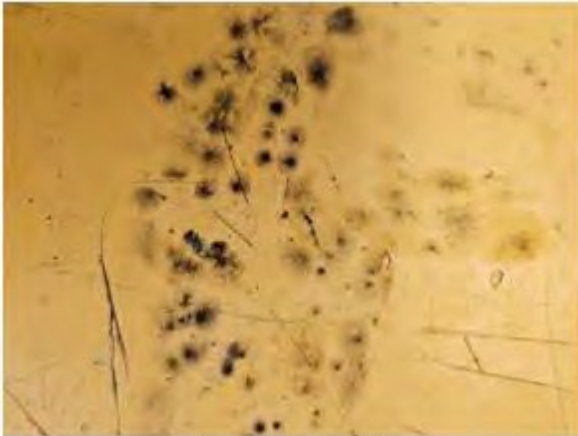
Image 7: Mould

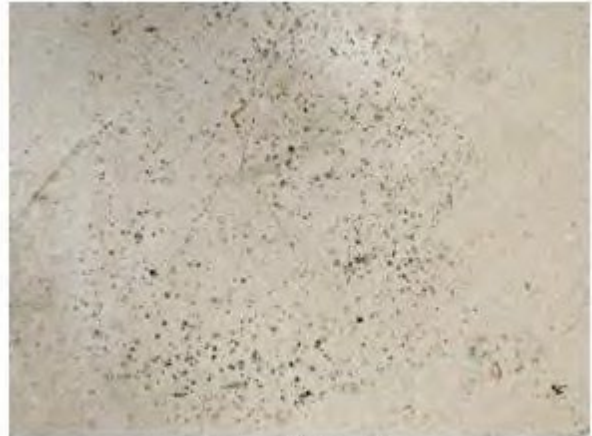
Image 8: Mould

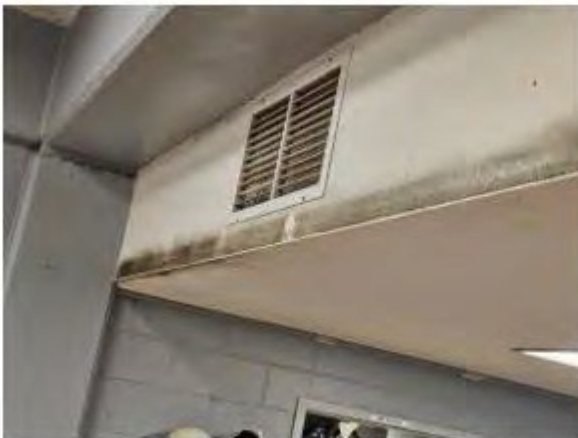
Image 9: Mould by air-conditioning duct

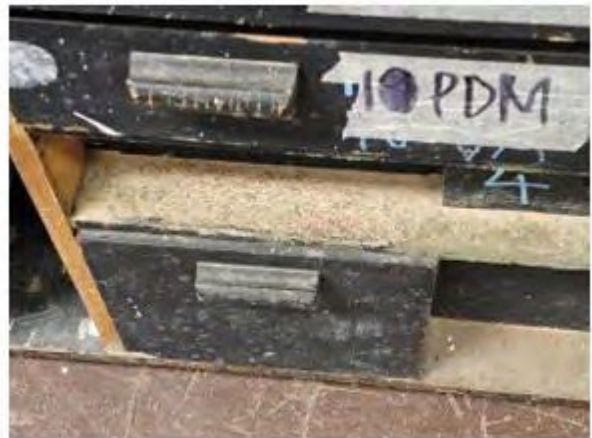
Image 10: Cabinet, infestation

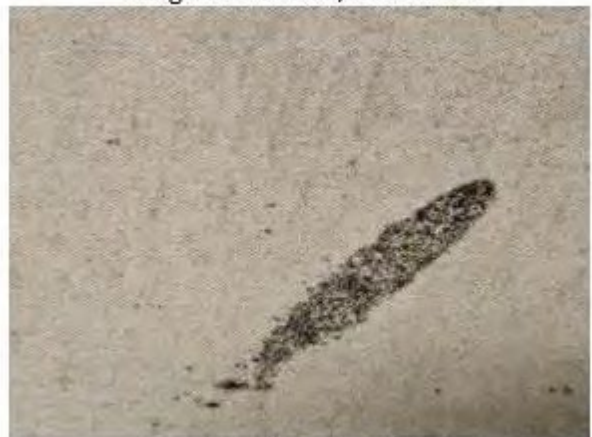
Image 12: Mould on fabric

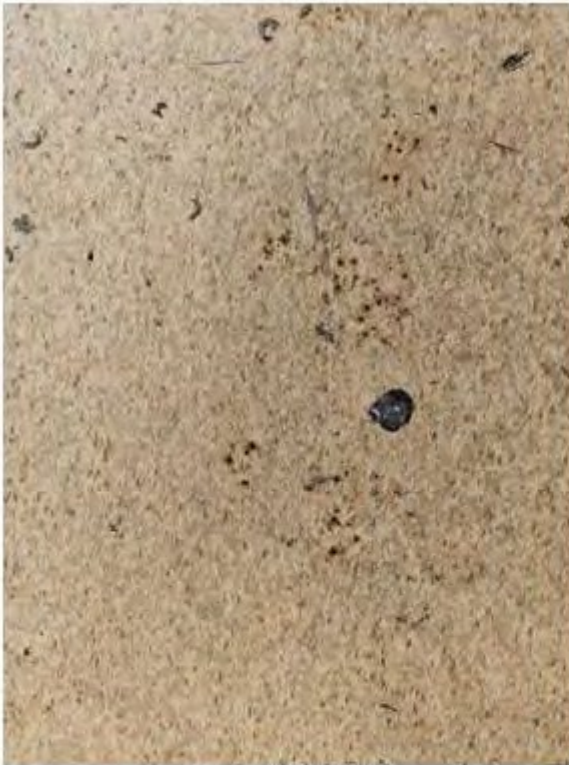
Image 13: Mould

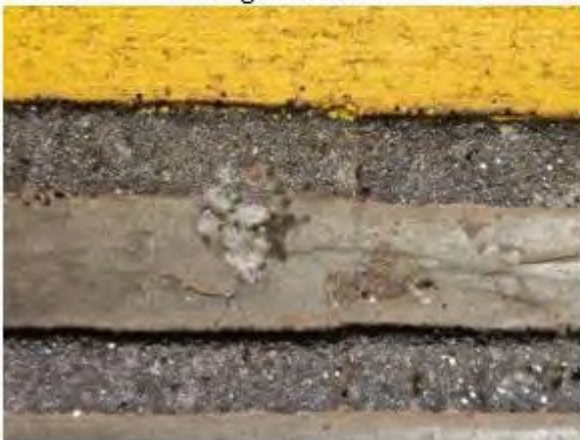
Image 15: Mould

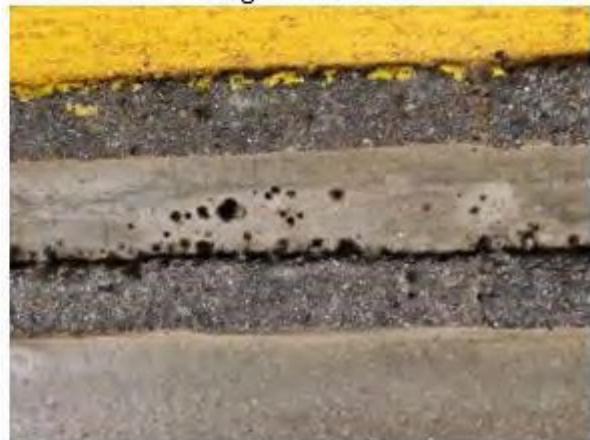
Image 16: Mould

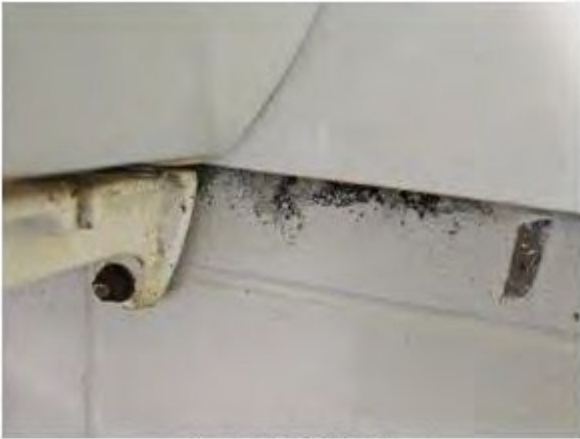
Image 17: Mould

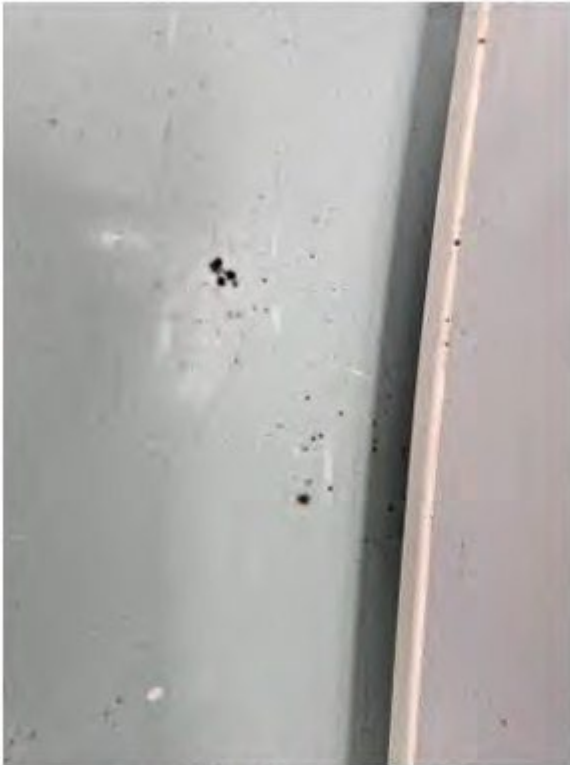
Image 21: Ceiling condensation

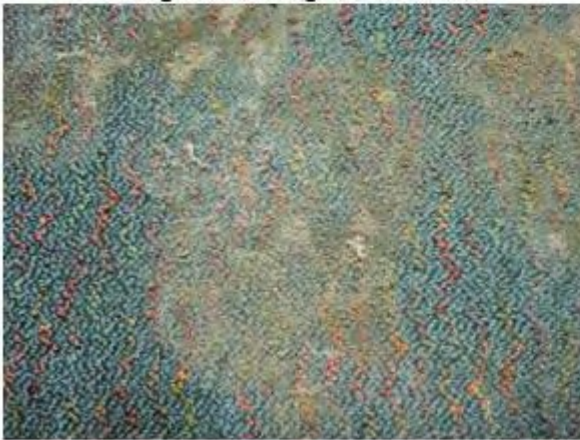
Image 23: Carpet, mould

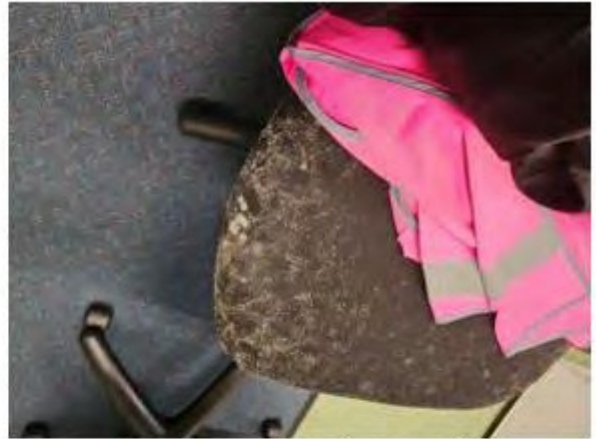
Image 26: Fabric chair, mould

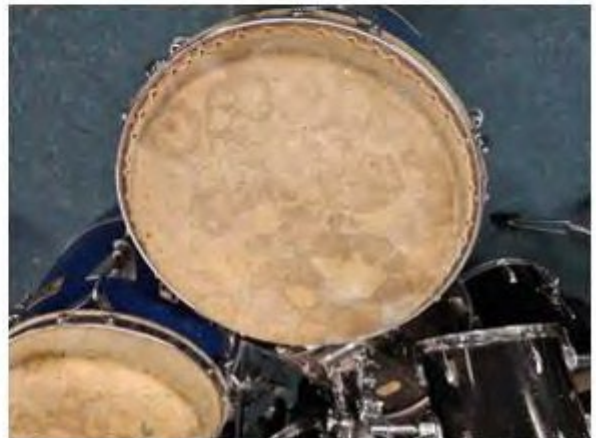
Image 28: Drum skins, mould

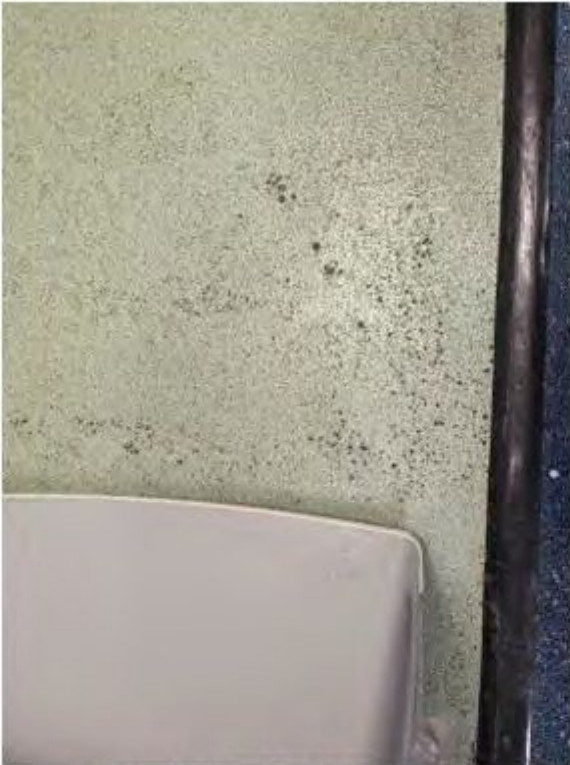
Image 29: Mould, vinyl sheet floor

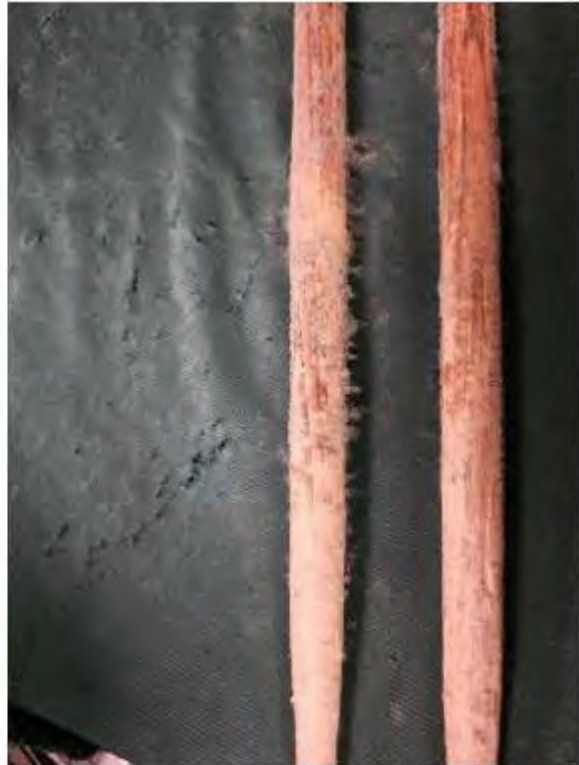
Image 30: Drum sticks

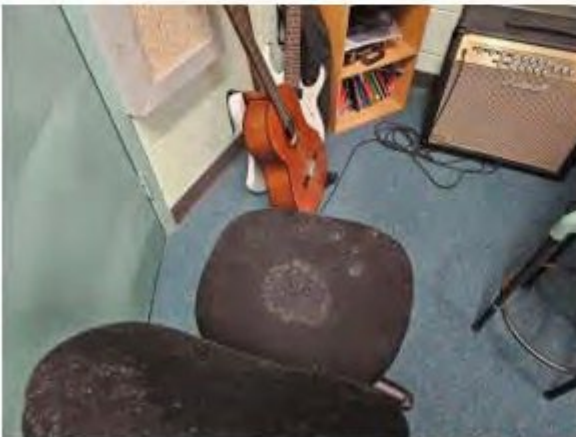
Image 31: Instruments and chair

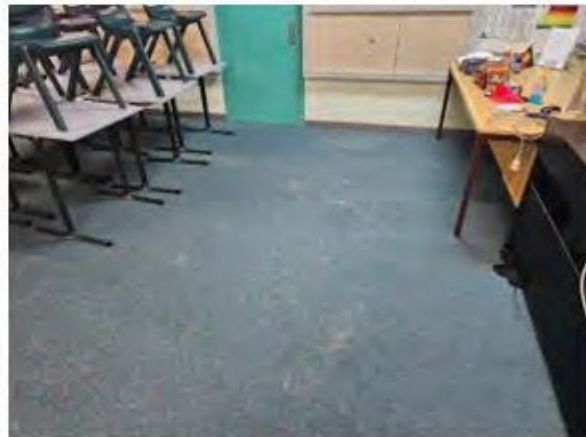
Image 32: Mould, carpet

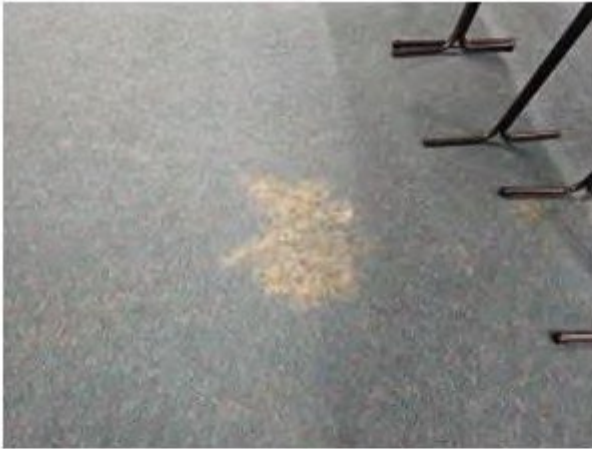
Image 33: Mould on carpet

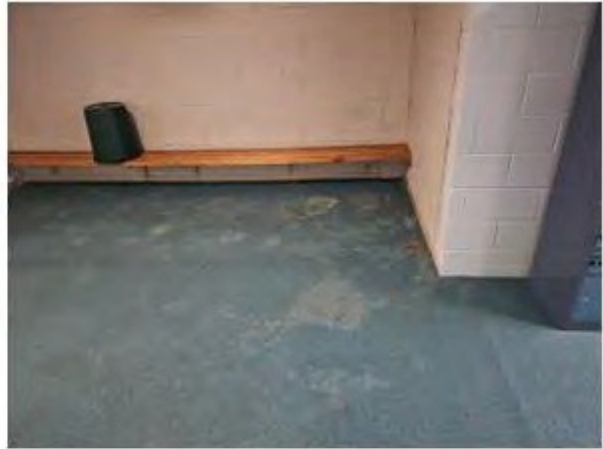
Image 34: Mould

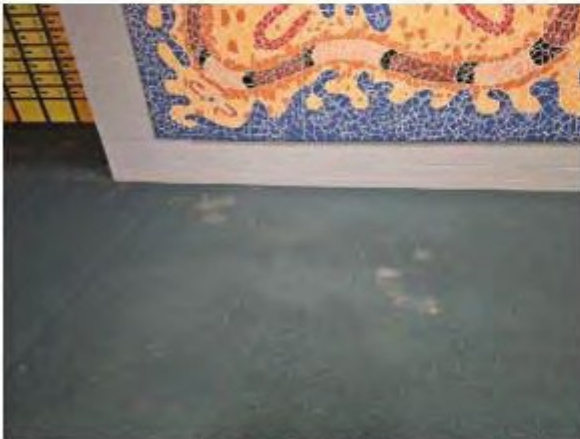
Image 35: Mould

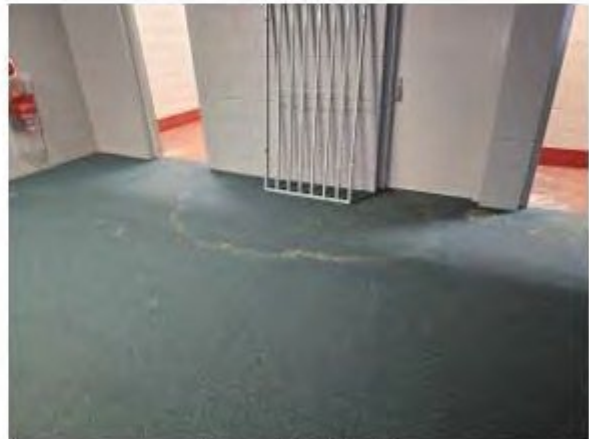
Image 36: Mould

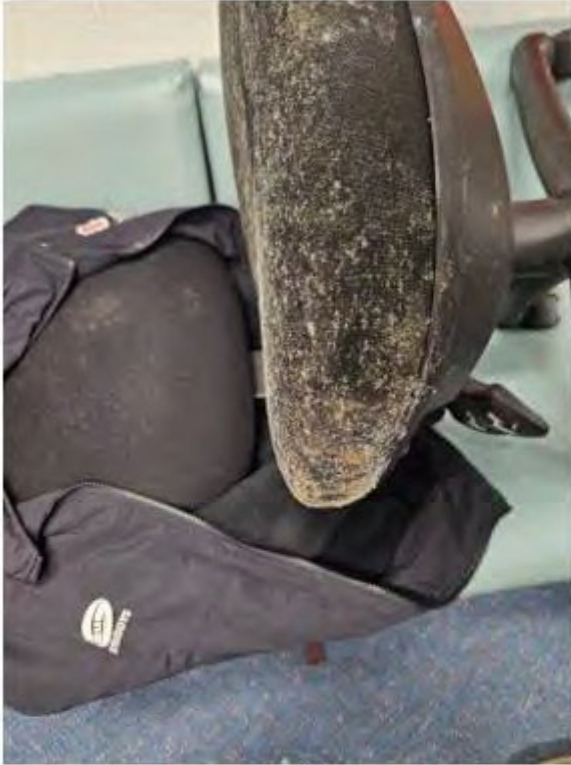
Image 37: Mould infestation

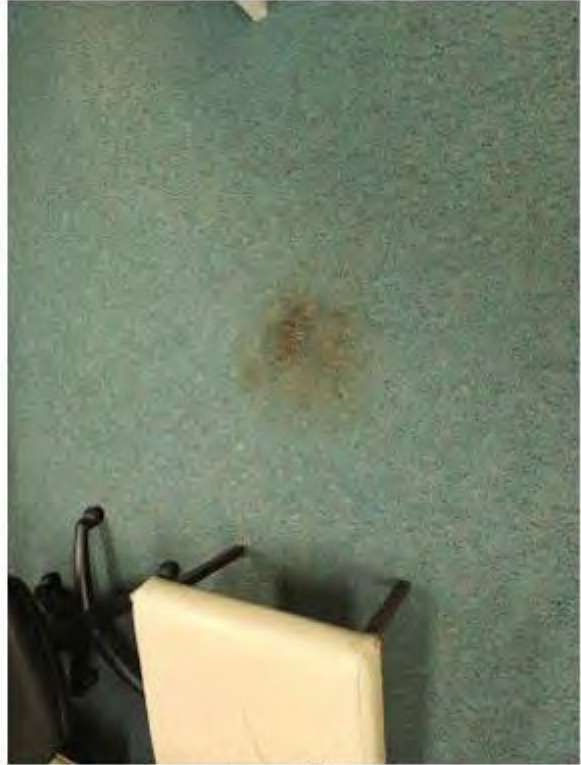
Image 38: Mould on carpet

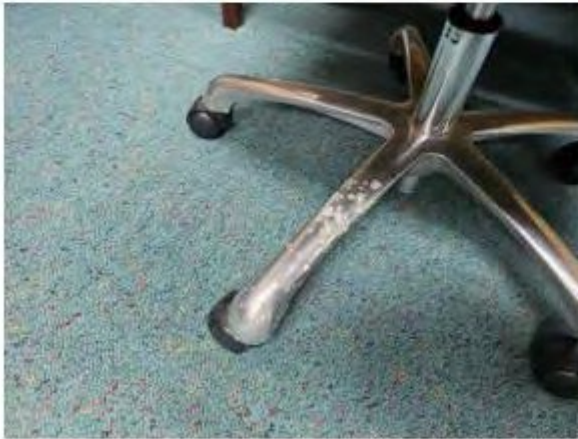
Image 39: Mould, desk chair

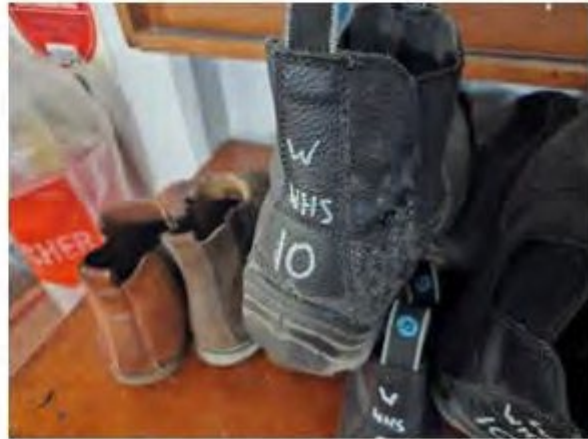
Image 40: Shoes, mould

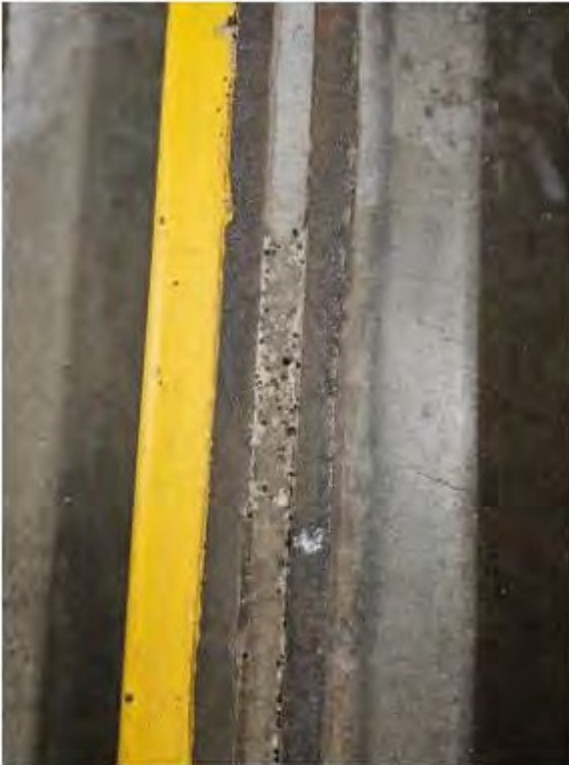
Image 41: Mould, concrete steps

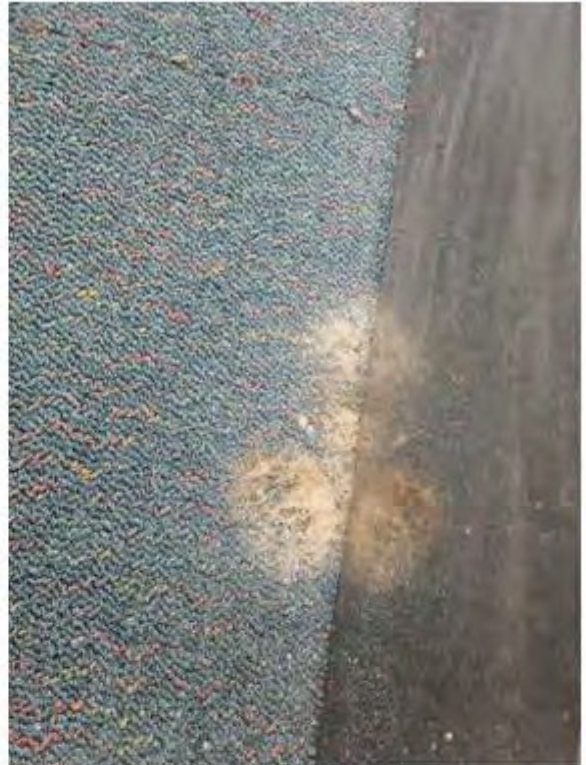
Image 42: Mould

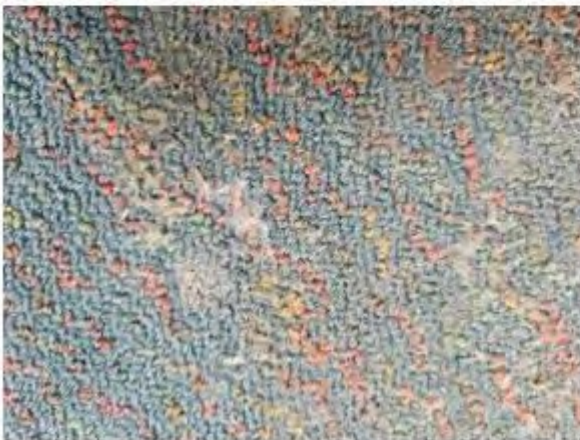
Image 43: Mould

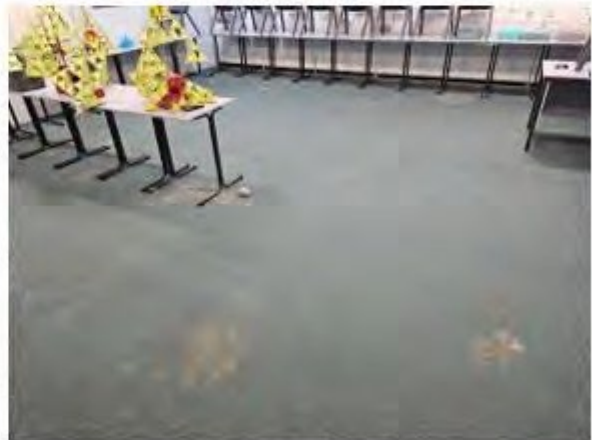
Image 44: Mould

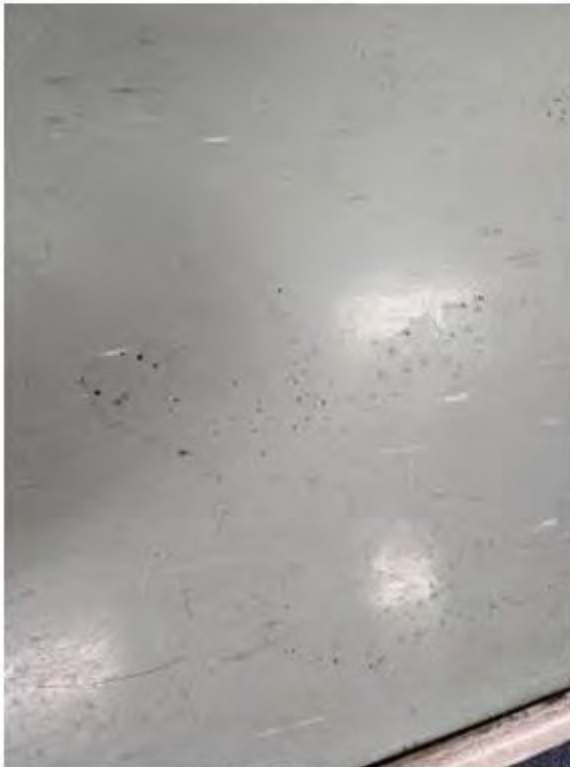
Image 47: Mould, vinyl sheet

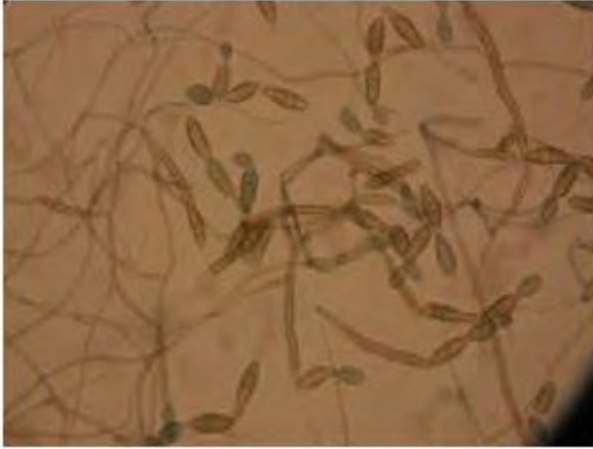
Image 49: *Alternaria* spp x400

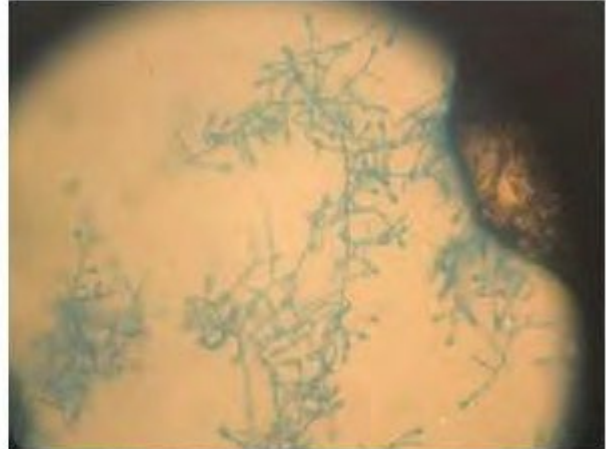
Image 50: *Cladosporium* spp x400

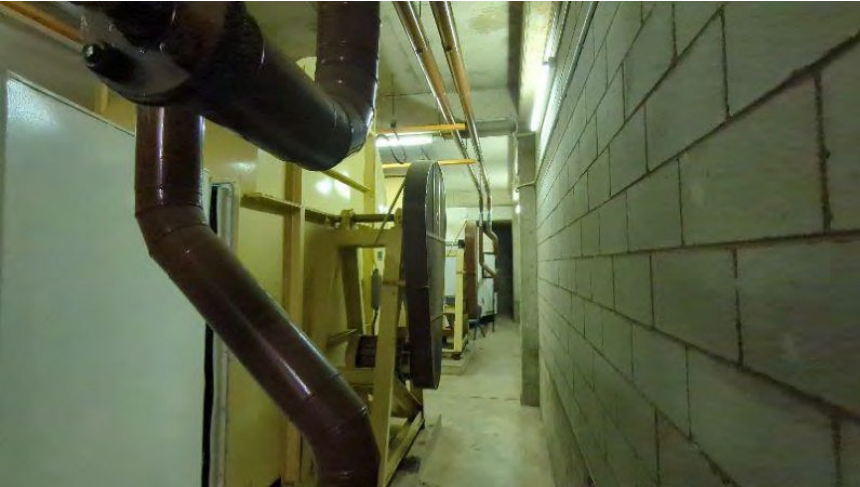
<p data-bbox="358 856 646 888">B00A-R0E03 - Plant room</p>	<p data-bbox="954 363 1242 432">Masonry walls, concrete ceiling and concrete floor.</p>	<p data-bbox="1279 363 1555 512">No signs of visual mould growth or water damage were noted. Condition 2</p>

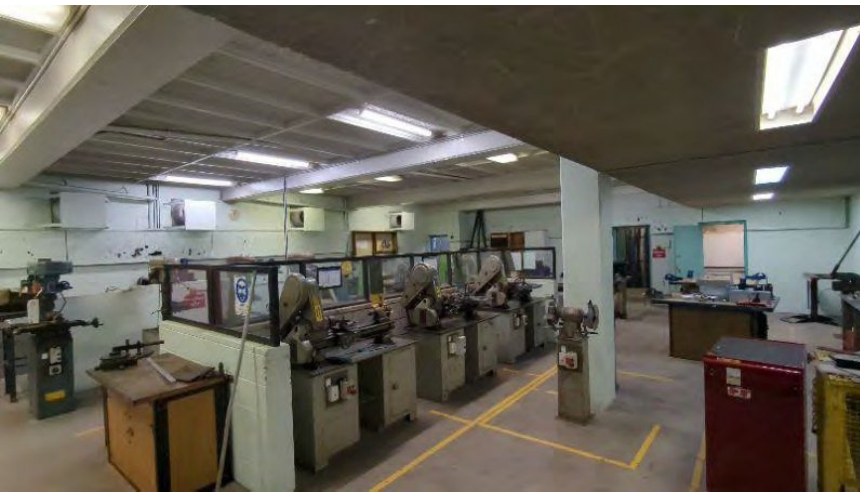
<p data-bbox="212 1409 792 1440">B00A-R0E04 - Materials Technology Learning Space</p>	<p data-bbox="954 909 1242 1094">Masonry walls, concrete floor and a mix of suspended ceiling tiles and sprayed coating (vermiculite) ceiling.</p>	<p data-bbox="1279 909 1555 1058">No signs of visual mould growth or water damage were noted. Condition 2</p>

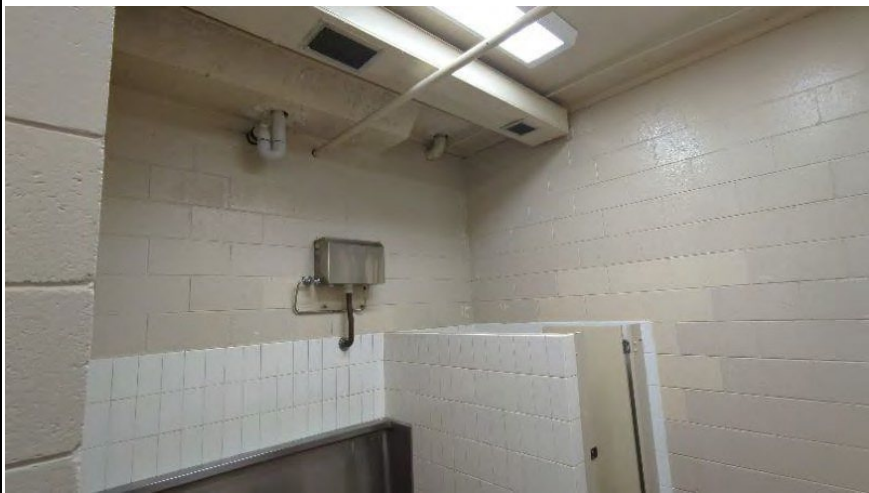
B00A-R0E20 - Boys Toilet	Masonry wall, ceramic wall tiles, ceramic floor tiles.	Suspected visual mould growth was noted to upper section of masonry wall . Evaporative water stains noted to ceramic floor tiles. Condition 3

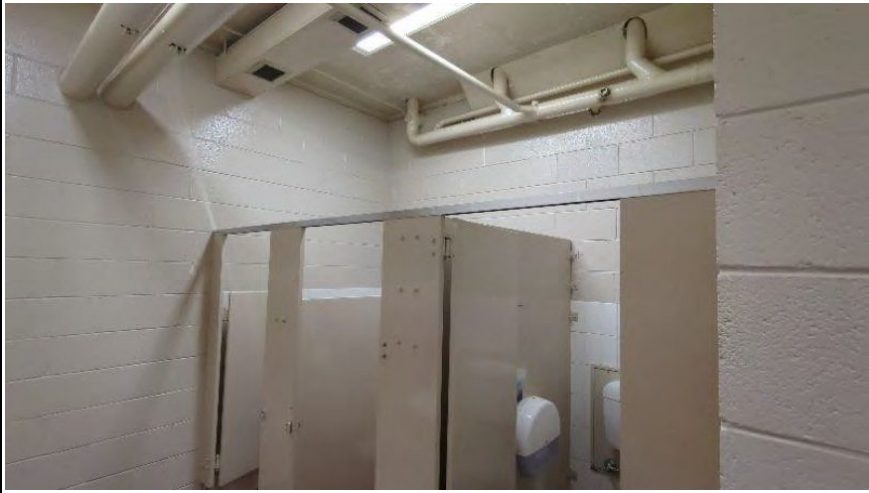
B00A-R0E21 - Girls Toilet	Masonry wall, ceramic wall tiles, ceramic floor tiles.	No signs of visual mould growth were noted. Evaporative water stains noted to ceramic floor tiles. Condition 3

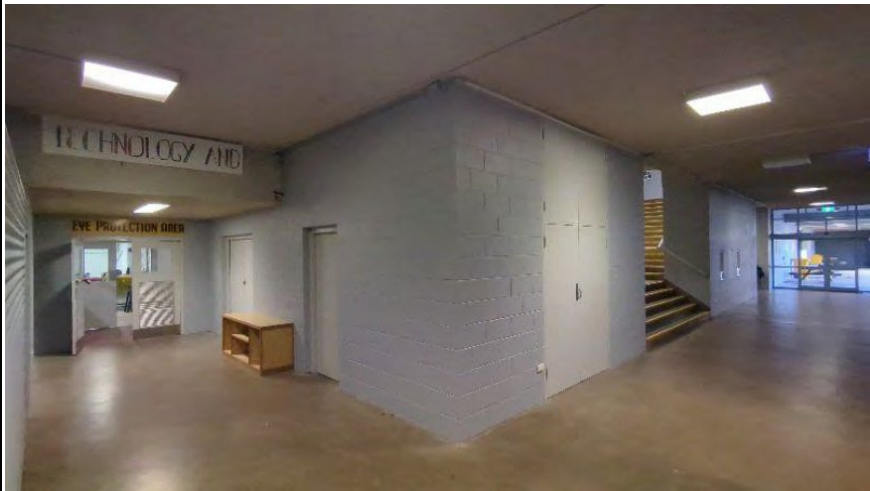
<p>B00A-R0E24 - Movement</p>	Masonry walls, concrete floor and sprayed coating (vermiculite) ceiling.	Traces of suspected visual mould were noted to concrete floor and lower section of masonry wall. Condition 3

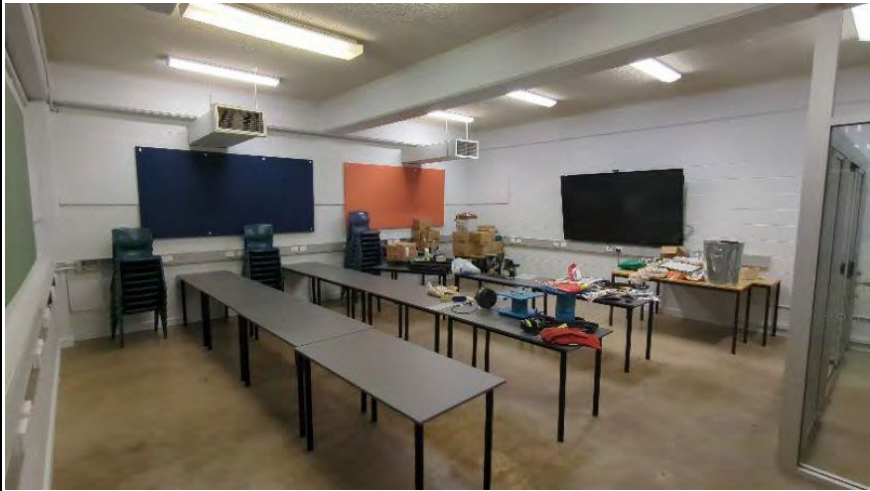
<p>B00A-R0E06 - Design LS</p>	Masonry walls, concrete floor and sprayed coating (vermiculite) ceiling.	No signs of visual mould growth or water damage were noted. Condition 3

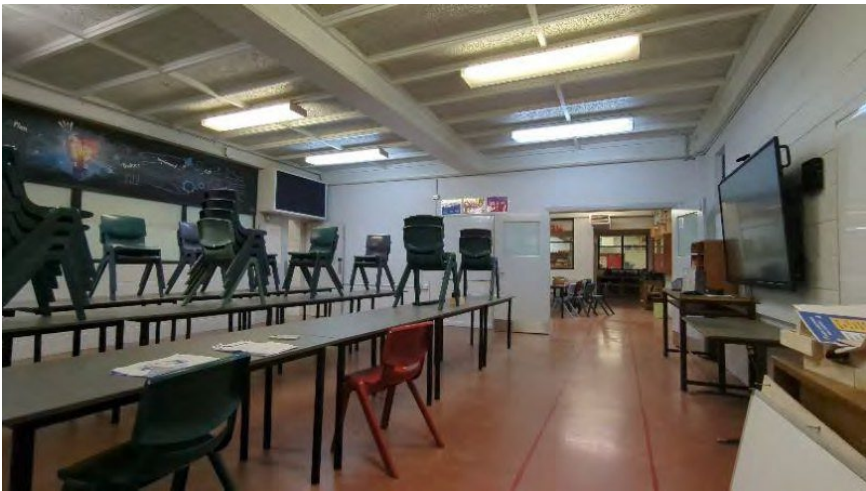
<p>B00A-R0E26 - General LS</p>	Masonry walls, vinyl floor sheeting, composite ceiling panels.	<p>Suspected visual mould growth was noted to leather boots on shoe rack. Traces of suspected visual mould growth noted inside bench cupboard.</p> <p>Refer to index photo 18 Condition 3</p>

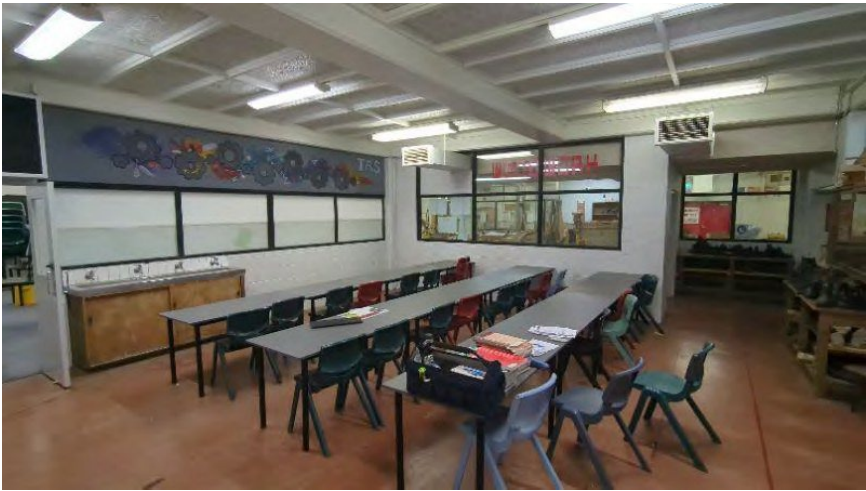
<p>B00A-R0E25 - General LS</p>	Masonry walls, vinyl floor sheeting, composite ceiling panels.	<p>Suspected visual mould growth was noted to leather boots on shoe rack. Traces of suspected visual mould growth noted to inside sink top cupboard.</p> <p>Condition 3</p>

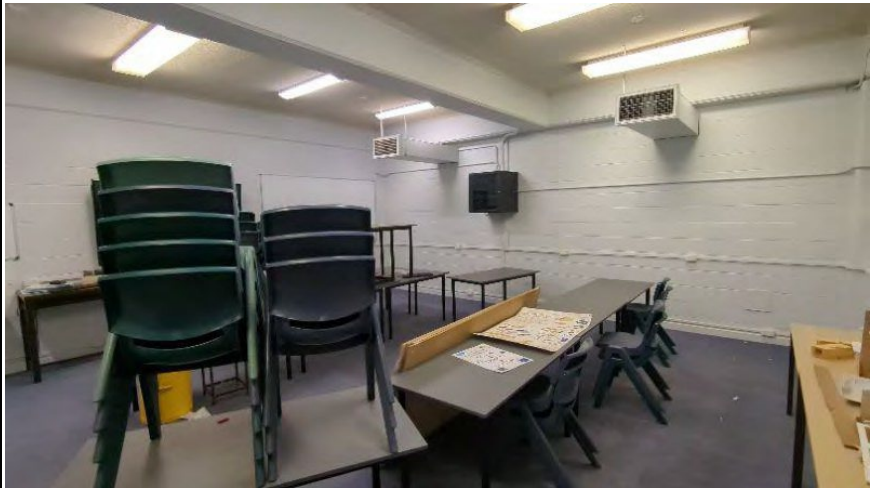
<p>B00A-R0E07 - Design LS</p>	Masonry walls, carpet over concrete and sprayed coating (vermiculite) ceiling	<p>Suspected visual mould growth was noted to carpet and hardwood cupboard.</p> <p>Refer to Index photo 19 Condition 3</p>

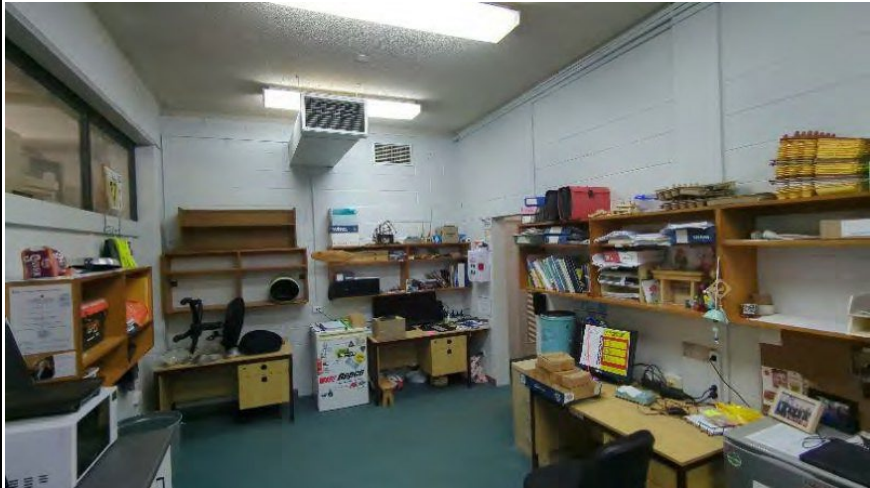
<p>B00A-R0E14 - Staff Study</p>	Masonry walls, carpet over concrete and sprayed coating (vermiculite) ceiling	<p>Suspected visual mould growth was noted to carpet, porous furniture and porous contents.</p> <p>Refer to Index photos 20 - 25 Condition 3</p>

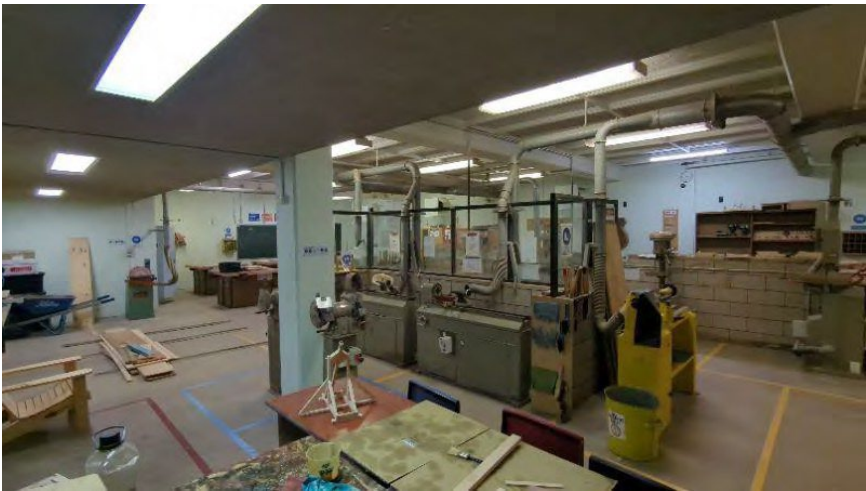
<p>B00A-R0E09 - Materials LS</p>	Masonry walls, concrete floor and sprayed coating (vermiculite) ceiling	Suspected visual mould growth was noted to chipboard cabinetry Refer to Index photo 28 Condition 3
