# Scope of Works for Hazmat Remediation and Demolition

Willyama High School, Broken Hill, NSW, 2880

**Report No.:** 31174 - R02

**Site visit and assessment** - 4<sup>th</sup> June 2024

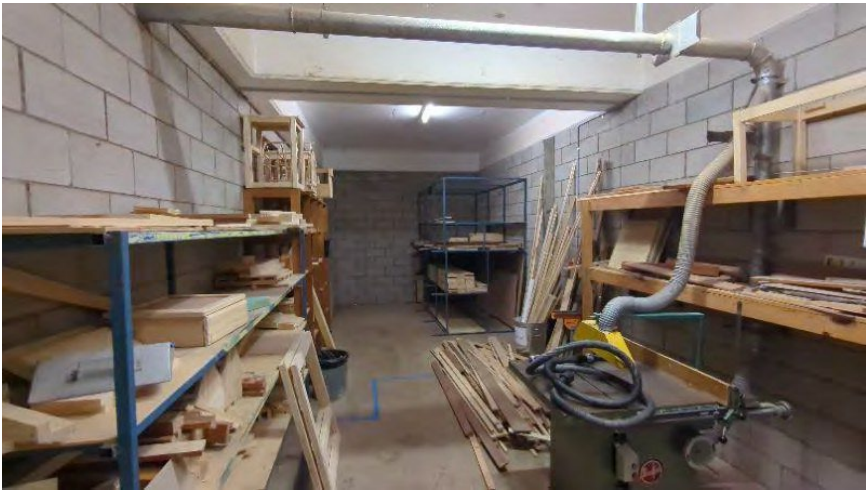
<p>B00A-R0E12 - Store room</p>	Masonry walls, concrete floor and sprayed coating (vermiculite) ceiling	No signs of visual mould growth were noted. Water ingress (leaching) was noted to the upper section of masonry wall. Refer to index photo 26 - 27 Condition 3

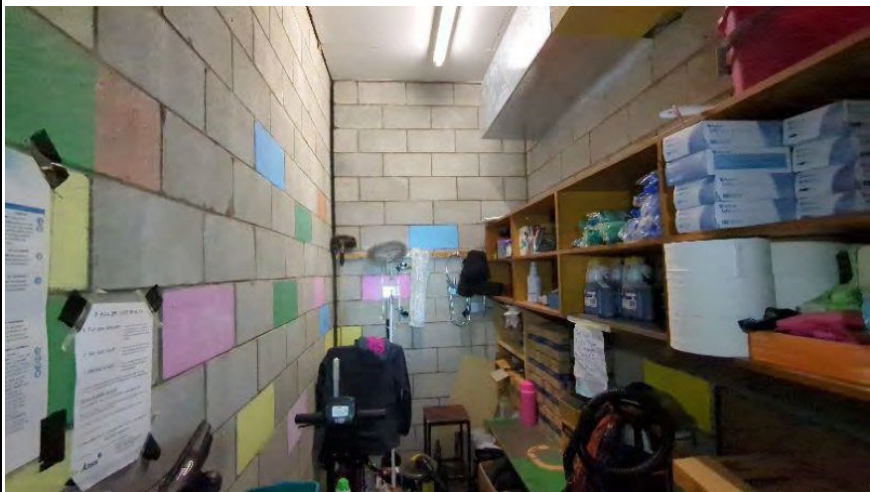
<p>B00A-ROE18 - Store room</p>	Masonry walls, carpet over concrete and sprayed coating (vermiculite) ceiling.	Suspected visual mould were noted to chipboard shelves, chipboard benchtop and porous contents.  Refer to index photo 29 - 31  Condition 3

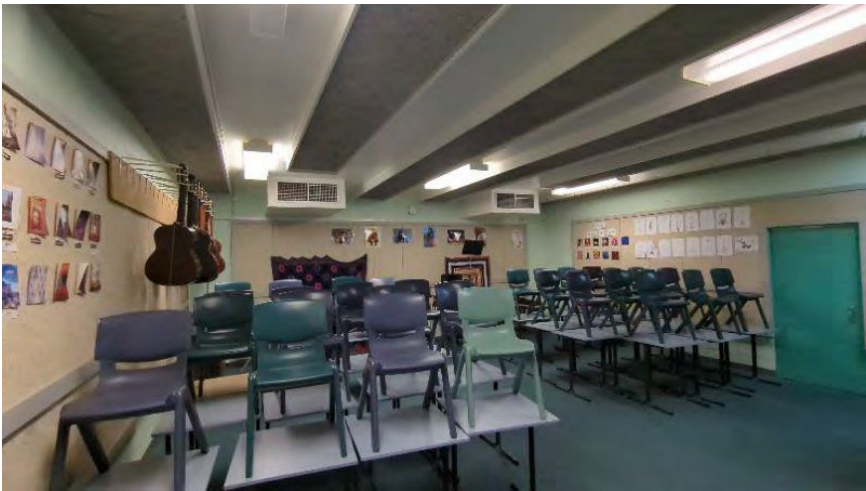
<p>B00A-R0N12 - Music LS</p>	Masonry walls, plasterboard walls, carpet over concrete and acoustic ceiling tiles.	Suspected visual mould growth was noted to carpet, plasterboard wall, all furniture and all contents. Refer to index photo 32 - 40 Condition 3

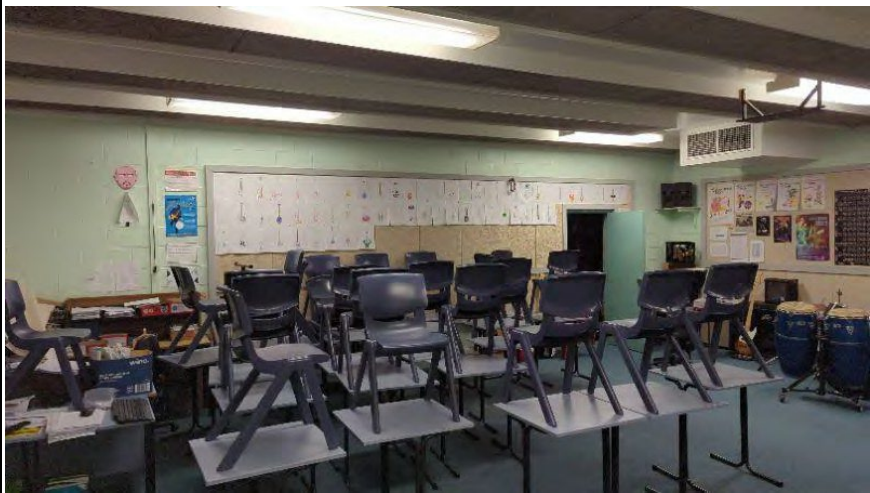
</div> <div>B00A-R0N11 - Music Practice Room</div>	Masonry walls, plasterboard walls, carpet over concrete and acoustic ceiling tiles.	<p>Suspected visual mould growth was noted to carpet, plasterboard wall, all furniture and all contents.</p> <p>Refer to index photos 41 - 48</p> <p>Condition 3</p>

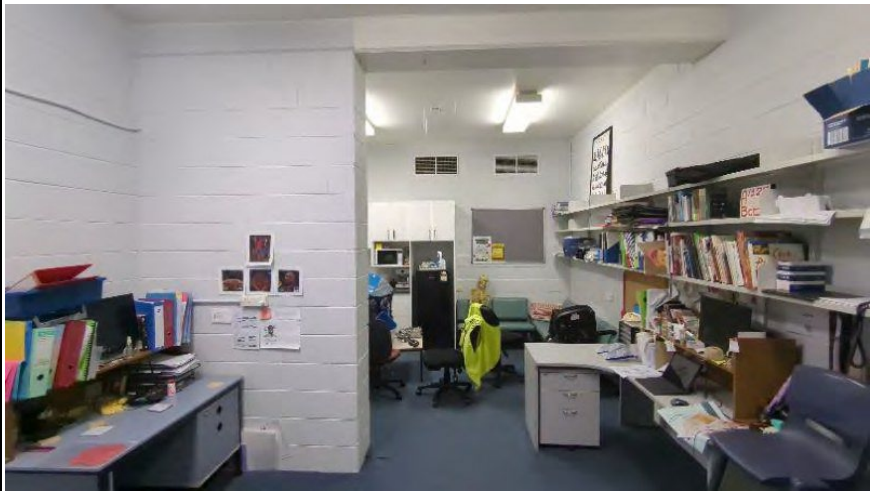
</div> <div>B00A-R0N08 - Staff Study</div>	Masonry walls, carpet over concrete and sprayed coating (vermiculite) ceiling.	Suspected visual mould growth was noted to carpet, all furniture and all contents.  Refer to Index photos 49 - 62  Condition 3

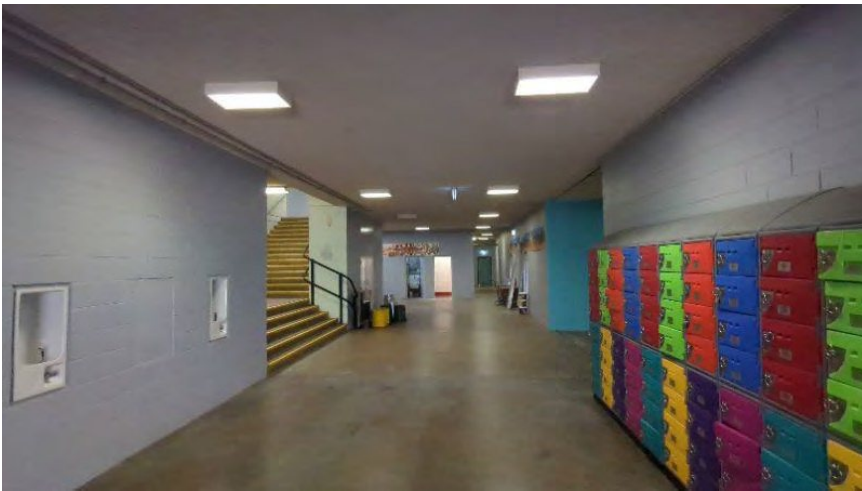
<p data-bbox="354 993 651 1020">B00A-R0W32 - Movement</p>	<p data-bbox="948 499 1252 600">Masonry walls, carpet over concrete and sprayed coating (vericulite) ceiling.</p>	<p data-bbox="1268 499 1559 758">Traces of suspected visual mould growth were noted to the concrete floor, lower sections of masonry walls, hardwood furniture and artworks.</p> <p data-bbox="1349 730 1477 758">Condition 3</p>

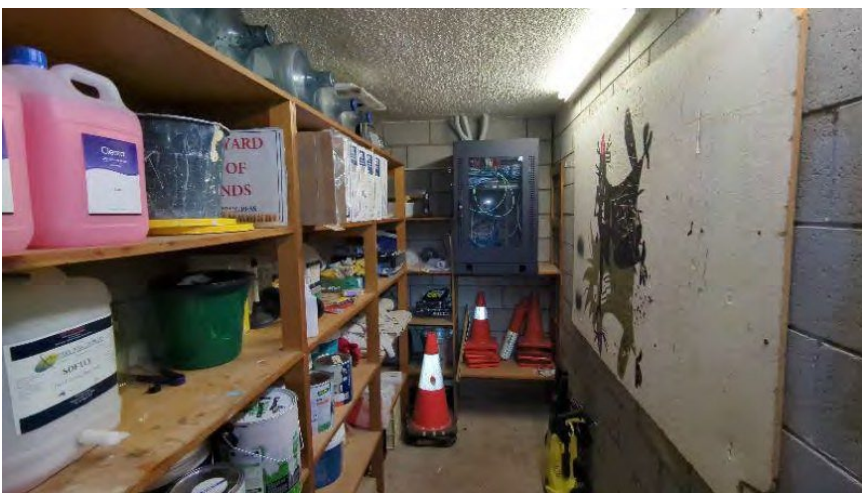
<p data-bbox="337 1541 667 1568">B00A-R0N21 - Cleaning Store</p>	<p data-bbox="954 1050 1242 1150">Masonry walls, concrete floor and sprayed coating (vermiculite) ceiling</p>	<p data-bbox="1268 1050 1559 1314">Traces of suspected visual mould growth were noted to chipboard shelving unit</p> <p data-bbox="1268 1203 1559 1268">Refer to Index photos 63 - 66</p> <p data-bbox="1349 1287 1477 1314">Condition 3</p>

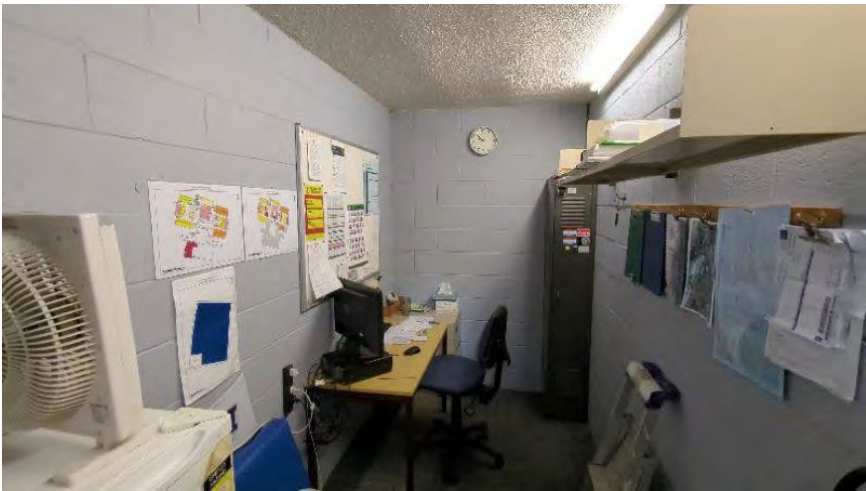
<p>B00A-R0N22 - GA office</p>	Masonry walls, carpet over concrete and sprayed coating (vermiculite) ceiling.	<p>No signs of visual mould growth or water damage were noted.</p> <p>Refer to index photos 67 - 68</p> <p>Condition 3</p>

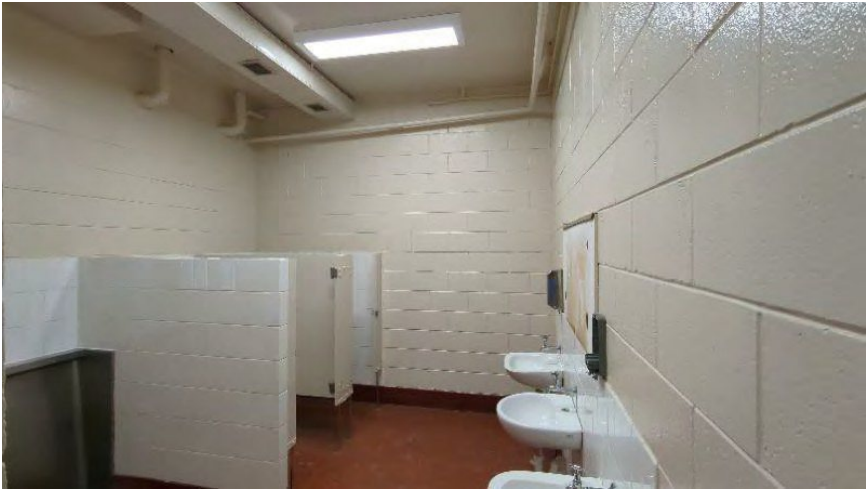
<p>B00A-R0W05 - Boys Toilet</p>	Concrete ceiling, ceramic, masonry walls, ceramic wall tiles and ceramic floor tiles.	<p>Suspected visual mould growth was noted to ceramic floor tiles, masonry walls, ceramic wall tiles and concrete ceiling.</p> <p>Refer to index photos 70 - 77</p> <p>Condition 3</p>

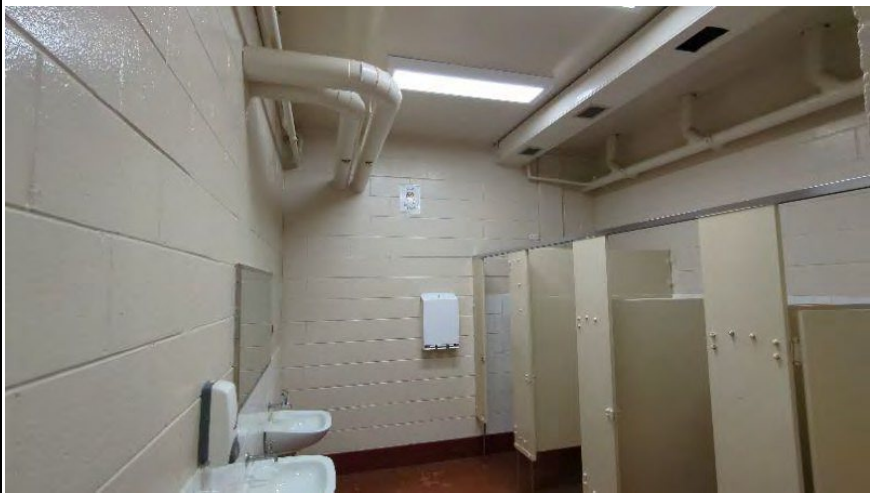
<p>B00A-R0W06 - Girls toilet</p>	Concrete ceiling, ceramic, masonry walls, ceramic wall tiles and ceramic floor tiles.	<p>Suspected visual mould growth was noted to ceramic floor tiles, masonry walls, ceramic wall tiles and concrete ceiling.</p> <p>Refer to index photos 78 - 81</p> <p>Condition 3</p>

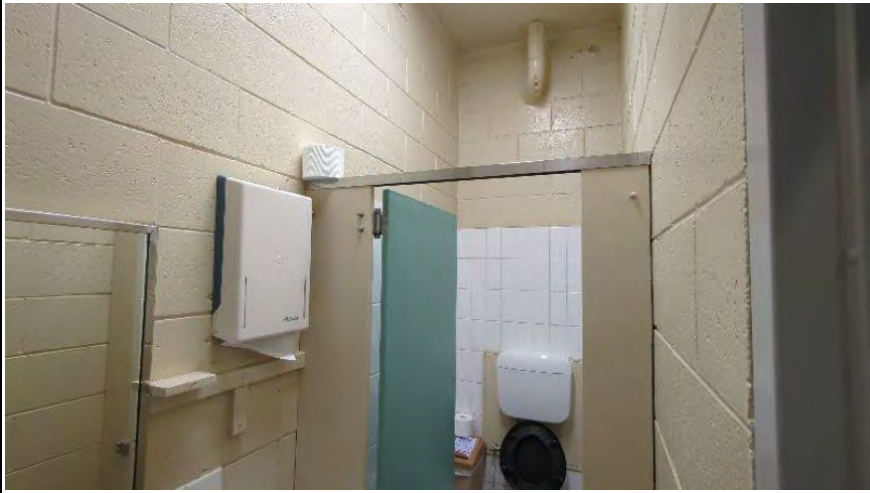
<p>B00A-R0W04 - Staff Toilet</p>	Concrete ceiling, masonry walls and ceramic floor tiles.	<p>No signs of visual mould growth were noted. Evaporative water stains were noted to ceramic floor tiles.</p> <p>Refer to index photos 82 - 83</p> <p>Condition 3</p>

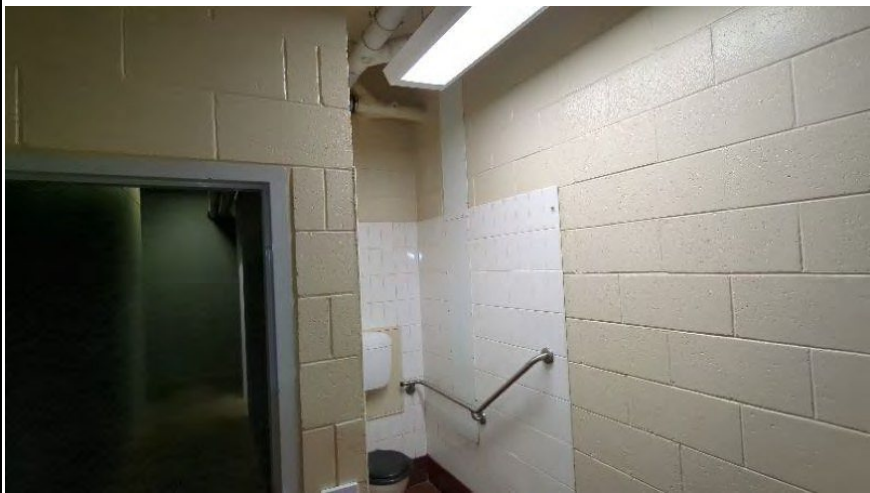
<p>B00A-R0W03 - Staff Toilet</p>	Concrete ceiling, ceramic, masonry walls, ceramic wall tiles and ceramic floor tiles.	No signs of visual mould growth were noted. Evaporative water stains were noted to ceramic floor tiles. Condition 3

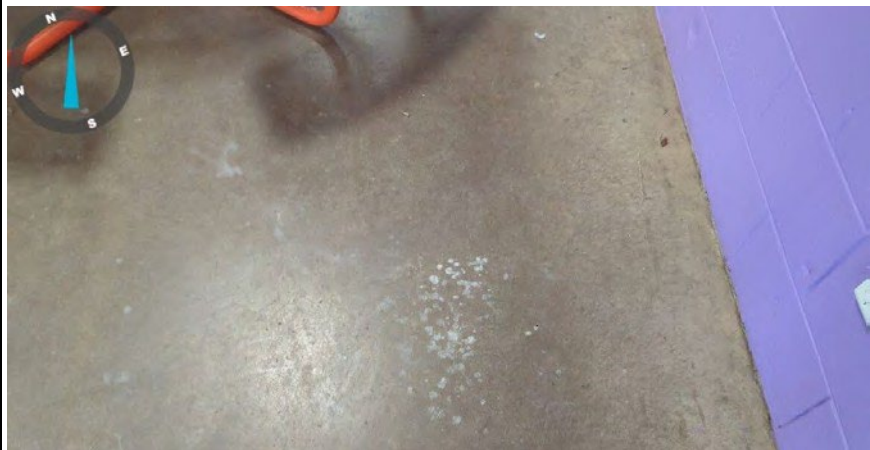
<p>B00A-R0W02 - Movement</p>	Concrete floor, masonry walls and sprayed coating (vermiculite) ceiling.	Traces of suspected visual mould growth were noted to concrete floor, lower sections of masonry walls and art works. Refer to index photos 85 - 86 Condition 3

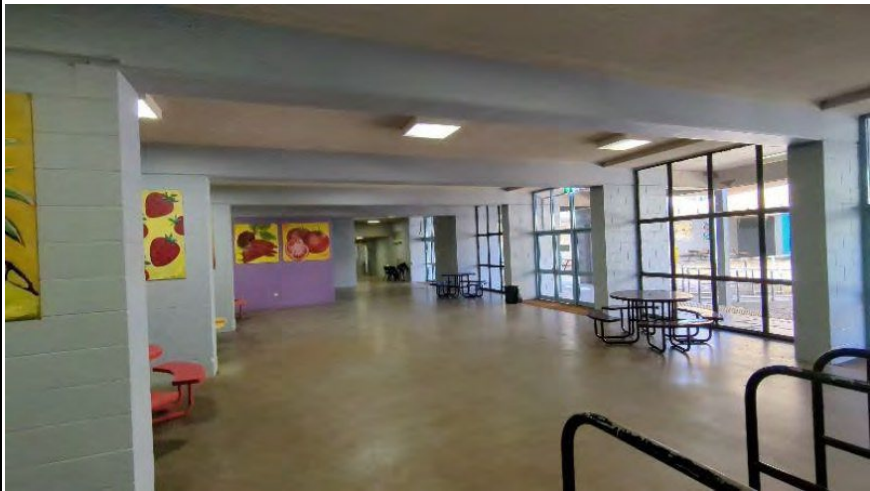
<p>B00A-R0N19 - Movement</p>	Concrete floor, masonry walls and sprayed coating (vermiculite) ceiling.	Traces of suspected visual mould noted to floor, lower sections of masonry wall and art works.  Condition 3

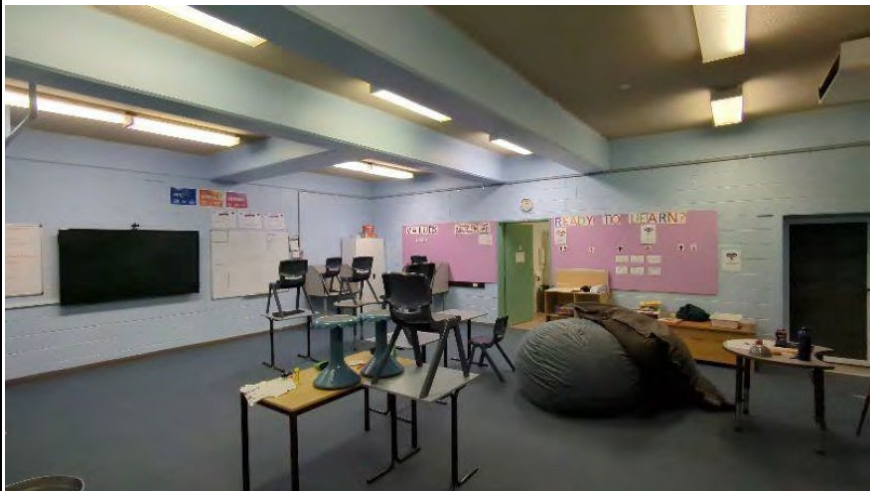
<p>B00A-R0W26 - Special Learning Space</p>	Masonry walls, carpet over concrete and sprayed coating (vermiculite) ceiling.	No signs of visual mould growth or water damage were noted. Refer to index photos 88 - 92  Condition 3

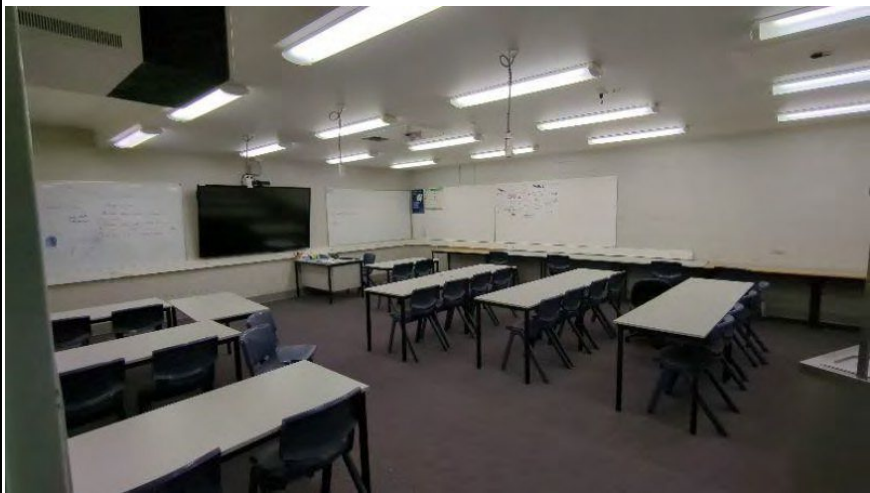
<p>B00A-R0W23 - Materials Technology L.S</p>	Masonry walls, concrete ceiling and carpet over concrete.	<p>Suspected visual mould growth was noted to carpet, porous furniture and within benchtop cupboard.</p> <p>Refer to index photos 92 - 97</p> <p>Condition 3</p>

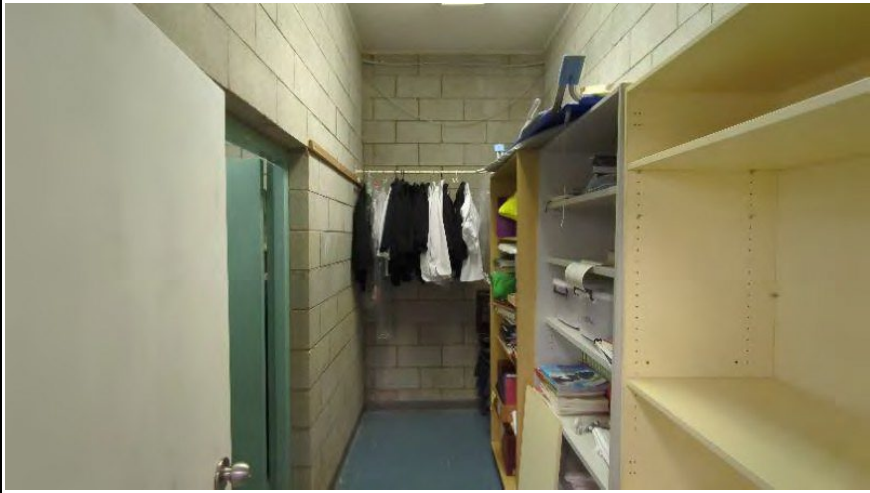
<p>B00A-R0W22 - Storeroom</p>	Masonry walls, concrete ceiling and carpet over concrete.	<p>No signs of visual mould or water damage were noted.</p> <p>Condition 3</p>

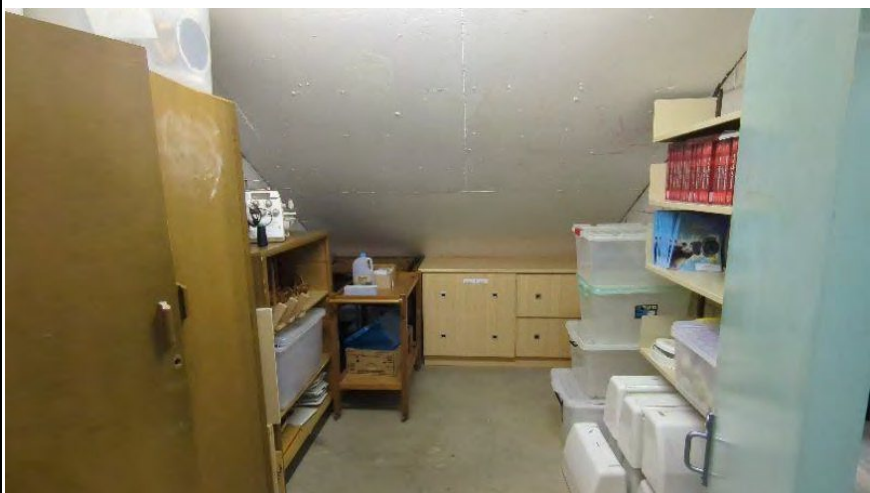
<p data-bbox="349 993 656 1020">B00A-R0W21 - Store Room</p>	<p data-bbox="954 499 1242 562">Masonry walls, concrete ceiling and concrete floor.</p>	<p data-bbox="1279 499 1549 598">No signs of visual mould or water damage were noted.</p> <p data-bbox="1271 619 1557 682">Refer to index photos 98-101</p> <p data-bbox="1349 701 1479 728">Condition 3</p>

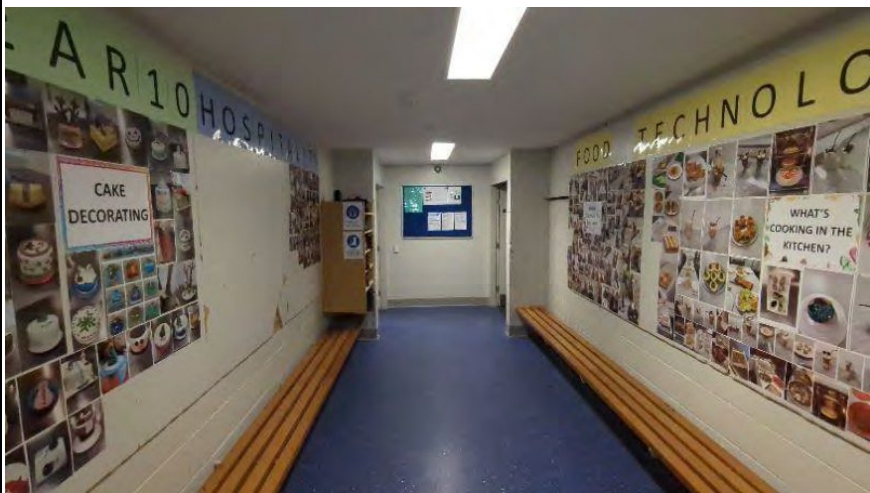
<p data-bbox="354 1543 651 1570">B00A-R0W40 - Movement</p>	<p data-bbox="943 1050 1253 1148">Masonry walls, vinyl floor sheeting and sprayed coating (vermiculite) ceiling.</p>	<p data-bbox="1279 1050 1549 1148">Suspected visual mould was noted to leather boots within shoe rack.</p> <p data-bbox="1292 1169 1536 1232">Refer to index photos 102-104</p> <p data-bbox="1349 1251 1479 1278">Condition 3</p>

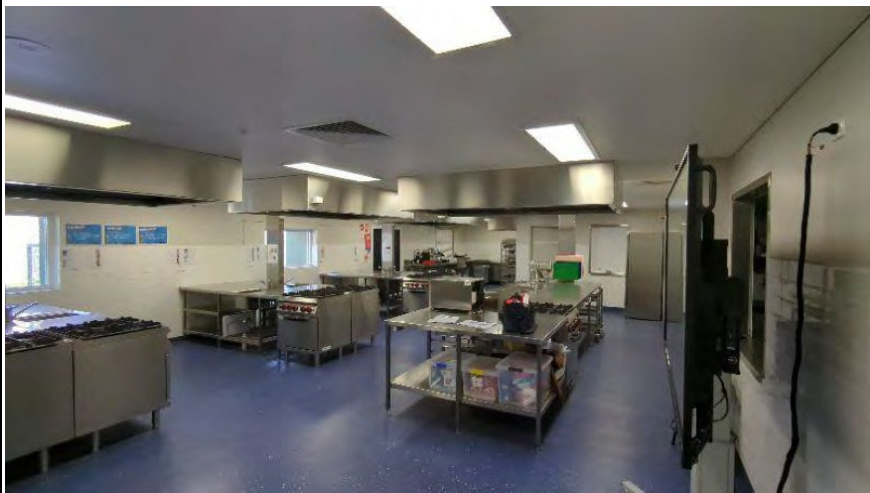
<p>B00A-R0W34 - Food Tech LS</p>	Masonry walls, plasterboard walls and plasterboard ceiling.	<p>Traces of suspected visual mould growth noted to vinyl floor sheeting.</p> <p>Refer to index photos 105 - 113</p> <p>Condition 3</p>

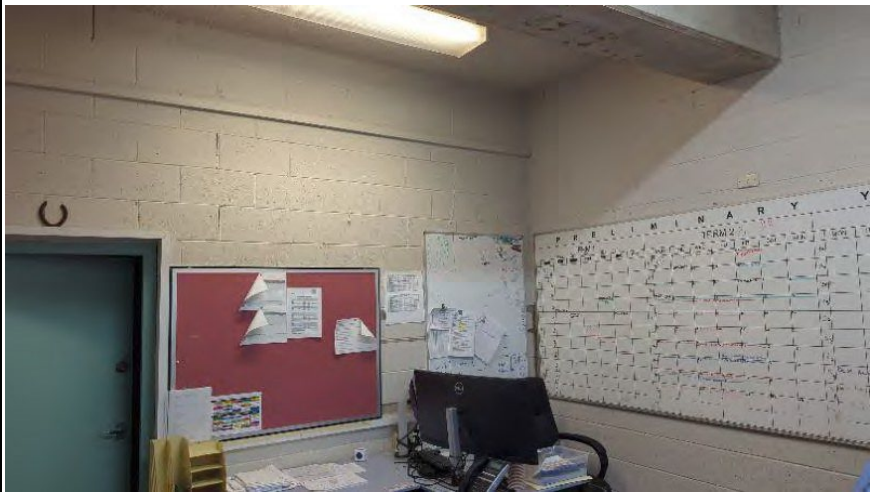
<p>B00A-R0W29 - Staff Study</p>	Masonry walls, carpet over concrete and concrete ceiling.	<p>Suspected visual mould growth was noted to carpet.</p> <p>Refer to index photos 115 - 120</p> <p>Condition 3</p>

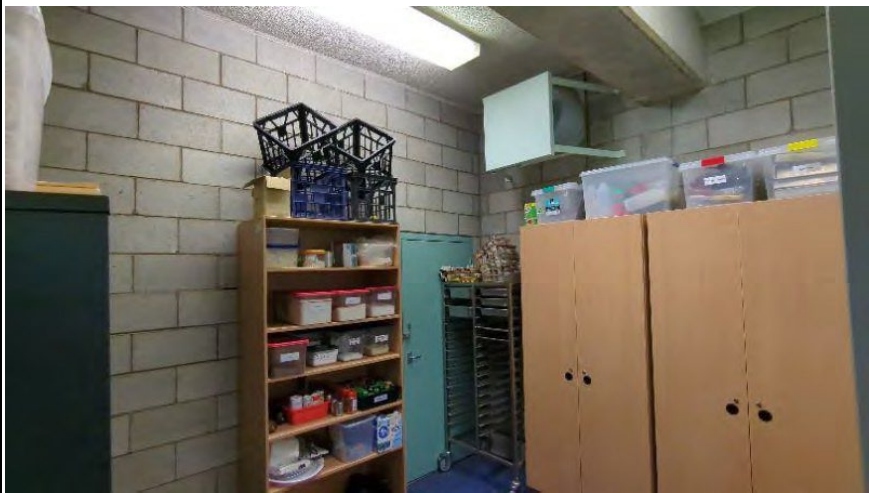
B00A-R0W27 - Storeroom	Masonry walls, concrete floor and sprayed coating (vermiculite) ceiling	No signs of visual mould or water damage were noted. Refer to index photos 121 - 127 Condition 3

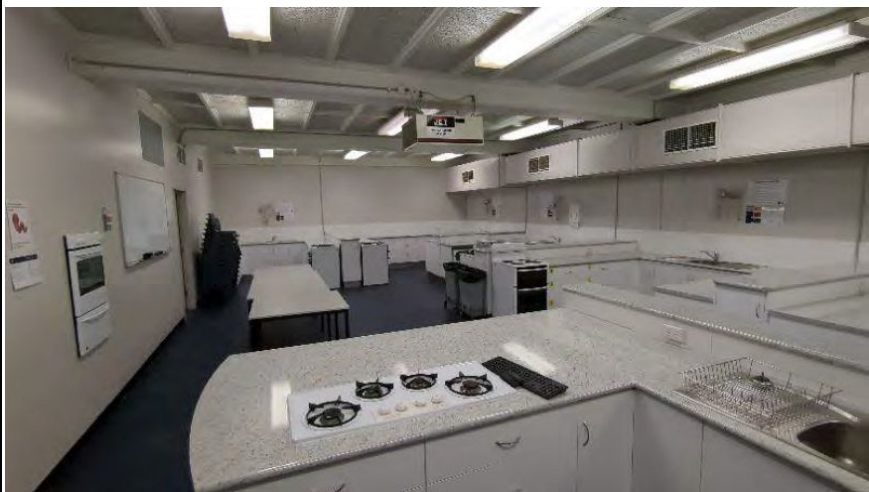
<p>B00A-R0W39 - Food Tech</p>	<p>Plasterboard walls, carpet over concrete and acoustic ceiling tiles.</p>	<p>Traces of suspected visual mould growth was noted to carpet floor. Refer to index photos 138 - 143 Condition 3</p>

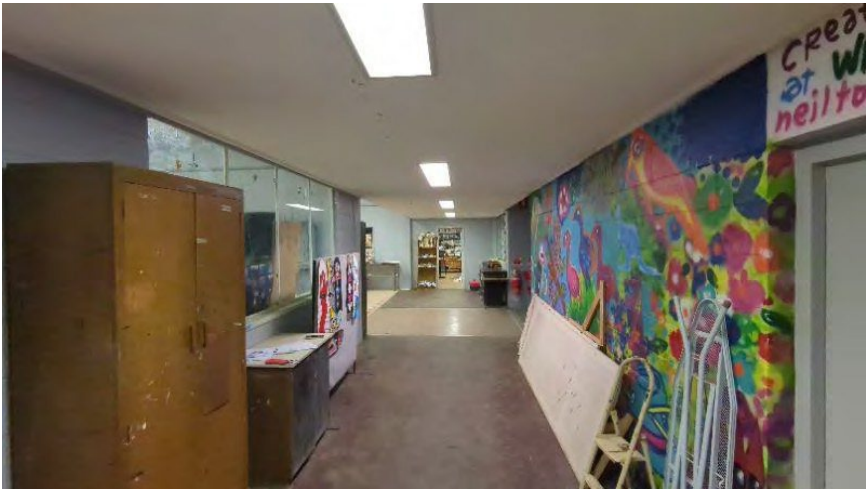
<p>B00A-ROW17 - Movement</p>	Masonry walls, concrete floor and plasterboard ceiling.	<p>Suspected visual mould growth was noted to masonry walls, concrete floor, plasterboard ceiling and all contents.</p> <p>Refer to index photos 147 - 156</p> <p>Condition 3</p>

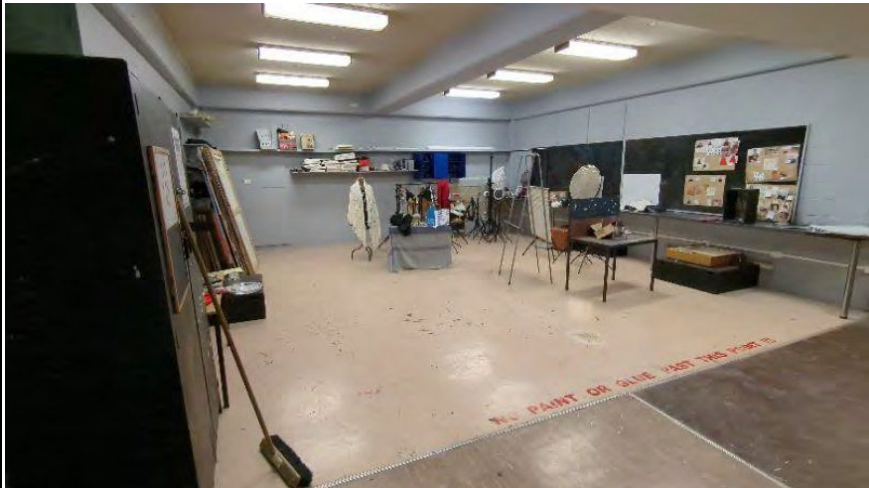
<p>B00A-R0W16 - Workshop</p>	Masonry walls, vinyl floor sheeting and sprayed coating (vermiculite) ceiling.	<p>Suspected visual mould growth noted to vinyl floor sheeting, masonry walls and all contents.</p> <p>Refer to B00A- R0W17 + index photo 173</p> <p>Condition 3</p>

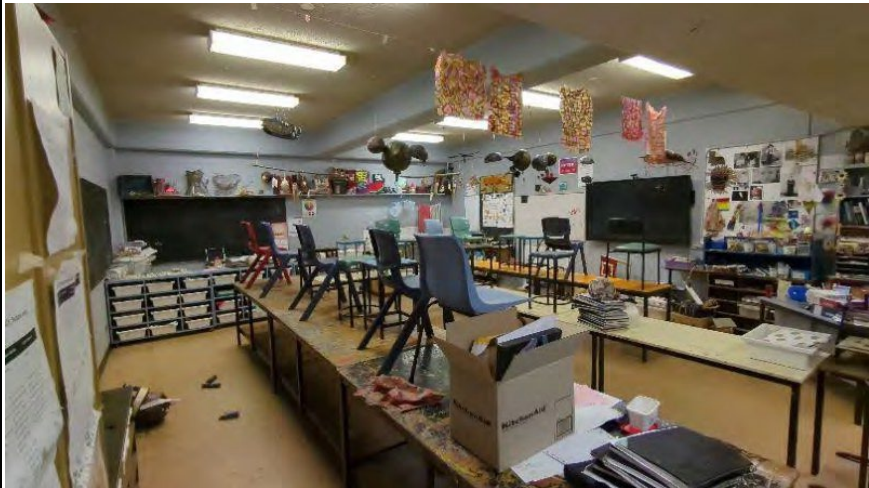
<p>B00A-R0W14 - Art L.S</p>	Masonry walls, vinyl floor sheeting and sprayed coating (vermiculite) ceiling.	<p>Suspected visual mould growth noted to vinyl floor sheeting, masonry walls and all contents.</p> <p>Refer to index photos 171 - 175</p> <p>Condition 3</p>

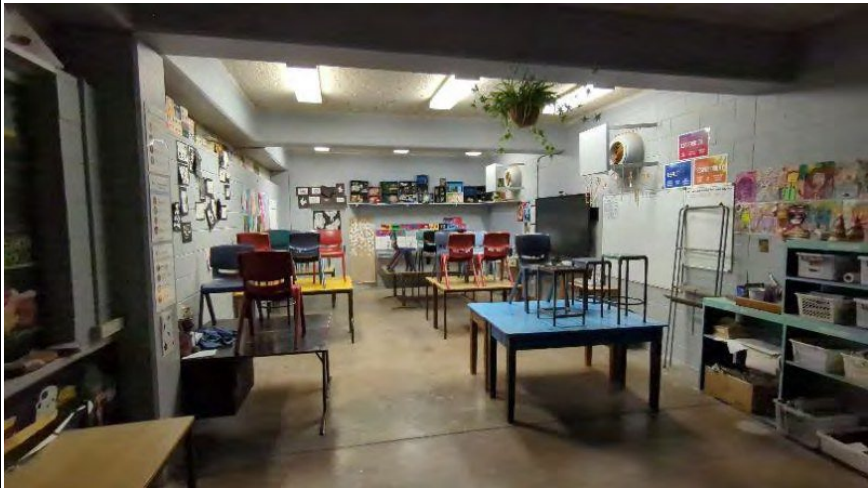
<p>B00A-R0W12 - Art L.S</p>	Masonry walls, vinyl floor sheeting and sprayed coating (vermiculite) ceiling.	<p>Traces of suspected visual mould growth was noted to porous contents.</p> <p>Refer to index photos 176 - 180</p> <p>Condition 3</p>

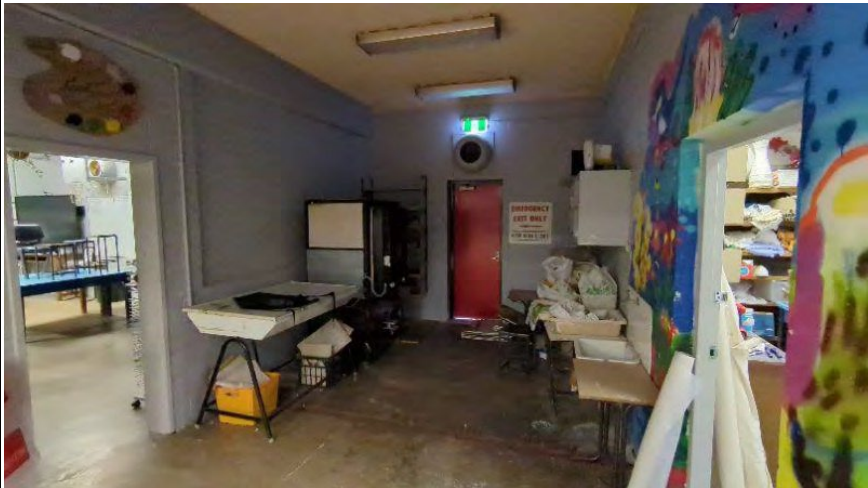
<p>B00A-R0W11 - Kiln</p>	Masonry walls, concrete floor and sprayed coating (vermiculite) ceiling.	<p>Suspected visual mould growth noted to hardwood shelving unit.</p> <p>Refer to index photos 181 - 186</p> <p>Condition 3</p>

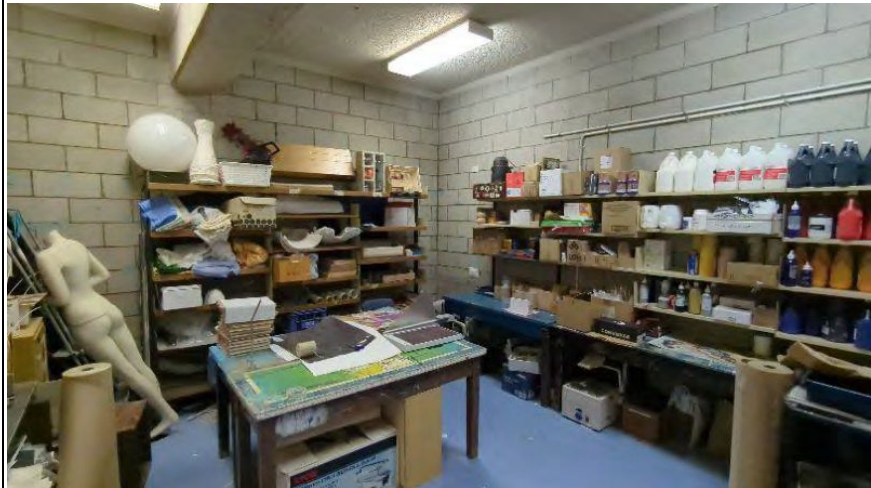
<p>B00A-ROW09 - Printing</p>	Masonry walls, vinyl floor sheeting and sprayed coating (vermiculite) ceiling	Suspected visual mould growth was noted to porous contents. Refer to index photos 187 Condition 3

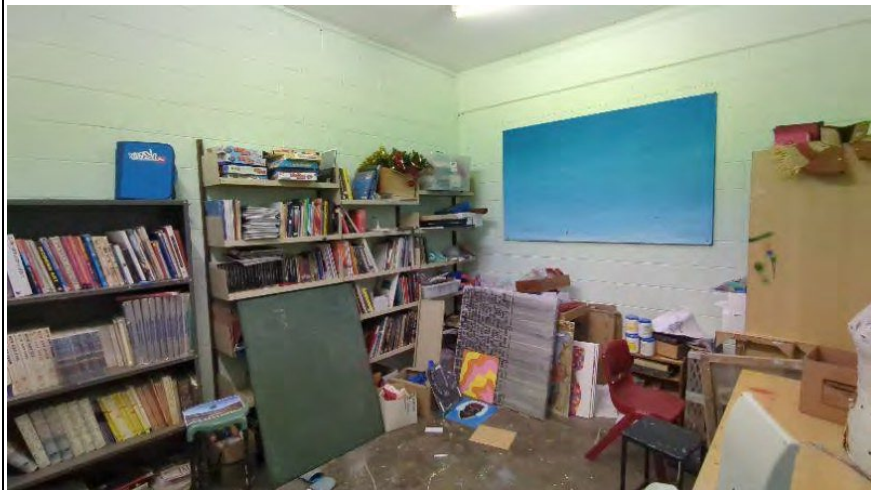
<p>B00A-ROW13 - Storeroom</p>	Masonry walls, concrete floor and plasterboard ceiling.	No signs of visual mould growth or water damage were noted. Condition 3

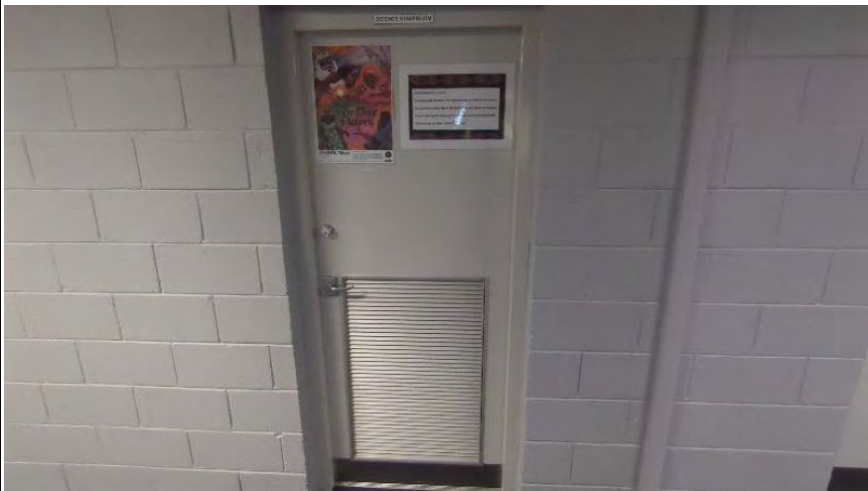
<p>B00A-R1E15 Staff study</p>		No access Assumed mould
<p>B00A-R1E18 Staff study</p>		No access Assumed mould

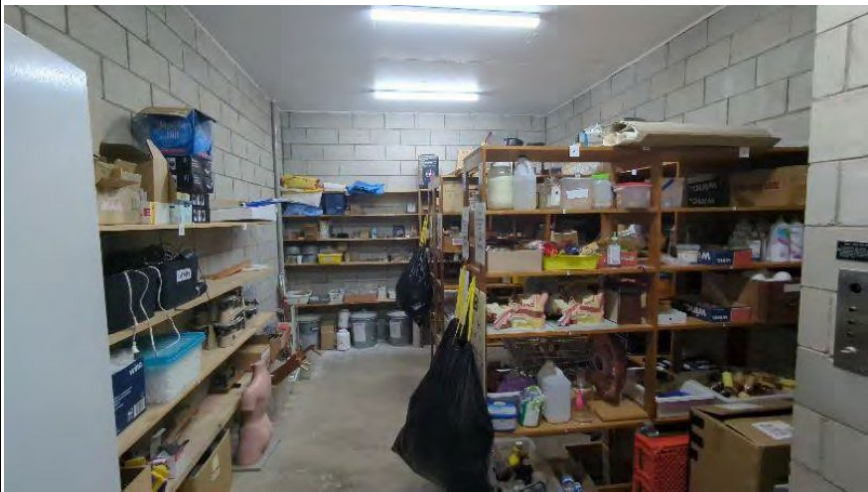
<p>B00A-R1E09 - App Store</p>	Masonry walls, concrete floor and plasterboard ceiling.	No signs of visible mould or water damage were noted. Condition 3

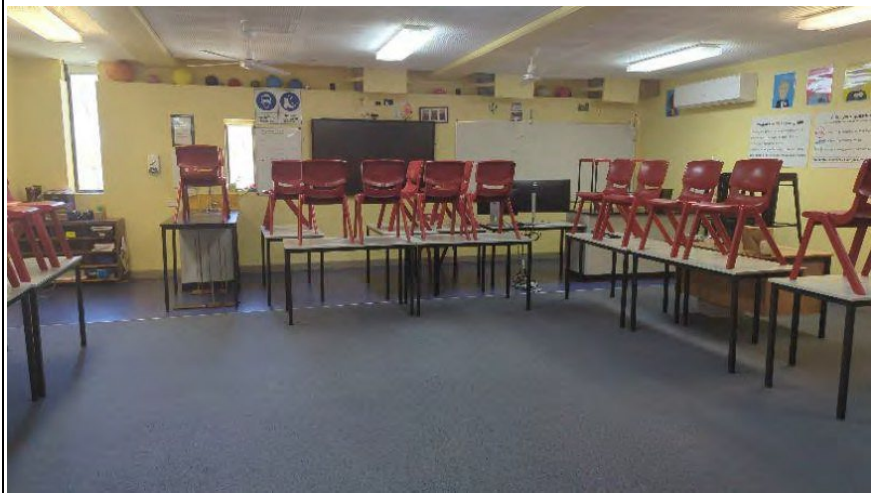
<p>B00A-R1E01 - Laboratory L.S</p>	Masonry walls, perforated plasterboard ceiling and carpet over concrete.	No signs of visual mould growth or water damage were noted. Condition 3

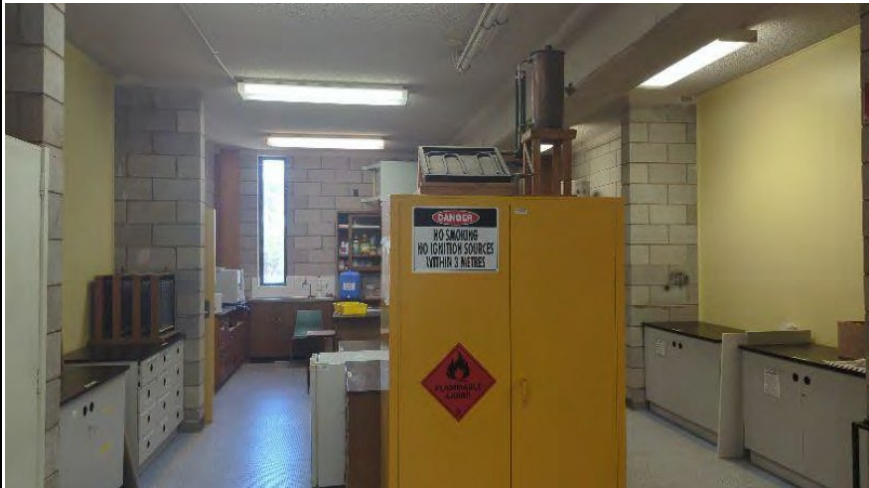
<p>B00A-R1E02 - Preparation</p>	Masonry walls, vinyl floor sheeting and concrete ceiling.	<p>No signs of visual mould growth were noted. Evaporative water staining was noted to vinyl floor sheeting and benchtops.</p> <p>Refer to index photos 205 - 210</p> <p>Condition 3</p>

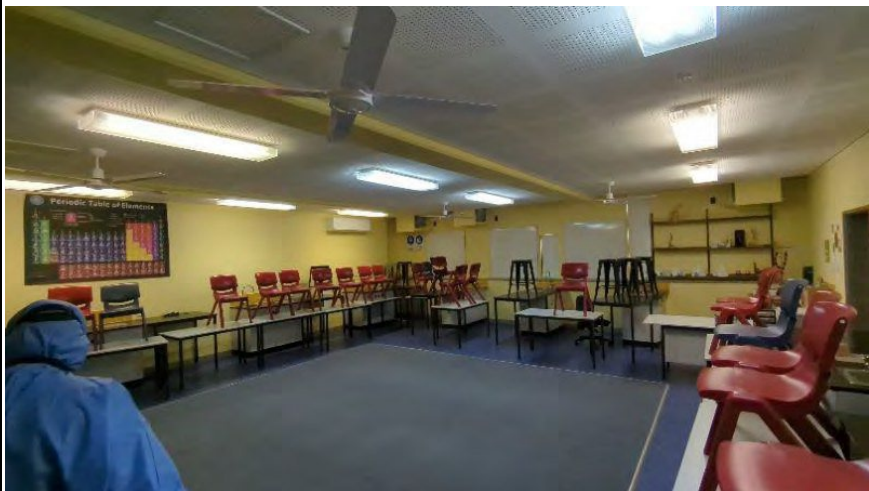
<p>B00A-R1E03 - Lab L.S</p>	Plasterboard walls, perforated plasterboard ceiling and carpet over concrete.	<p>No signs of visual mould growth were noted. Water stains were noted to carpet.</p> <p>Refer to index photos 211 - 212</p> <p>Condition 3</p>

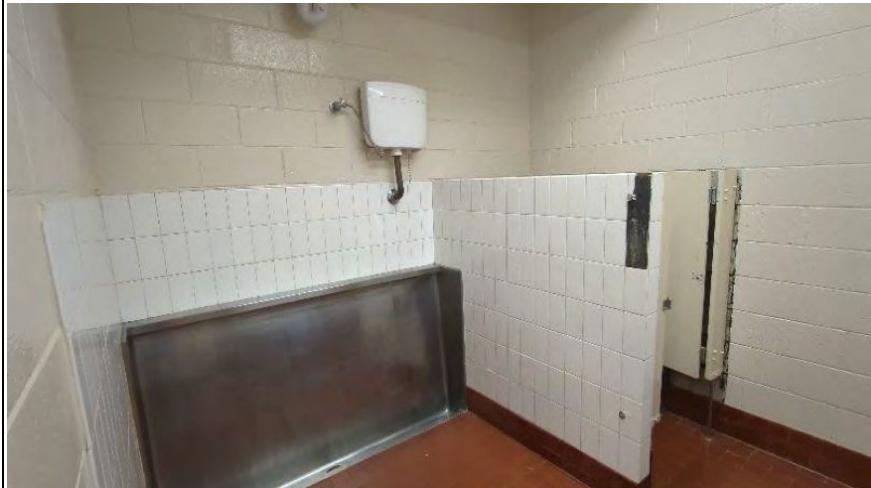
<p>B00A-R1E07 Boys Toilet</p>	Masonry walls, ceramic wall tiles, ceramic floor tiles and concrete ceiling.	<p>Suspected visual mould growth was noted to chipboard 'splashback' behind sink mirror.</p> <p>Refer to index photos 213 - 216.</p> <p>Condition 3</p>

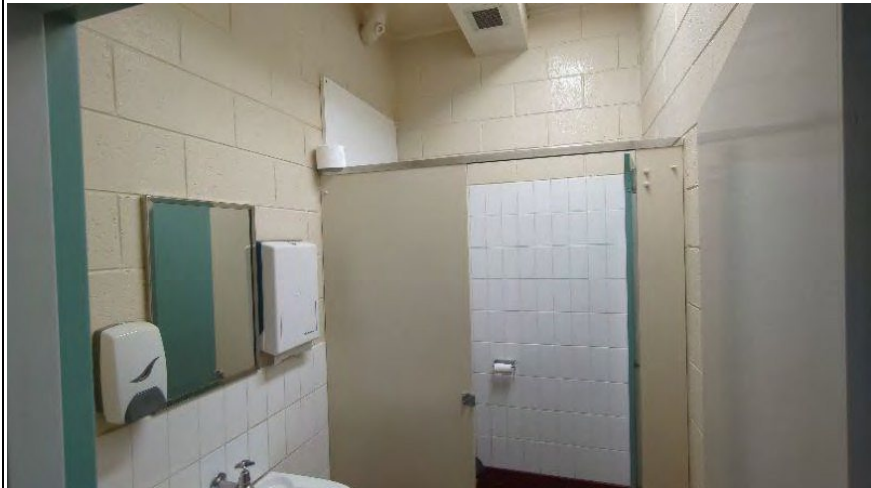
<p>B00A-R1E06 Staff Toilet</p>	Masonry walls, ceramic wall tiles, ceramic floor tiles and concrete ceiling.	<p>Suspected visual mould growth was noted to the toilet seat.</p> <p>Refer to index photo 217</p> <p>Condition 3</p>

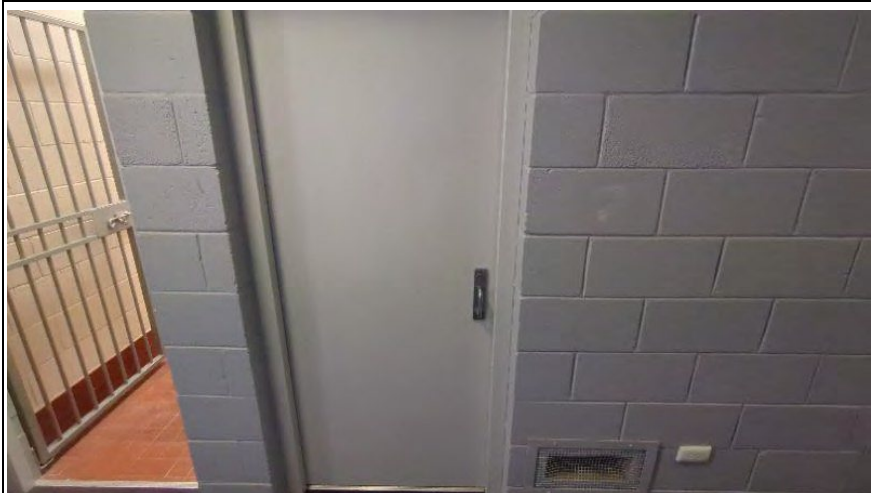
<p>B00A-R1E05 Staff Toilet</p>		No access Assumed mould

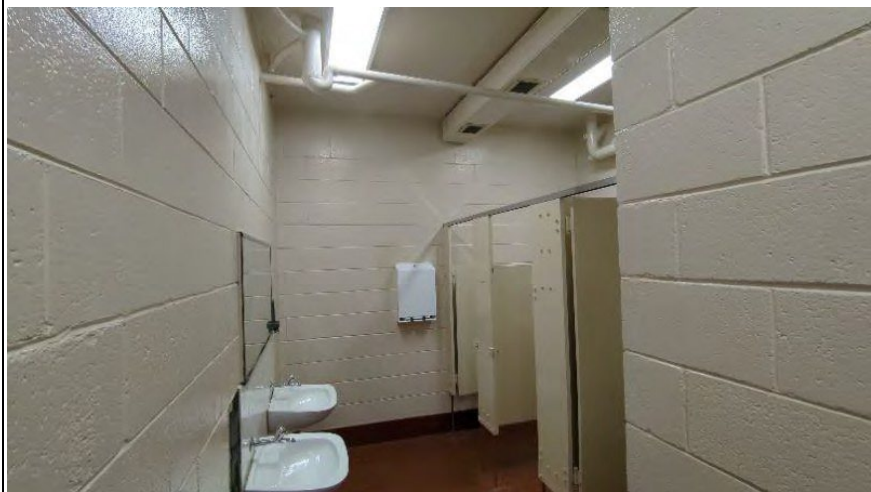
<p>B00A-R1E04 Girls Toilet</p>	Masonry walls, ceramic wall tiles, ceramic floor tiles and concrete ceiling.	No signs of visual mould growth. Evaporative water stains were noted to ceramic floor tiles. Condition 3

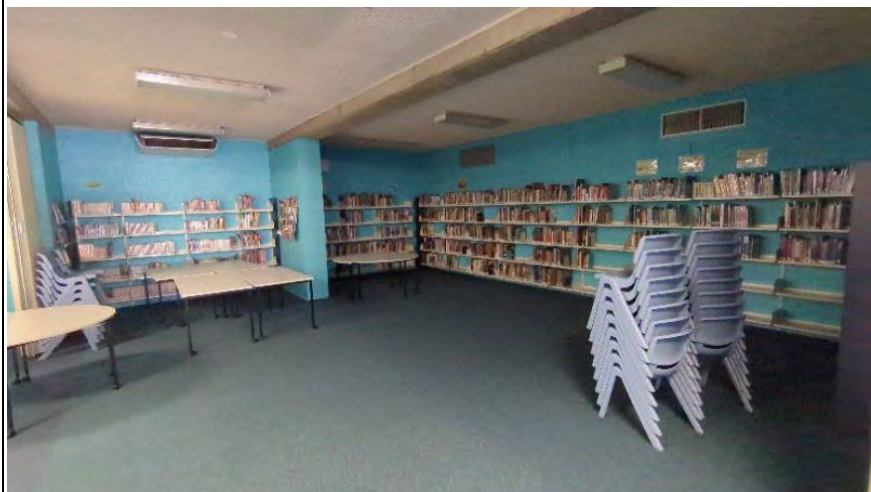
<p>B00A-R1N03 - Work room</p>	Masonry walls, carpet over concrete and sprayed coating (vermiculite) ceiling.	<p>No signs of visual mould growth or water damage were noted.</p> <p>Condition 3</p>

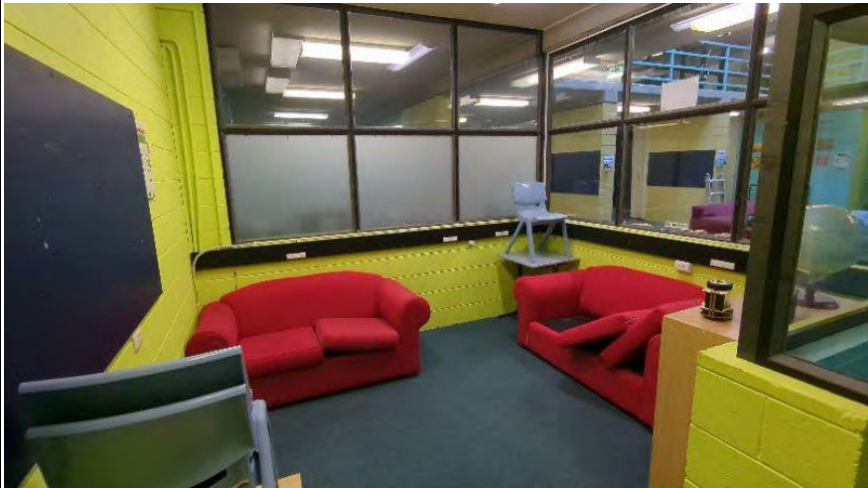
<p>B00A-R1N09 - Librarian</p>	Masonry walls, carpet over concrete and sprayed coating (vermiculite) ceiling.	<p>Suspected visual mould growth was noted on the couch.</p> <p>Refer to index photos 226 - 227</p> <p>Condition 3</p>

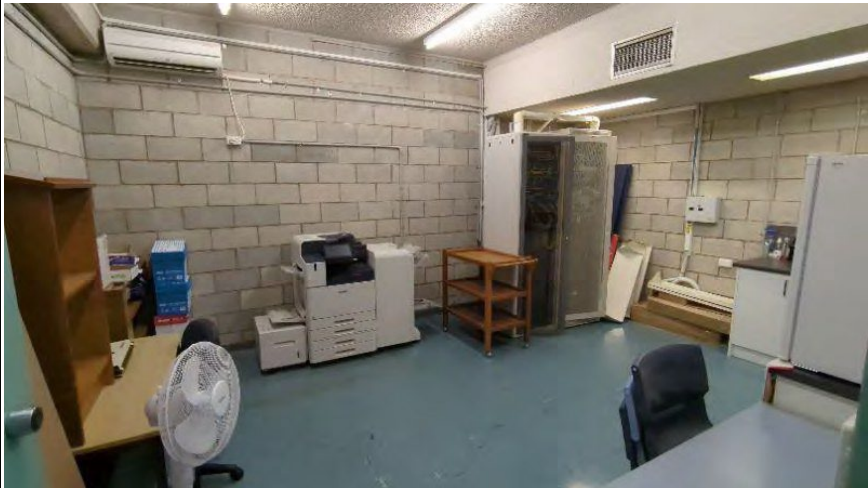
<p>B00A-R108 - Storeroom</p>	Masonry walls, carpet over concrete and sprayed coating (vermiculite) ceiling.	<p>Suspected visual mould growth was noted to porous contents.</p> <p>Refer to index photo 228</p> <p>Condition 3</p>

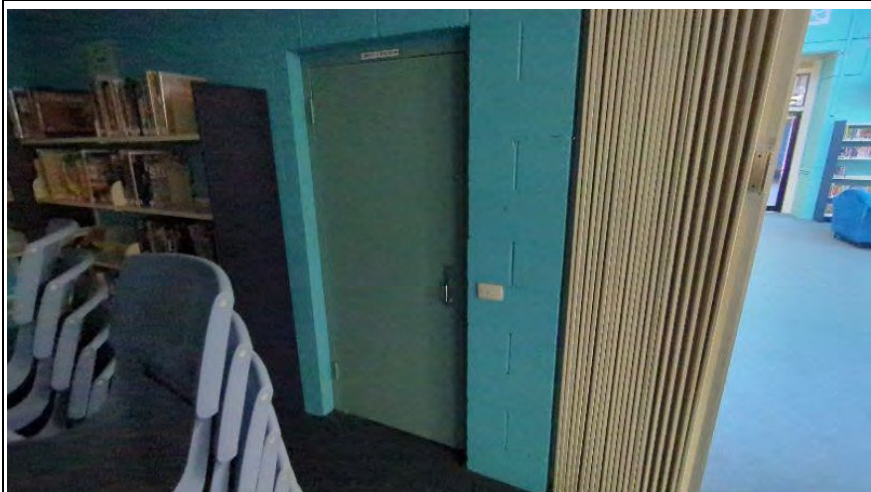
<p>B00A-R1N04 - Storeroom</p>		<p>Storeroom no access</p> <p>Assumed mould</p>
<p>B00A-R1N07 Store room</p>		<p>No access</p>

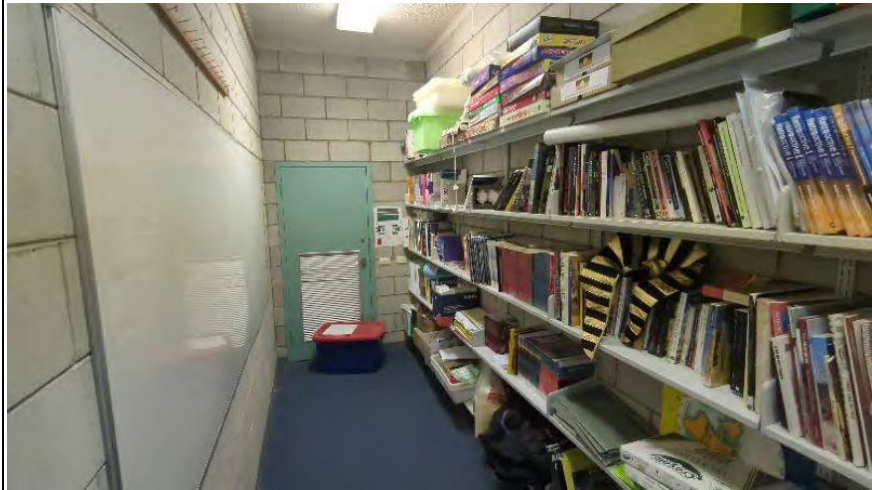
<p data-bbox="354 947 651 978">B00A-R1W24 - Store room</p>	<p data-bbox="943 447 1255 552">Masonry walls, carpet over concrete and sprayed coating (vermiculite) ceiling.</p>	<p data-bbox="1273 447 1552 552">Suspected visual mould growth was noted to the carpet.</p> <p data-bbox="1273 569 1552 632">Refer to index photos 239 - 240</p> <p data-bbox="1349 648 1476 680">Condition 3</p>

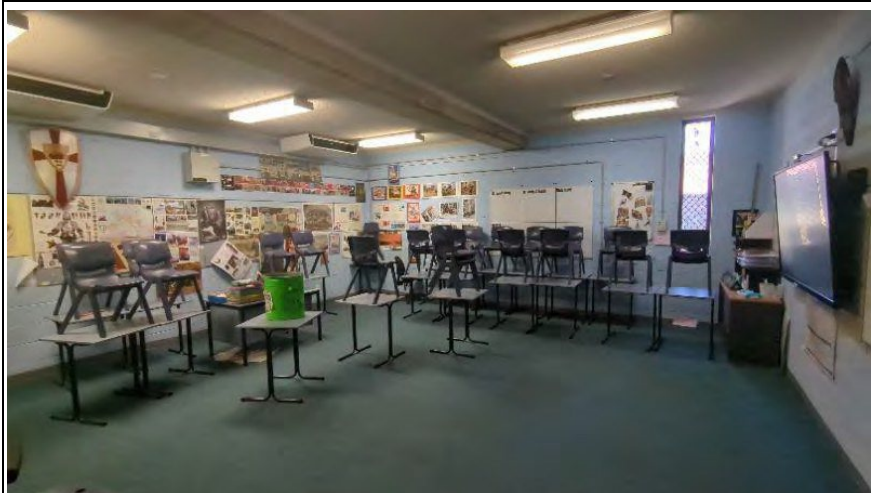
<p>B00A-R1W22 - General L.S</p>	Masonry walls, carpet over concrete and sprayed coating (vermiculite) ceiling.	No signs of visual mould growth or water damage were noted. Condition 3

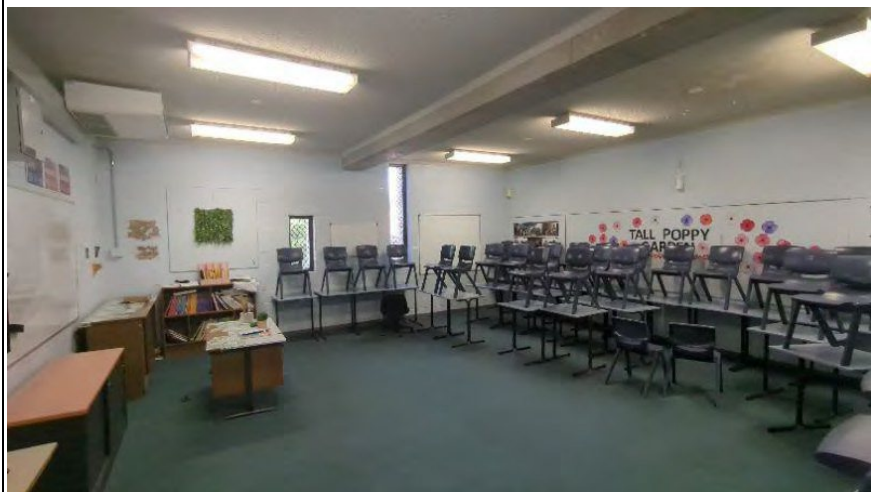
<p>B00A-R1W21 - General L.S</p>	Masonry walls, carpet over concrete and sprayed coating (vermiculite) ceiling.	Suspected visual mould growth was noted to carpet floor and all contents. Refer to index photos 261 - 267 Condition 3
